## 15. Appendix B – Snyder Watershed Sediment Assessment 2012

### Snyder Creek Watershed Sediment Assessment 2012

Prepared by Dan Richardson,  
UCD Watershed Resource Technician

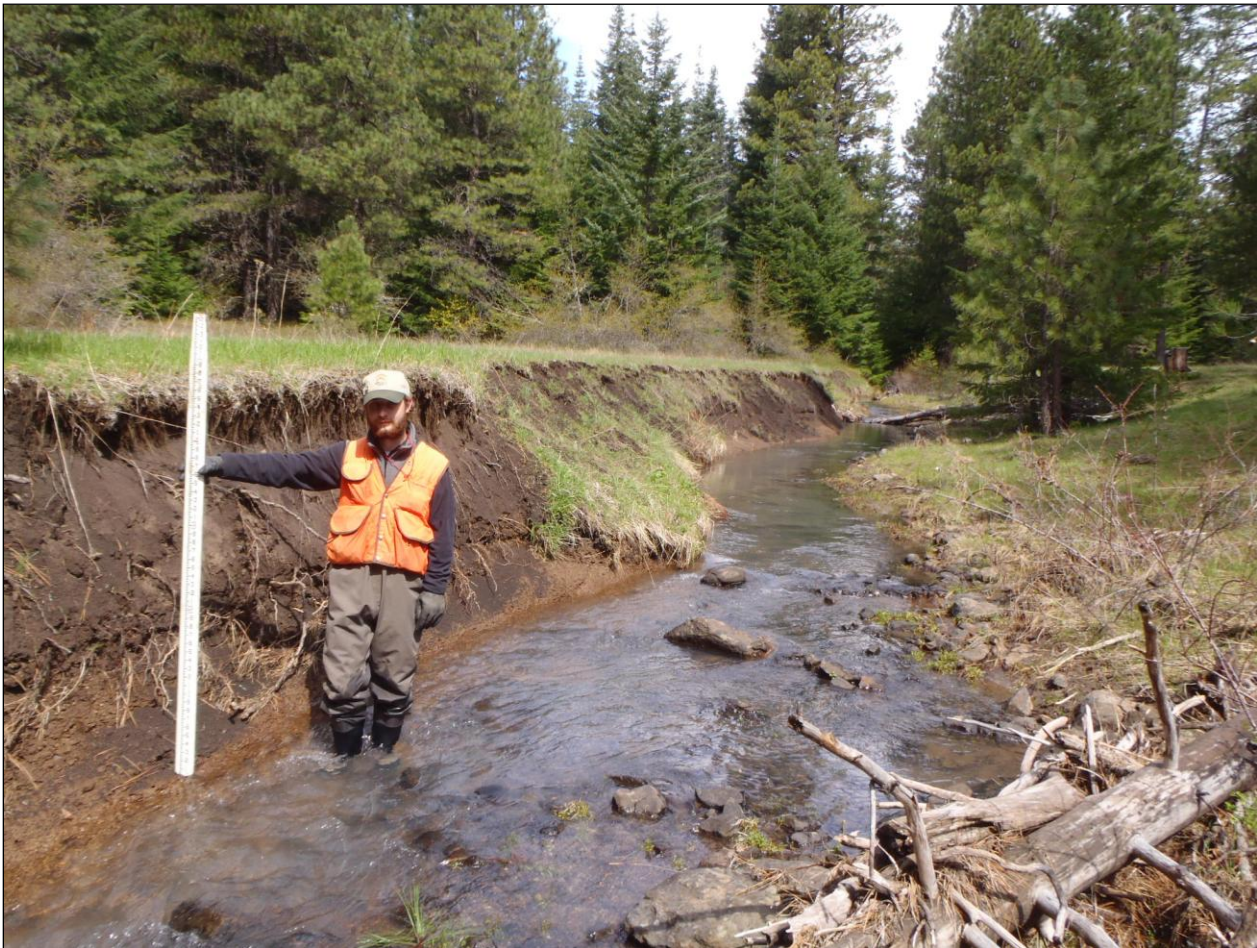
**Simmons Creek (West Fork).** Typical view of an incised channel. The historic channel meandered through the low-gradient meadows of this area.

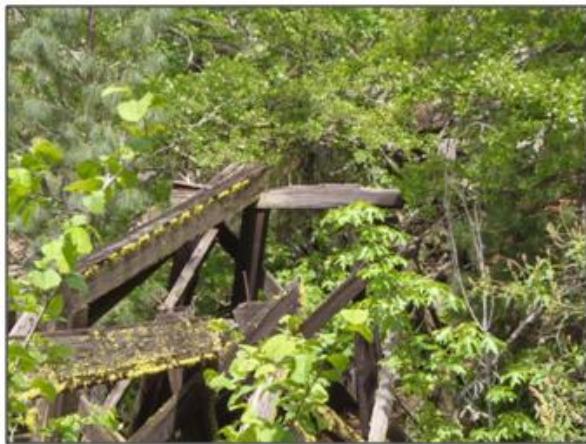
Figure 4: Wreckage of an abandoned railroad line up Snyder Canyon. Historically, rail lines transported logs from productive flats at the top of the watershed to be milled near Klickitat, at the bottom.

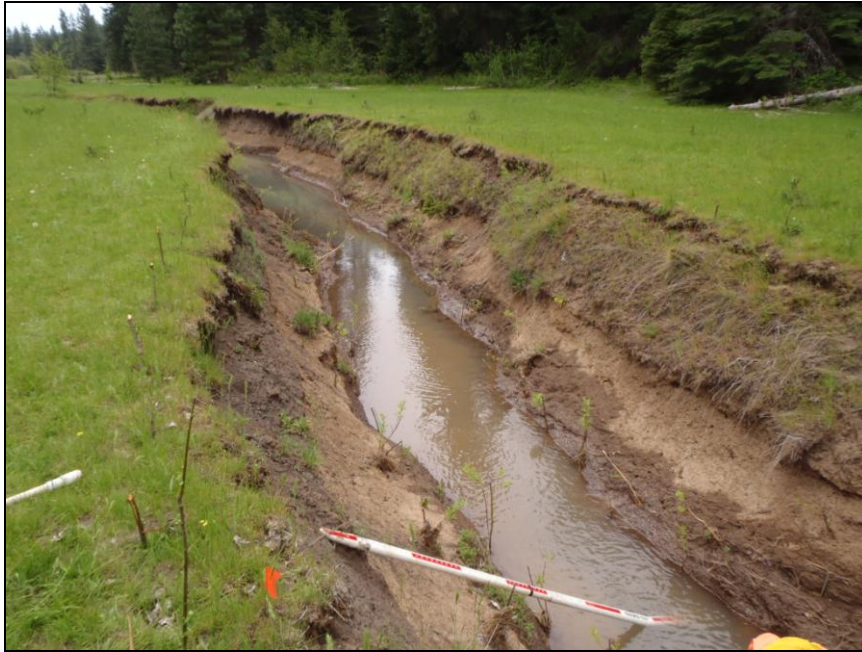
## Simmons Meadow

**Figure 6: Simmons Meadow.** Looking downstream from the top of the measured erosion site.

One of the three large historic meadow complexes in the watershed, Simmons Meadow has experienced significant erosion, likely as a result of channel-straightening during previous logging periods. There is very little to no riparian vegetation except short grass, which grows on the meadow perched above the stream. The result is a deeply incised channel (approximately 5-6' deep, with an extremely narrow channel (its bankfull width/depth ratio averaging 5.16 in the measured portion, the lowest of any of the sites' ratios) running for approximately 3,300 feet of stream longitudinal distance. This meadow is a reference area for our protocol. This site has seen initial restoration measures by WA Dept. of Fish and Wildlife, Mid-Columbia Fisheries Enhancement Group, and Underwood Conservation District for the past several years, including log check dams, riparian exclusion fencing, two hardened cattle crossings and continued bank re-vegetation (primarily willow live-stakes, with some red-osier stakes, sedges and rushes). These efforts are preliminary, with hoped-for results in the next several seasons as vegetation takes root. Ownership: John Hancock Life Insurance.

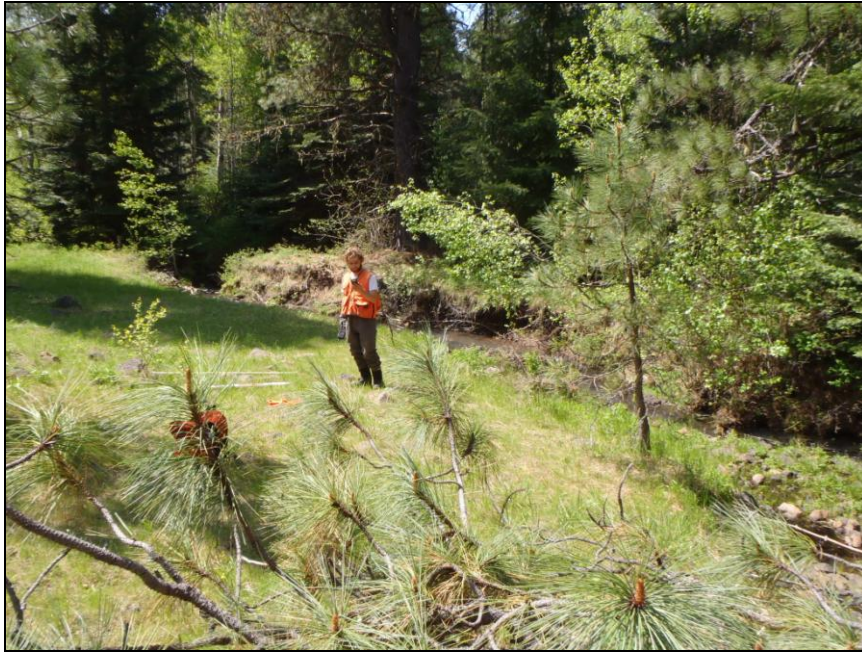
## Check Dam 9

**Figure 7: Check dam 9 erosion site.** The stream rapidly incises from a connected floodplain, a few yards upstream from the right-hand side of the image, to the deepening channel at the bend on the photo's left.

This site represents the upstream initiating site of the long incised channel down to Simmons Meadow, separated only by a few hundred feet of functioning wet meadow, attached floodplain and aspen groves. An earlier generation of watershed-restoration measures identified ongoing erosion of the Simmons West Fork as a primary need and attempted to address that in part through small check-dams made of fence posts and heavy fabric. At least 14 were installed, by field observation. Most appear to have held back sediment temporarily: only small amounts (<1 cubic yard) generally remains in situ. This site is the ninth dam upstream of Simmons Meadow. It's located at a sharp S-bend in the stream, where the West Fork of Simmons Creek rapidly descends from a somewhat-functioning meadow and connected floodplain into a deep incised channel which runs downstream through historic woods and meadows to Simmons Meadow. There is current evidence of a perched water-table here, with percolation observed from the side of the incised channel, 2-3' above the spring stream-flow. The ongoing erosion, in other words, appears to have incised the stream channel below the surrounding water table. Atop the perched floodplain/wet meadow area are mixed stands of ponderosa pine, grand fir and aspen; their roots reach only about half-way down the incised bank toward the bottom of the measured site (and downstream). Like Simmons Meadow half a mile downstream, this site has no stream-bottom vegetation. Given its longitudinal impact, this site represents the beginning, not totality, of an incised stream reach. Ownership: Washington Department of Natural Resources.

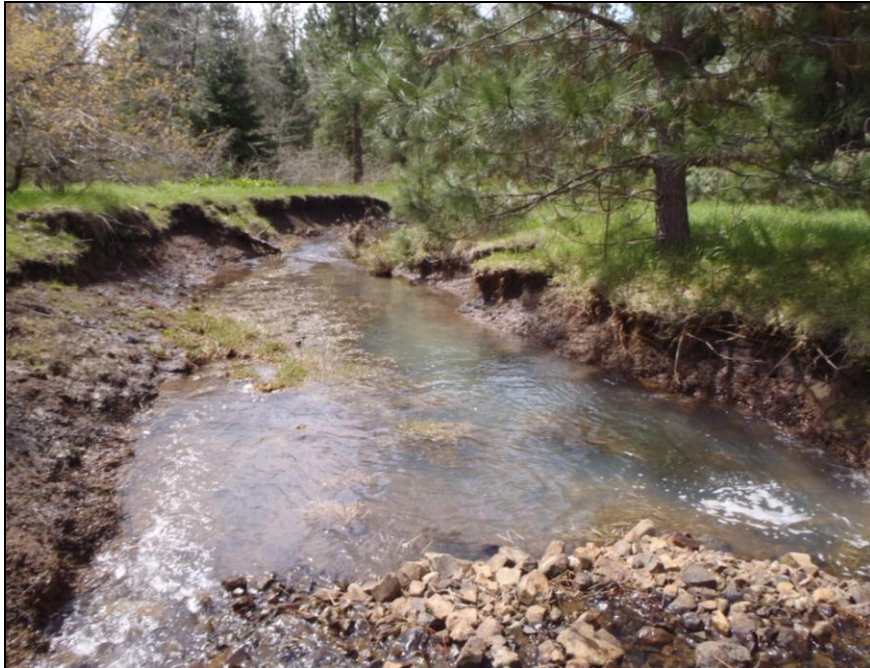
**Figure 8: Check dam 10 /Camp erosion site.**

This view looks downstream from the hardened crossing at the site's head. Eroded banks are evident, especially on the photo's left, immediately downstream of the crossing.

Located at the tenth observed fabric check dam upstream of Simmons Meadow, this short erosion site is located a few dozen yards east of an informal but popular camping site on DNR property along Legall Road. The Dam 10 site was measured at the check dam (and apparent hardened crossing), downstream. The banks are shallowly incised (1.5-2'), but appear to be deepening. There are functional, attached wet-meadow areas upstream and downstream of Dam 10, which suggests the possibility that restoration work here could be successful. There is also evidence of occasional cattle and off-road vehicle use; an important first step would be to strengthen the fence and gate near the informal camp area. Ownership: Washington Department of Natural Resources.

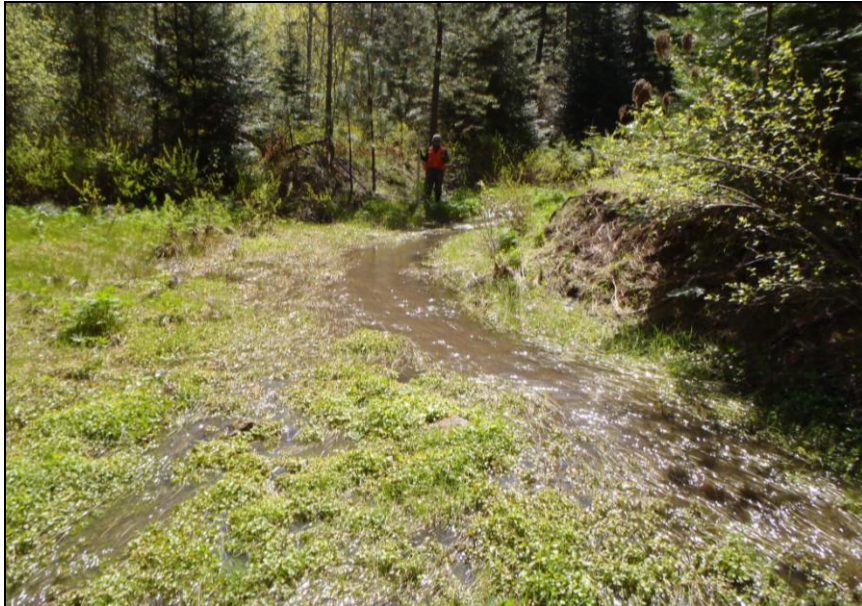
## L5 / Check Dam 11

**Figure 9: L5 / Check Dam 11.** Looking upstream from the downstream end of the site. Heavily vegetated in places, especially toward the downstream portion, with aquatic vegetation, but also featuring sloughing banks.

This erosion site is located in an area we're calling the Legall meadows complex: a long string of wet meadows and meandering stream channels amid saturated woodlands (cottonwoods, aspen) situated near Legall Road in the upper reaches of the West Fork of Simmons Creek. This string of meadows is approximately 1.4 miles long, from the Check Dam 10 site upstream to the "L6" sites. Technicians labeled six wet meadow areas of various size, ending upstream at the L6 area (see Figure 6). At L5/Check Dam 11, a downstream wet meadow area in a ponderosa pine plantation of ~20-year-old trees, to a short section of 2-3' eroded banks. A few shrubs and stream-bottom grasses are present. Given its distance from Legall Road and lower elevation, restoration at this site could include a thinning of the pines, replanting riparian shrubs and trees, and adding large-woody debris jams. This site is within a few dozen yards of the L6/Lower Meadow site, separated by a small attached floodplain, a copse of mature cottonwood trees and small logjam, and a boundary line. Restoration work at this site could, probably should, be combined with work at the L6/Lower Meadow site, approximately 200 feet upstream. Ownership: Washington Department of Natural Resources.

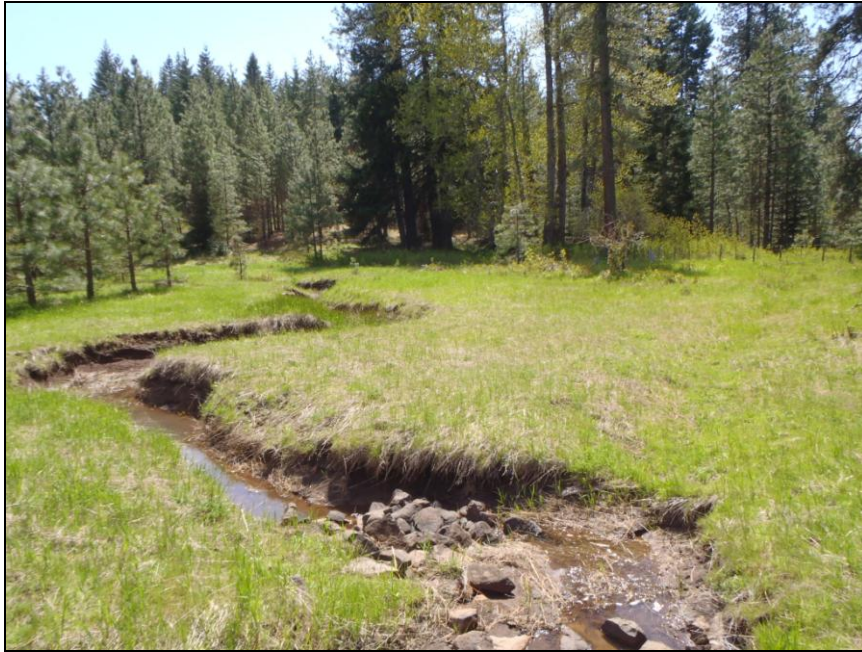
## L6 / Lower Meadow

**Figure 10: L6/Lower Meadow.** The view downstream, where the channel is both meandering and incising. The edge of a pine plantation is visible in the upper left portion of the photo.

At approximately 4.75 acres, L6 is a substantial wet meadow area (~4.75 acres), and the Lower Meadow erosion site is situated nearly at its outlet. At the downstream end of L6 (i.e., upstream of the Dam 11 site), the stream splits into two headwaters forks, watering two arms of the Y-shaped meadow area. The northerly fork drains down from meadows and forests, through a 0.3-acre holding pond, and then in a narrow channel along the base of rising ground, to the Y confluence. Much of this is thinly vegetated, being apparently previously logged, and now planted as a timber plantation. Above the confluence, the Lower Meadow erosion site is located where the stream bends at an apparent overflow channel, and incises to approximately 1' before regaining, for a short distance, an active flood plain. Restoration efforts here could be conducted with a minimum of disturbance to the timber being grown by adding riparian vegetation.

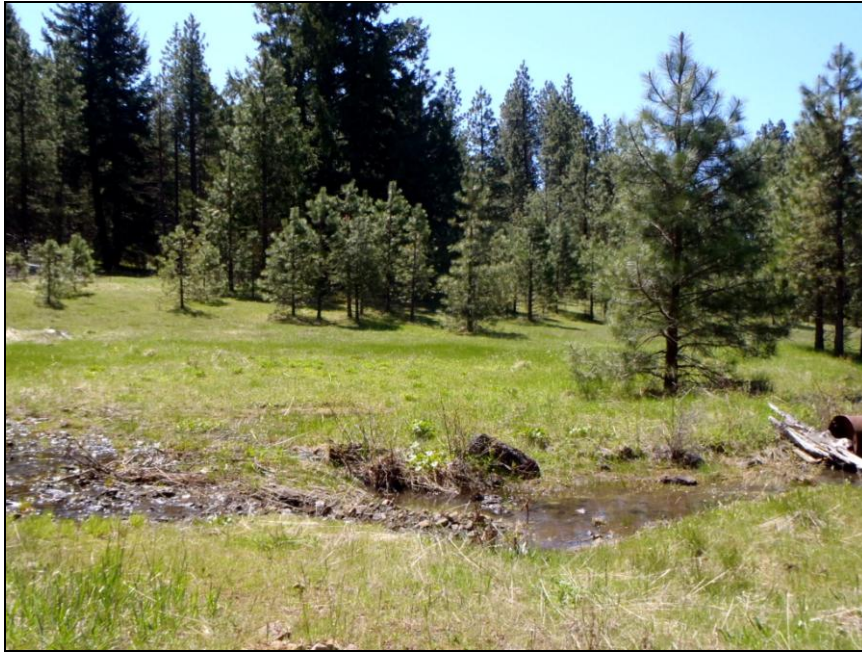
**Figure 11: L6/Ford.**

Looking across the ford (photo left), and immediately downstream. The stream, representing a small volume of flow in this headwater reach, is percolating through/over the cobbles of the ford.

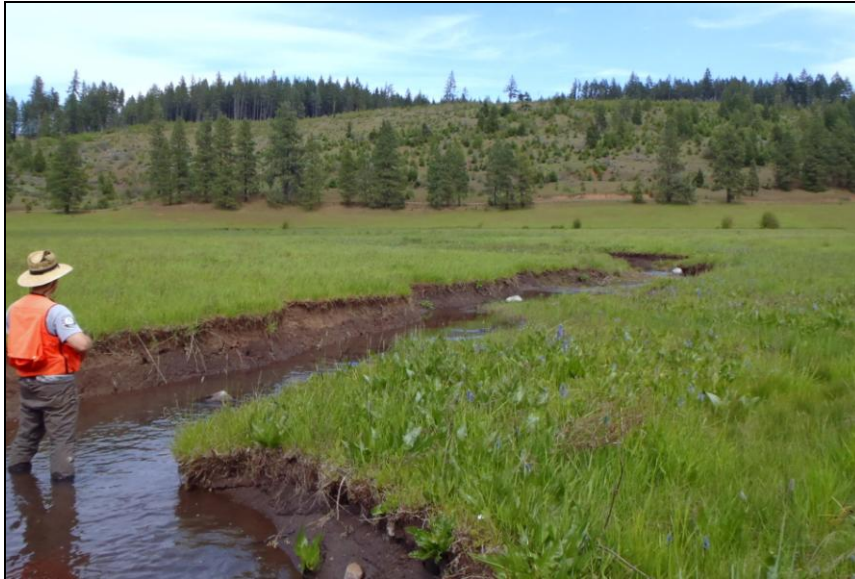
## Swale Meadow

**Figure 12: Swale Meadow: newly incising stream.** This historic wetland was ditched and drained, but the stream (Snyder South Fork) here is escaping its ditch at the base of a steep reach, and is meandering across the Swale toward the main stem of Snyder Creek (below trees in photo).

Unscored. “Swale Meadow” is a site name given to an identified portion of lower Snyder Swale that represents an active channel-forming area where a stream appears to have recently escaped a ditch. This does represent a “hazard” in the sense that carving new channels is exposing considerable mineral, and no doubt exporting it as sediment. However, we believe this process is a natural one: a reassertion of stream dynamics long pent up by previous ditching efforts and land-uses, and representing as much an opportunity as an erosion problem. Furthermore, there are multiple (2-3) active, sinuous stream channels: the stream appears to have no single established channel yet.

There appears to be substantial potential for stream and meadow restoration here: The landowner has taken a hands-off management approach and granted UCD access; future timber harvest is unlikely; there's a stream confluence with active channel-formation (multiple newly created channels); and there are functional wet meadows / wetlands downstream to expand. The area immediately upstream and downstream of the Snyder South confluence represents a meadow area of approximately 3 acres. These two private Snyder Swale parcels, and particularly the downstream one, hold excellent potential for maximizing sediment- and water-storage capacity. Owners: Private individual.
