**Technical Memorandum:
Ala Spit Restoration Feasibility,
Island County, WA - Draft**

Prepared for: Island County Public Health

Prepared by: Coastal Geologic Services Inc.

August 15, 2013

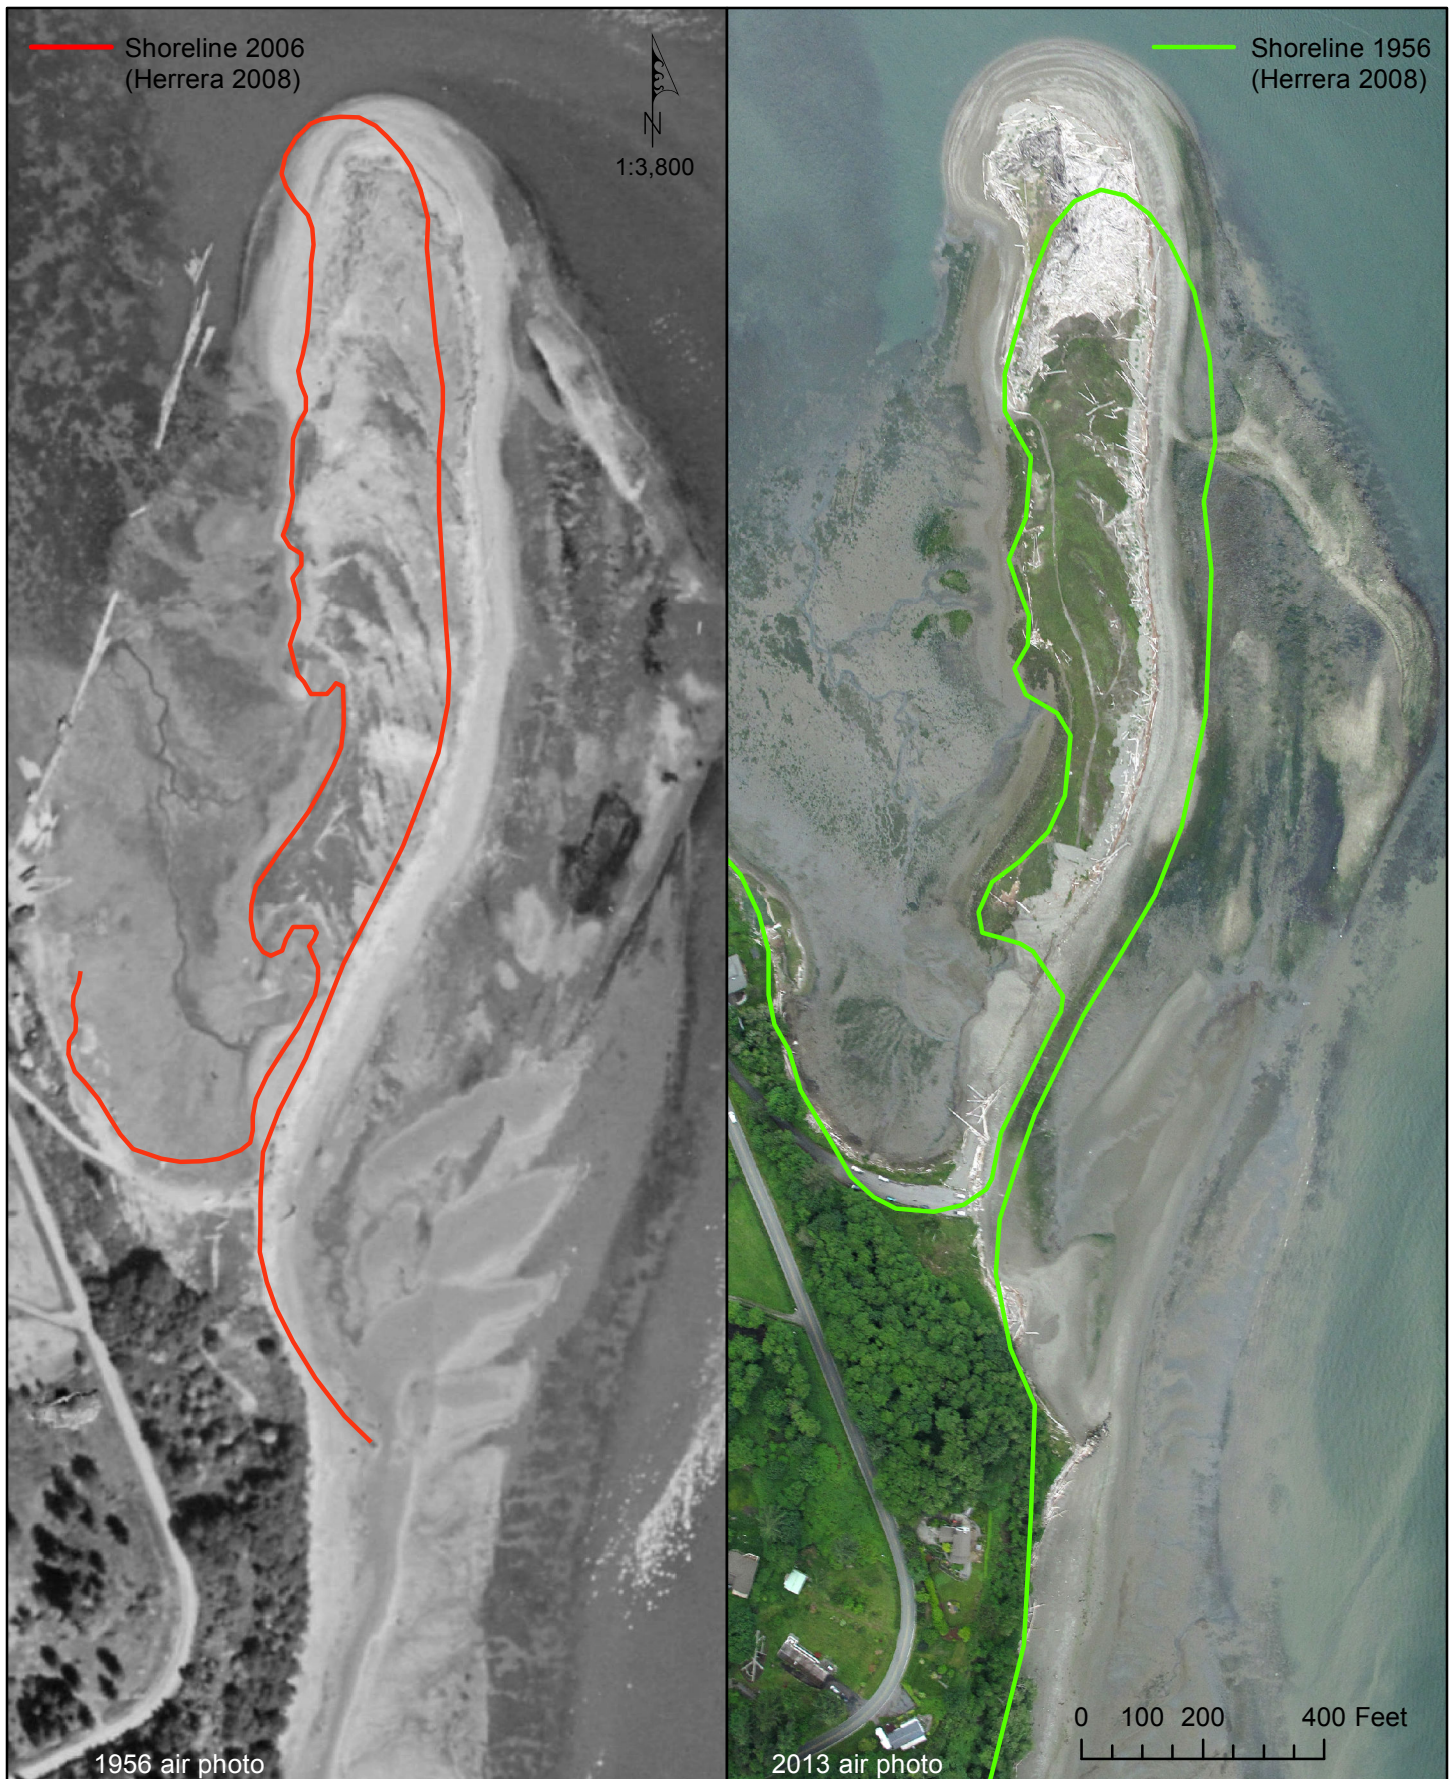
Figure 7. Historic 1956 and current (2013) air photo with contrasting shorelines.

Comparison of the 1956 and current (2007) aerial photos with contrasting high water shorelines for the Ala Spit area reveal that the groin appears to have played a significant role in altering the morphology of the spit. The spit was much straighter in plan form in 1956 as compared to later years (Figure 7). The groin appeared to fill out into the intertidal and cause wave refraction and disruption of upper-beach

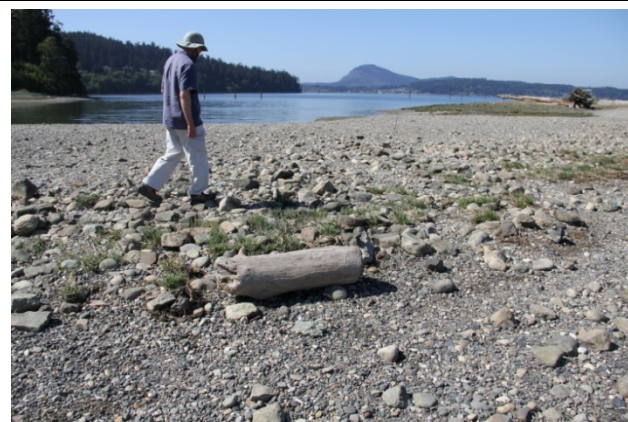
Sub-angular quarry spall and pebble near the neck of the spit

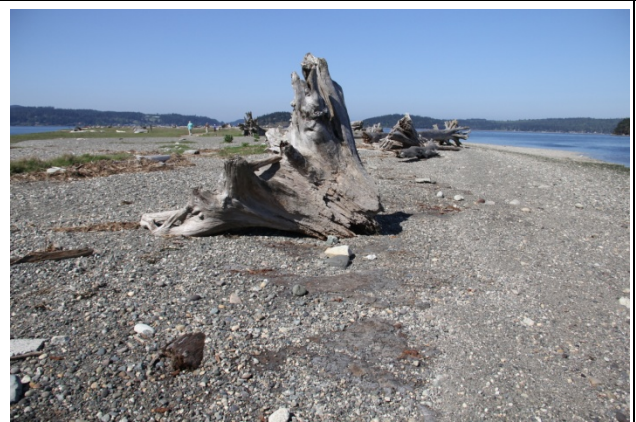
Higher pebble concentrations in the central portion of the spit

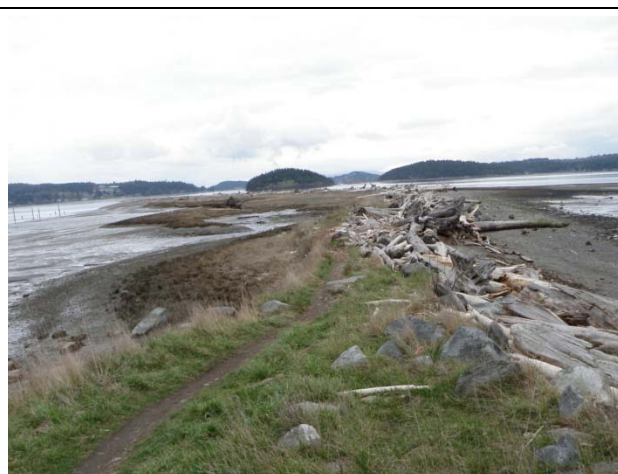
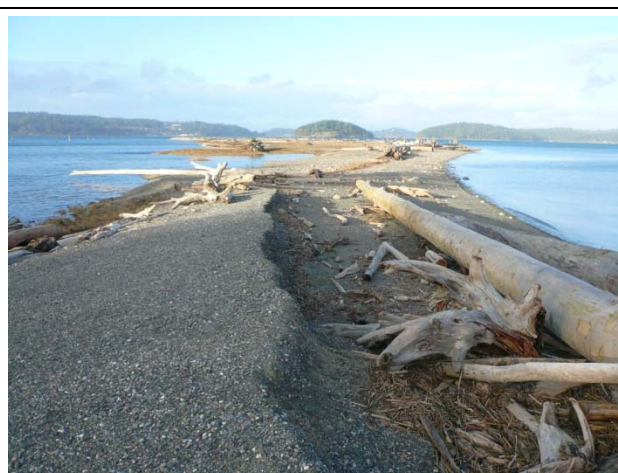
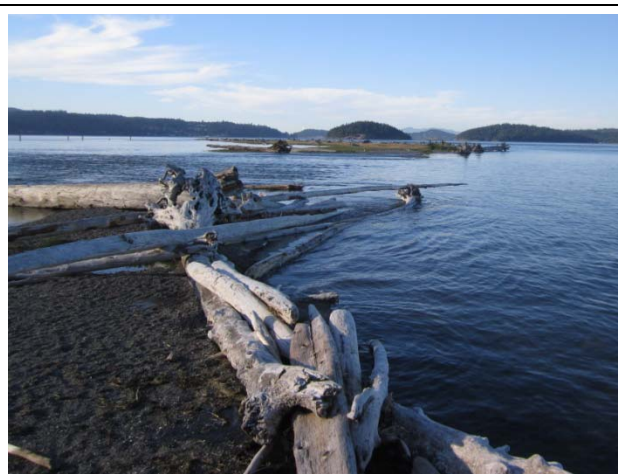
Photo Page 5. Ala Spit neck partial breach progression. The log with rootwad in left background can be used for relative scale and water level.

- ◆ The neck of the spit is not about to be breached. However, the riprap revetment is being undermined as the pocket estuary/lagoon is slowly eroding due to the loss in sediment supply and the increase in wave energy. The loss of sediment supply has been caused by the elimination of overwash by the riprap revetment.
- ◆ The small rock groin and the park bulkhead are not responsible for the changes observed at the neck of Ala Spit. Instead, the riprap revetment has precluded sediment accretion on the spit by preventing overwash and splay formation.

10/11/2007, mid tide event and pre-revetment removal.
(H. Shipman)

2010, low tide event and pre-revetment removal. (T. Smayda)

11/2011, mid tide event and post-revetment removal
(H. Shipman)

2/22/12, mid tide event and post-revetment removal (CGS)

12/2012, extreme high tide event, post-removal (T. Zackey)

7/24/13, high tide event, post-removal (CGS)
