**Technical Memorandum:
Ala Spit Restoration Feasibility,
Island County, WA - FINAL**

Prepared for: Island County Public Health

Prepared by: Coastal Geologic Services, Inc.

October 18, 2013

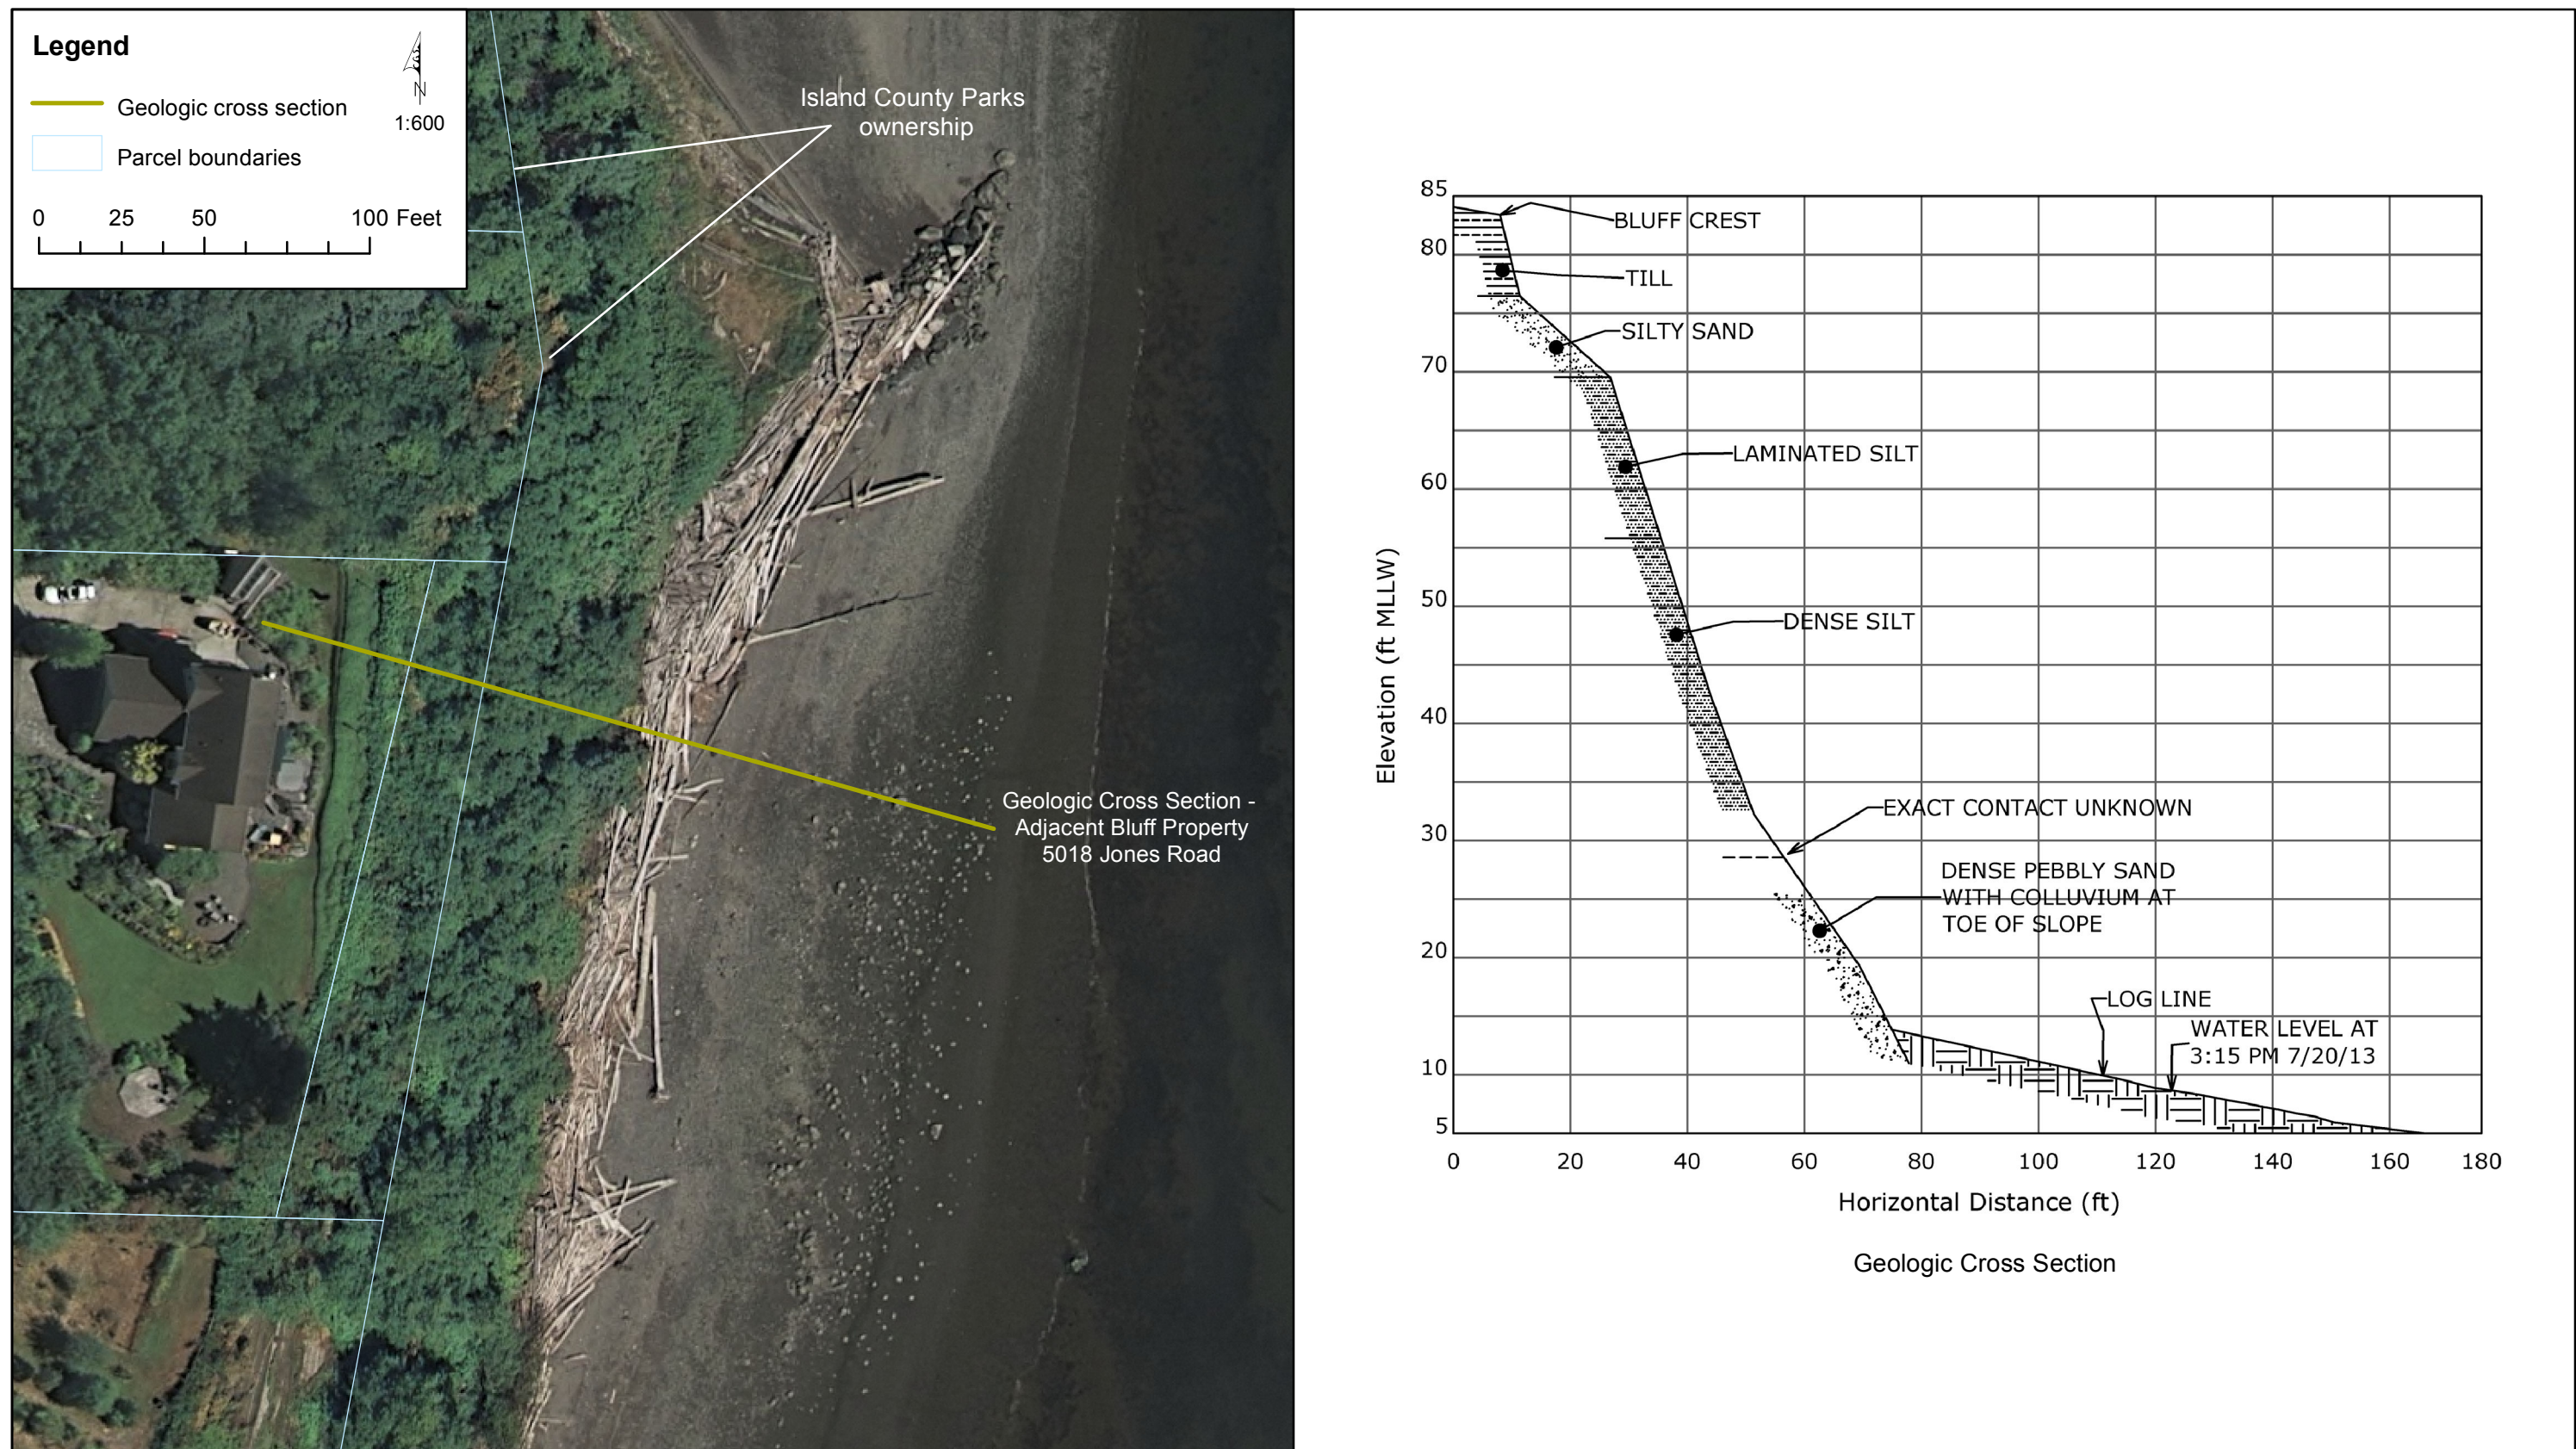
Figure 3. Ala Spit adjacent bluff property geologic cross section.

The base of the bluff was covered with colluvium (slide debris) in this area. Colluvium consisted of silt and sand with lesser amounts of pebble. At approximately +33 ft Mean Lower Low Water (MLLW) elevation, dense silt and fine sand beds were encountered. Above dense silt beds at approximately +51 ft MLLW deposits were interpreted as laminated glacial lake deposits. Minor seepage was observed at this elevation. Above this, an unknown thickness of sand and silty sand was encountered. Till was found towards the top of the bank with a definitive contact located approximately 12 ft below the bluff crest.

The geology observed in the field closely aligns with that mapped by Dragovich et al. (2000). The geologic units were characterized while ascending the bluff for topographic survey. A bluff cross section was generated from the topography data with approximate locations of the geologic units (Figure 3, Photo Page 2). The description of the units as observed in the field and correlated with the previously mapped units is as follows:

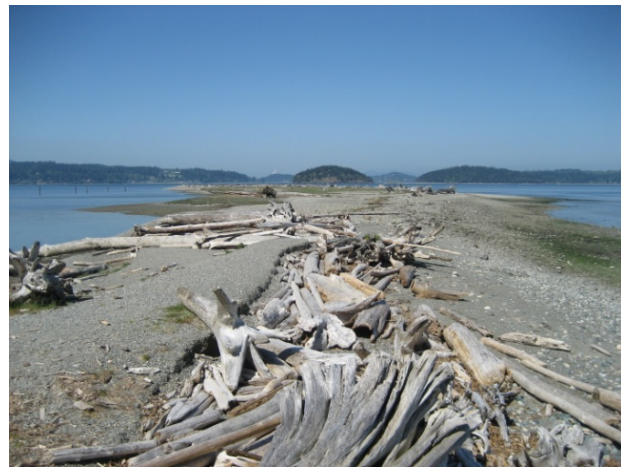
Low tide from neck and parking area looking north (5-9-13)

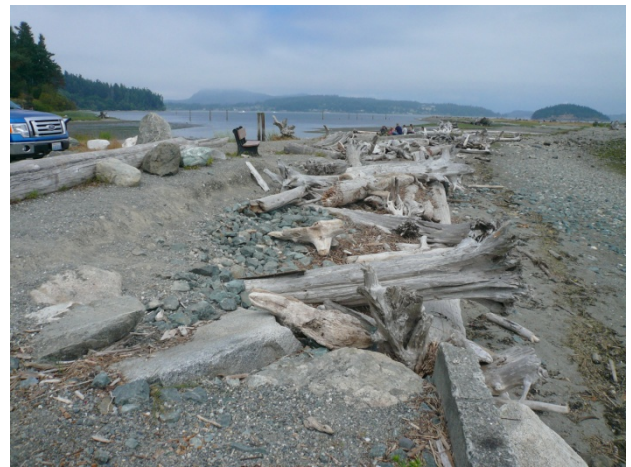
Parking and large wood placement looking north (7-20-13)

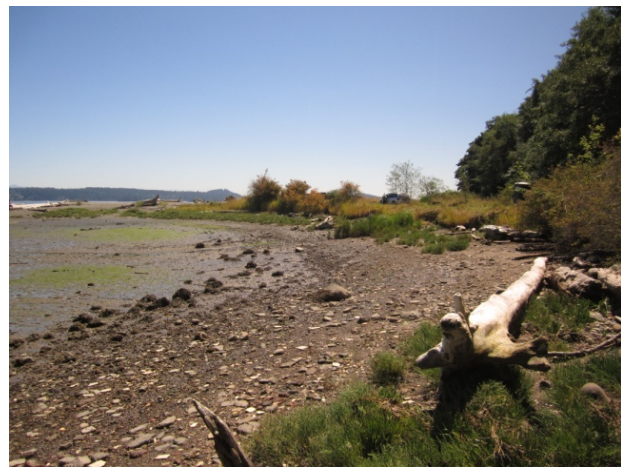
Southwest edge of lagoon, road and parking to right (7-25-13)

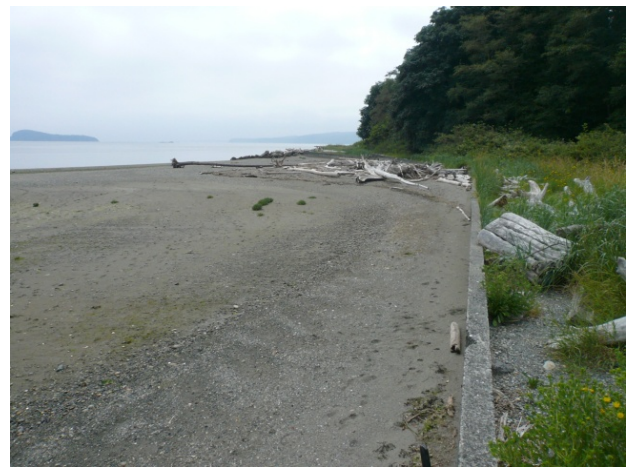
Bulkhead from parking area south to rock groin (7-20-13)

It should be noted that actions involving the removal of the bulkhead would appear to have no impact on the stability of the adjacent bluff property, especially in regard to potential erosion of the back fill west of (behind) the bulkhead.

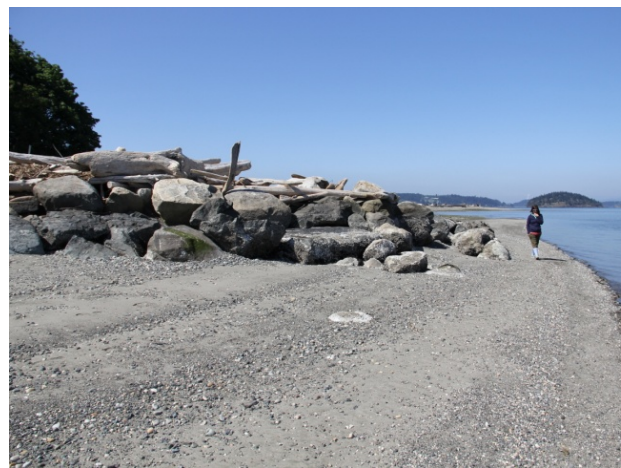
The groin has caused the beach south of it to accrete both sediment and large woody debris (LWD). It is likely that the rock groin abates toe erosion of the adjacent bluff property and reduces the susceptibility of this bluff to mass wasting processes and landslide events. This effect appears to extend approximately 125–175 ft south of the groin.

It is important to note that construction of the groin moved the shoreline on the order of 75 ft waterward, as evidenced by comparison of a 1956 aerial photo to current conditions. The groin also caused down-drift erosion north of the structure, as typically occurs (further discussed in the *Historical Shore Change* section below).

Rock groin extending into lower intertidal (5-9-13)

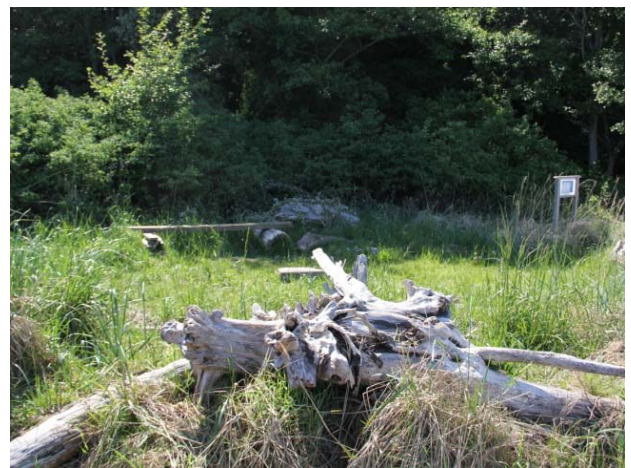
A small Washington Water Trails camp site for human-powered crafts such as kayaks is located landward of the rock groin and the south end of the concrete bulkhead. When observed on July 20, 2013, the camp site appeared as if it had not been used all spring and early summer. Very tall grass was growing which was not knocked down in any way. The fire area appeared as if it had not been used. This camp has a maximum footprint of 650 square ft as mapped in the field, but with encroachment of grasses, Nootka rose, and Himalayan blackberry, as well as drift logs thrown over the groin and bulkhead into the camping area, the footprint is smaller. Amenities at the camp site include a fire pit, sitting area, and room for one small tent. This camp site land is only dry and available due to the presence of the groin and bulkhead and the associated bad fill that was added to this area.

Kayak camp in fill area between groin and bulkhead (5-9-13)

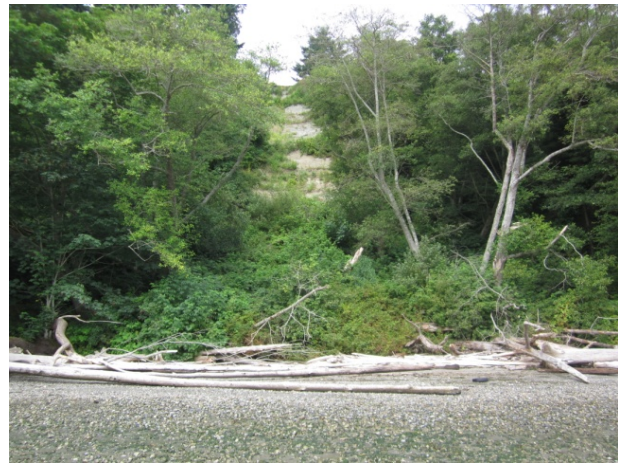
Factors that control landslides in Puget Sound bluffs are dependent on the characteristics of the bluff – composition, resistance, permeability, slope structure, bluff weaknesses – and local topography including the slope's landslide history (Emery and Kuhn 1982). Drivers of coastal erosion include marine, subaerial, or human-induced (Johannessen and MacLennan 2007). Of these drivers, most landslides in Puget Sound occur as a result of subaerial erosion in response to heavy precipitation, initiating shallow failures, or elevated groundwater conditions (Shipman 2004). Precipitation frequently leads to destabilization of Puget Sound bluffs due to contrasting slope-forming processes of underlying strata (Tubbs 1974). An example of this is when permeable outwash sands overlie impermeable glacial lake clays, and at this contact between sand and clay the saturated lower sands weaken and lead to upslope failures (Tubbs 1974). Many Puget Sound bluffs have a mid-slope bench that occurs at this contact (Gerstel et al. 1997) as is the case with Reference Bluff 1 (Photo Page 3).

Southern most reference bluff (1), and likely Qga unit exposed

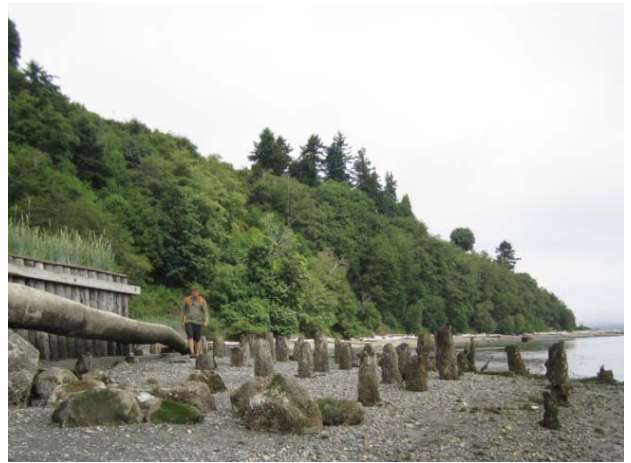
Reference bluffs (2-4) from private bulkhead north to Ala Spit

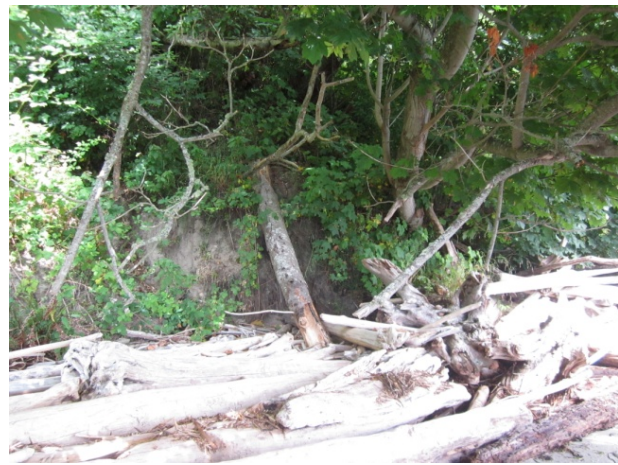
Reference Bluff 3: Steady moderate bluff crest recession between all years observed. A house had been constructed prior to 1956 at the bluff crest and a bare scarp was present immediately below the house on the upper bluff face. A possible debris flow, earth flow, or earth slump had occurred between 1956 and 1969 as shown by the appearance of a “chute” below the house devoid of vegetation and a bare scarp immediately below the house. The 1985 aerial photo indicated a period of relative stability, as both the vegetation and the upper bluff scarp appeared to have grown in. The house at the bluff crest appeared to have been moved back and/or reconstructed sometime between 1985 and 2007.

Reference bluff 3 – silty sandy colluvium with toe erosion

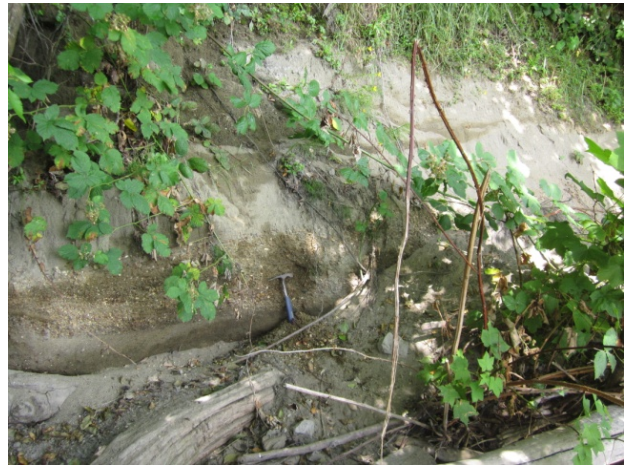
Reference Bluff 4: Steady moderate bluff crest recession between all years observed. A house had been constructed between 1956 and 1969 at the bluff crest. A debris flow or earth flow appeared to have occurred in close proximity to the bluff cross section between 1956 and 1969, possibly associated with the construction of the residence. The 2007 aerial photo showed a bare scarp in the upper bluff face in the same location as the previous slide.

Reference bluff 4 – sand and pebble with minor toe erosion

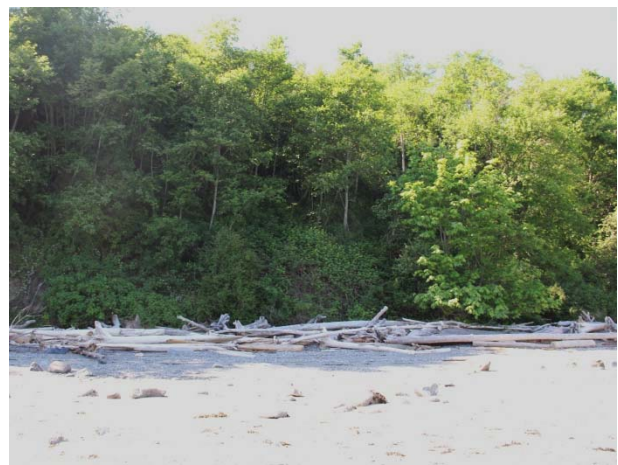
Broad, accreted beach immediately south of the groin at the “Adjacent Bluff Property”

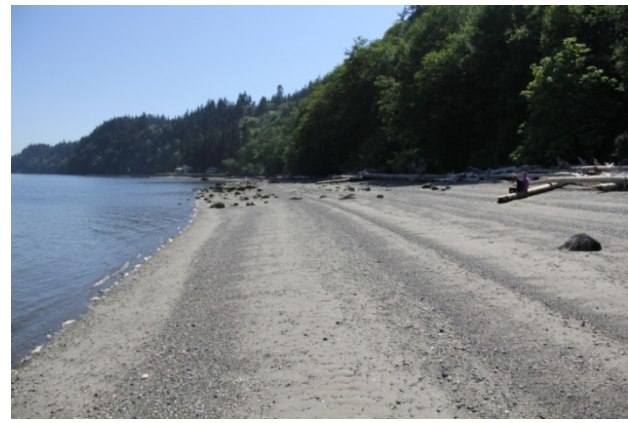
Sand and pebble south of groin with landslide runout boulder deposits background

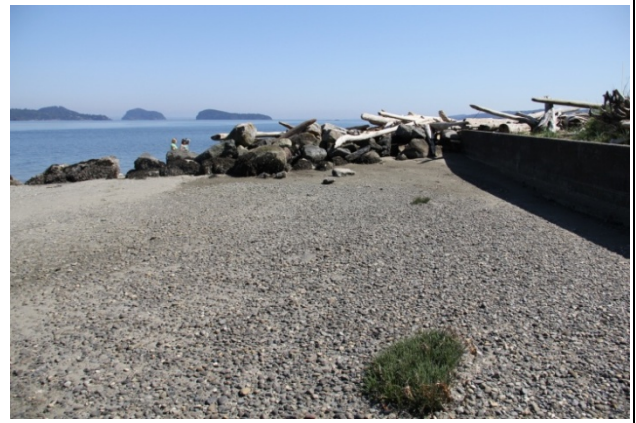
Higher pebble concentrations over sand north of the groin with patches of *Salicornia*

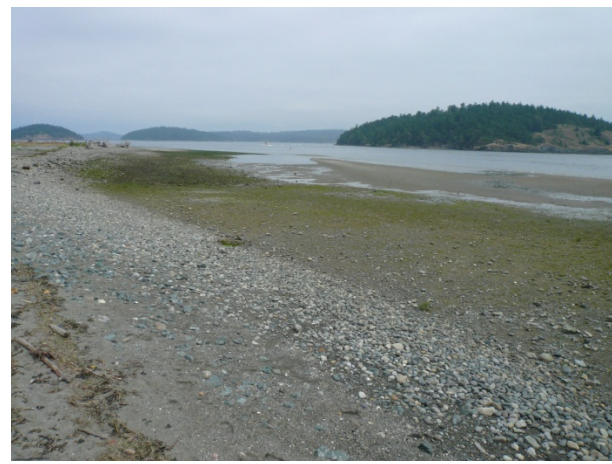
East side of spit, gentle slopes at beach toe and sand flats

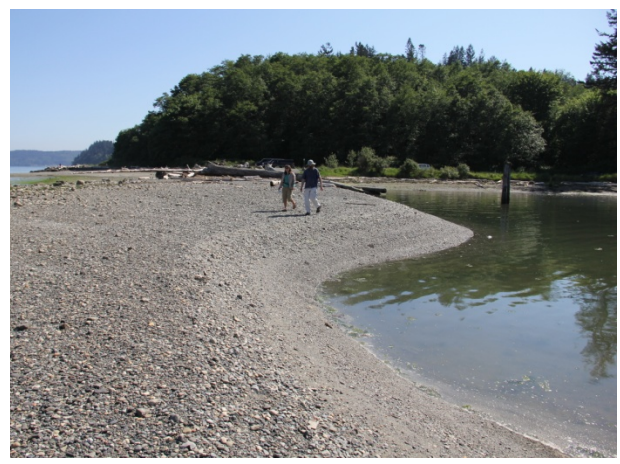
West side (lee) of spit with steeper gravelly slopes

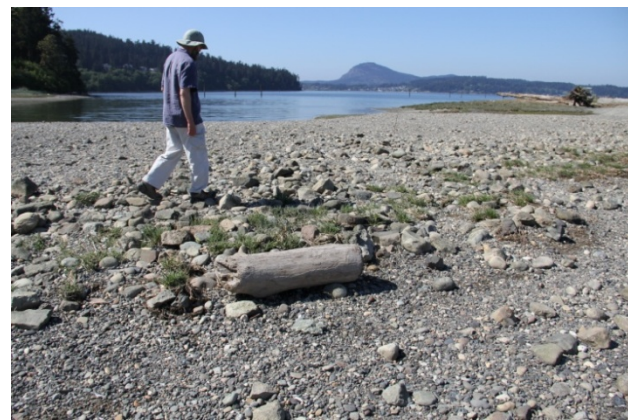
Cobble and large pebble were observed south of this overwash area on the upper beach (Photo Page 4). The overwash area was devoid of logs and other backshore features over a total length of approximately 300–375 ft. Photo Page 5 shows the neck breach and tidal currents flowing over the neck of the spit in recent years. The elevation of the low portion of the neck of the spit corresponded to approximate middle elevations of pickleweed (*Salicornia virginica*), a type of salt marsh vegetation which typically grows just below MHHW.

Sub-angular quarry spall and pebble near the neck of the spit

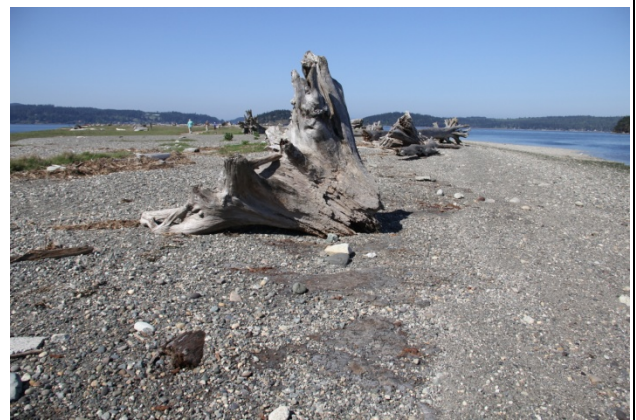
Higher pebble concentrations in the central portion of the spit

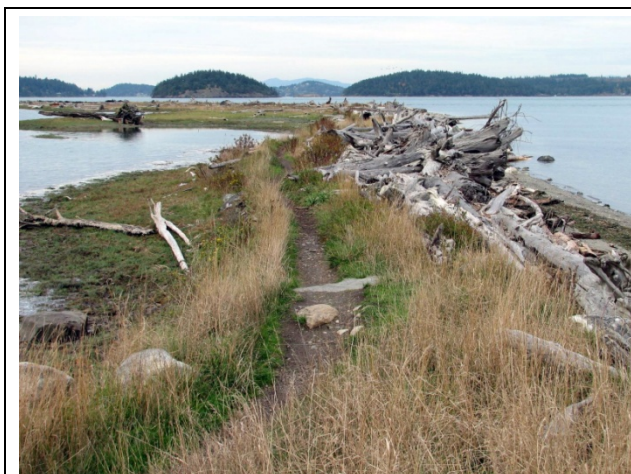
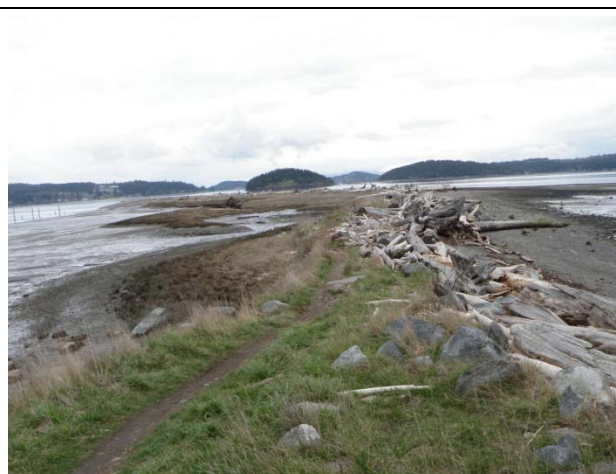
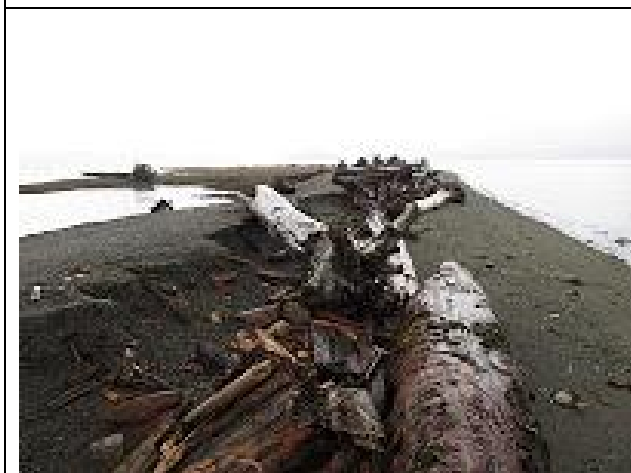
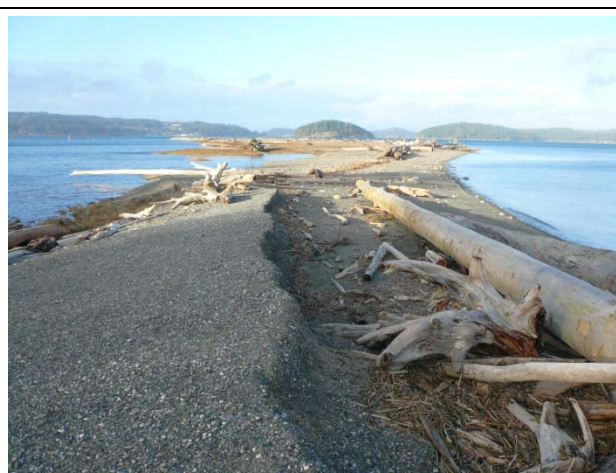
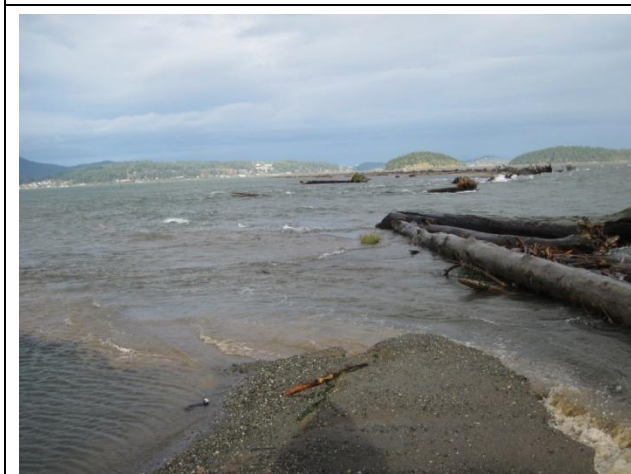
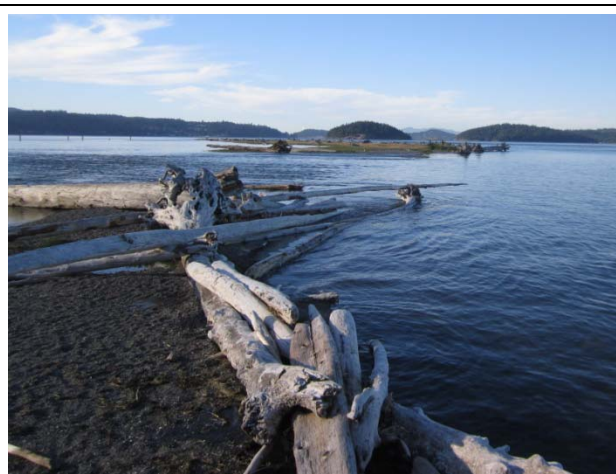
Photo Page 5. Ala Spit neck partial breach progression. The log with rootwad in left background can be used for relative scale and water level.

Based on photographic evidence and visual interpretation the neck of Ala Spit has recently lowered. A partial breach of the spit neck has occurred and portions of the neck are impassable by park users during times of high tides. Sediment nourishment of the spit neck is recommended and the topographic survey will help determine the volume and placement of sediment. Additionally, analysis of the existing sediment size ranges of sediment will allow for determination of nourishment sediment sizes to provide the most benefit and resiliency.

10/11/2007, mid tide event and pre-revetment removal.
(H. Shipman)

2010, low tide event and pre-revetment removal. (T. Smayda)

11/2011, mid tide event and post-revetment removal
(H. Shipman)

2/22/12, mid tide event and post-revetment removal (CGS)

12/2012, extreme high tide event, post-removal (T. Zackey)

7/24/13, high tide event, post-removal (CGS)
