# The Nason Creek Fill Removal and Oxbow Enhancement Project (N1)

## 2015 Monitoring Report

Prepared by: Chelan County Natural Resources Department

Adrienne Roumasset, May 2015

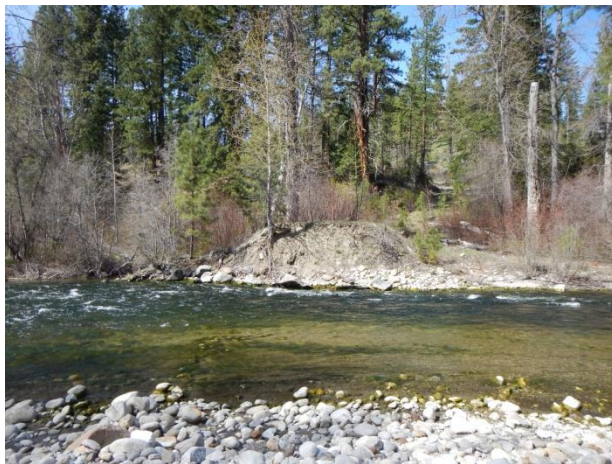
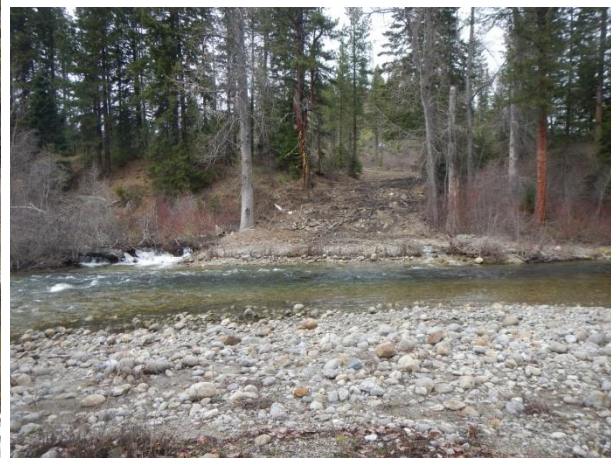
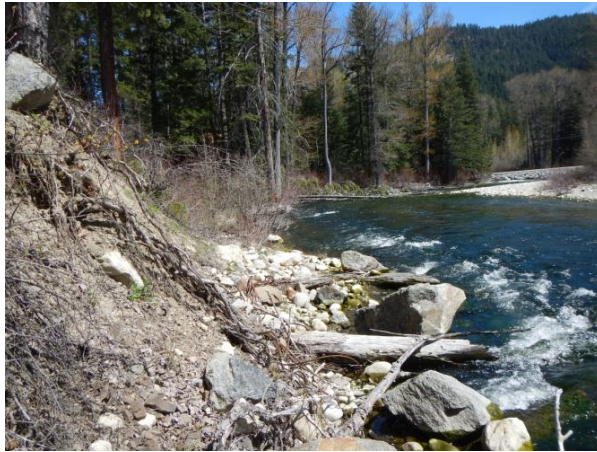
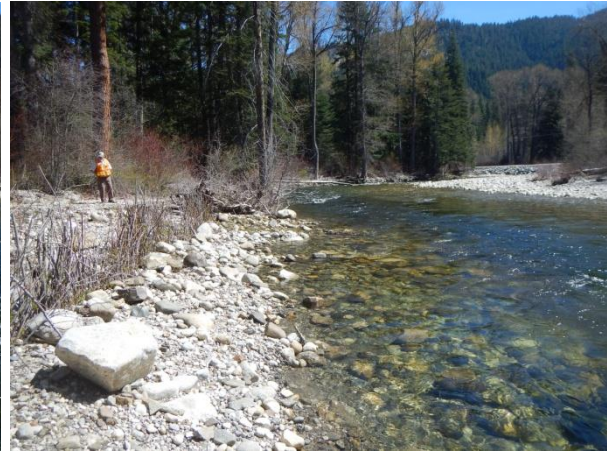
Removal of fill on river left provides Nason Creek with access to its floodplain (Figure 4).

Figure 4. Abutment fill removed, river/floodplain connection restored

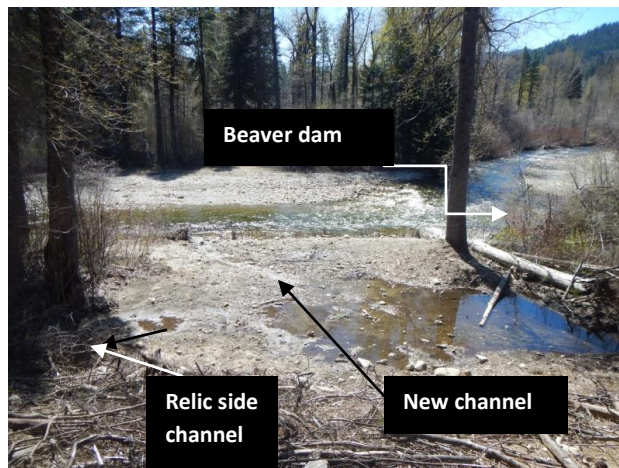
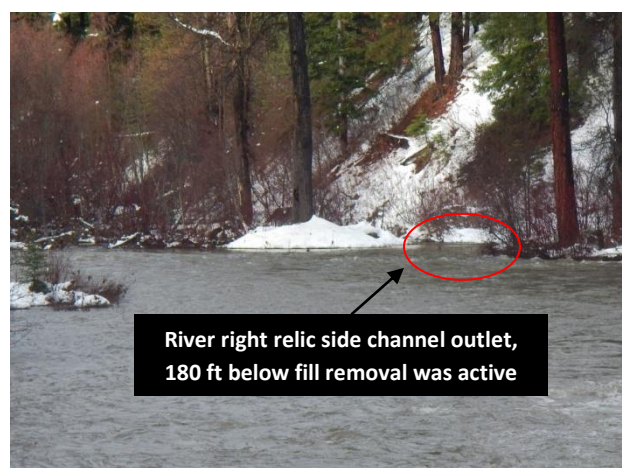
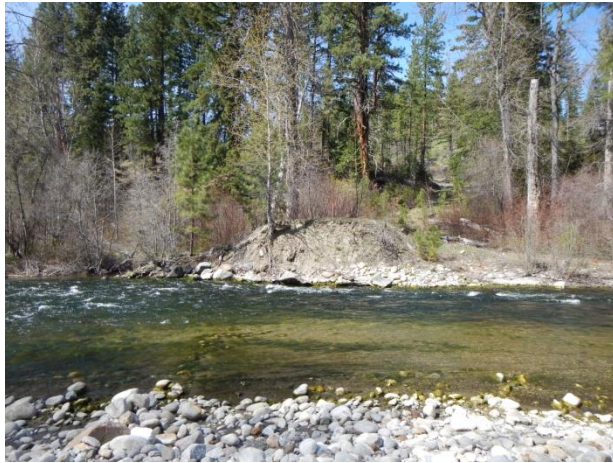
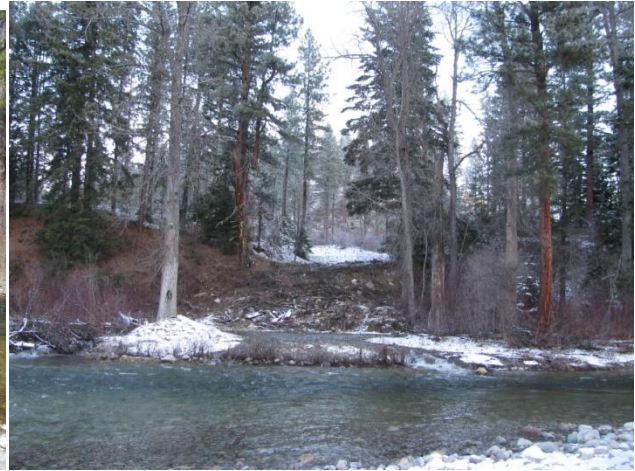
Photo points indicate abutment removal restored natural floodplain processes. Just prior to project construction in summer 2014, beavers built a dam on a tributary to Nason Creek which is located at the upstream end of the abutment (Figure 2). The beaver dam elevated water levels throughout the floodplain just upstream of the abutment fill removal area. Thus, post construction, those flows inundated the project area and a shallow channel formed through the project area. Photo points on April 6<sup>th</sup>, 2015 document water from the beaver pond (Figure 2) flooding the project area and draining back to the mainstem Nason Creek through the brush mattress plantings (Figure 5, PP3). The new channel across the abutment removal area was also observed in December after heavy fall rain (Figure 5, fourth image). During the December 9<sup>th</sup> high flow event, the entire floodplain was flooded and the relic side channel downstream of the project area was activated; water flowed from the beaver ponded area, through the project area, and into the side channel downstream of the project area (Figure 5, right photo). One goal of the floodplain fill removal was to restore activation of this downstream floodplain side channel.

Figure 5. Flooding of abutment removal area (left and bottom) and relic side channel (right).

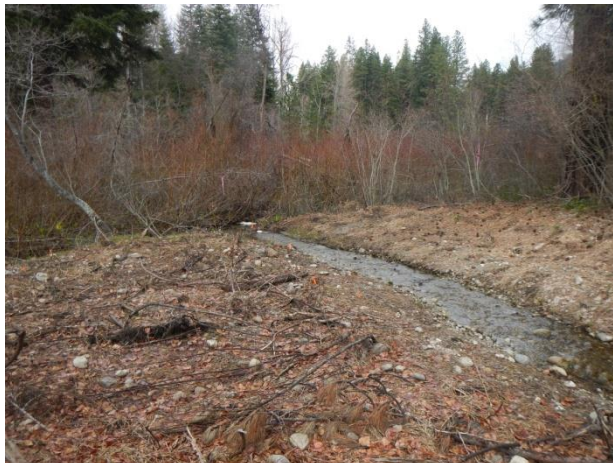
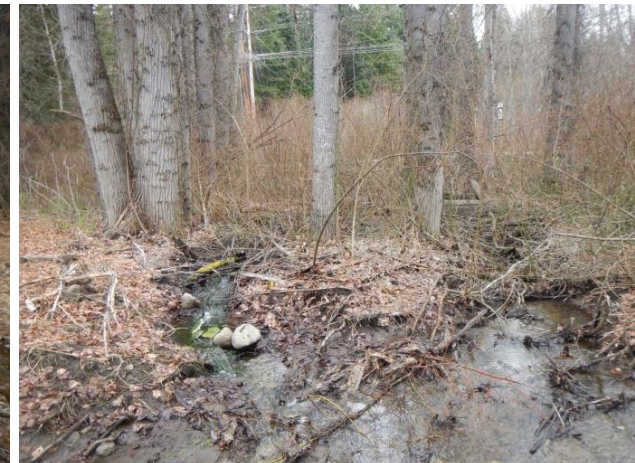
The parking lot fill removal has resulted in floodplain activation and a return of natural process. Photos from April 6<sup>th</sup>, 2015 (Figure 6) indicate the rain in late March and early April 2015 caused activation of the constructed channel (the upstream end of the channel is activated by precipitation and Nason Creek backwaters the downstream end, see Figure 2). During the high flow event of December 9<sup>th</sup>, the parking lot floodplain was inundated from the river south to the constructed channel, indicating an increase flood storage capacity at the site (Figure 7). December 2015 flood conditions were due to a combination of river flooding and rain runoff.

Figure 6. River right constructed channel was activated on April 6<sup>th</sup>, 2015 due to rain runoff.

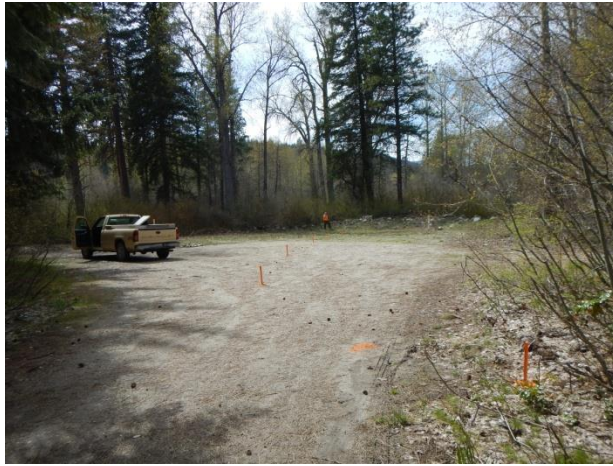
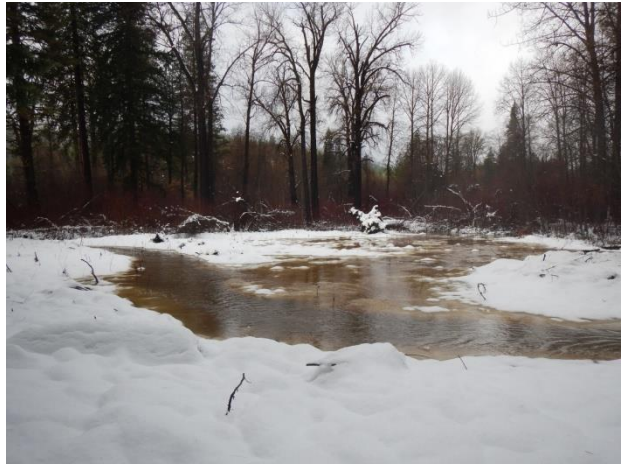
Figure 7. Floodplain activation occurred on December 9<sup>th</sup> due to mainstem flooding and rain runoff

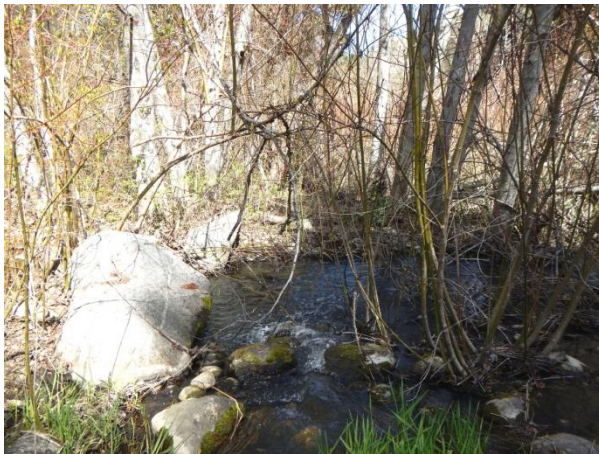
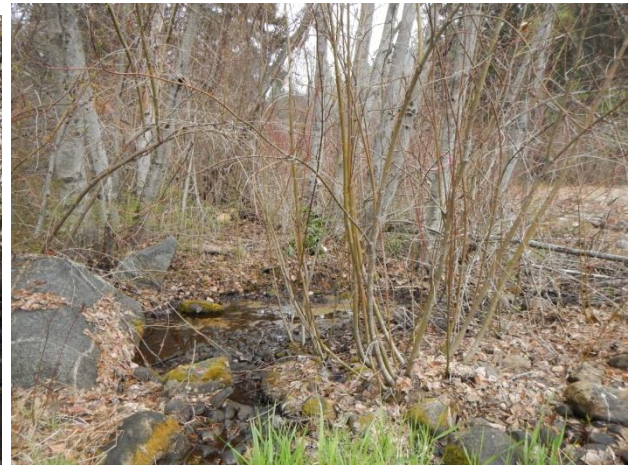
Figure 8. Water in old channel around parking lot pre and post project

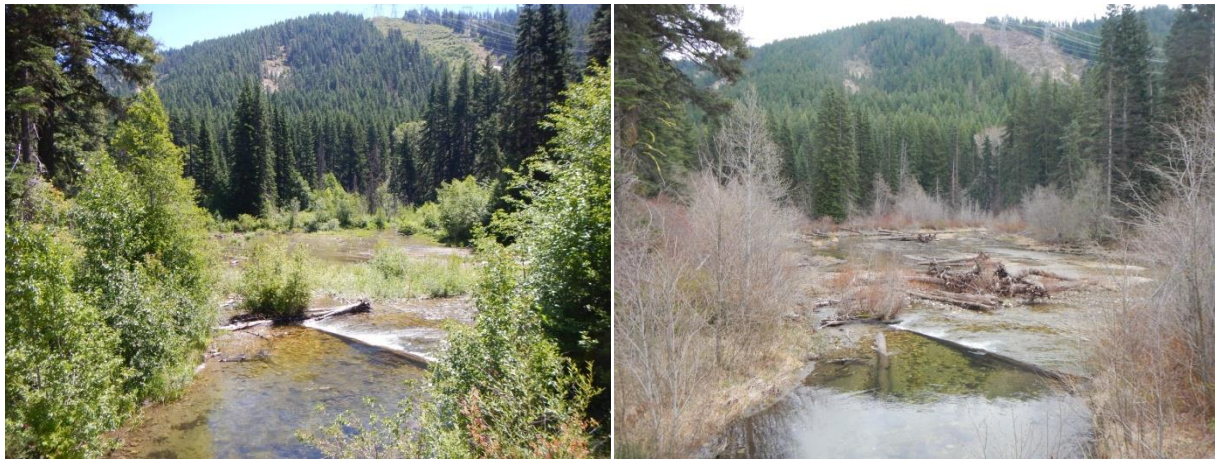
As planned, most of the large wood added to the oxbow was above water levels on April 6<sup>th</sup> at a mainstem flow of 325 cfs, although the perimeter pieces provided fish cover (Figure 9). High water flood events in the late fall and early winter of 2015 (estimated 25 year event in Icicle Creek but the Nason gage does not record high flows) caused relocation of approximately 10 pieces of wood (Figure 10). Almost all the remaining wood was inundated on the December 9<sup>th</sup> flood event, at a mainstem flow of 2,730 cfs (Figure 10).

Figure 9. 2007 Oxbow pre and post construction.

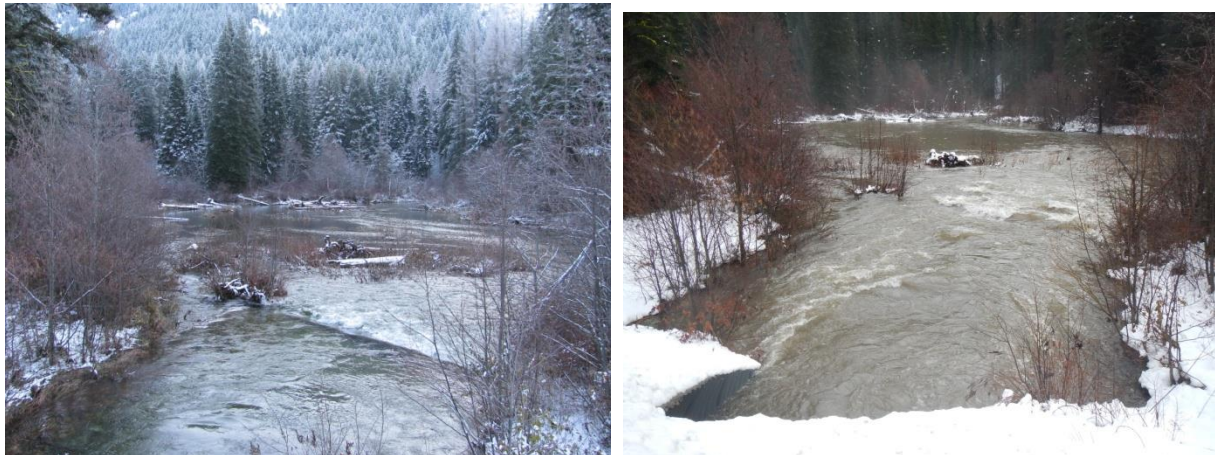
Figure 10. 2007 Oxbow after late fall and early winter floods caused wood to shift.

Approximately 10 of the 28 pieces of the large wood added to the oxbow, all in the two upstream most structures, were displaced by high 2015 fall flows. Staff will survey the site in 2016 to locate the wood that has likely shifted downstream but remained in the oxbow.

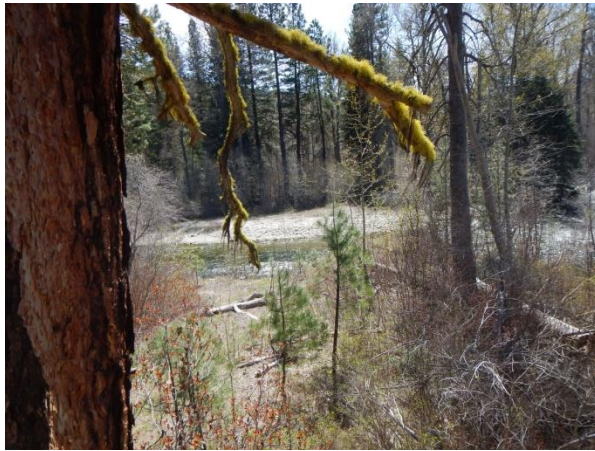
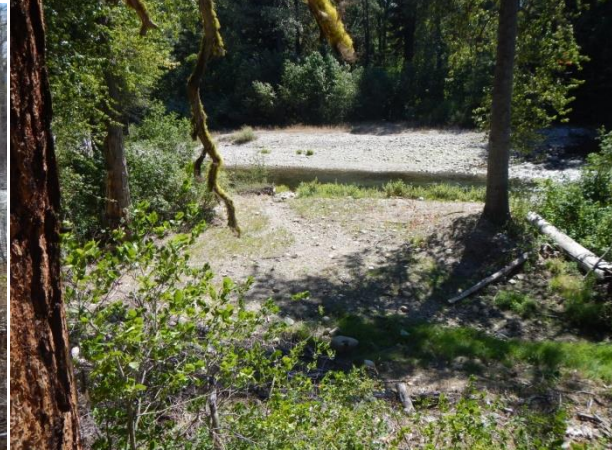
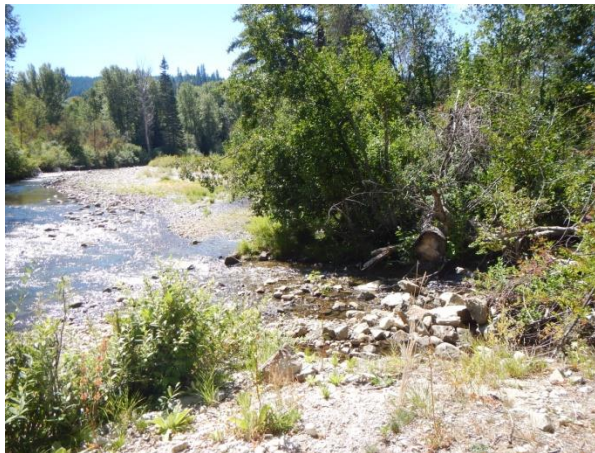
Water pathways on the left bank floodplain, although dry, were apparent in areas that had flood water on April 6<sup>th</sup>, 2015 (Figure 11). The beaver dammed tributary on the west side of the left bank floodplain was active at low flow (Figure 11 3<sup>rd</sup> photo).

Figure 11. Low flow conditions on river right floodplain, August 20<sup>th</sup>, 2015; 29 cfs

PP 18 – Aug 20, 2015; 29cfs flood pathways apparent

Aug 20, 2015; 29cf - Beaver dam tributary active

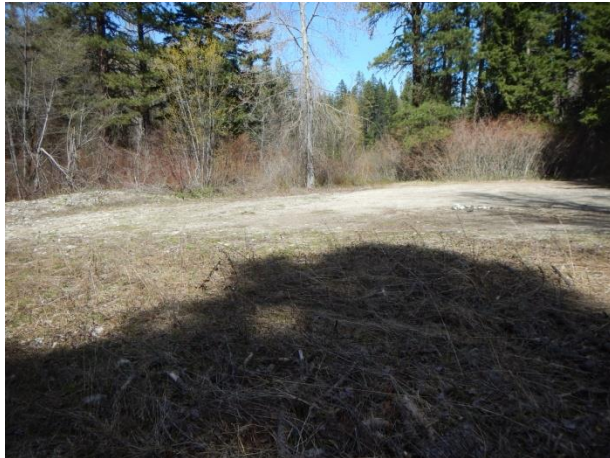
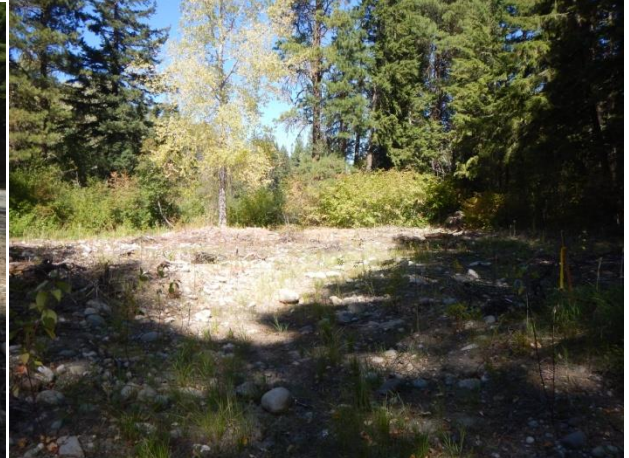
No erosion or sediment deposition issues were observed in the right bank constructed channel (Figure 12). Low flow photos also document vegetation establishment in the first year.

Figure 12. River left floodplain (parking lot fill removal) at low flow, pre and post construction.

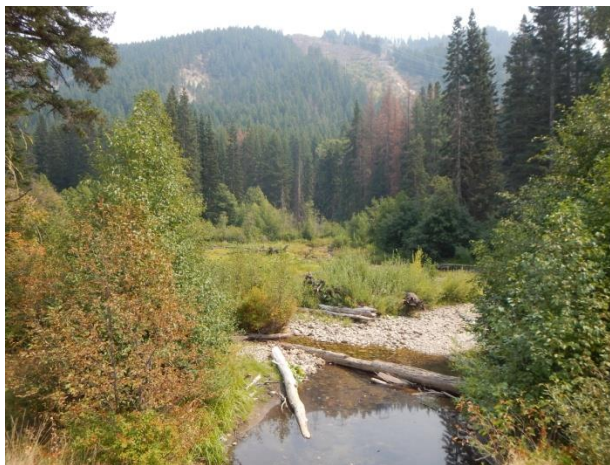
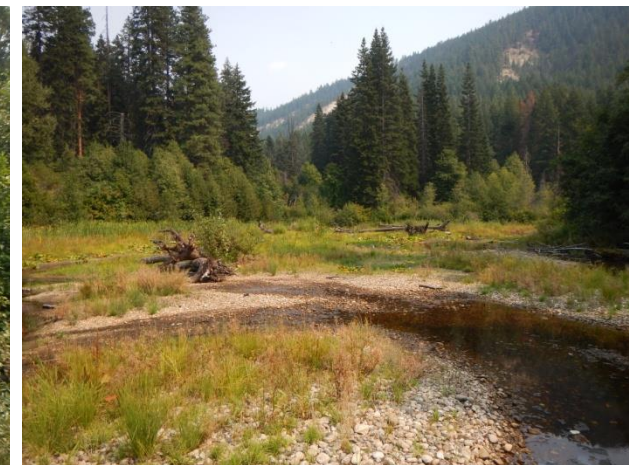
Extreme low flow conditions were observed in the 2007 oxbow and as anticipated, the wood placed was above water during low flow monitoring at 29 cfs in Nason Creek. There was not even flow over the grade control log at the oxbow inlet (Figure 13, PP1). Future survey at low flow will indicate any accumulated sediment around wood.

Figure 13. Post construction low flow conditions in the 2007 oxbow

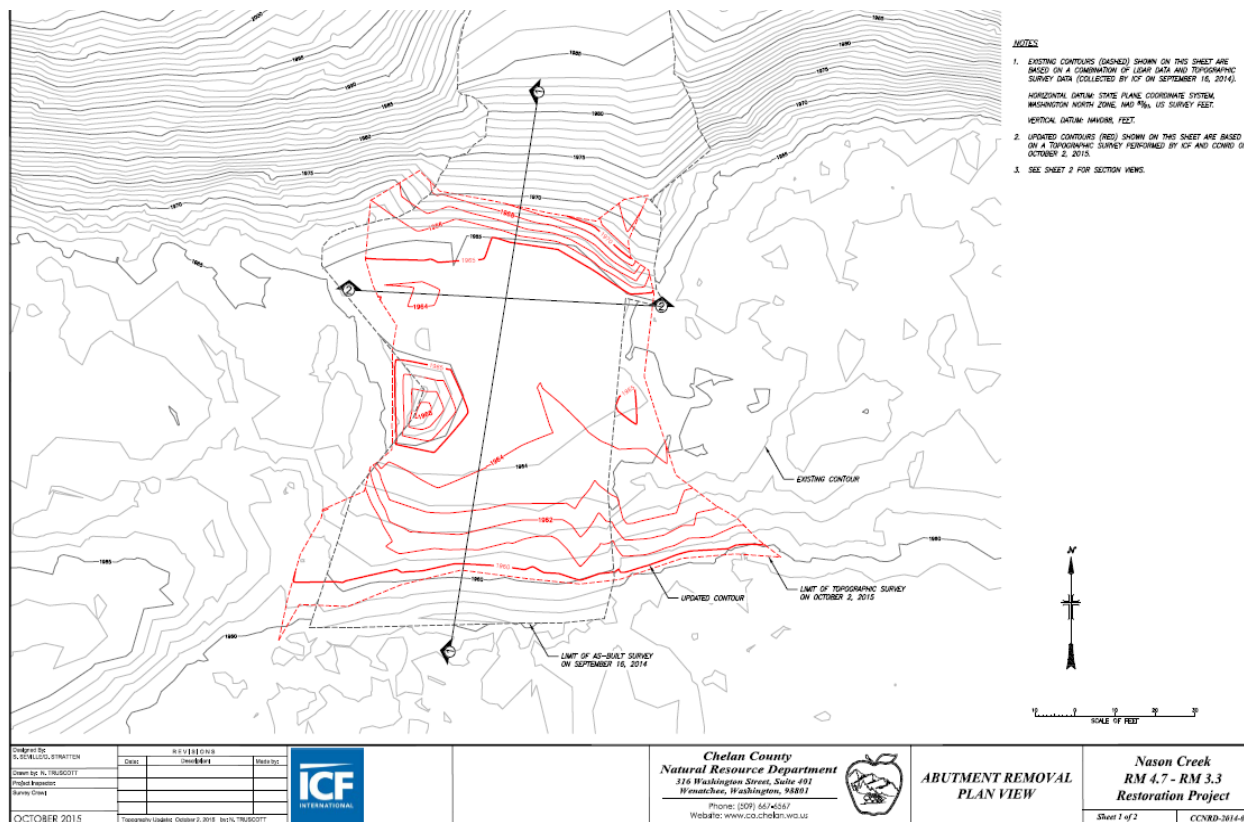
A fall 2014 as-built topographic survey was completed and is available upon request (Figures 16-18 are from the as-built survey). The fall 2015 topographic survey conducted on river left near RM 4.6 documents changes observed on site following the first season of high flows (Figure 14). The surveys indicate approximately a 0.4 ft reduction in elevation and formation of a shallow channel through the abutment fill removal area.

Figure 14. 2015 Topographic survey of abutment removal area. Black lines –September, 2014; Red lines – October, 2015

As designed, the fill removed from the abutment remained on site and it was placed in the road bed cut beyond the break in slope and some material was used to re-contour the slope. A small amount of fill extended beyond a large cottonwood tree at the base of the slope. That protrusion plus the ice and snow that extended from it may have partially blocked flows across the site from entering the relic side channel at moderate flow levels forcing flow to form the shallow channel through the site. In fall 2015, WCC crews manually removed some material from this high spot at the base of the slope to facilitate high flow activation of the downstream relic side channel.

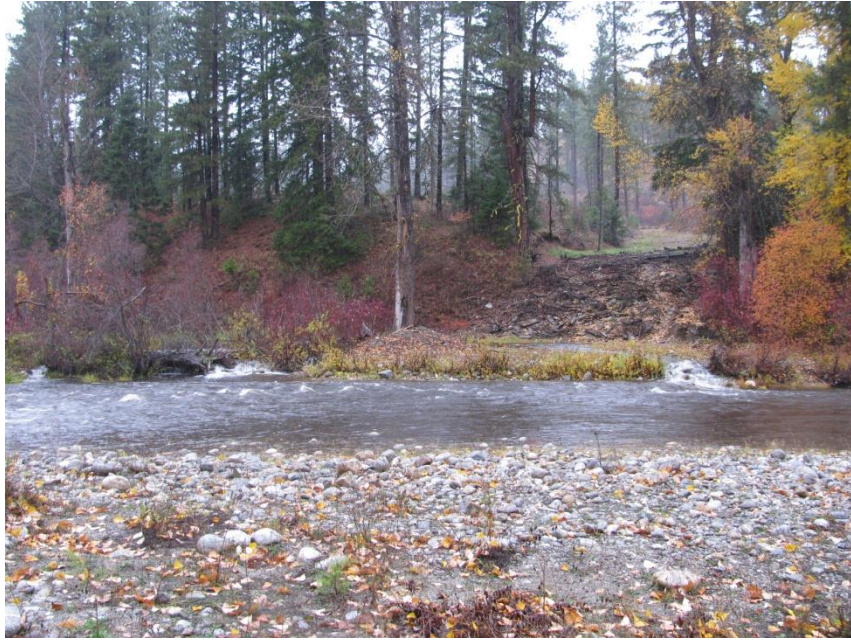
Figure 15. Photos depict the flooding in the project area and the breach in the brush mattress shows the shallow channel outlet to Nason Creek that is visible in the survey above (Figure 15).

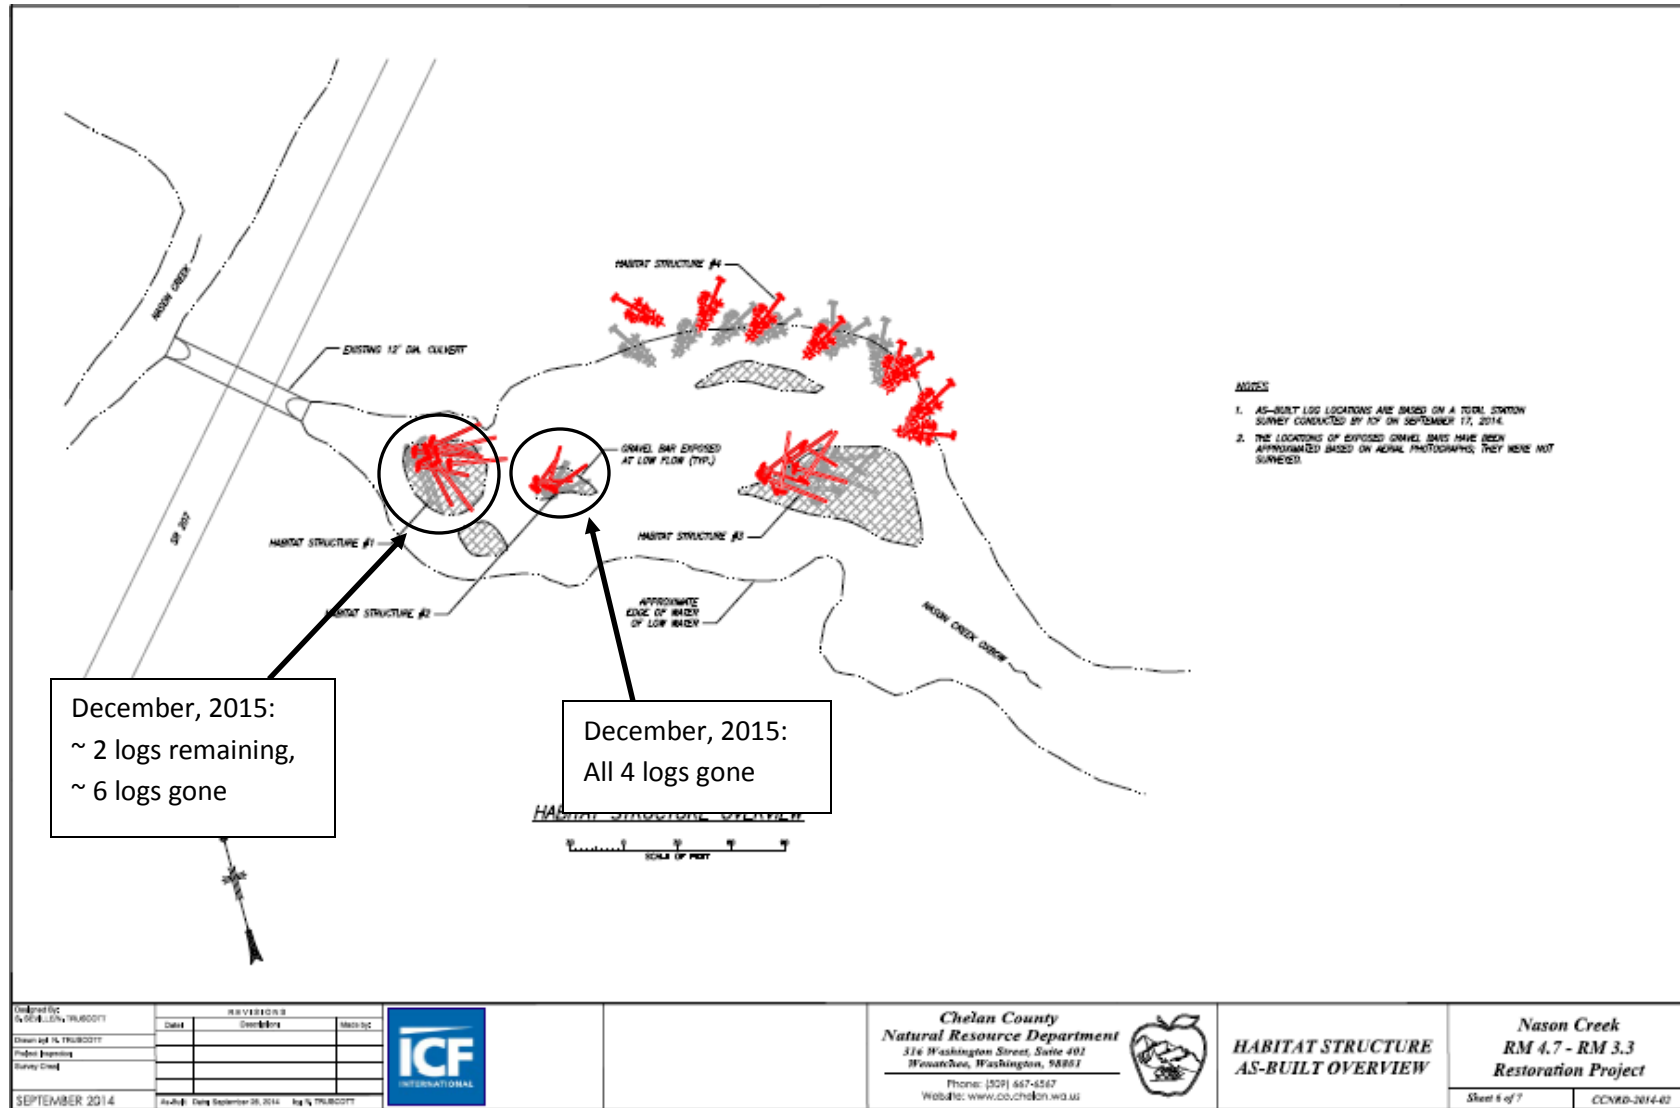
The as-built survey conducted in September, 2014 indicated that the 28 logs were added as shown in the plans. However, high flows in fall 2015 (possibly a 25 year event) caused approximately 10 logs to shift downstream (Figure 18). Surveys will be conducted in 2016 to document the post flood location of all logs which are likely still in the oxbow. Log placement was engineered to remain in place through the 5 year event and the December 2015 flows were likely higher than that. The Nason Creek gauge does not record high flows, however, this event was documented as a 25 year event in the nearby Icicle creek drainage. Logs were only engineered to withstand the 5 year event because they were placed manually without soil disturbance or vegetation removal for equipment access in an area with no recreation use and limited downstream infrastructure constraints. All of the wood likely has remained in the oxbow and initial exposure to high flows has already altered sediment deposition patterns and assisted with vegetation establishment.

Figure 18. As-built of added wood in 2007 Oxbow (in red). Also indicated is approximate number and location of displaced wood.

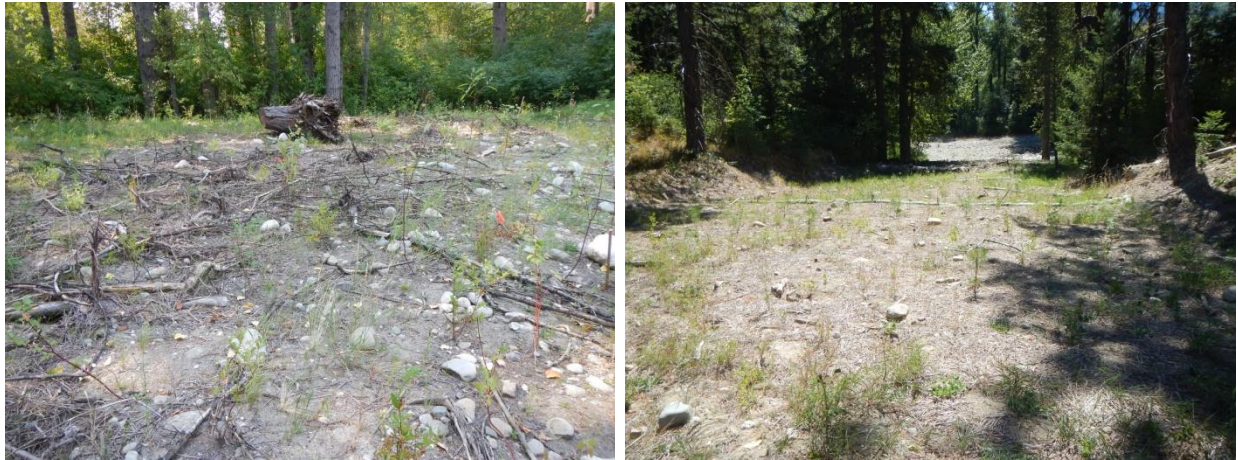
Results of the stem count on August 20<sup>th</sup>, 2015 indicate plant survival on the planted floodplains is meeting and exceeding permit requirements with 92 percent survival on abutment removal site and 89 percent survival on the parking lot removal site (Tables 1 and 2, Figure 19). Counts suggest 100 percent survival of many species, including serviceberry, ponderosa pine, and snowberry on both sides and red osier dogwood on river right only. The lowest survival rate for one species was the blue elderberry counted in the abutment removal (Tables 1 and 2).

Figure 19. High survival of plants on river right (left photo) and river left (right photo) floodplains.

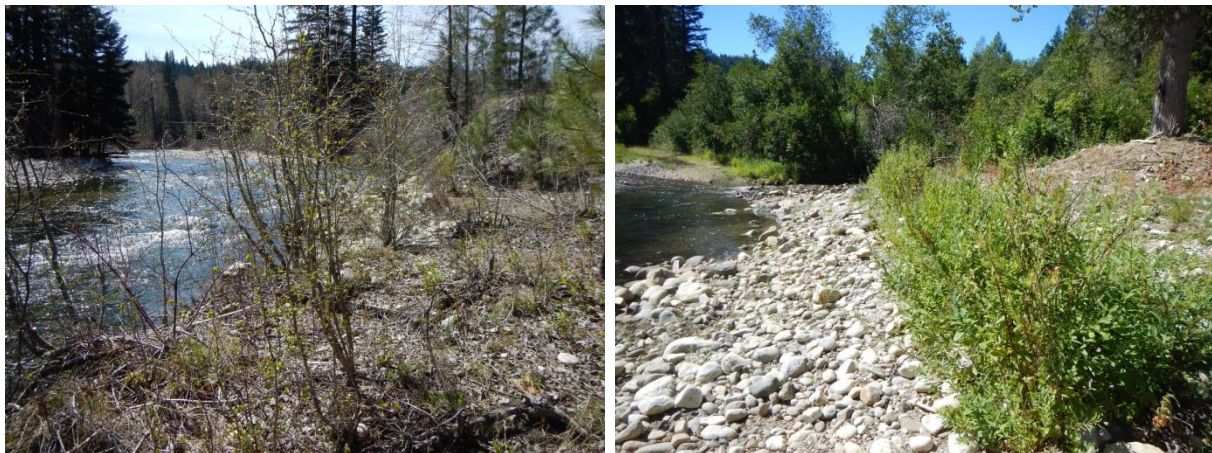
Cover and vitality of the brush mattress on abutment removal area was excellent, with an estimated cover and survival of 90-95 percent (Figure 20).

Figure 20. Brush mattress site pre and post construction.

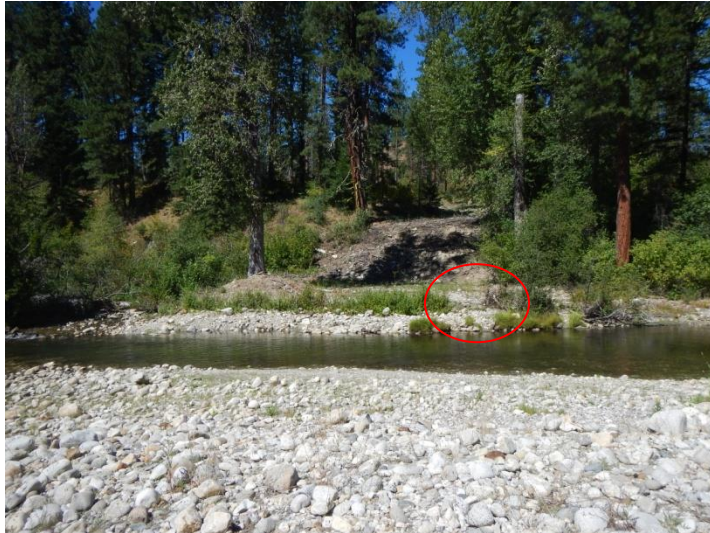
A breach was observed in the brush mattress, apparently due to the newly formed channel that conveyed fall 2014 and 2015 high flow (Figure 14 and 21).

Figure 21. Breach in brush mattress circled in red.

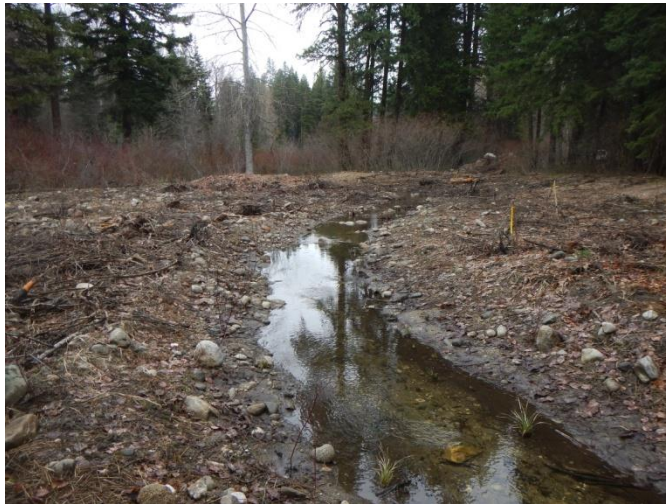
Tetra tech staff observed 47 juvenile steelhead in the new constructed channel in late April of 2015 (Figure 23, Table 5), indicating the site is meeting the goal of providing ESA-listed juvenile salmonids with off-channel rearing and refuge habitat.

Figure 23. Conditions in constructed channel during April, 2015 snorkel survey.
