Attachment 3 – Photos of Existing Conditions

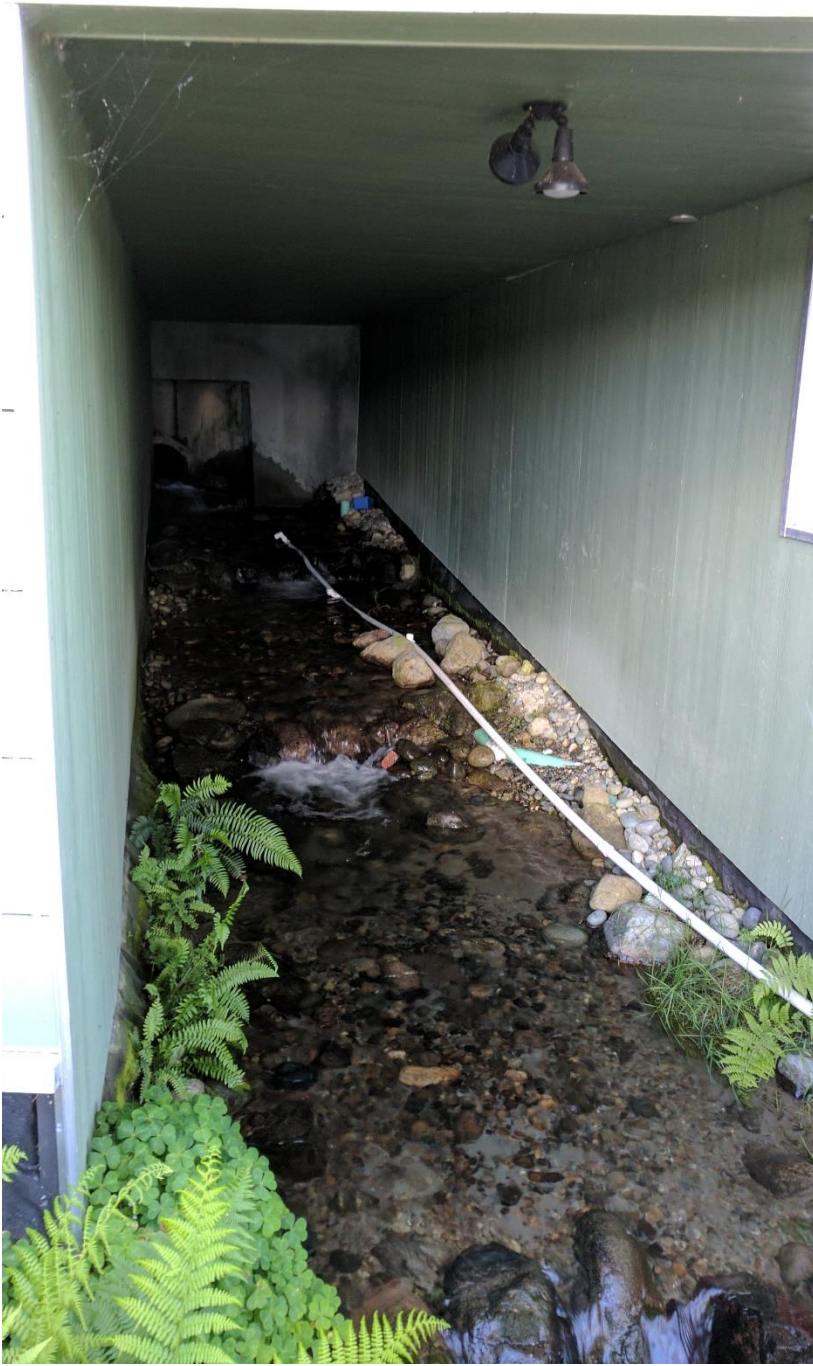
PHOTO 1: Culvert outlet on private property, under a house. This is the first of three barriers between the creek mouth and the east side of East Lake Sammamish Parkway, and is shown as Fish Barrier #1 on the Vicinity Map. This barrier will be abandoned and replaced with a new, open-stream channel on the adjacent property to the north.

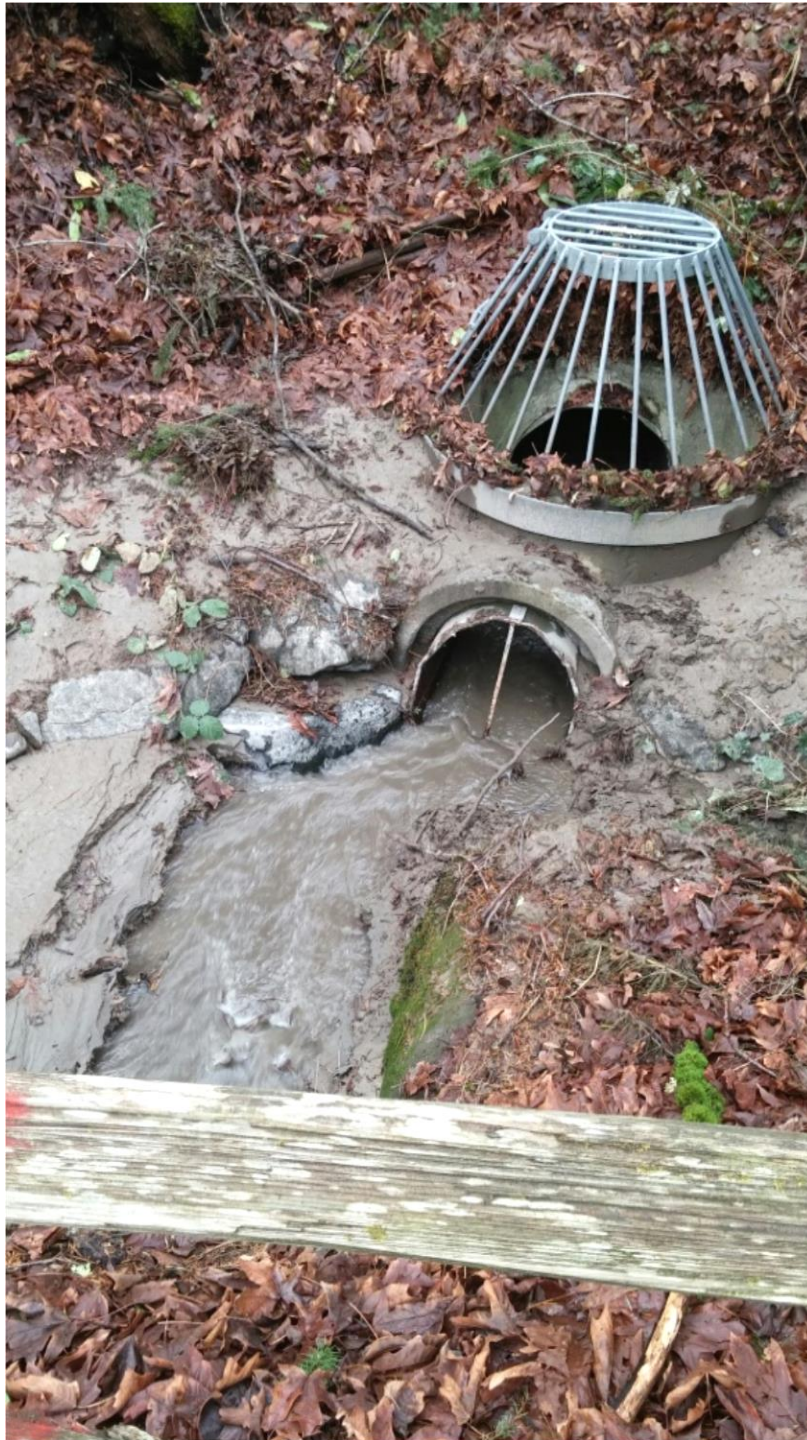
PHOTO 2: Culvert inlet to Fish Barrier #1, under East Lake Sammamish Shore Lane, on King County property.

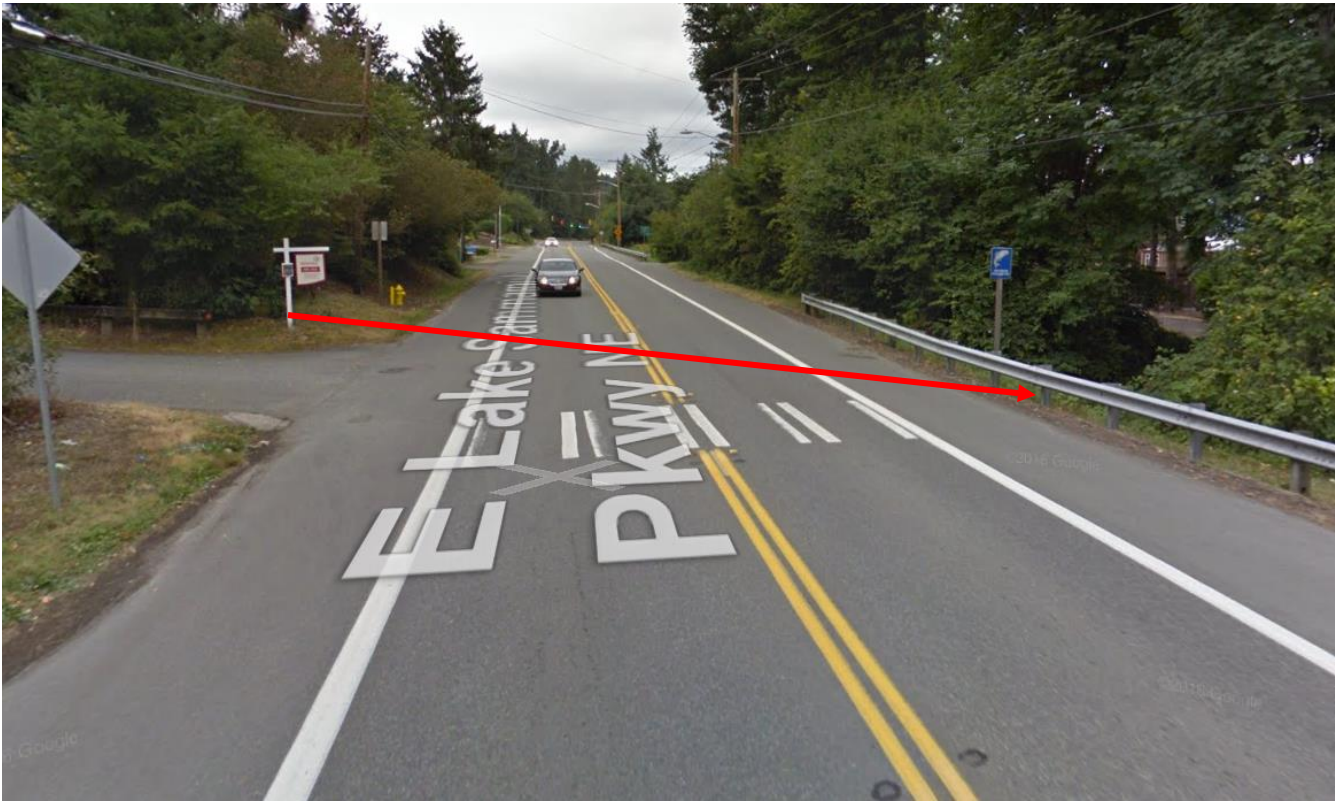
PHOTO 3: E Lake Sammamish Parkway above culvert, looking South. Red line shows culvert crossing under road.

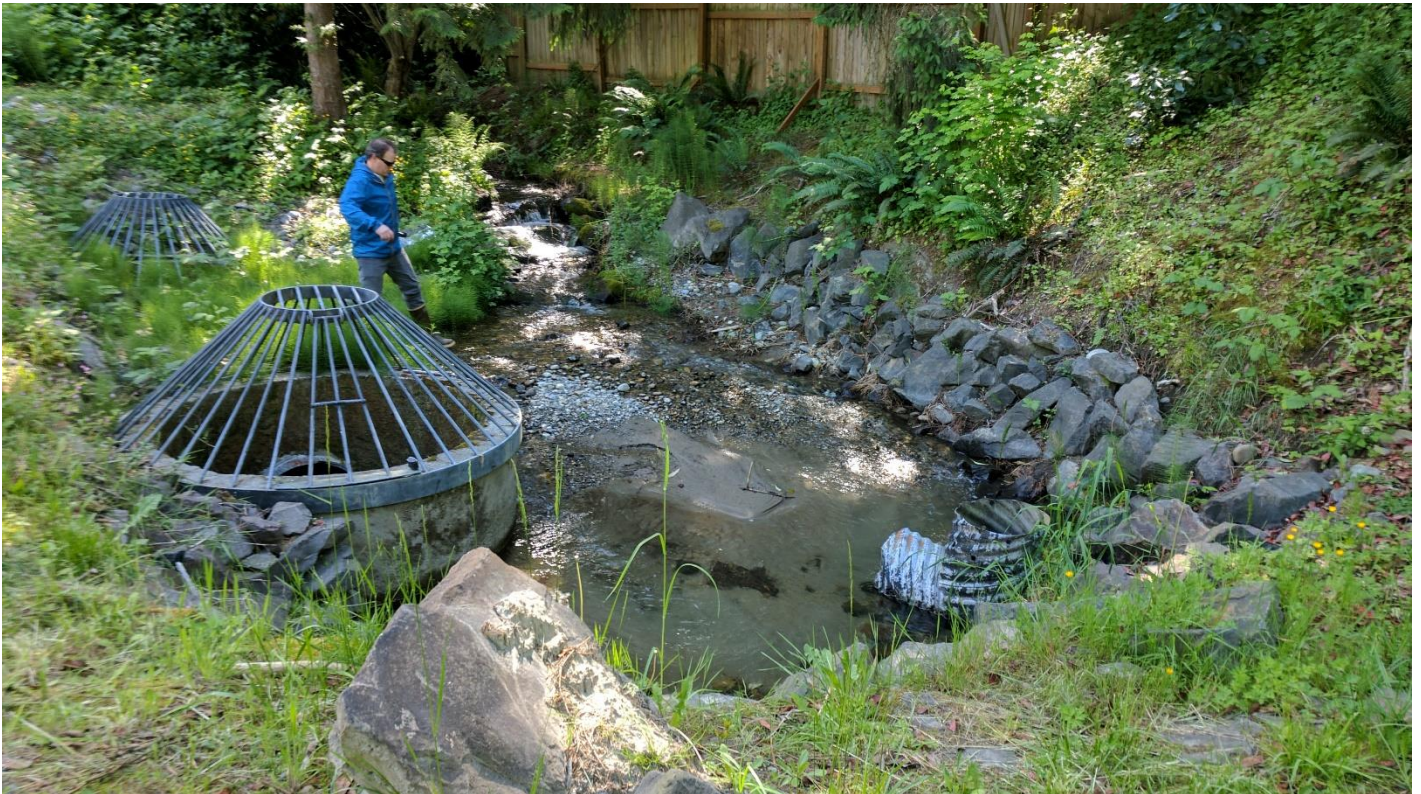
PHOTO 4: In-line sedimentation pond and culvert inlets on east side of E Lake Sammamish Pkwy, on City of Sammamish property. Birdcages on left are entrances to the high-flow bypass system. Corrugated metal standpipe on right side of pond passes low-flows of George Davis Creek. The pond in this photo has been recently maintained, with excess sediment removed.

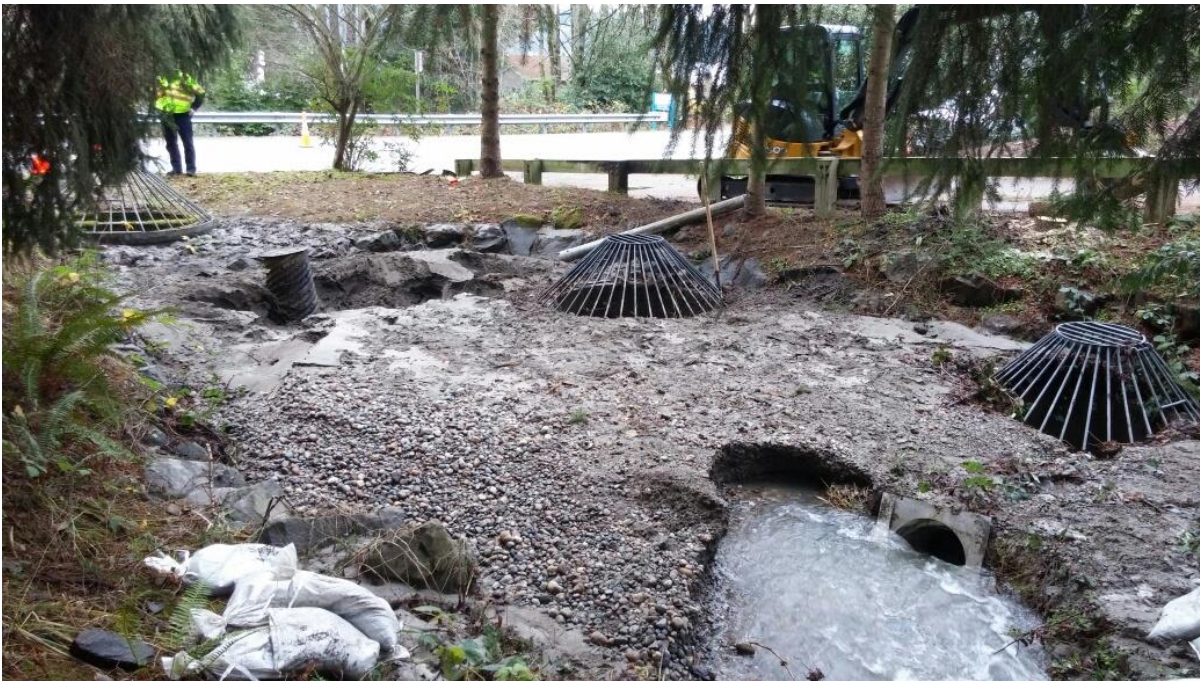
PHOTO 5: Same in-line sedimentation pond and culvert inlets on east side of E Lake Sammamish Pkwy. A landslide upcreek overwhelmed the sedimentation pond, and 100% of the creek is flowing into the high-flow bypass system.

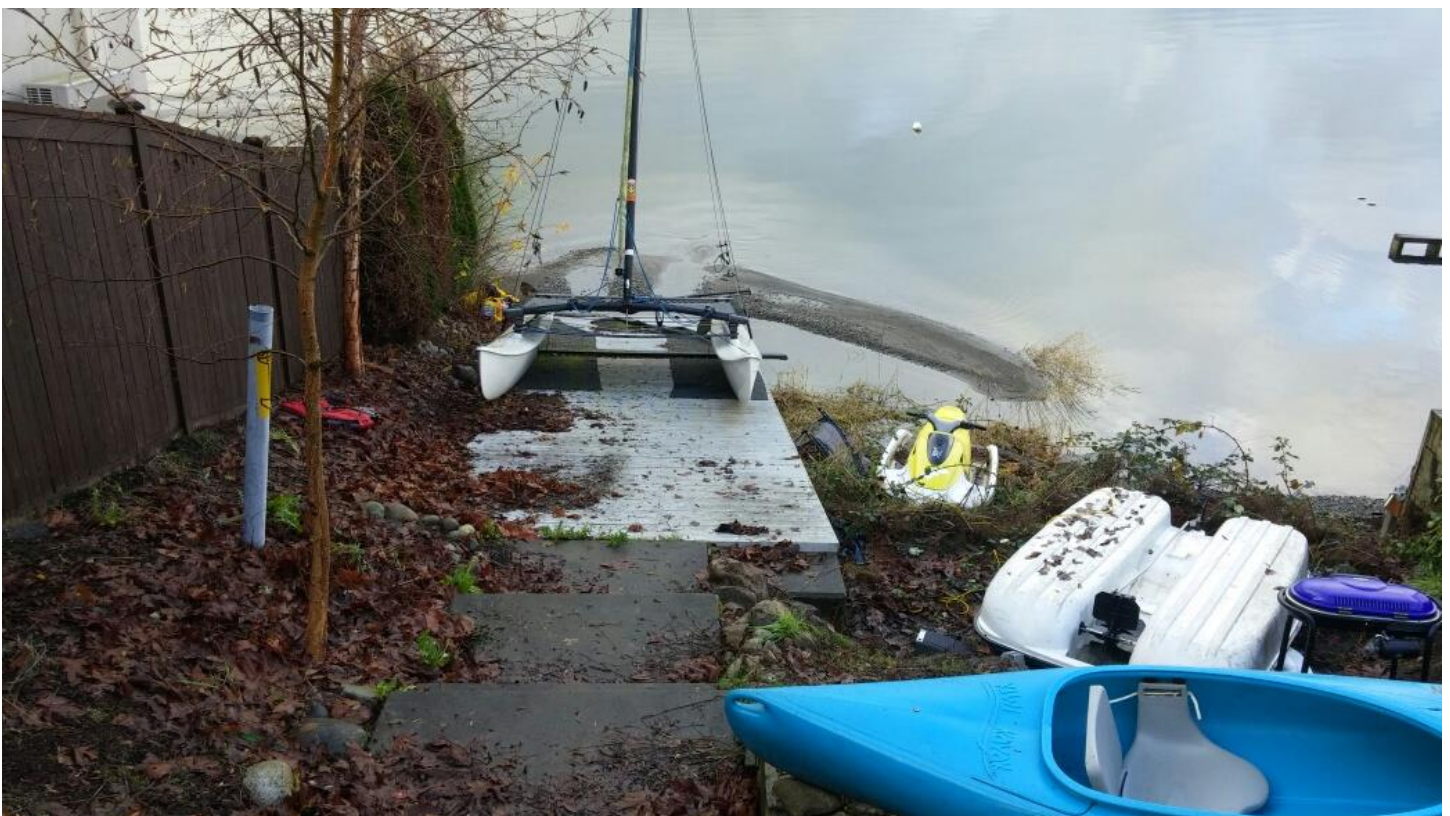
PHOTO 5: Outlet for high-flow bypass is under the boat ramp. This area becomes choked with sediment after storms, impacting adjacent private property.

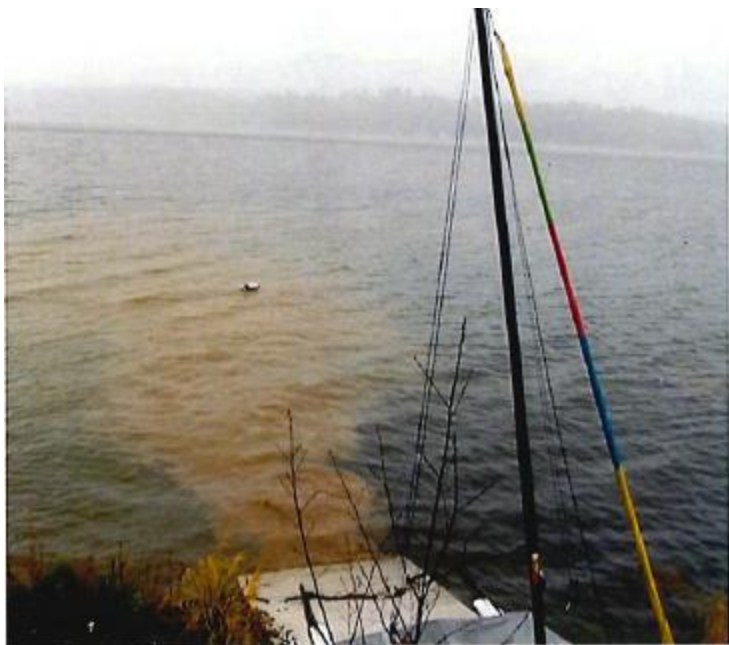
PHOTO 6: Outlet for high-flow bypass, showing turbid discharges into Lake Sammamish.

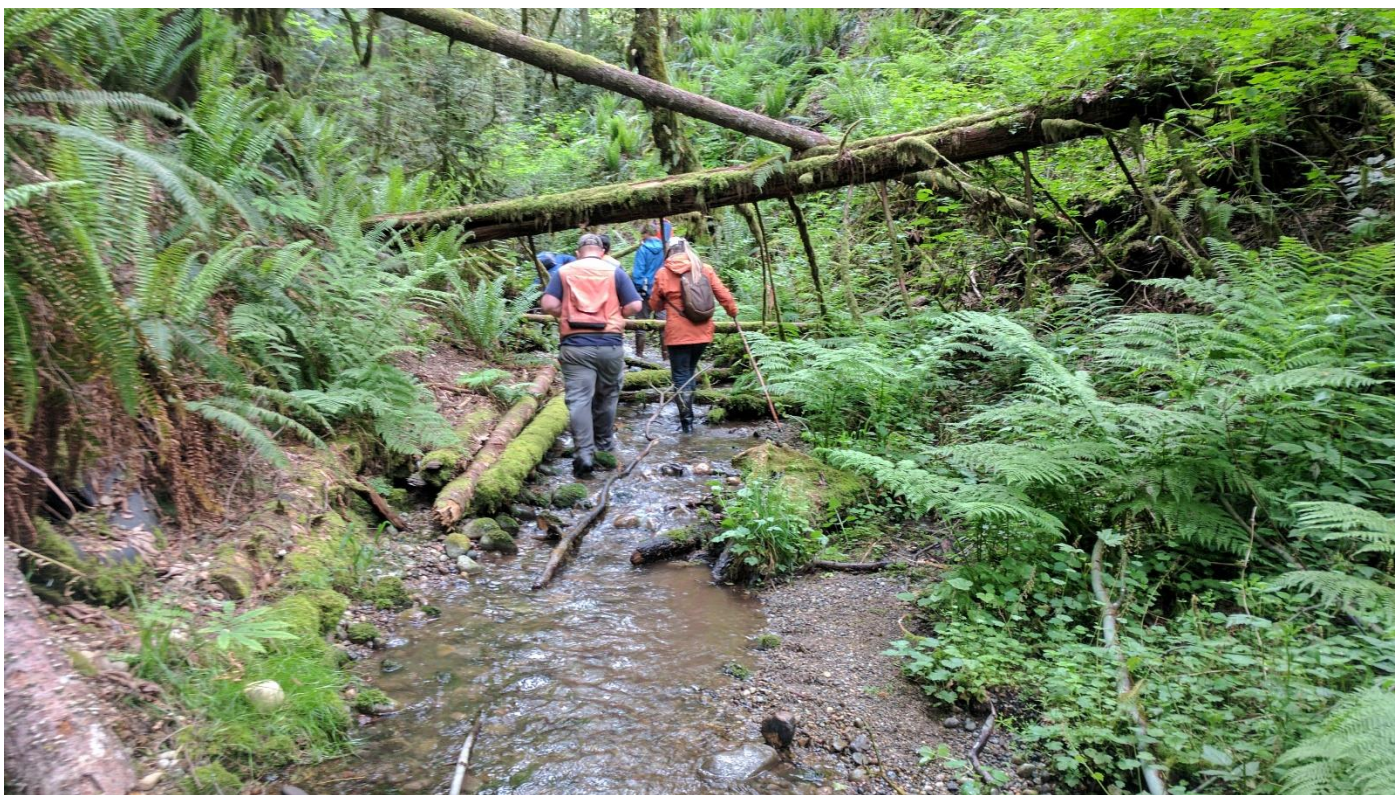
PHOTO 7: High-quality spawning habitat 1,000 feet upstream of E Lake Sammamish Pkwy.
