Mill Creek Culvert Replacement. Summer 2020 Implementation. RCO Project Number 18-1824R.

Permanent Photo Point Locations

Culvert Site Photos (Pre-implementation – 04/09/2020)

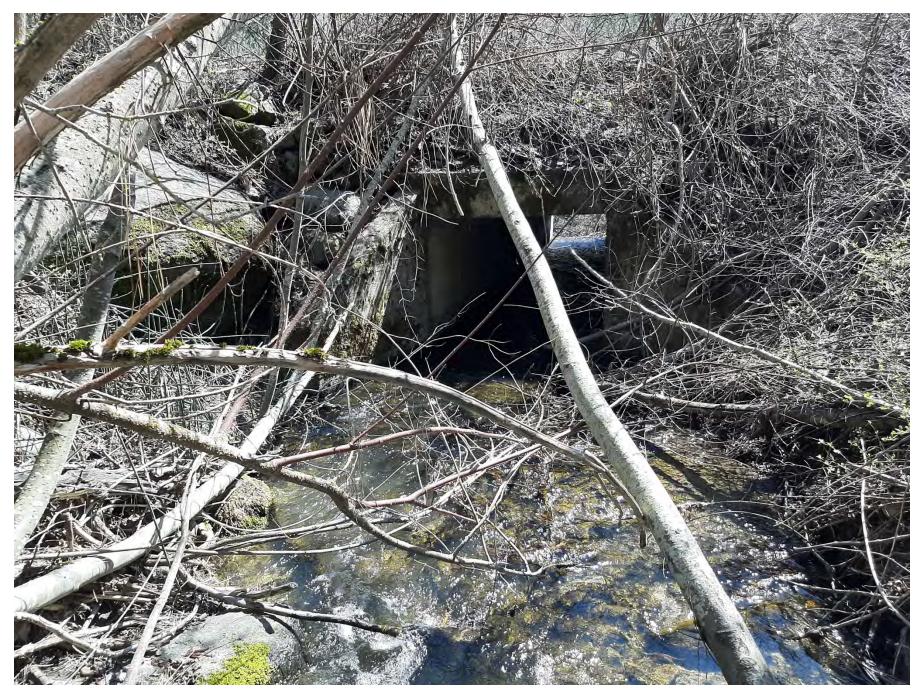
1. Looking at inlet from in-stream

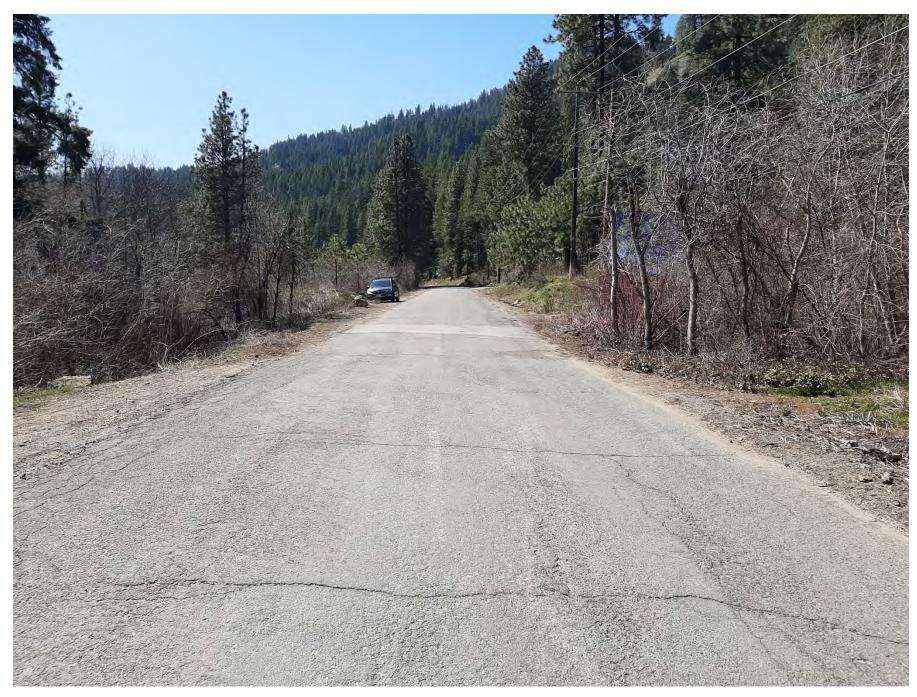
2. Looking southwest at crossing from road centerline

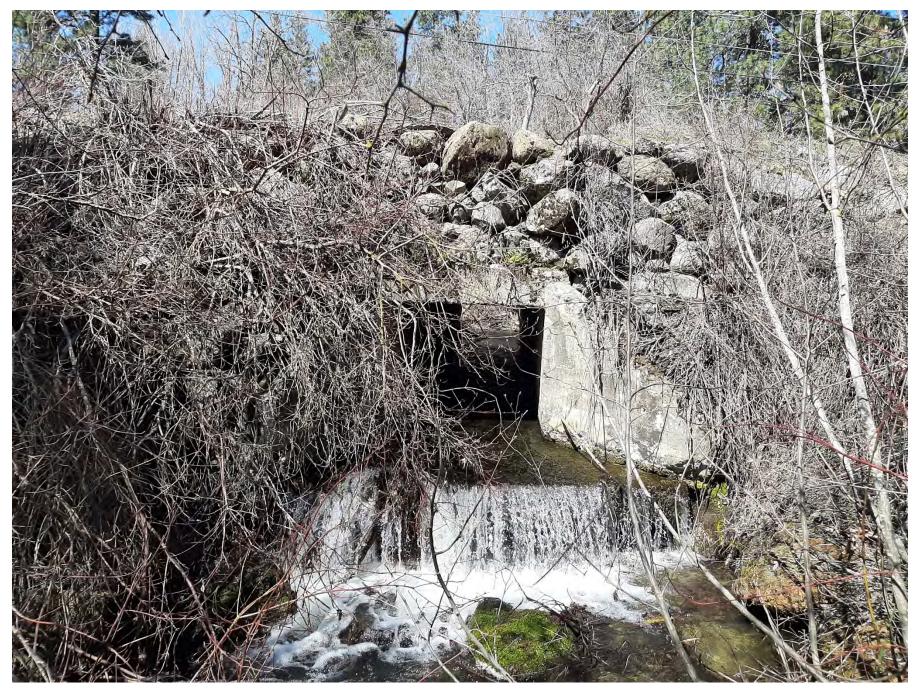
3. Looking at outlet from in-stream

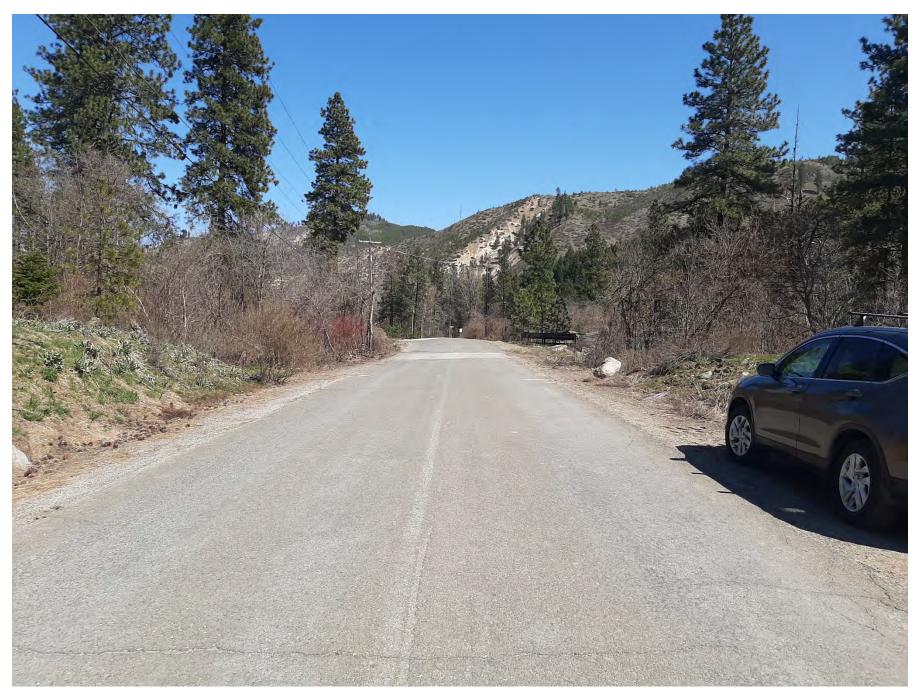
4. Looking northeast at crossing from road centerline

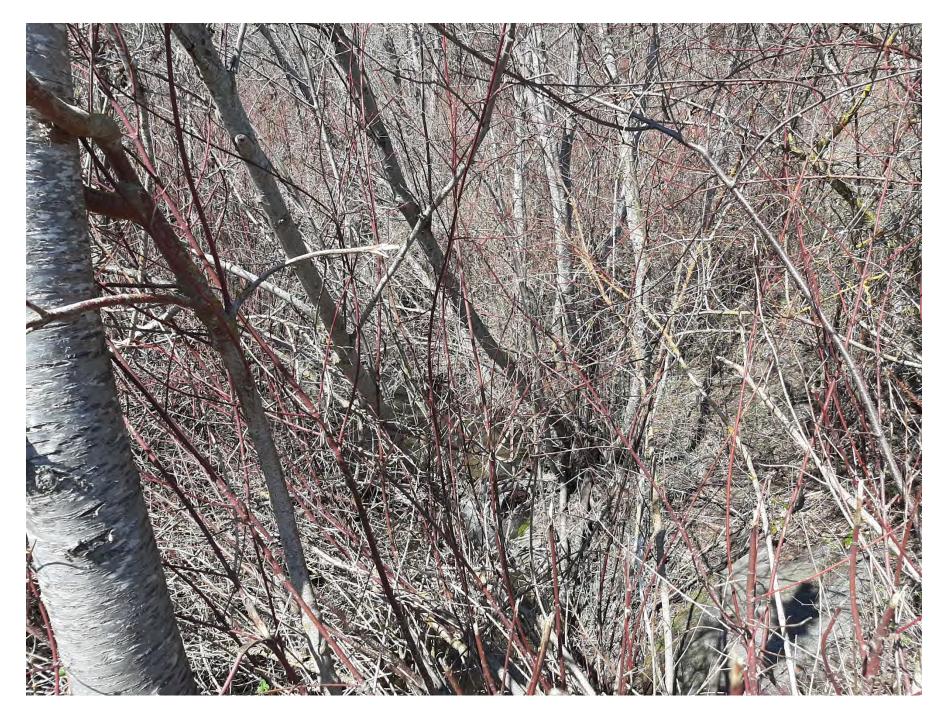
5. Looking upstream from above inlet

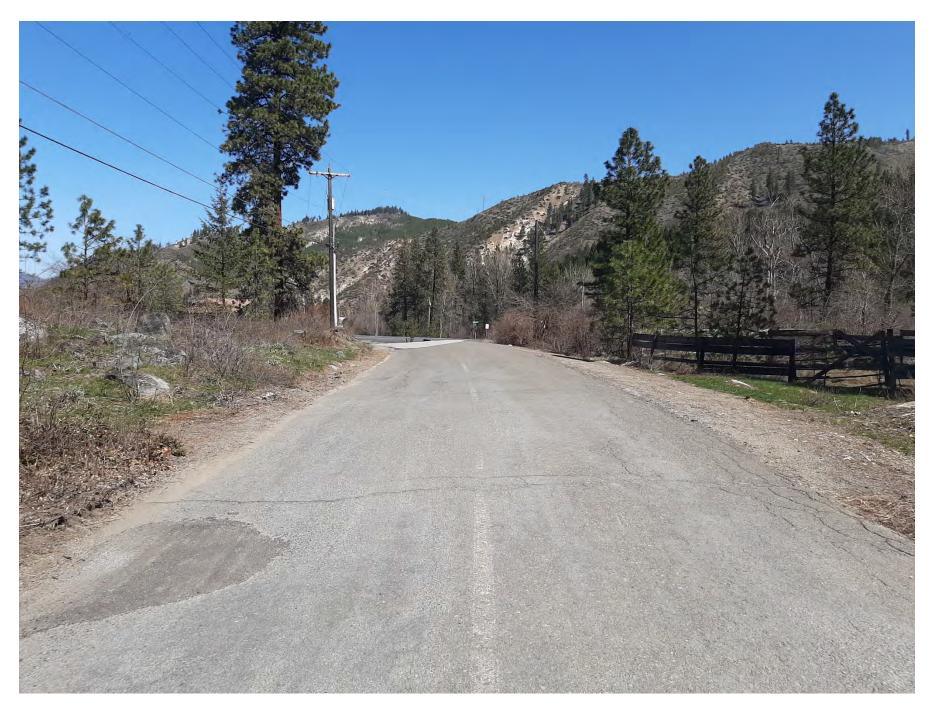
6. Looking northeast at road centerline from above structure

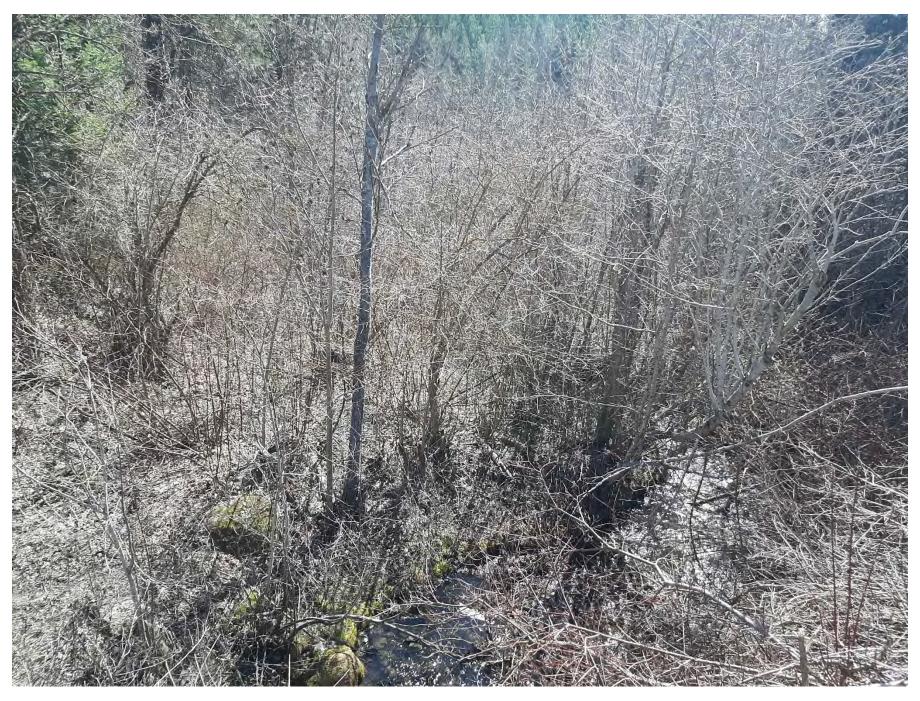
7. Looking downstream from above outlet

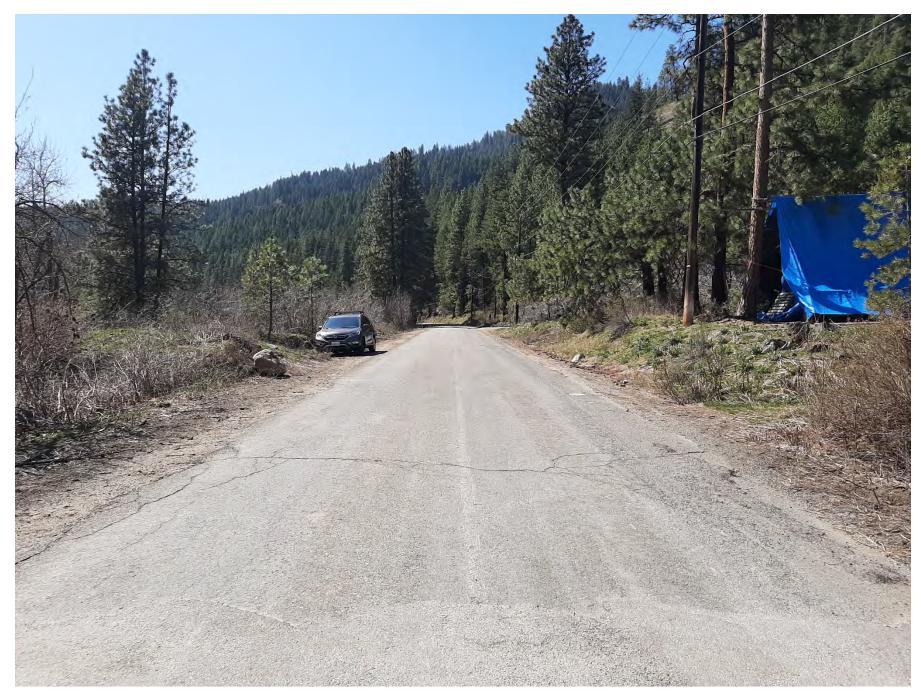
8. Looking southwest at road centerline from above structure

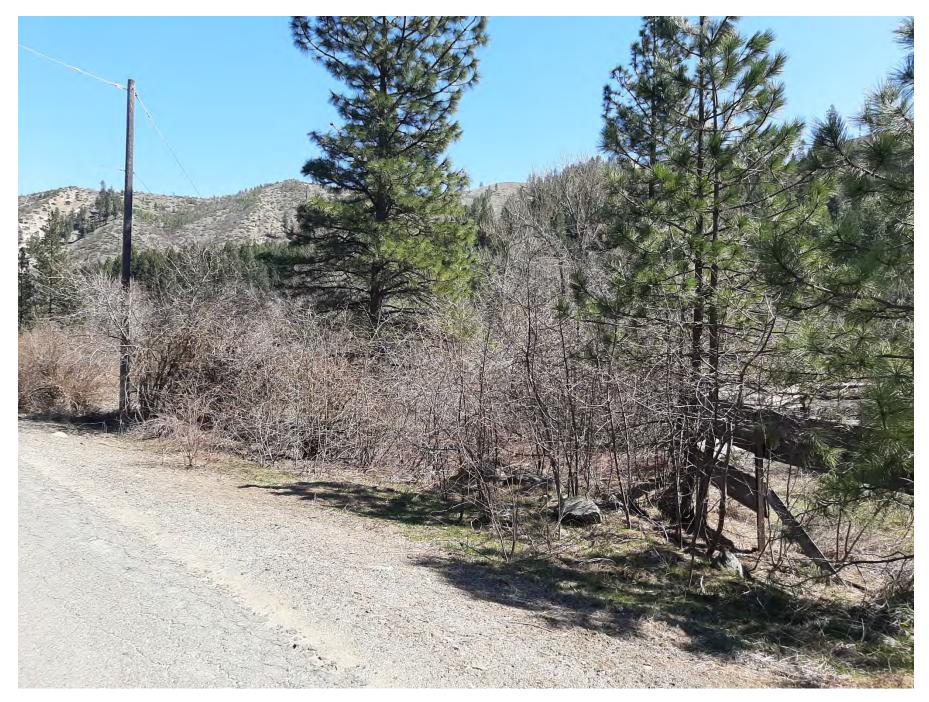
10. Looking southeast at staging area from road centerline

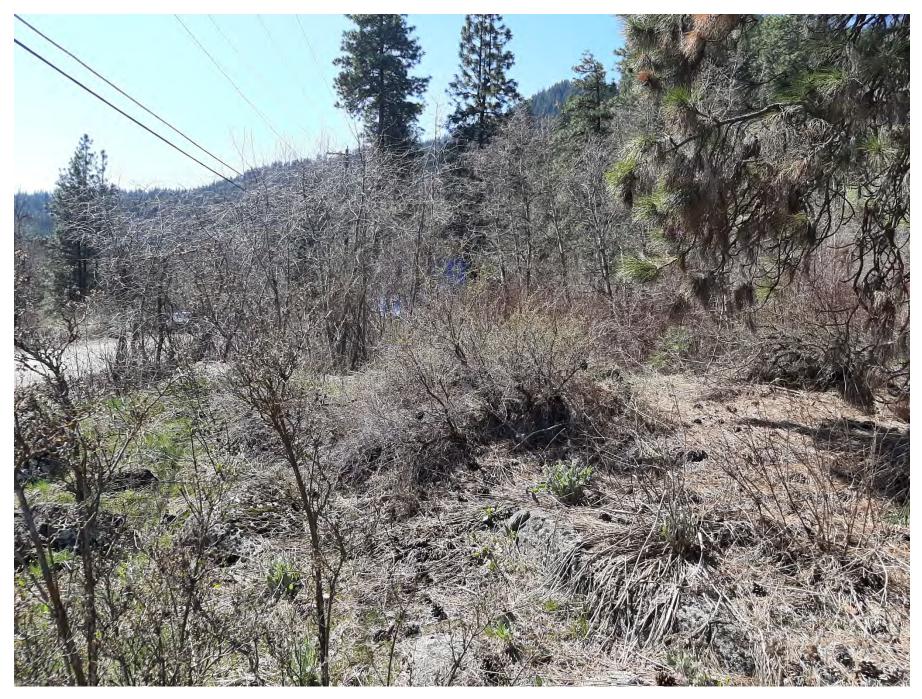
11. Looking southwest along temporary traffic bypass route

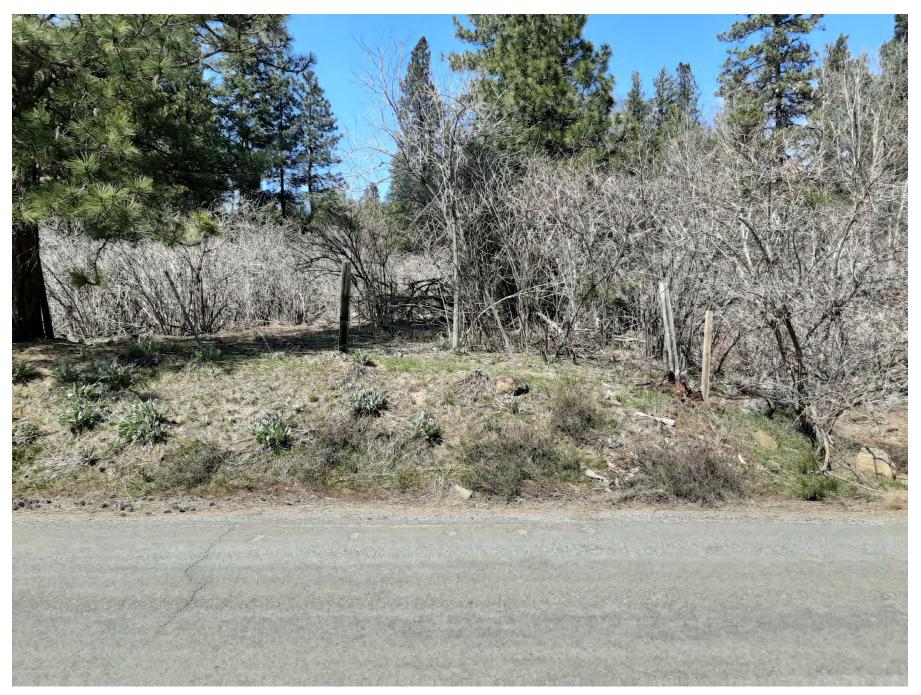
12. Looking northwest at temporary bypass entrance

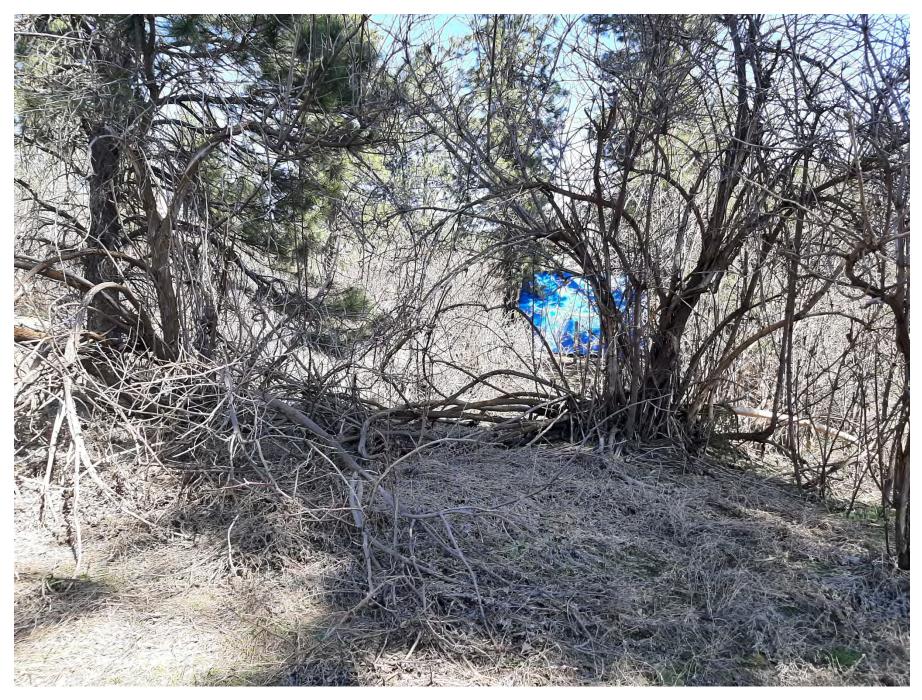
13. Looking northeast along temporary traffic bypass route

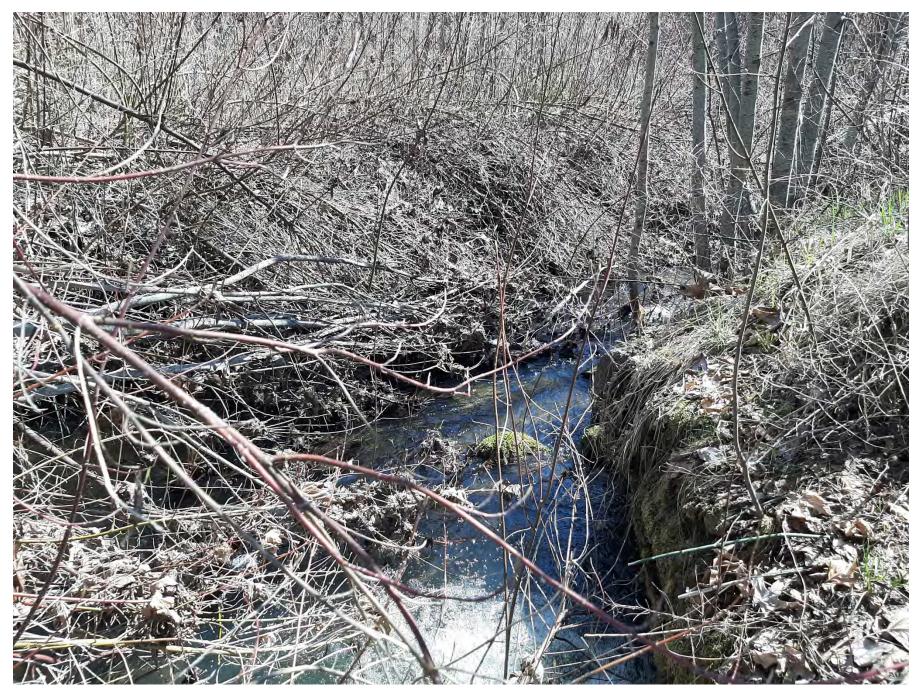
16. Looking downstream at weir correction wood structure

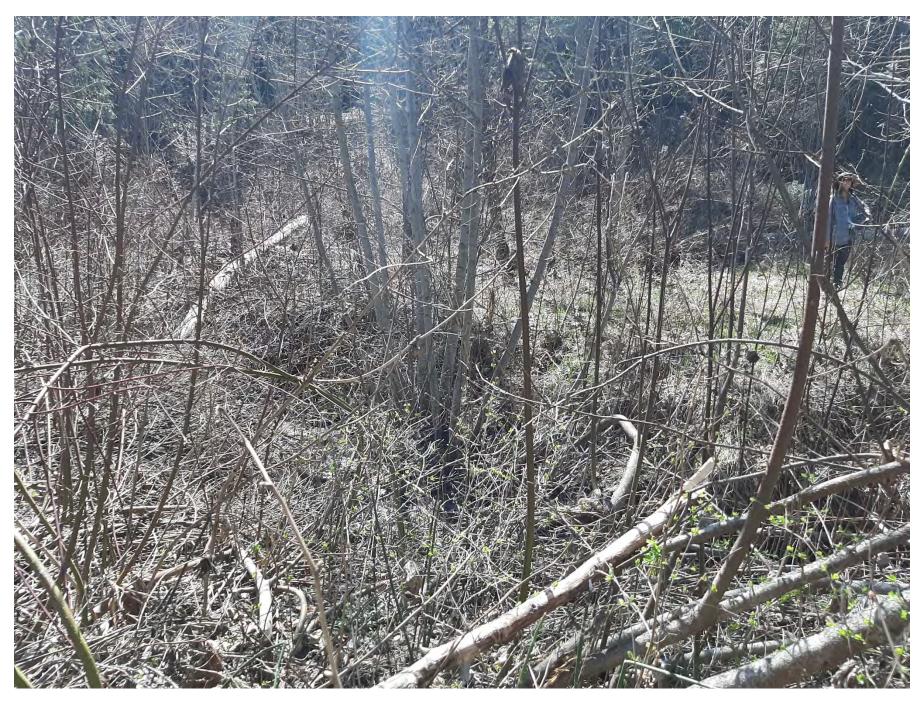
17. Looking at weir correction wood structure from a point lateral to left stream bank

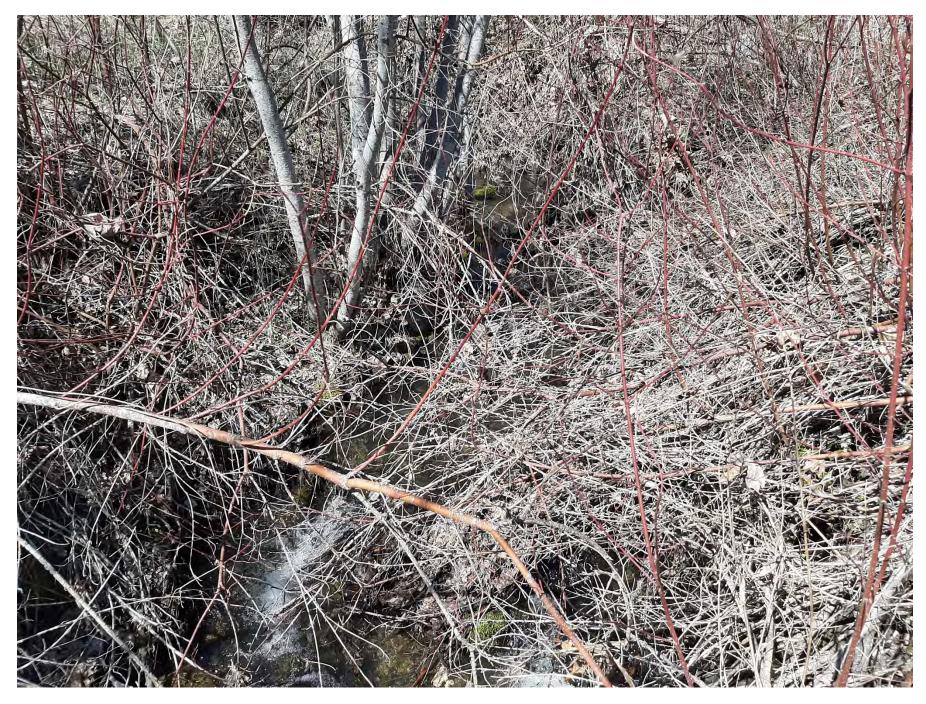
18. Looking upstream at weir correction wood structure

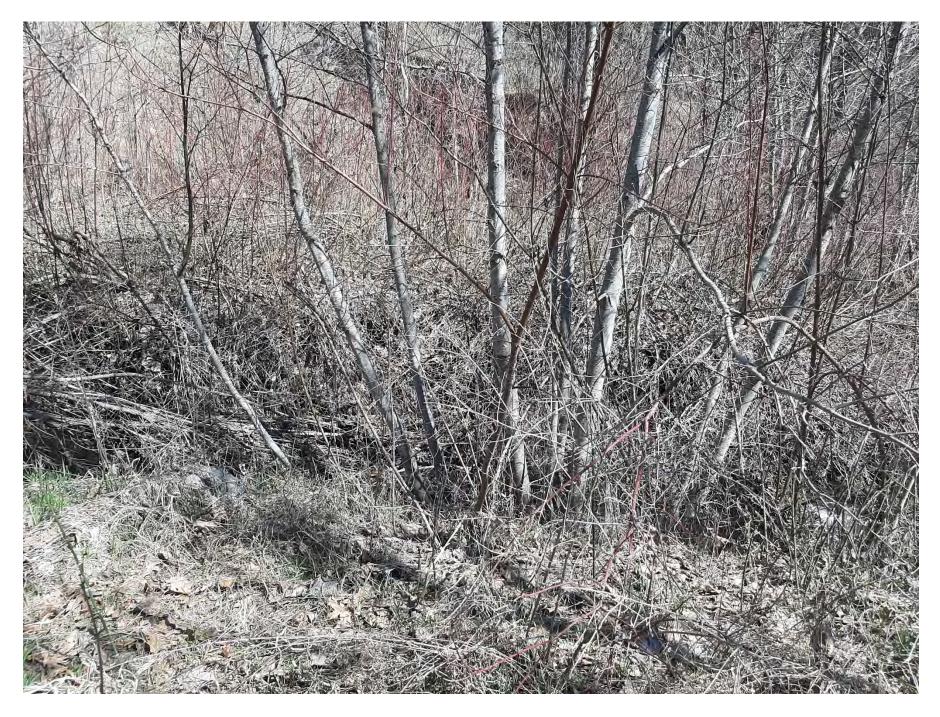
19. Looking at weir correction wood structure from a point lateral to right stream bank

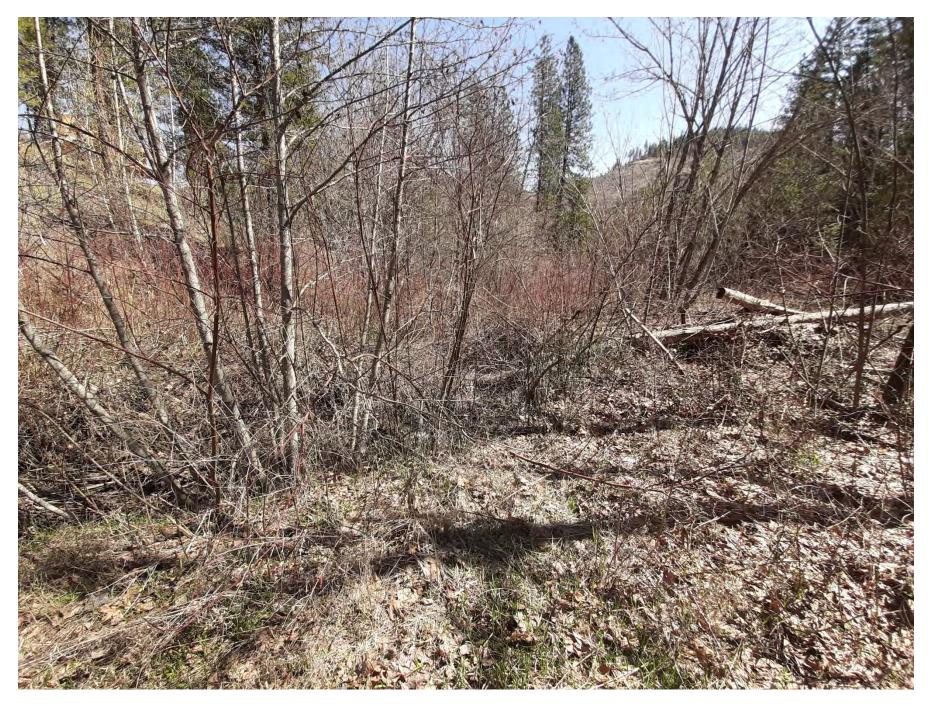
Looking at weir correction wood structure from a point lateral to right stream bank (wider view)
