**Mill Creek Culvert Replacement. Summer 2020 Implementation. RCO Project Number 18-1824R.**

**Permanent Photo Point Locations**

## Culvert Site Photos

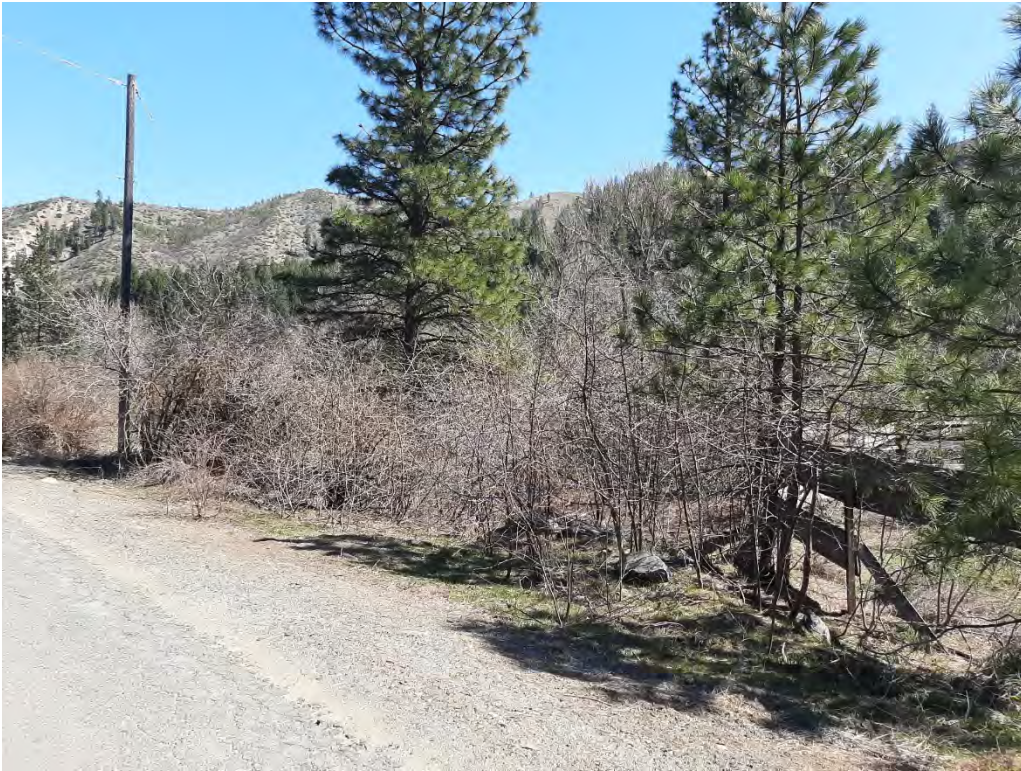
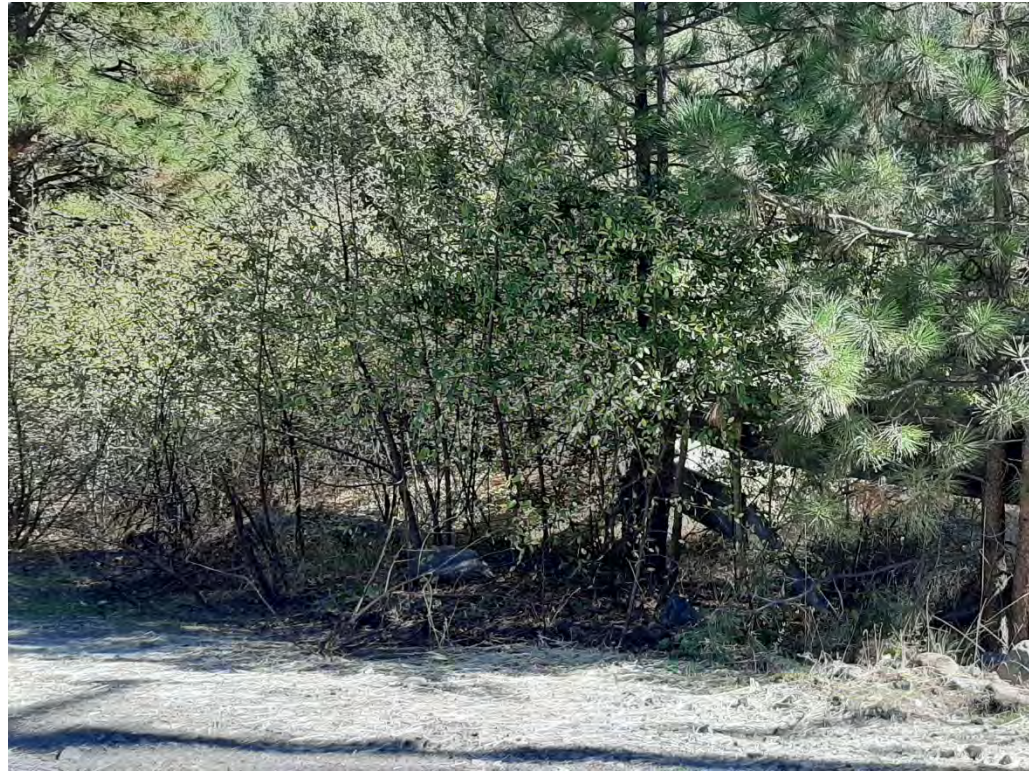
Photo 10. Looking southeast at staging area from road centerline – no disturbances here during implementation

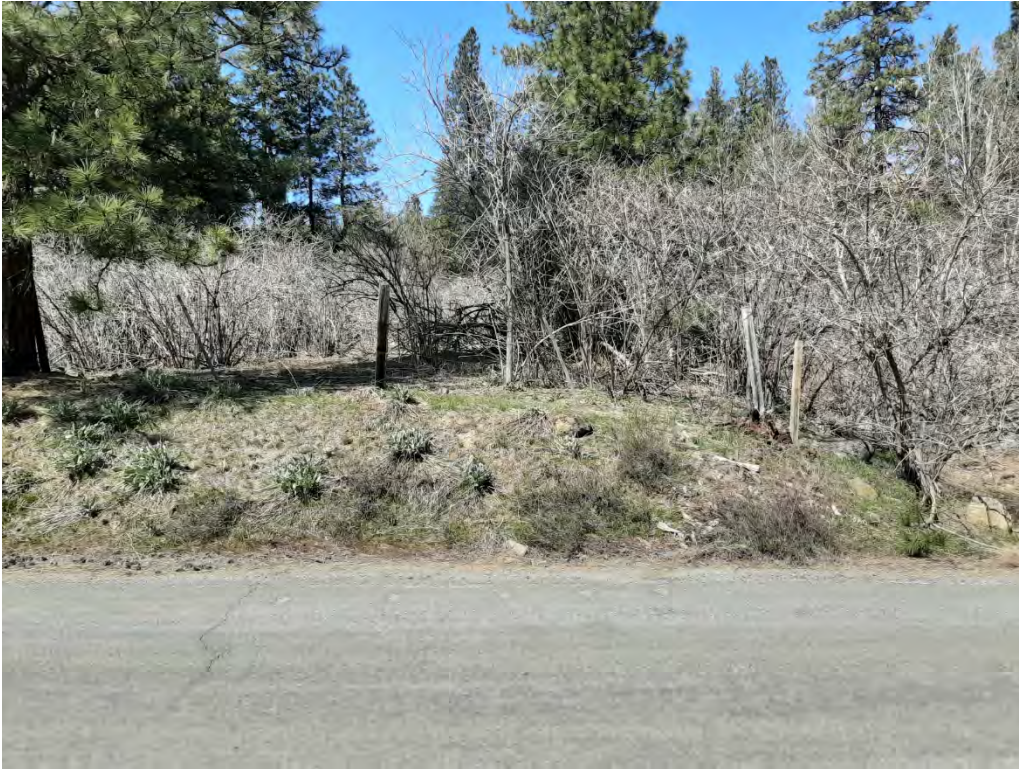
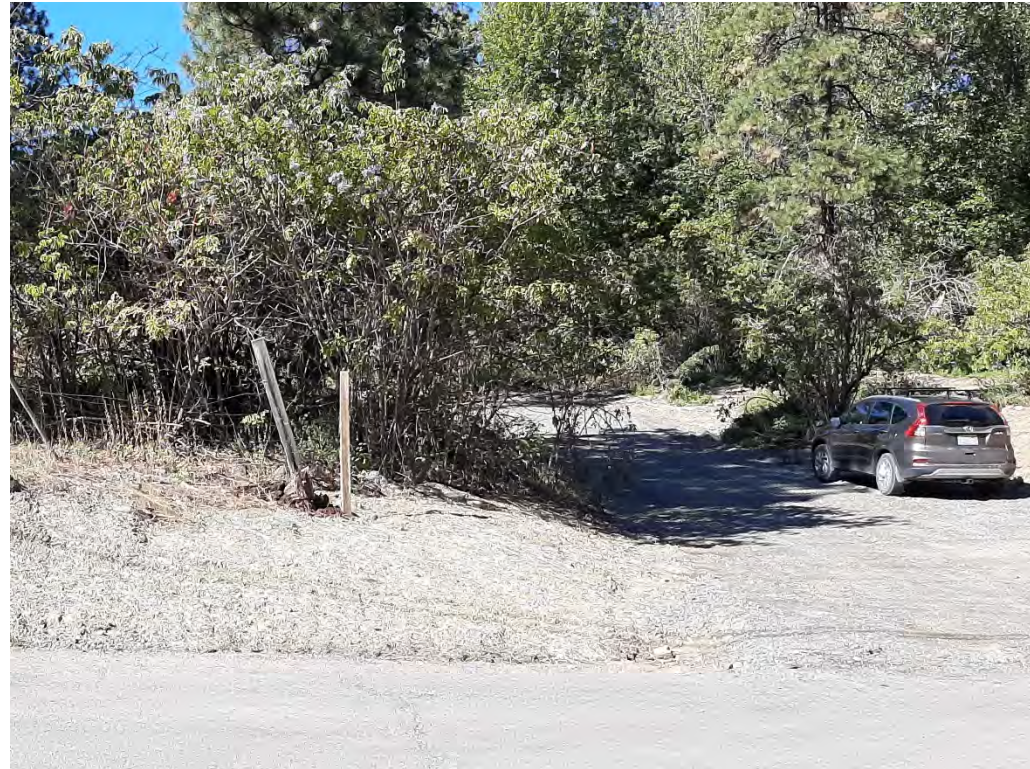
Photo 12. Looking northwest at temporary bypass entrance (location shifted north somewhat from design to implementation)

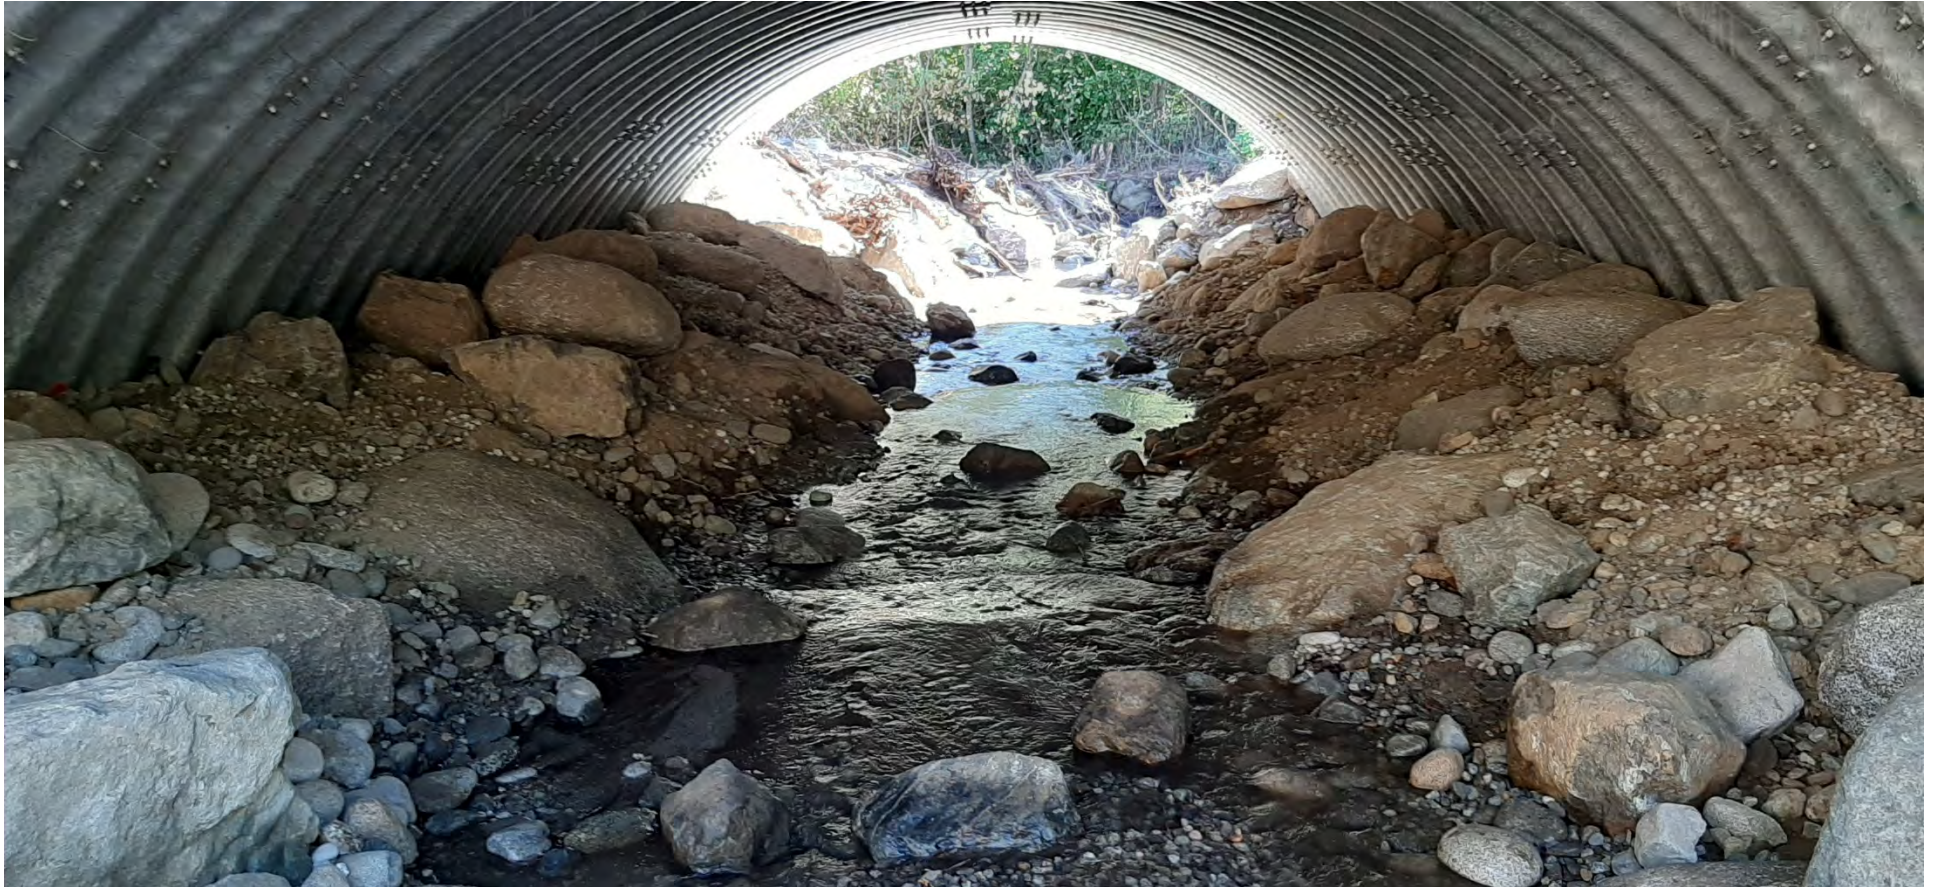
(detail) Looking downstream from inlet at constructed streambed in structure (pre-construction not depicted)

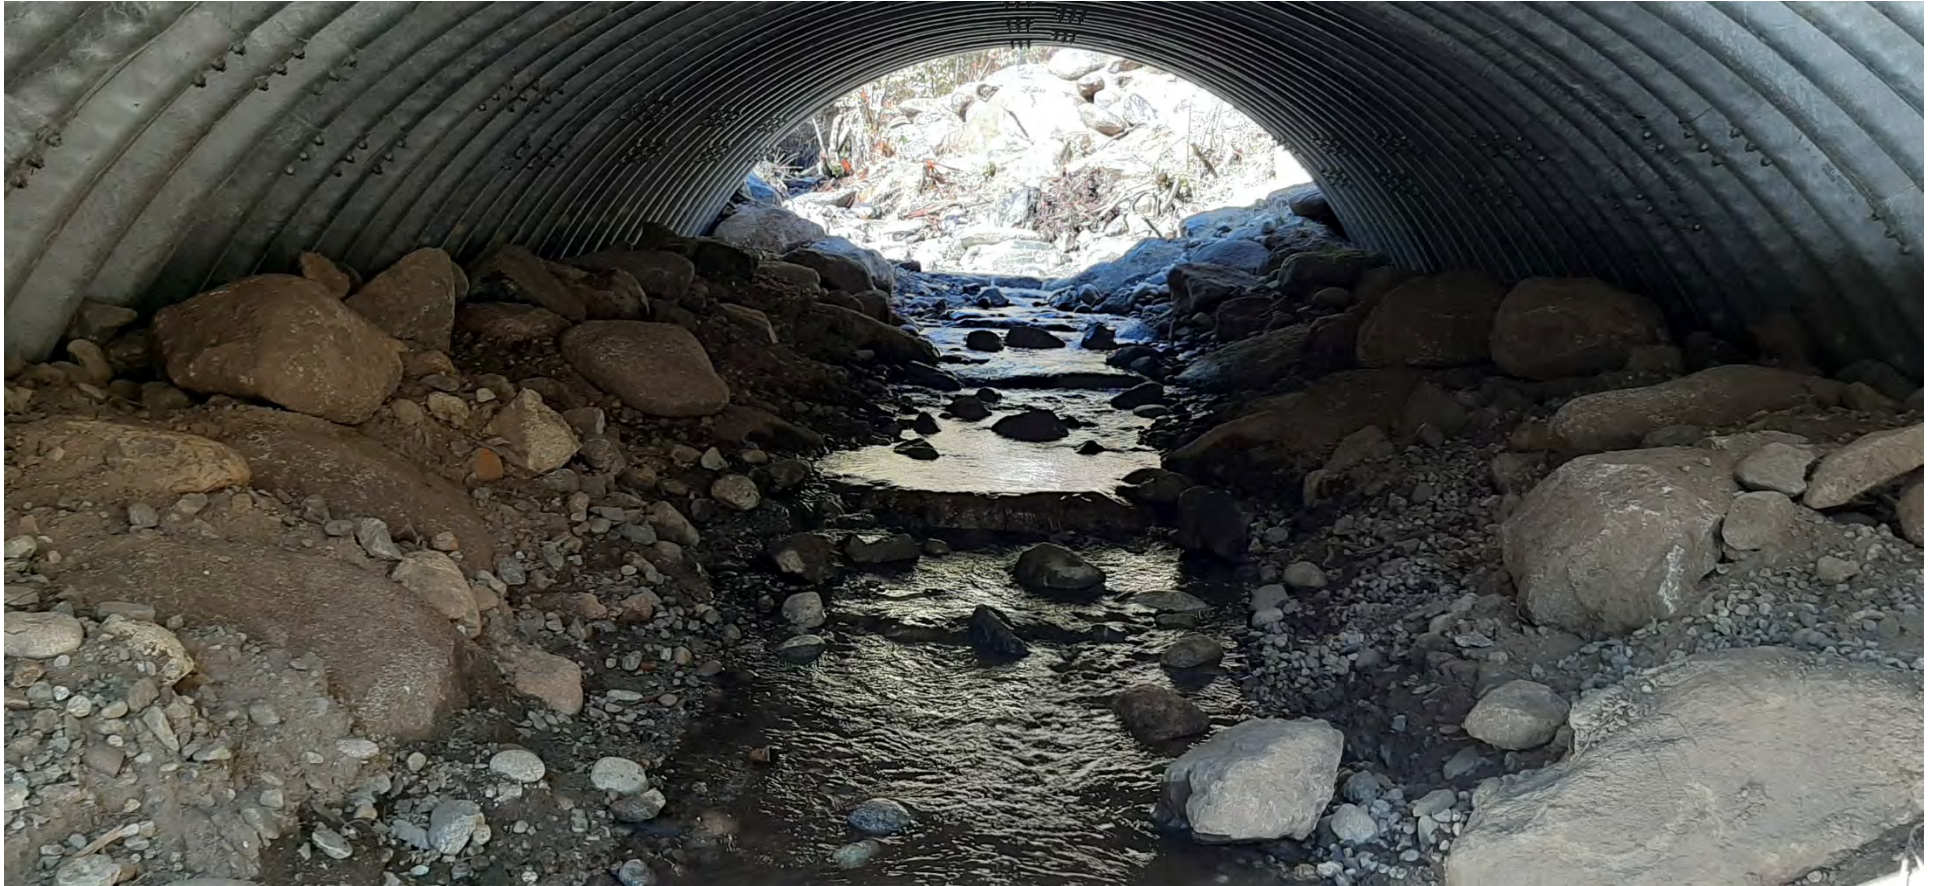
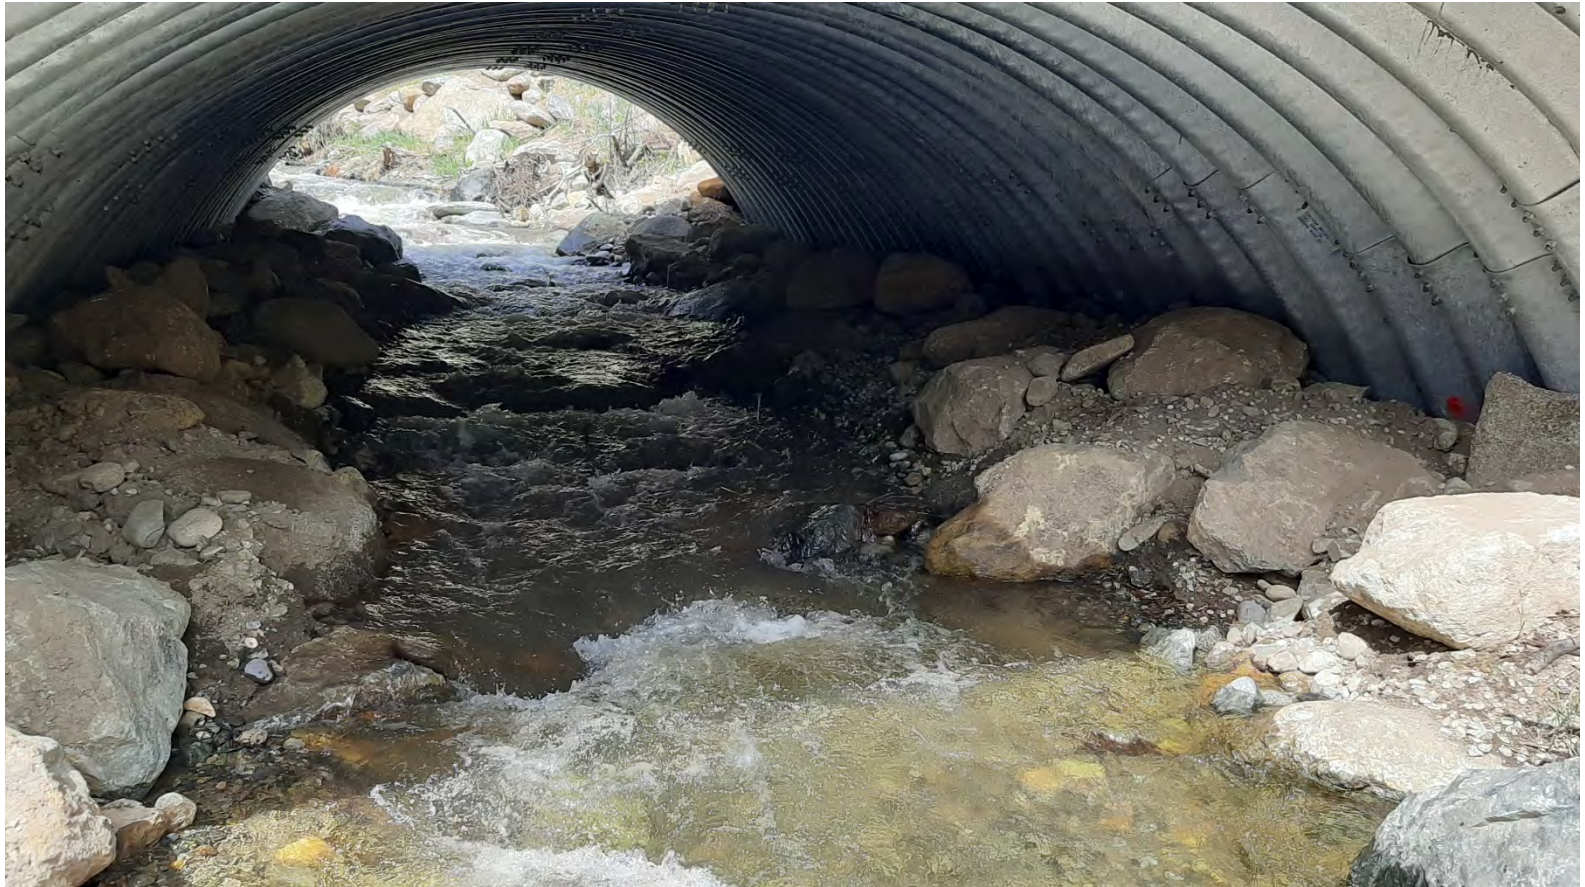
(detail) Looking upstream from outlet at constructed streambed in structure (pre-construction not depicted)
