Swan Lake Restoration Preliminary Feasibility Study Final Report

Prepared for:
Skagit Fisheries Enhancement Group
Swan Lake Watershed Preservation Group

By: Jim Johannessen, Licensed Engineering Geologist, MS and
Jonathan Waggoner, BS
Coastal Geologic Services, Inc.

Sep. 14, 2010

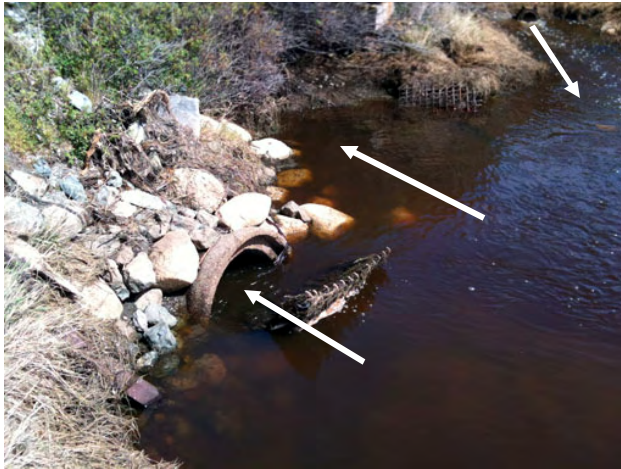
Arrow indicates direction of flow toward Strait

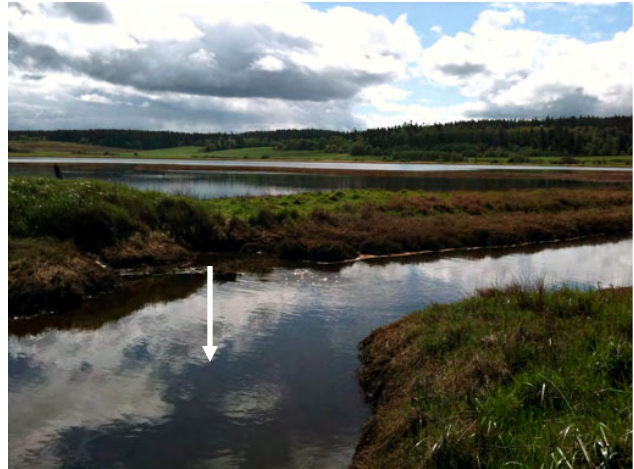
Two culverts connect the Swan Lake lagoon to the fairly narrow ditch running parallel to West Beach Rd (Figure 1, Photo Page 1). Both culverts had tidegate hardware, although the flaps were no longer present. Water was actively draining out of the lagoon to the western ditch during the April 28th field visit, although the eastern culvert was completely submerged. Both culverts appear to be considerably undersized for their purpose, as the lagoon water level was on the order of a foot higher than in the ditch. The northern culvert’s invert elevation (ie: inside bottom surface elevation) was at +2.2 ft MLLW.

Arrow indicates direction of flow from lagoon to ditch

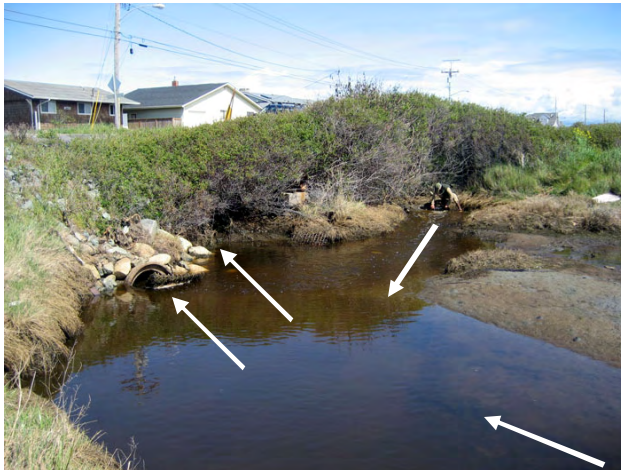
Three culverts were observed connecting the road ditch to the Strait of Juan de Fuca. The first, a 15” corrugated steel pipe, has been abandoned, as the waterward side, located in the northern tide gate well, has been plugged, and the elevation at the landward end appeared too high to effectively drain the lagoon except during the highest water levels (Photo Page 1). The south culvert, a 30” concrete pipe was partially submerged by water with an invert elevation of +0.7 ft MLLW, and had strong flow toward the Strait during the field assessment. It appears that a 24” plastic culvert had been slipped into the larger, older culvert. A grate had been installed in front of the pipe, although it was choked with vegetation, and leaned partially open allowing water to flow around the sides. The north culvert running beneath the road was below the water surface on the ditch side, and had been partially blocked by rocks that apparently had fallen from the roadbed above. The grate had been removed and placed on the side of the bank. The south pipe’s invert elevation was also +0.7 ft MLLW.

Arrows indicate direction of flow toward Strait

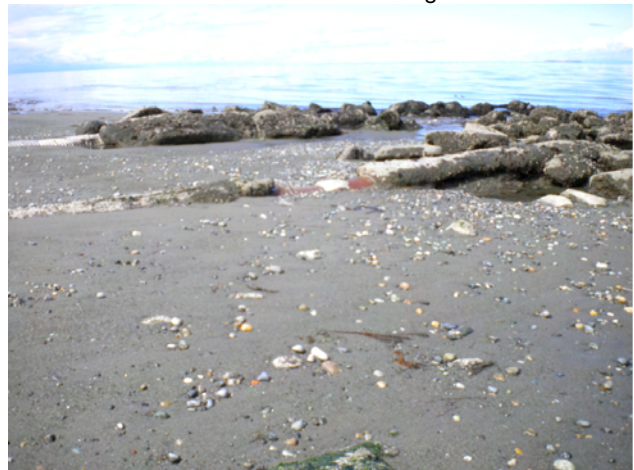
Tidegates and protective rock

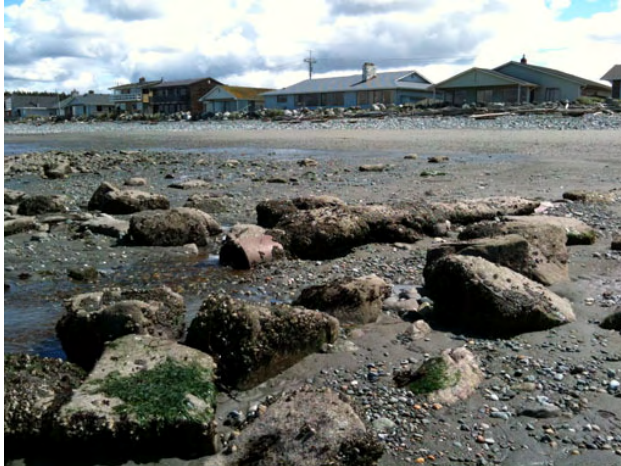
Investigation of the tide gate wells was conducted on June 29, 2010 as part of the limited topographic surveying effort. Both wells were constructed of concrete, and on the order of 10 ft deep. A concrete baffle had been constructed relatively recently, as the plywood used in forming the baffle was still visible in places. The northern tide gate well contained a functioning flap gate over the pipe leading from the lagoon. The flap appeared to have been part of the recent maintenance work performed by the County. The southern well contained a flap gate on the pipe through the central baffle, although the flap appeared to be rusted open, and so was not functional.

Northern tidegate – Strait side (note partial blockage and water flowing)

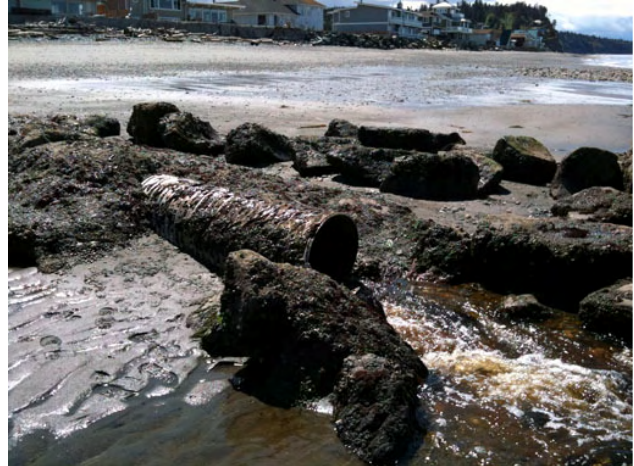
Southern tidegate – Strait side

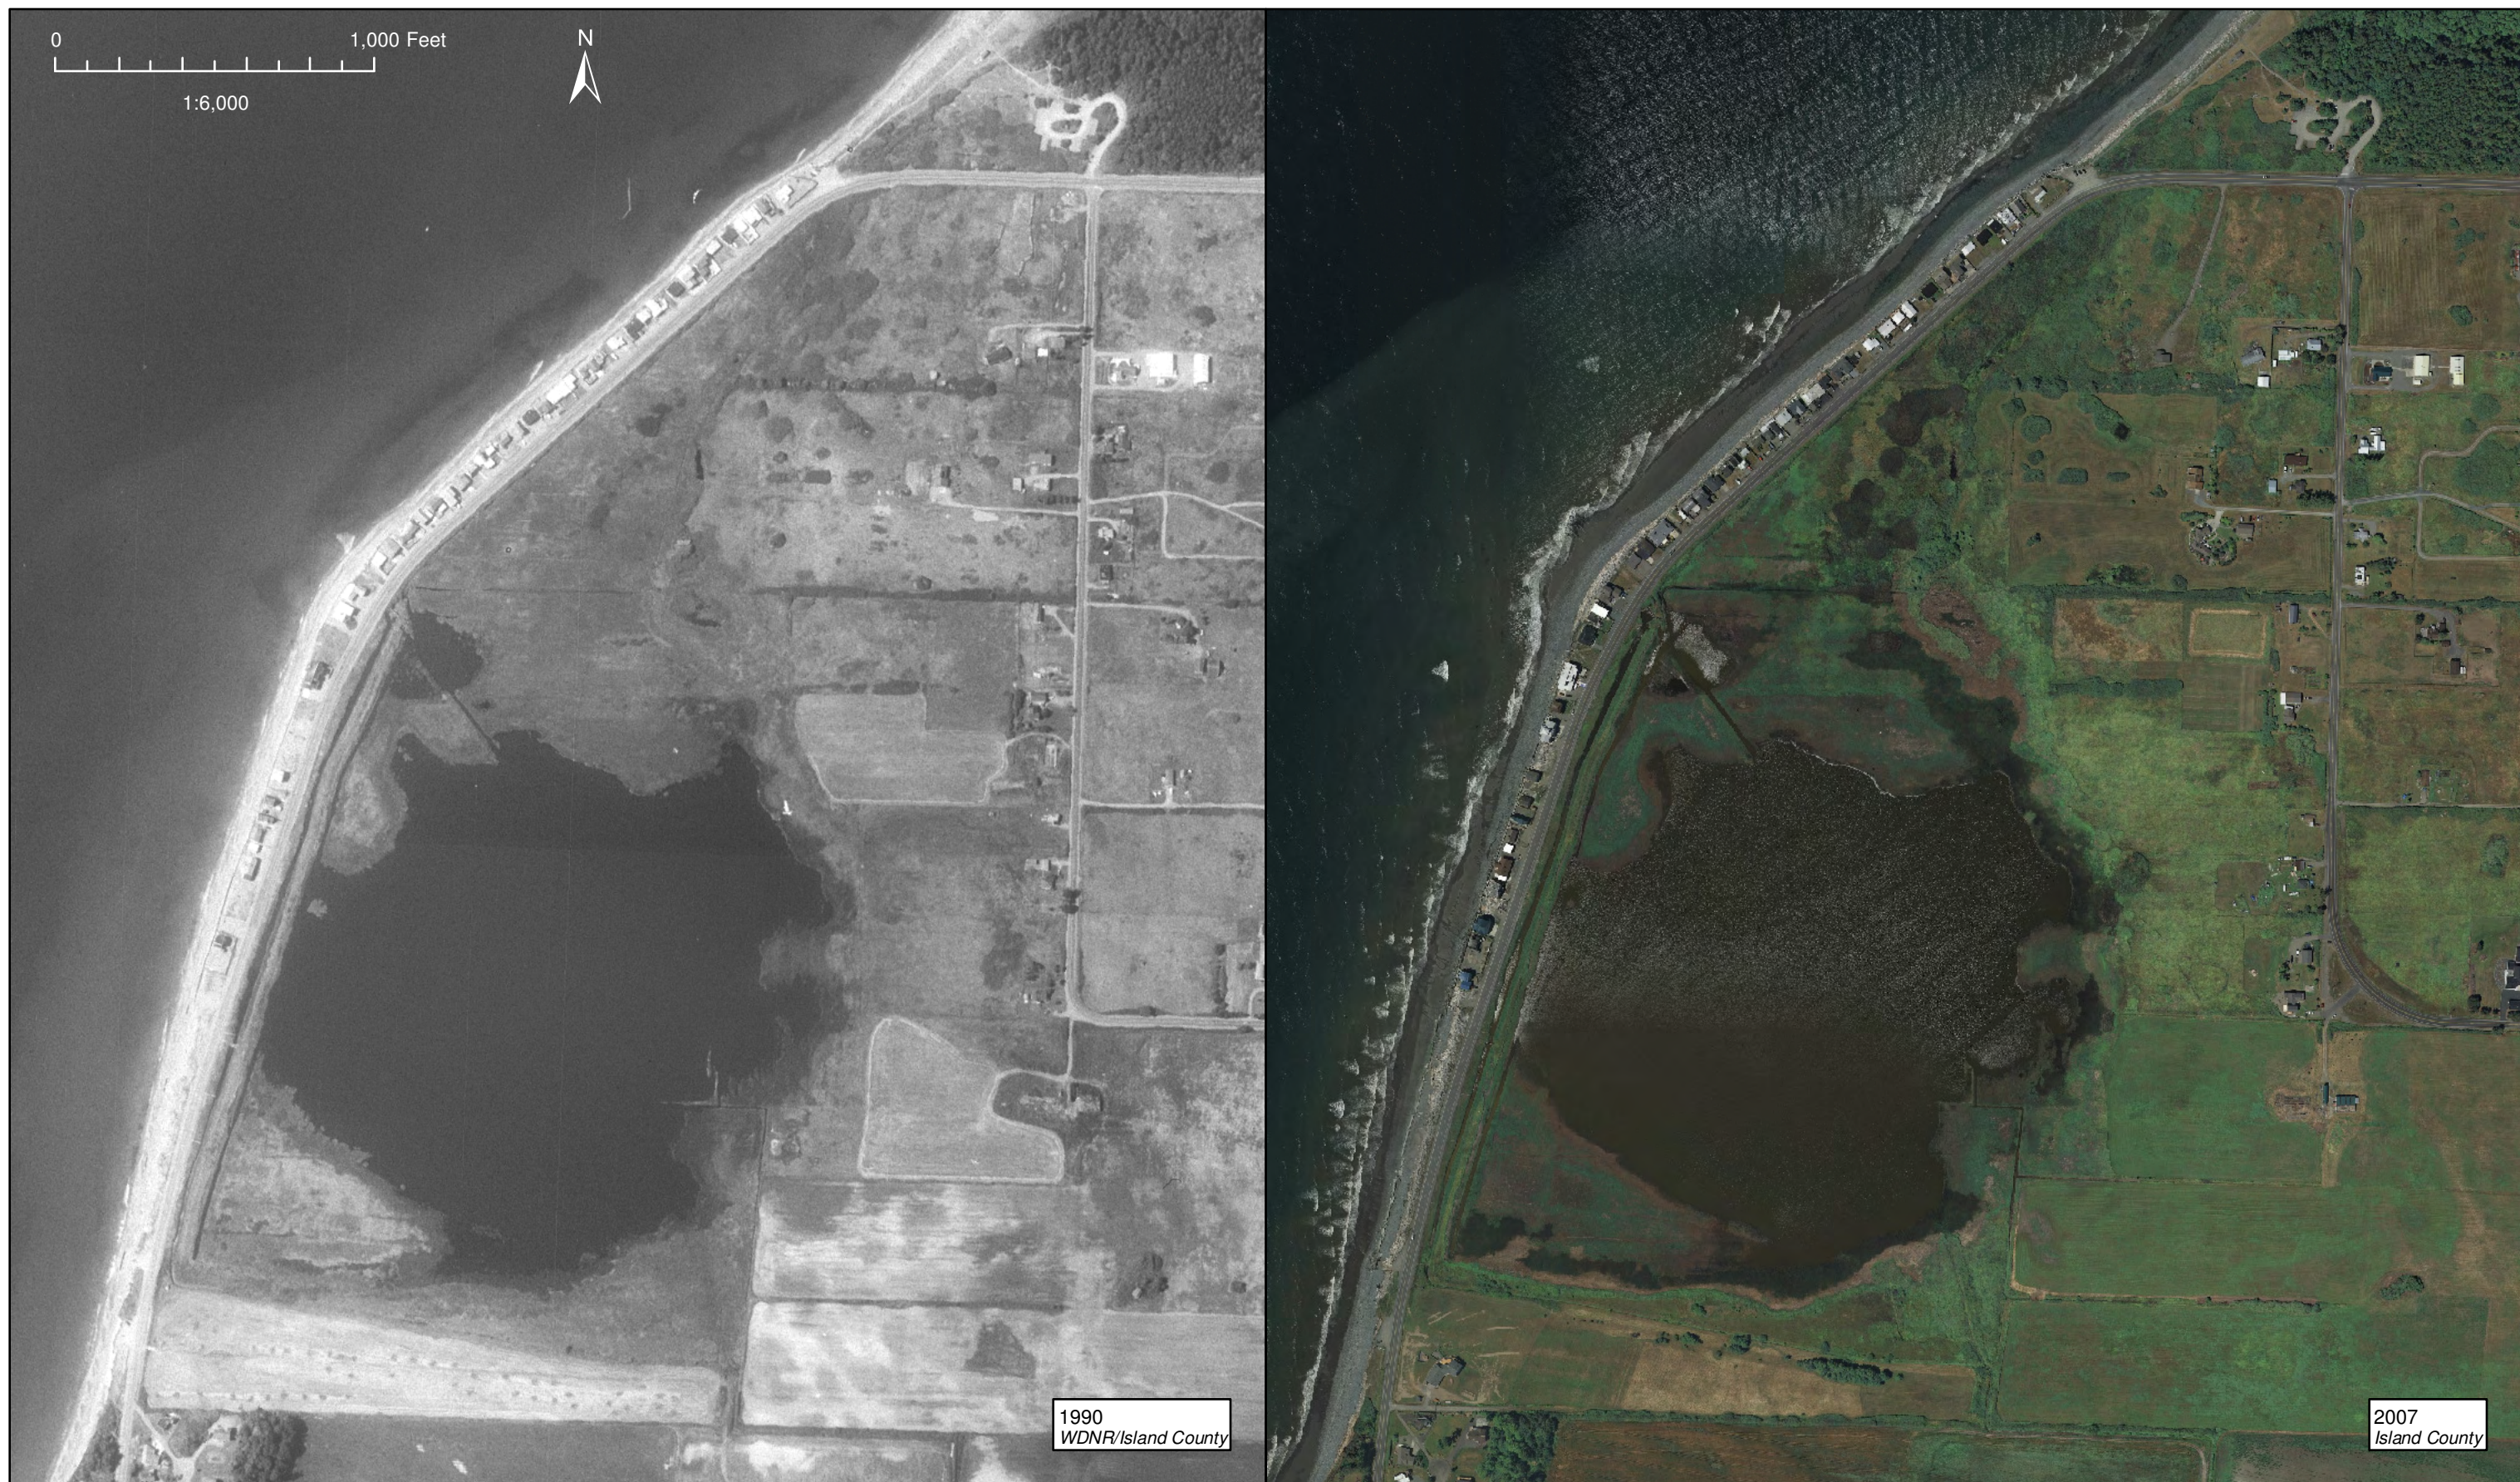
Figure 6c. Aerial photographs from 1990 and 2007.
 Note the high water level in 1990 and 2007, likely due to lack of tide gate maintenance following dissolution of Drainage District No. 1.
 2007 water level was on the order of +2 to +3 ft MLLW based on field survey.

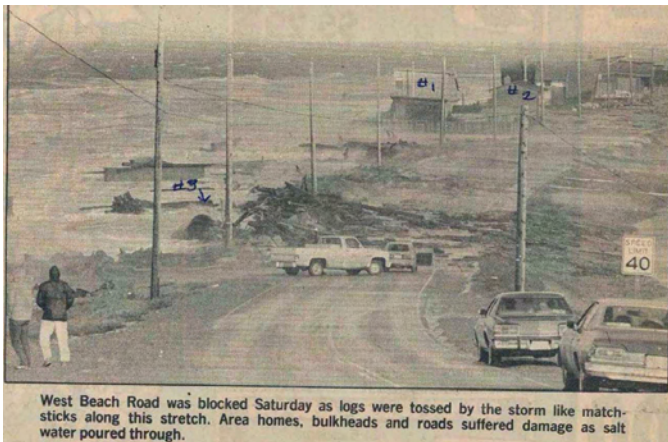
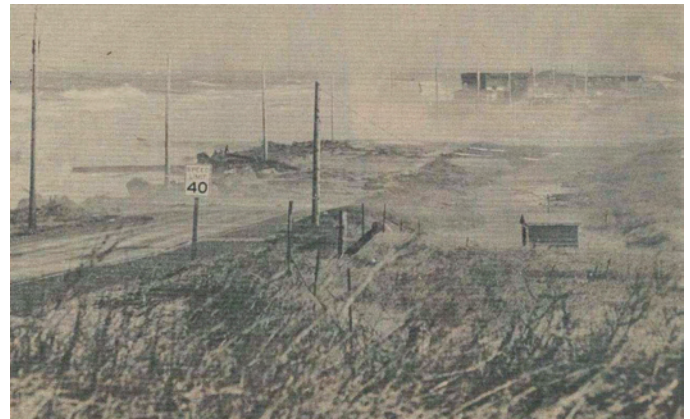
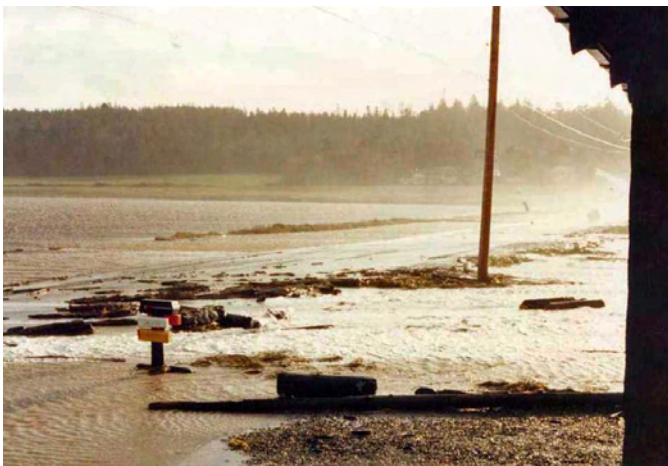
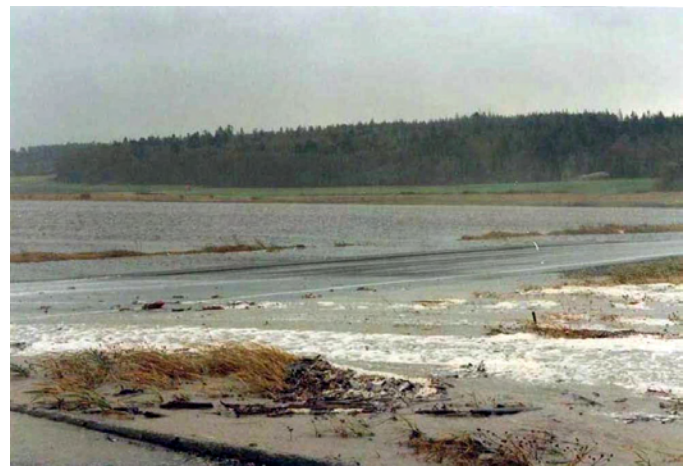
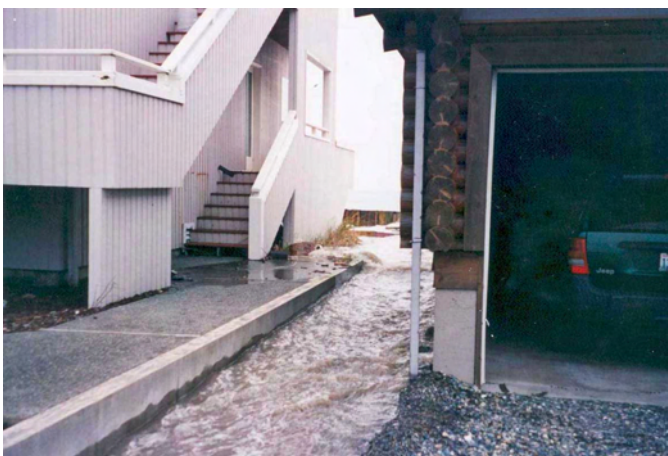
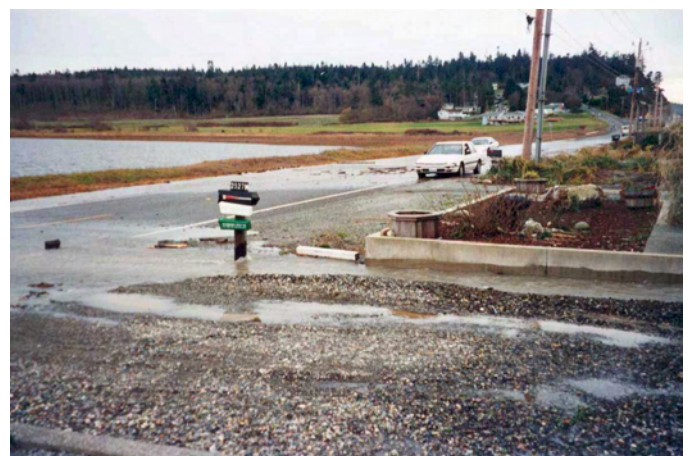
Saltmarsh vegetation was present in the lagoon in 1871, as mapped by the US Coast and Geodetic surveyors (Figure 4). Overwash of the berm occurs periodically under present tide gate conditions (Figure 8), and the failing tide gates allow some volume of marine water to enter the lagoon (as discussed in the Task 1 memo). Saltmarsh vegetation is widespread around the lagoon at present, including pickleweed (*Salicornia virginica*) and saltgrass (*Distichlis spicata*), such that conditions obviously already support this vegetation community and would not need to be substantially altered for enhancement of habitat conditions. However, if water levels in the lagoon were allowed to vary more in line with tidal levels in the Strait, the marsh vegetation may have to migrate up in elevation.

Figure 8. Photo page with post storm images.

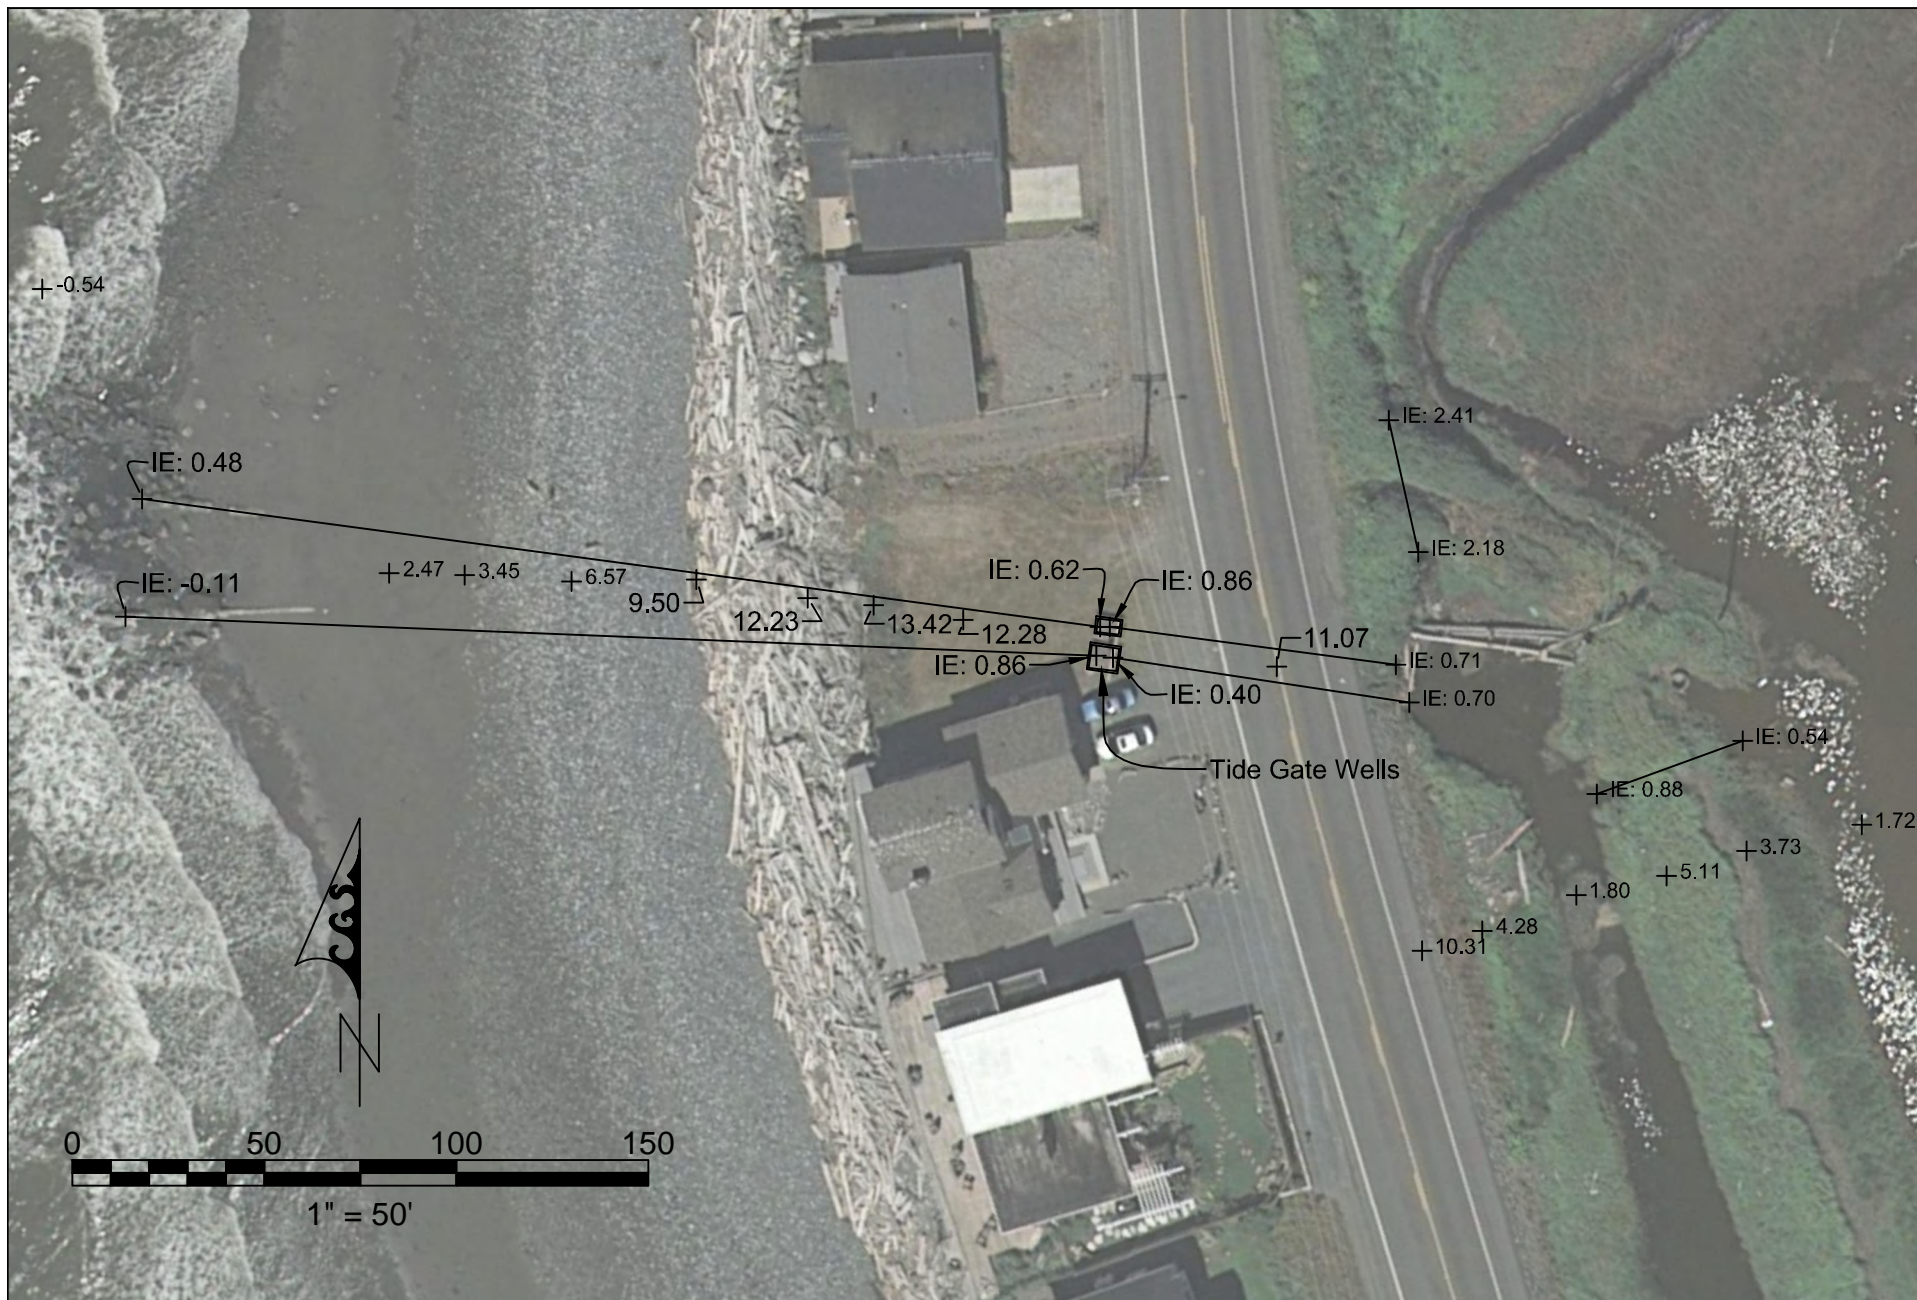
Figure 10. Tide gates and vicinity at Swan Lake showing invert elevations (IE) and selected spot elevations collected on 29 June, 2010. Elevations shown are in local mean lower low water (MLLW). Black lines indicate location of pipes. Lagoon (main basin) water surface at time of survey was +3.73 ft MLLW and falling approximately 1 ½ hours after low tide of -0.9 ft MLLW.
Air photo from Island County (2007).
