Livingston Bay Pocket Estuary Restoration Feasibility Assessment

September 15, 2011

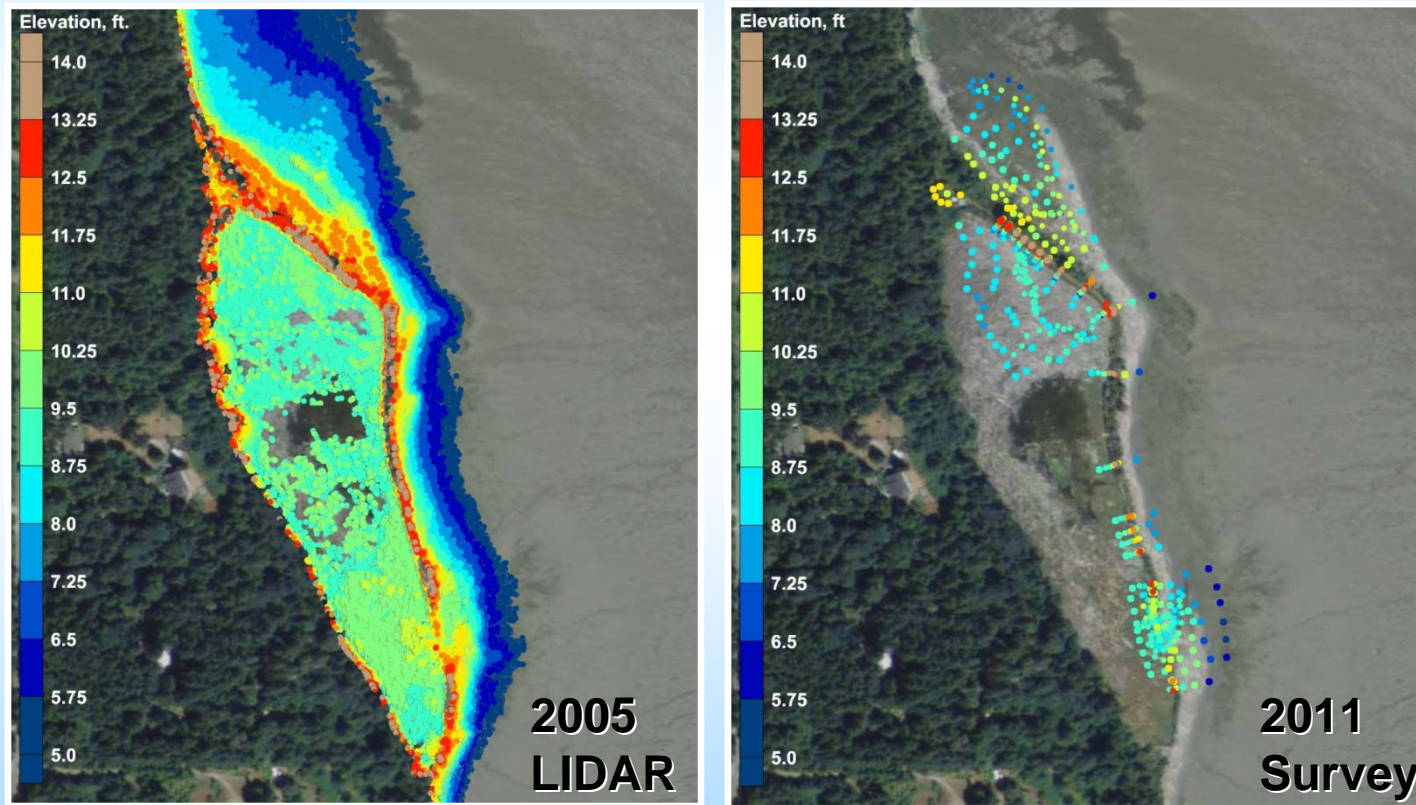
Comparison of LIDAR and ground survey, elevations ft NAVD88

- North spit location changed between 2011 & 2005
- LIDAR picks up the floating logs and thus gives higher elevations than the ground survey in the marsh (about 1.0 to 1.5 feet higher)

- Dike elevations match well (within 0.5 ft) however vegetation is not well removed from the bare earth LIDAR along the levee crest.
- South breach channel appears to have migrated to the north

- Mudflat elevations are within about 0.2 ft between LIDAR and survey, this is very good agreement
- LIDAR precision is about ± 0.25 ft on hard surfaces, accuracy on the order of ± 0.5 ft

- Surface gradient in the marsh plain is about 2.0 ft (10.0' to 12.0' MLLW) and LIDAR inaccuracy eats up about $\frac{1}{4}$ of that range.
- For numerical modeling LIDAR must be adjusted down in vegetated marsh area; mudflats data be used directly with some confidence.

- LIDAR inaccuracy forces us to rely upon ground survey to estimate tidal prism and for design drawings/quantities.

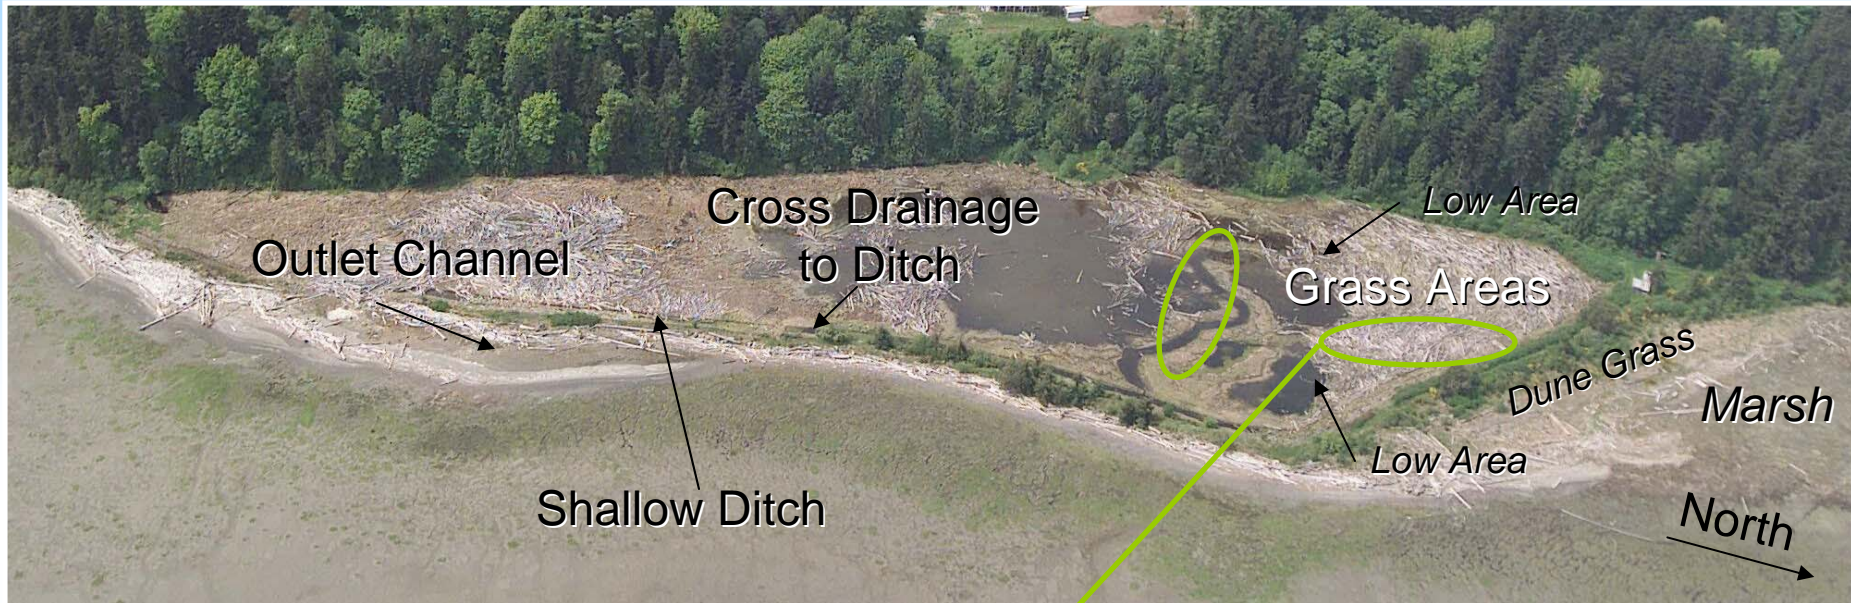
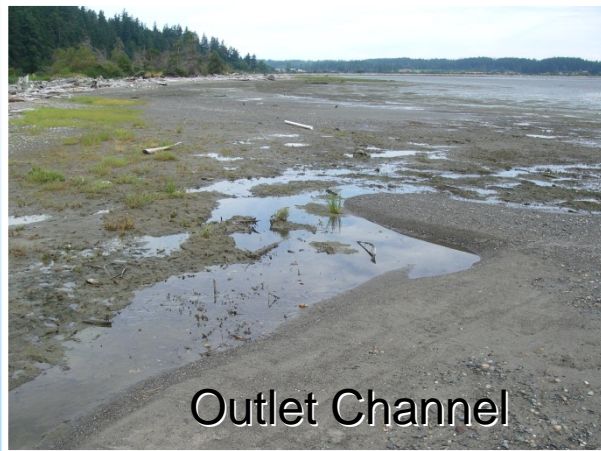
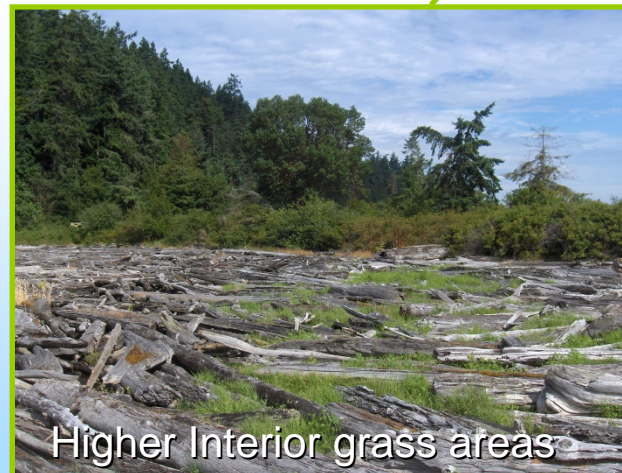
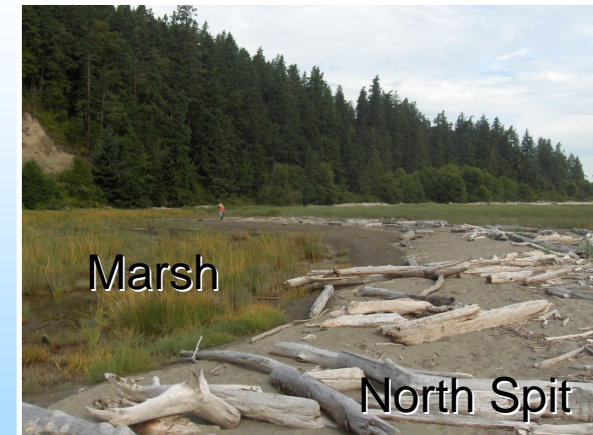
Site Visit Observations

- Majority of Tidal Prism located at north end of estuary
- Existing outlet is a long drainage path w/ high resistance ~ inefficient flow routing
- Estuary around current outlet is very high elevation ~ at or above MHHW
- Breach Outlet Channel at High Level (1' below MHHW)
- Restriction at old road crossing and filled ditch
- Growth of North Spit continues
- Ponding or tidal water "hold-in"

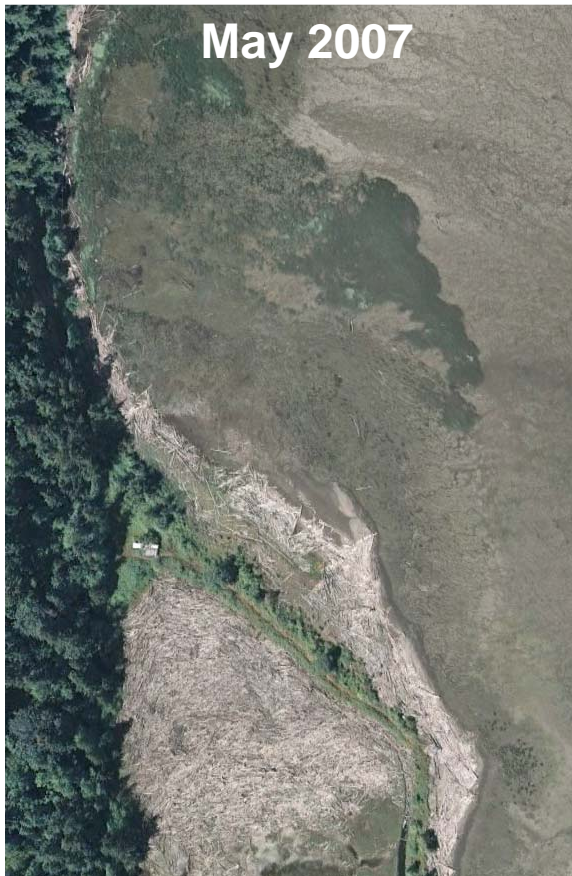
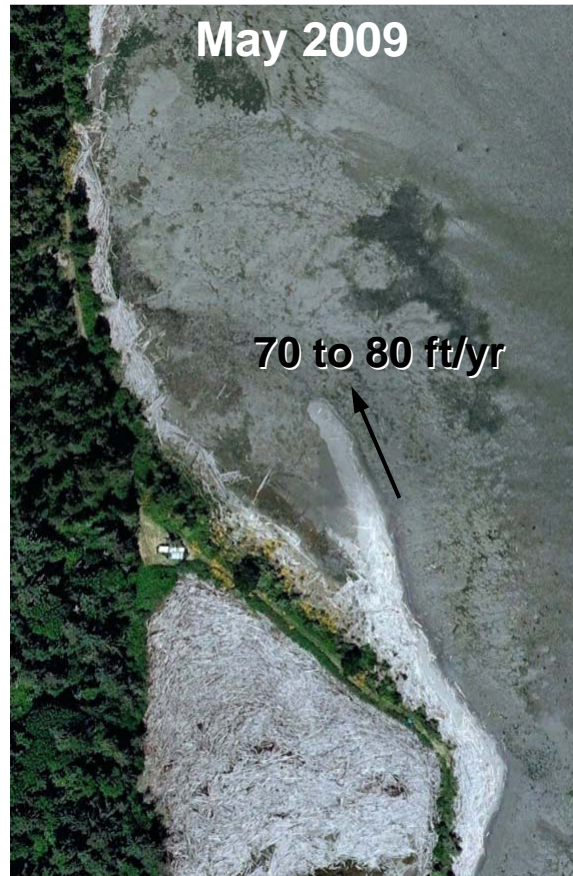
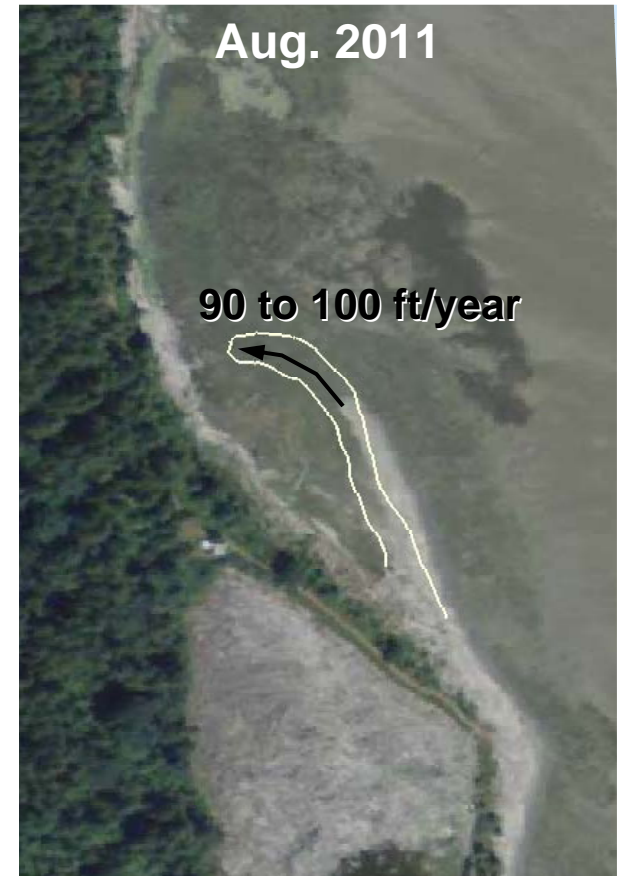
Growth of North Spit

Recent net growth on the order of 250 to 300 m³/year to the north

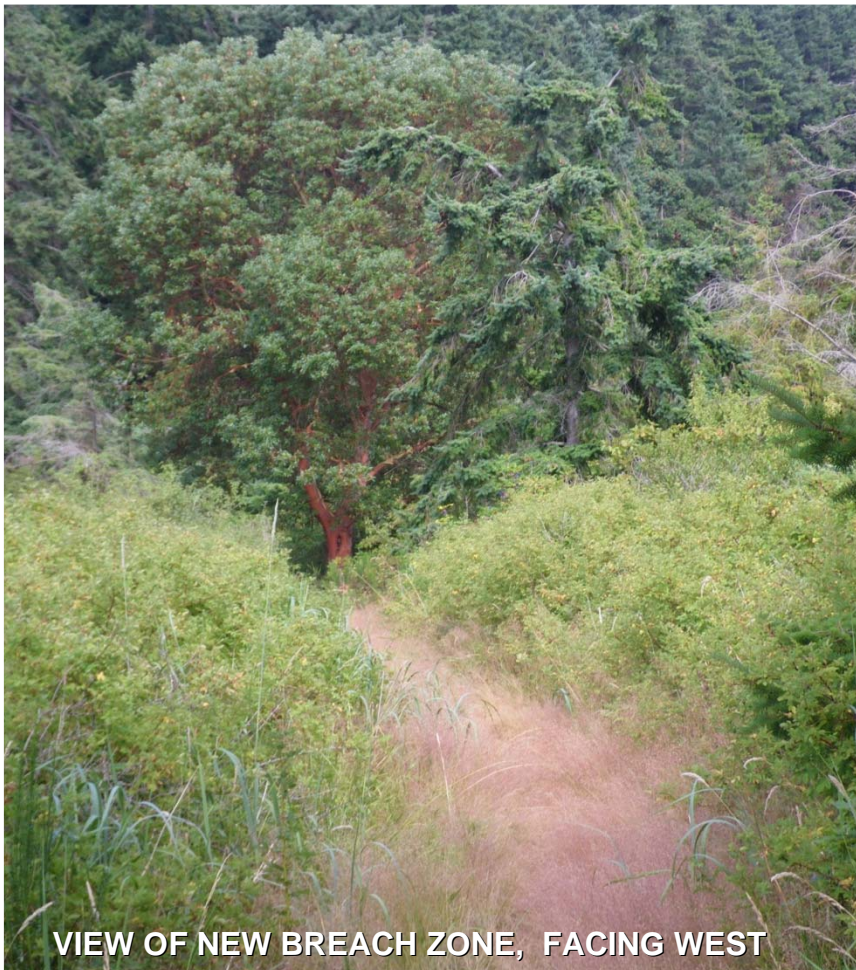
VIEW OF NEW BREACH ZONE, FACING WEST

- Ecological Function.
 - Fish and invertebrate access
 - Provide a deeper water refugium for juvenile salmonids at low tide.
- Location.
 - Breach and pilot channel to be located to take advantage of existing topographic features, oriented to the north.
- Size & Extent.
 - To equilibrium depth and width resulting from the estimated tidal prism and study of adjacent pocket estuaries.
 - Breach top width will be sized to at least the average length of driftwood within the site. Top width constrained to less than 100 feet.
- Hydraulic Performance:
 - Sufficient to provide tidal exchange and mobilize existing sediments in the tidal channel at peak ebb and flood tide.
 - Remove wood from the project area.

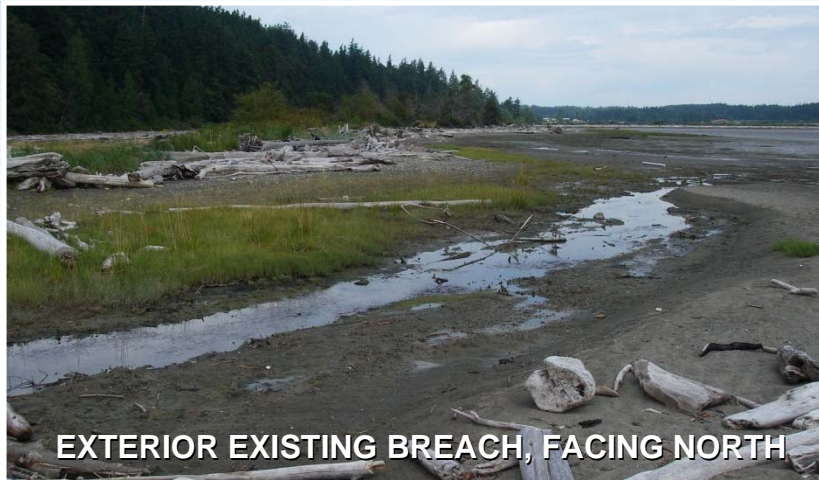
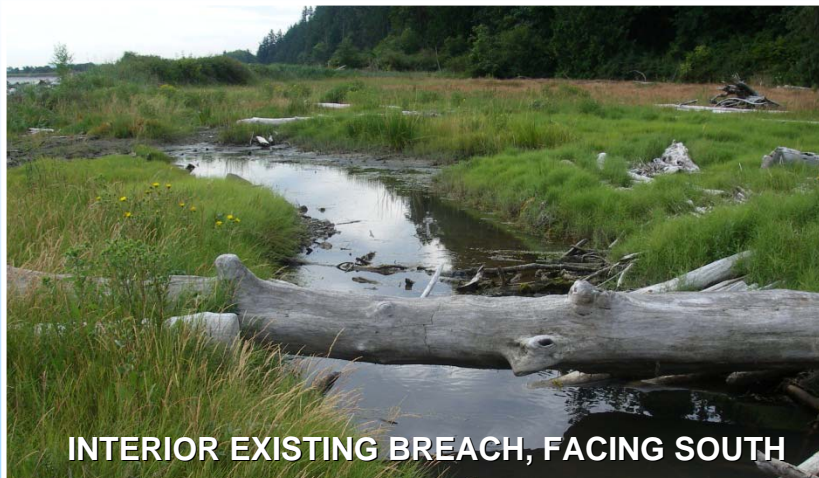
Existing South Dike Breach Modifications

- Ecological Function.
 - Restore Long Shore Sediment Processes
 - Increase shoreline riparian area
 - Aid in driftwood removal
- Location.
 - Primary existing south breach
- Size & Extent.
 - Rebuild Beach Berm
- Hydraulic Performance.
 - Route tidal flows through north pilot channel.

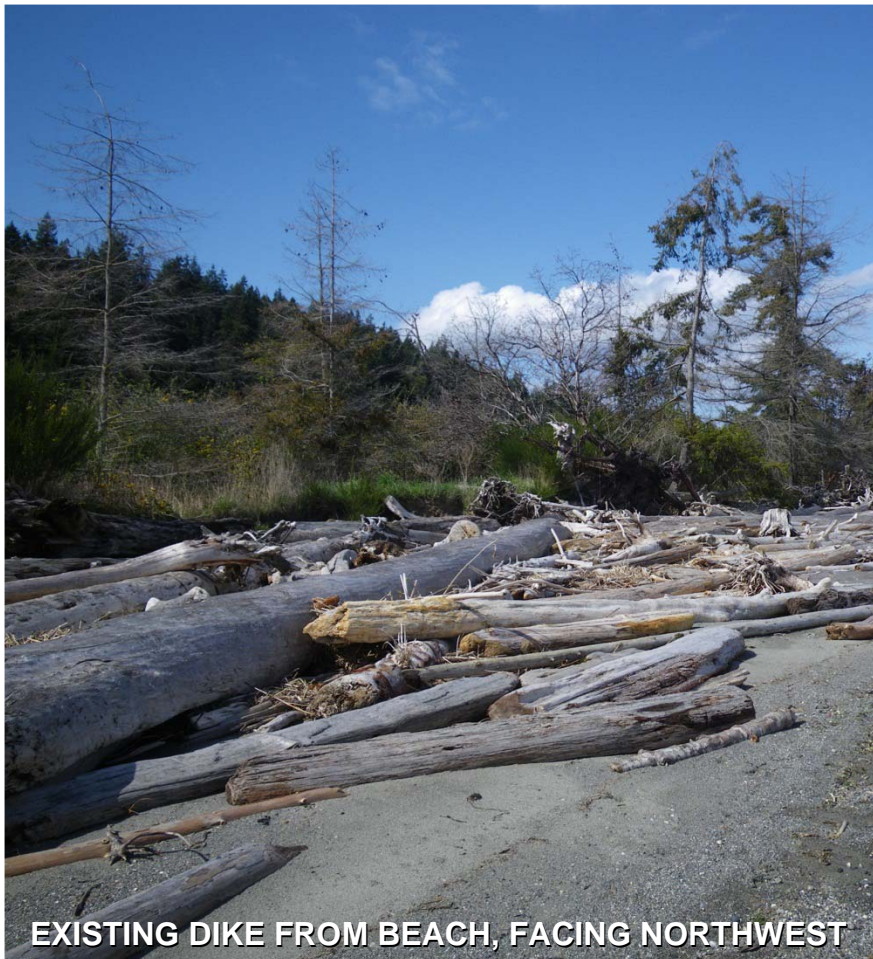
EXISTING DIKE FROM BEACH, FACING NORTHWEST

- Ecological Function.
 - Aid in natural LWD removal from estuary – north dike only.
- Location.
 - Primarily along north dike
 - Minimal benefit along east dike.
- Size & Extent.
 - Within footprint of existing north dike
- Hydraulic Performance.
 - Increased wave overtopping during storms.

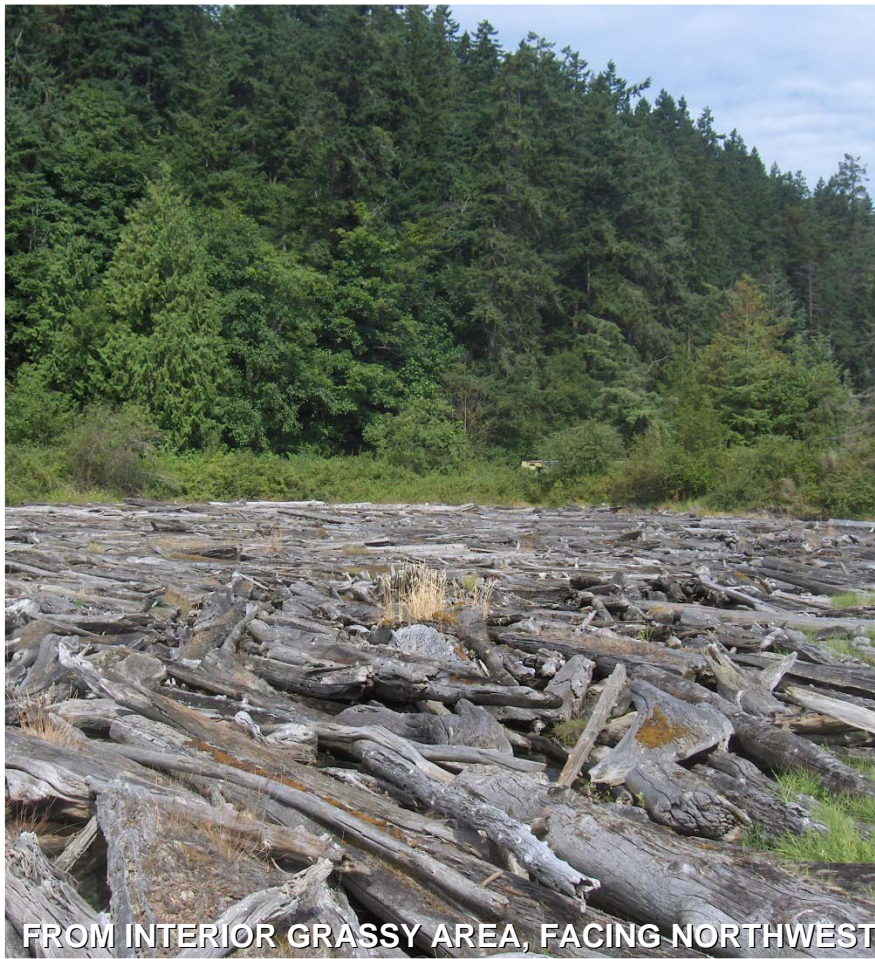
FROM INTERIOR GRASSY AREA, FACING NORTHWEST

- Ecological Function.
 - Wood removal improves fish access and directly restores estuarine marsh
- Location.
 - At minimum, in the vicinity of pilot channel.
 - Strategic locations determined by hydraulic analysis.
- Size & Extent.
 - Pilot channel to provide unobstructed tidal channel flow between the bay and estuary.
 - Partial Removal due to budget limitations. Focus on areas most critical for connectivity and restoration.
 - Natural Recovery. Residual driftwood would be allowed to mobilize through natural processes upon completion of construction.

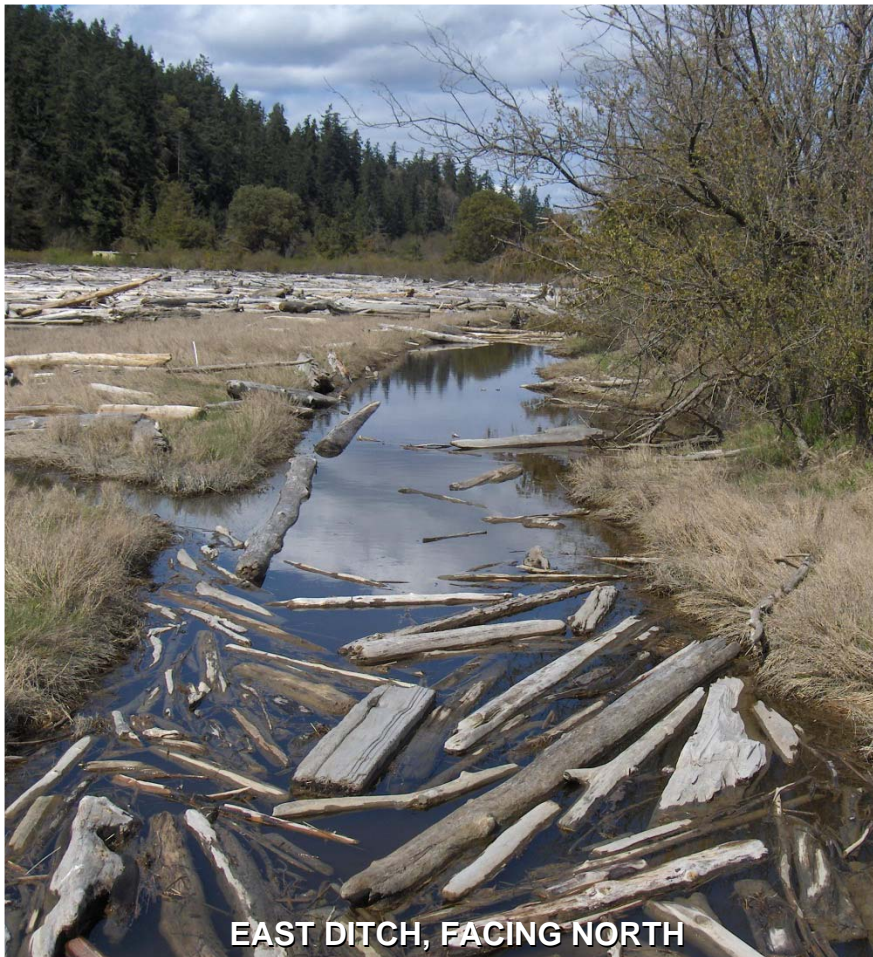
Existing Borrow Ditch Modifications

- Ecological Function. Improved fish access and deep water refugia.
- Location. Location varies; orientation follows existing ditch.
- Size & Extent. Filling/Excavating of borrow ditches to be evaluated to aid in new outlet channel hydraulic and geomorphic processes.
- Hydraulic Performance. Ensure flow routing to new pilot channel to maximize hydraulic performance.

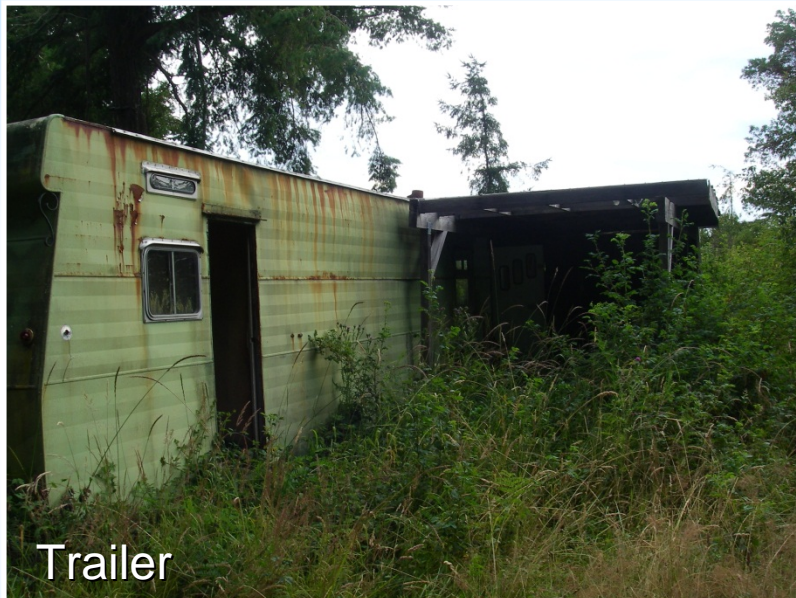
Demolition

- Ecological Function.
 - Reduced potential for contaminants entering the restored estuary. No other specific ecological benefits were identified.
- Location.
 - At three existing structures/vehicles.
