The Nason Creek Fill Removal and Oxbow Enhancement Project (N1)

2016 Monitoring Report

Prepared by: Chelan County Natural Resources Department

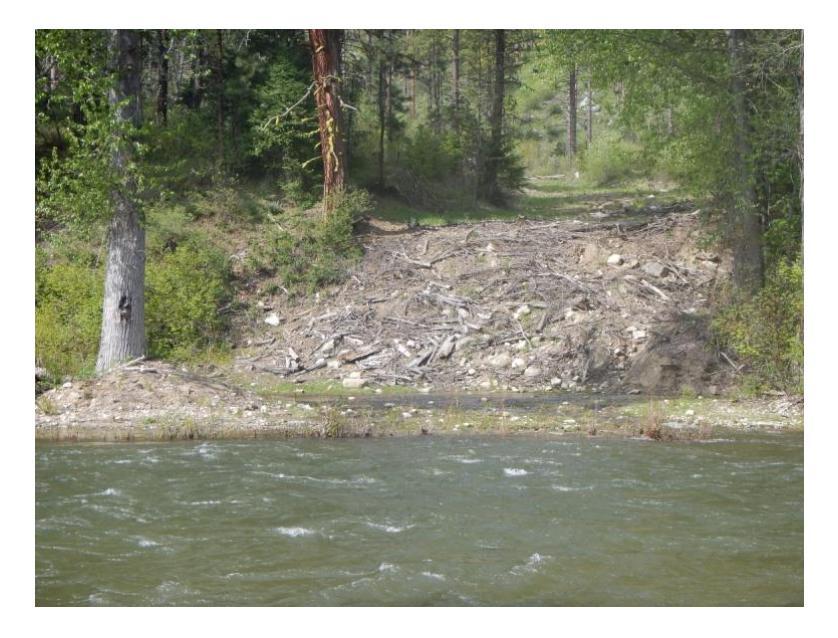
The abutment removal area is active and flooded at high flow and has undergone natural process, including channel formation and relic side channel activation, following fill removal. Initial post-construction floods in November 2014 formed a "new channel" that extends across the floodplain from the upstream beaver pond to a breach in the brush mattress that formed during this same flood. The floodplain was under water and both the relic side channel and the new floodplain channel were activated on April 21, 2016 when the Nason Creek gage recorded 1750 cfs (Figure 5). Flood waters were from both Nason Creek and the beaver pond (Figure 2). The brush mattress was inundated, partially out of the water and along with the activated floodplain provided high flow refuge habitat to juvenile salmonids.

Figure 5. The abutment removal area floodplain was active April 21, 2016 at 1750 cfs.

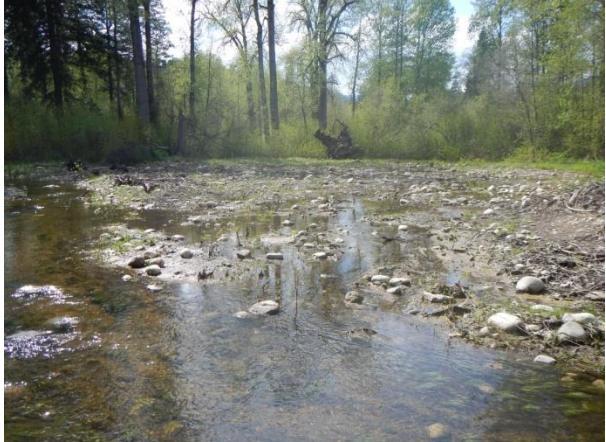
The river right parking lot removal floodplain was inundated on the northwest side of the constructed channel during the April 21st, 2016 visit at a mainstem flow of 1750 cfs (Figure 6). Slash within the flooded area had been mobilized and was built up at the outlet of the constructed channel (Figure 6). The constructed channel was active and its banks were overtopped mid channel adjacent to the floodplain inundation (Figure 6).

Figure 6. Parking lot fill removal area on April 21st, 2016 at 1750 cfs

Flooding on northwest side of floodplain

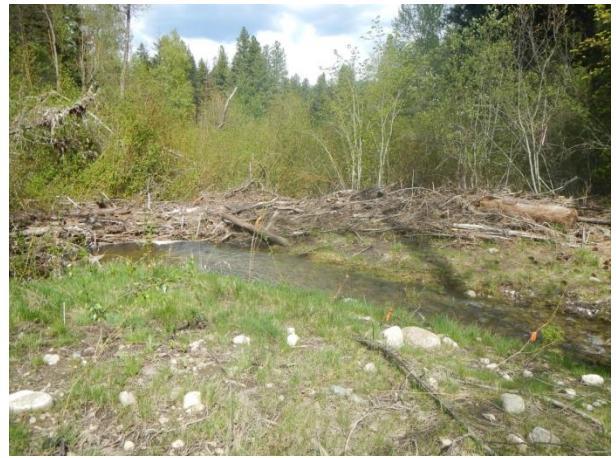
Mobilized slash from northwest side at downstream end of constructed channel

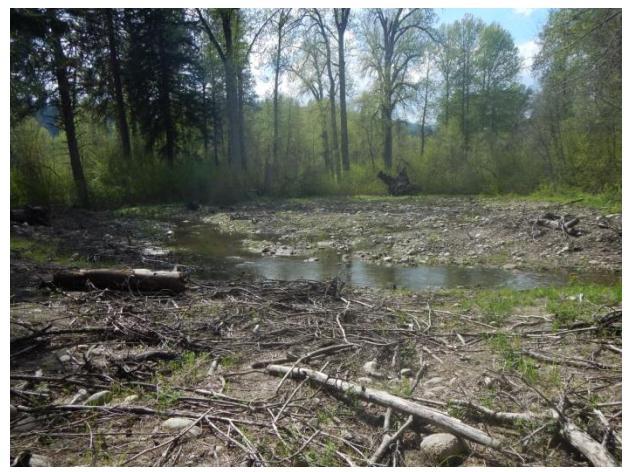
Constructed channel was activated

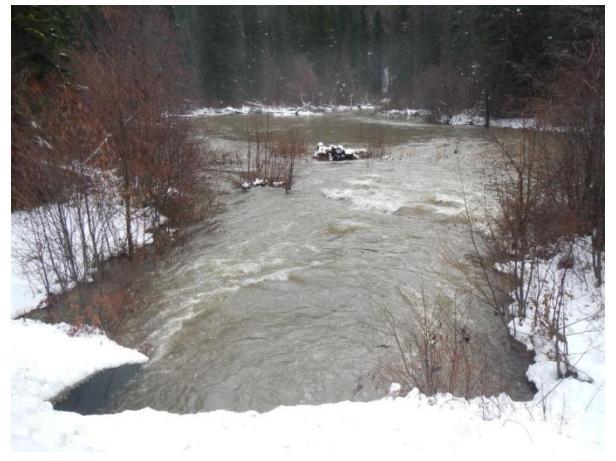
Large flood events in late fall of 2015 (estimated 10-year flood, Figure 3) resulted in significant change in the 2007 oxbow and the mainstem Nason Creek in the oxbow vicinity (Figure 7). The inlet of the oxbow is located on a side-channel of Nason Creek. A large log jam at the head of this side-channel shifted considerably during the flood, causing more water to be diverted into the side-channel and also into the 2007 oxbow. During their snorkel survey in March 2016, Yakama Nation staff noted a shift in both reaches from the typical slow, off-channel habitat to higher water velocities. In addition, 10 of the 28 pieces of wood that were added to the 2007 oxbow in 2014 were displaced during this flood – wood placed in the oxbow was designed to withstand the 5-year event. All wood still present (8 perimeter logs, 2 near the inlet and 8 in the downstream of the inlet) were partially inundated and provided instream and overhead fish cover on April 21st, 2016, during a typical high flow of 1750 cfs (Figure 8). All wood added complexity and structure to the widened inlet area of the 2007 oxbow.

Figure 7. 2007 Oxbow, December 9th, 2015; 2,730 cfs (just following 10-year event)

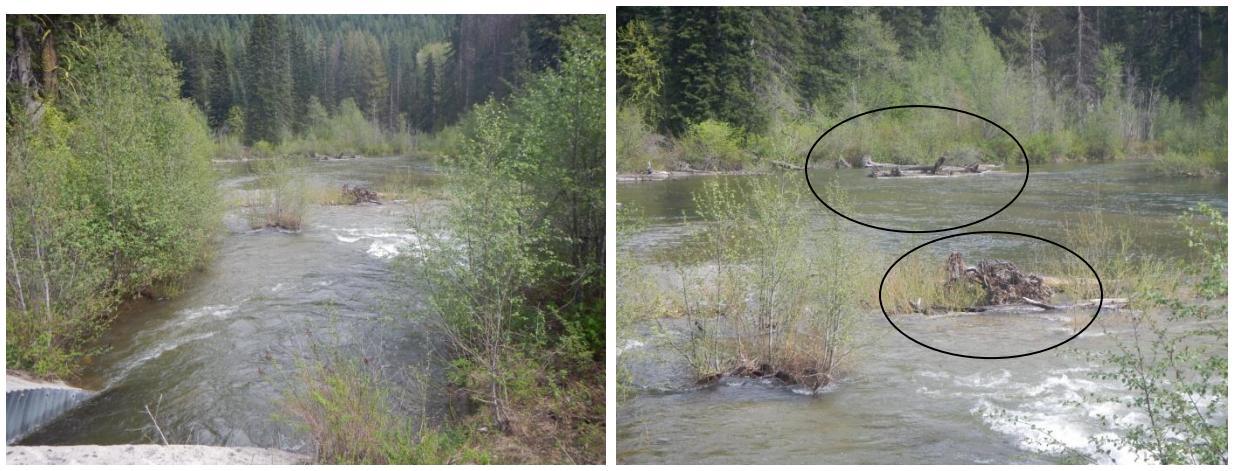
Figure 8. Photos during typical high flow, April 21st, 2016; 1750 cfs.

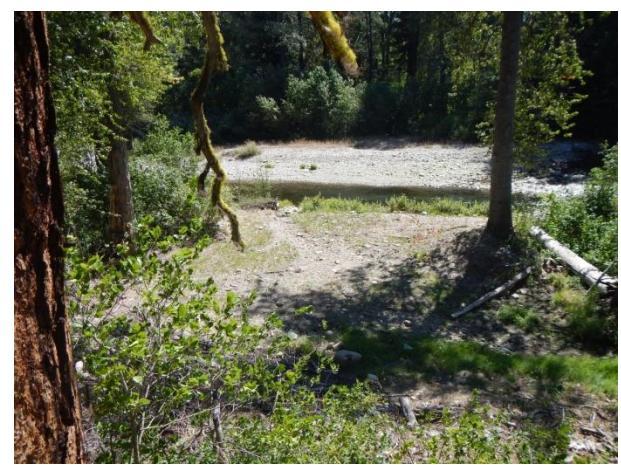
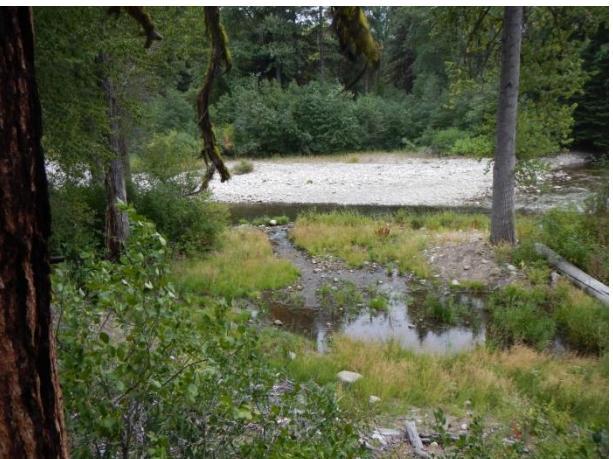
Low flow monitoring indicates that the natural stream processes continue to change the abutment floodplain and have resulted in enhanced activation of the floodplain, relic side-channel and new channel (Figure 9, PP18). Photo points indicate that while the channel was dry in the summer of 2015, the new channel was flowing at approximately 1 cfs on September 1st, 2016 during a similar flow level (Figure 9, PP9). This and photo points of the channel outlet indicate that the new channel, initially formed in fall floods of 2014, underwent further natural excavation in the late fall flood of 2015 (Figure 9 and 10). The floodplain and relic side-channel were also watered and active on September 1st, 2016 at a mainstem flow of 36 cfs – like the new channel, these elements were both dry on August 20th, 2015 at 29 cfs. The relic side channel was watered from the inlet to approximately 50 feet into the woods east of the floodplain on September 1.

Figure 9. Photo points indicate enhanced floodplain inundation and channel excavation

PP 18 – Aug 20, 2015; 29cfs floodplain dry

PP 18 - Sep 1, 2016; 36 cfs, floodplain active

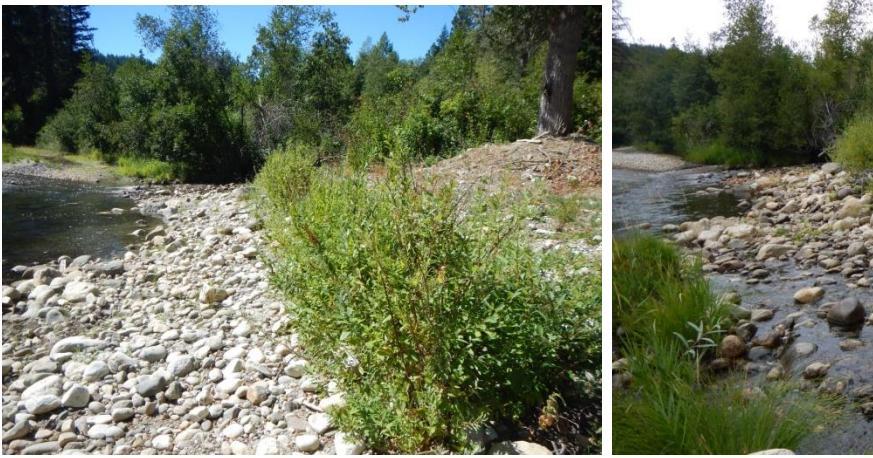
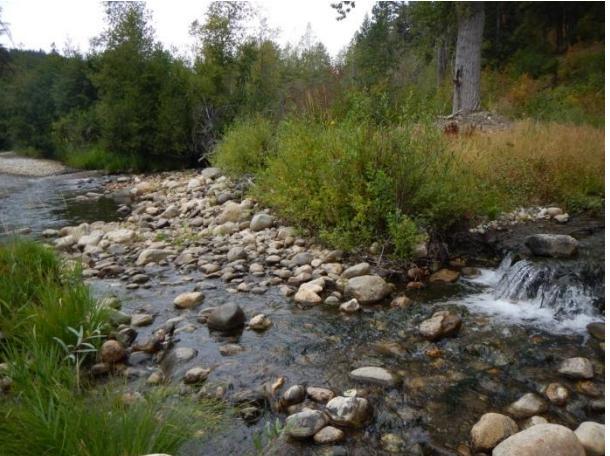
PP9-Aug 20, 2015; 29cfs

PP 9 – Sep 1, 2016; 36 cfs

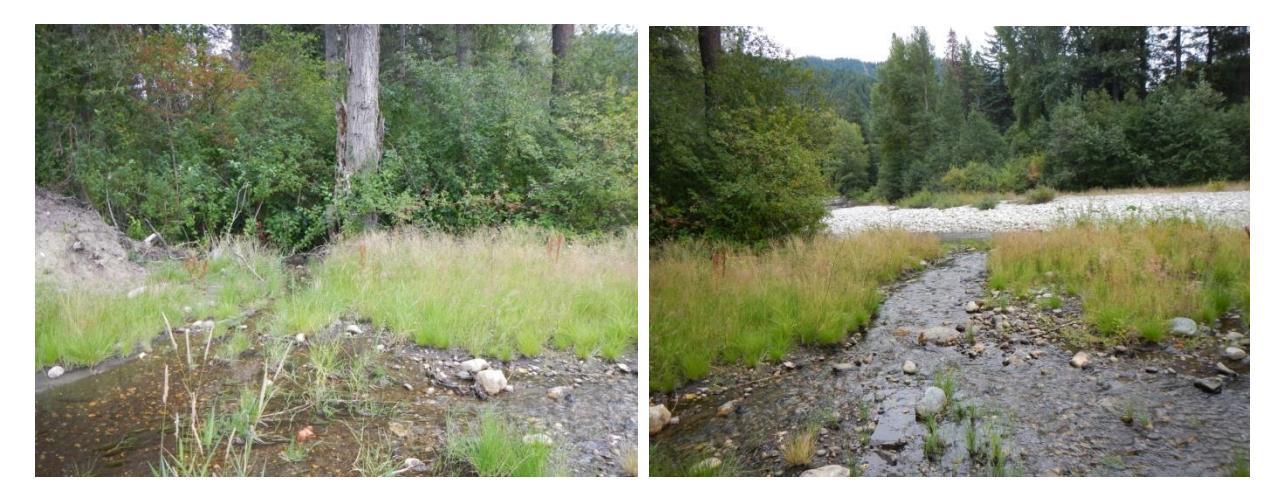
Figure 10. Additional photo points

Relic side channel inlet active at 36 cfs

New channel active at 36 cfs

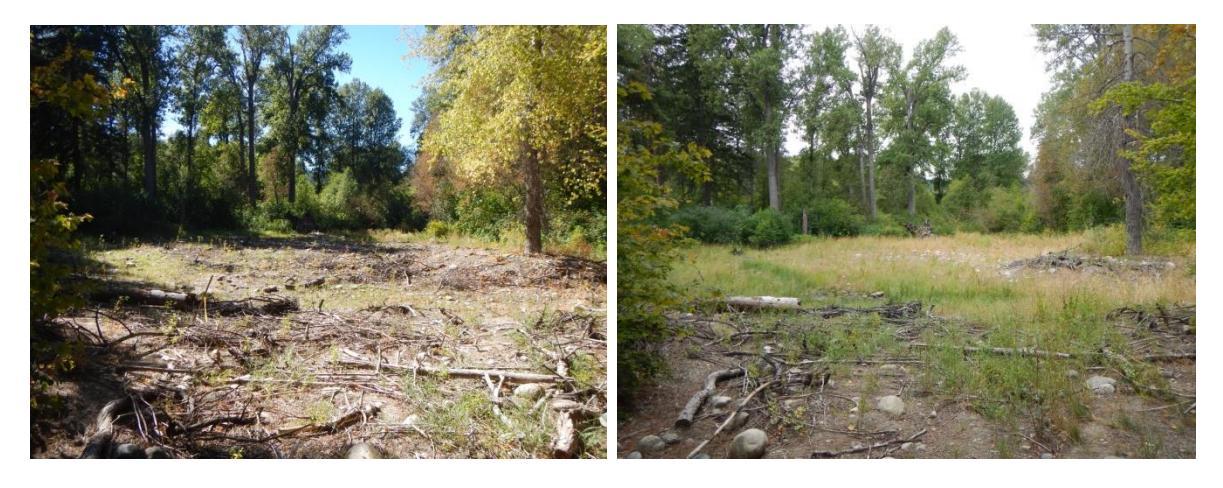
As designed, the river right parking lot floodplain was dry during the low flow visit on September 1st, 2016 (Figure 11). Scour that occurred in the late fall 2015 flood was observed in the northwest area of the floodplain and had resulted in an area of cleared slash, exposed cobble, and some willow mortality (Figure 11, see riparian monitoring section for more detail). This is considered natural process and congruent with design goals. No erosion or sediment deposition issues were observed in the constructed channel.

Figure 11. Parking lot floodplain on September 1, 2016, Nason creek flow 36 cfs

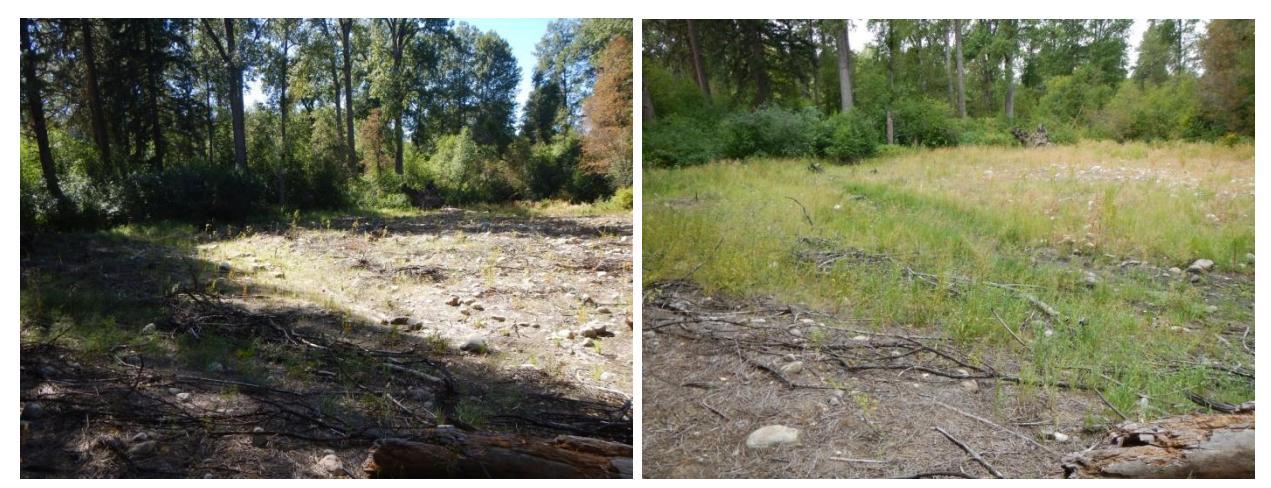
PP18

PP18. Sep 1, 2016 – exposed cobble in upper right corner due to scour that occurred in Nov 2015 flood

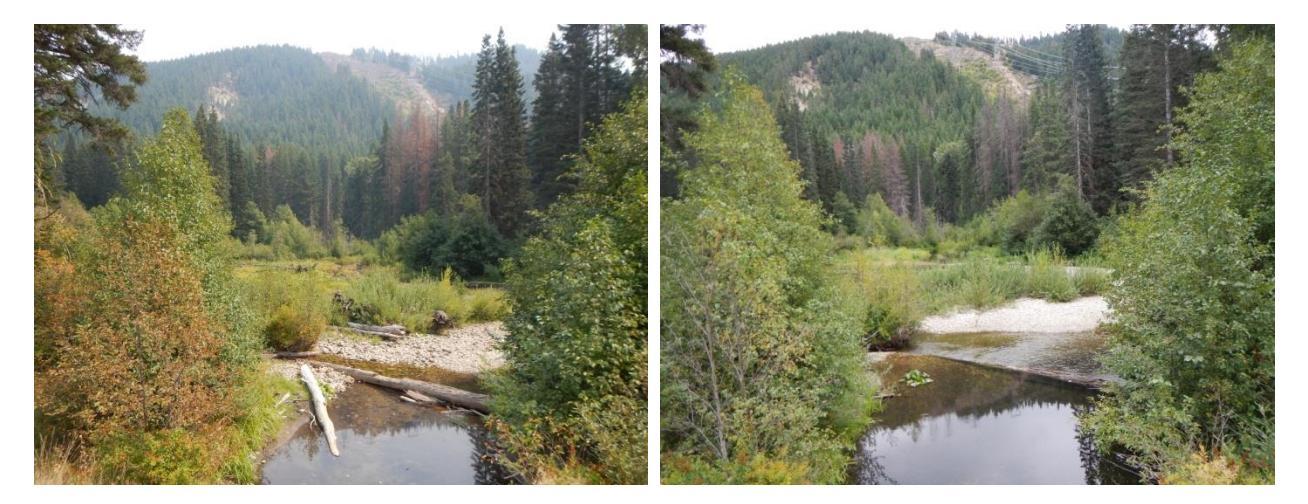
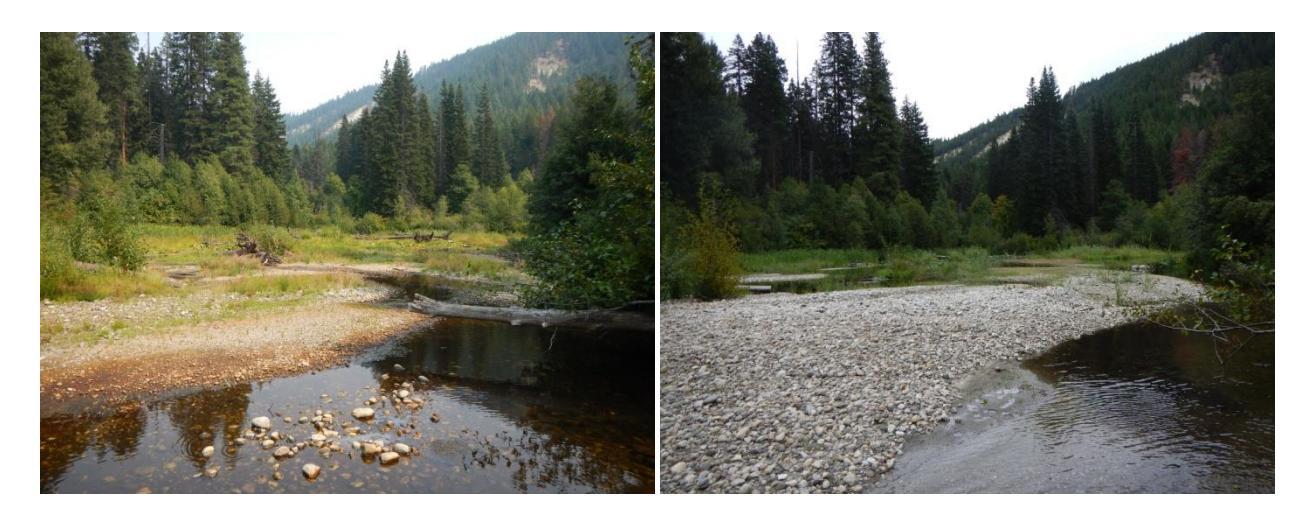
CCNRD staff confirmed the displacement of 10 of the 28 added logs in the 2007 oxbow during the low flow visit on September 1, 2016 (Figure 12). Photo points also depict other changes to the 2007 oxbow that occurred as a result of the 10-year flood in late fall 2015, including some shifting of coarse sediment (Figure 12 PP2) and more of the total Nason Creek flow being diverted into the oxbow (Figure 12 PP1). Photo points confirm that although 2015 and 2016 low flow photos were shot during similar flow levels, substantially more water is present in the oxbow during low flow 2016 resulting in higher water velocities (Figure 12). Deposition of fine sediment and willow and cottonwood establishment around wood placed in the oxbow was also recorded (see vegetation monitoring for more detail).

Figure 12. 2007 oxbow on September 1, 2016, Nason creek flow 36 cfs

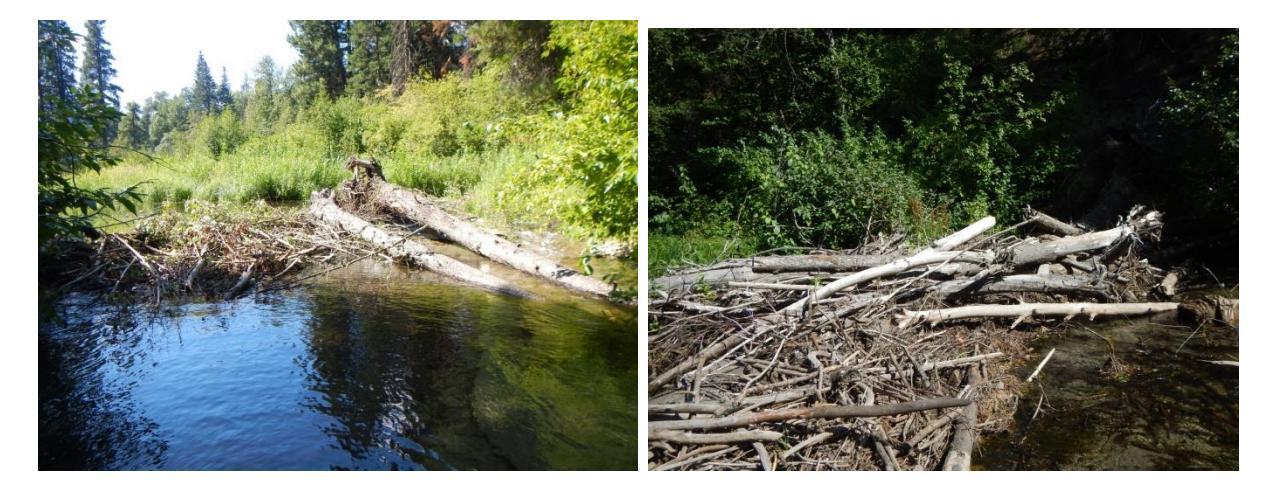
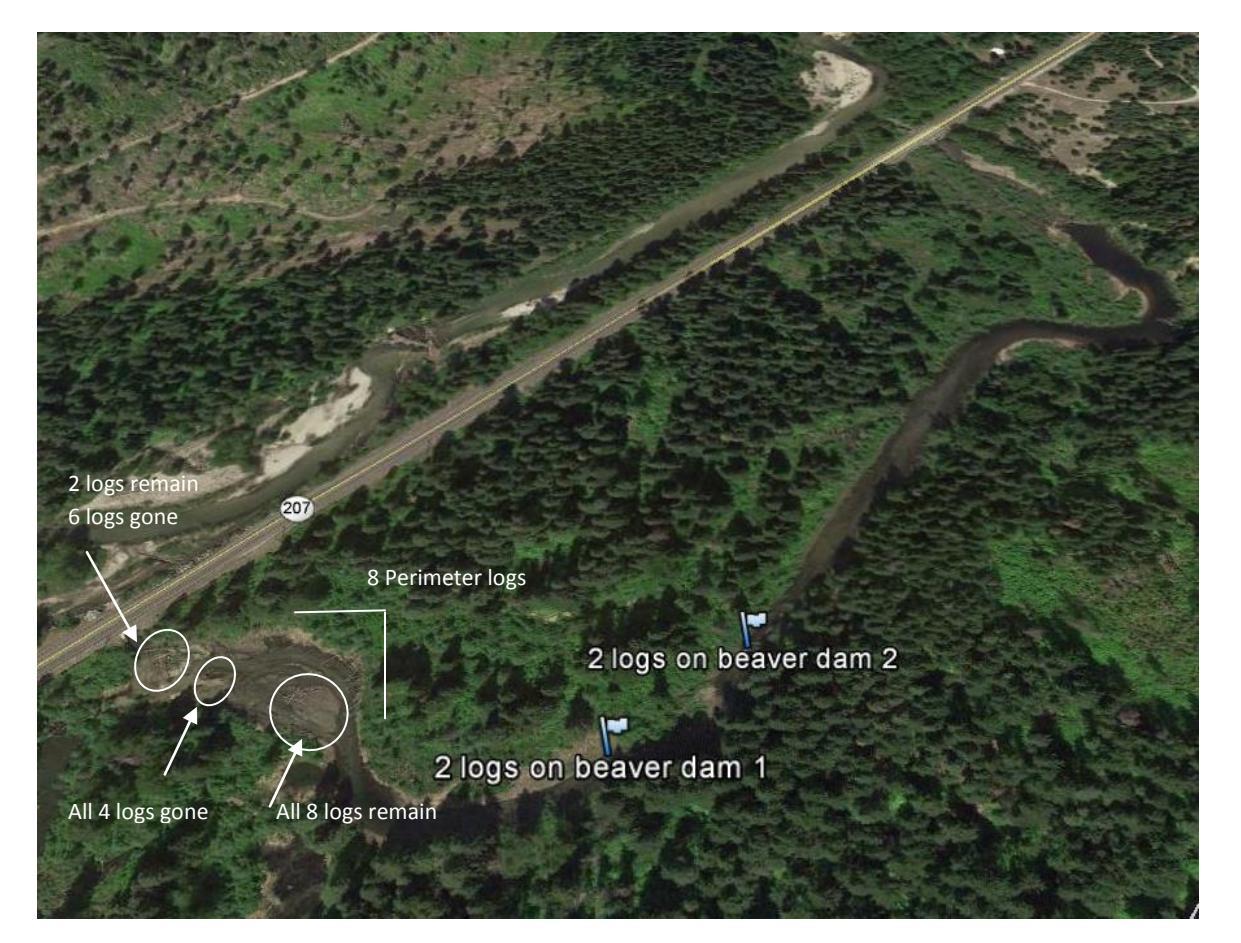
CCNRD was able to definitively locate 4 of the 10 displaced logs on a float of the oxbow on August 23, 2016. All were hung up on major beaver dams downstream of the widened inlet area (Figure 13 and 14). It was difficult to discern logs acquired for restoration from the large amount of natural wood accumulation throughout the oxbow. Therefore, other restoration logs were likely present but may have been submerged or hidden from view among naturally recruited wood.

Figure 13. 4 of the displaced restoration logs were found on two beaver dams on August 23, 2016.

Figure 14. Four of the ten logs displaced in the November 2015 flood were found on beaver dams downstream in oxbow.

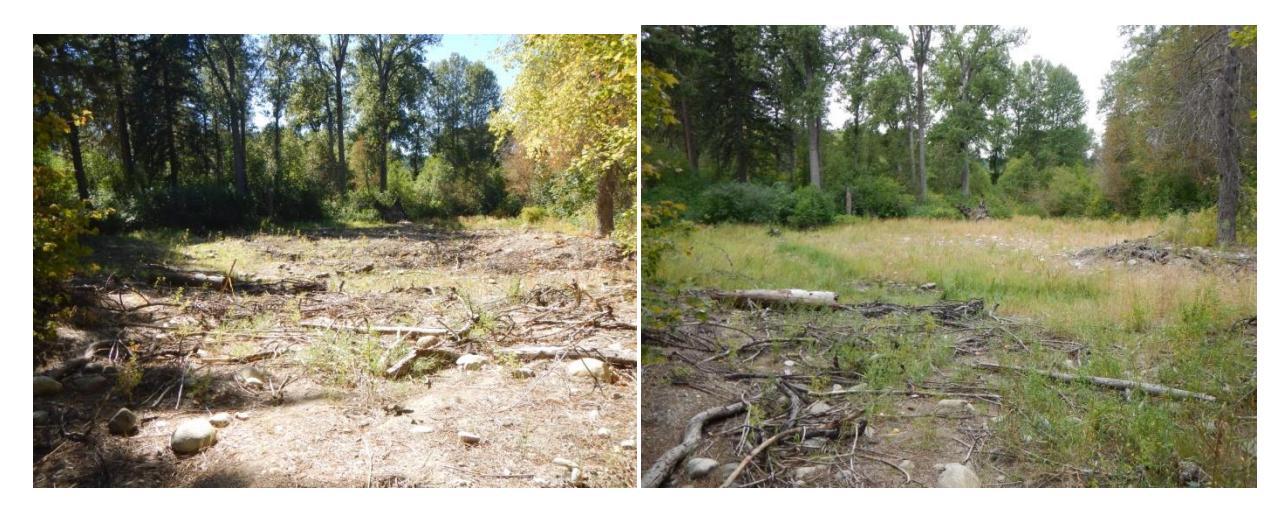
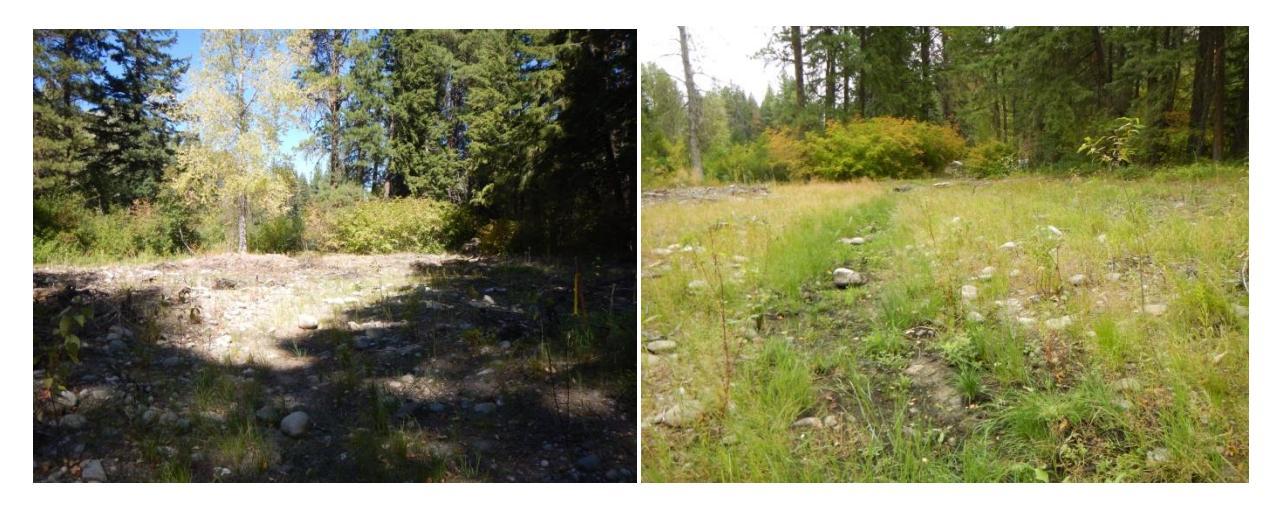
Results of stem counts on the parking lot removal site indicate an increase in installed plant survival from 89 percent in 2015 to 92 percent in 2016. (Table 1). Natural revegetation and minor error in counts account for the increase. The decrease in willow counts from 77 to 69 (Table 1) was primarily in the north side of the floodplain, where floodplain scour and slash mobilization during the late fall 2015 flood caused substantial willow mortality. Photo points indicate a substantial increase in ground cover site wide, composed of native grasses from seed spread following fill removal and naturally recruited alluvium species (Figure 15). CCNRD staff estimated site wide shrub cover at 10 percent and ground cover at 50-60 percent in 2016.

Figure 15. An increase in ground cover from 2015 to 2016. Shrub cover 10 percent, ground cover 50-60.

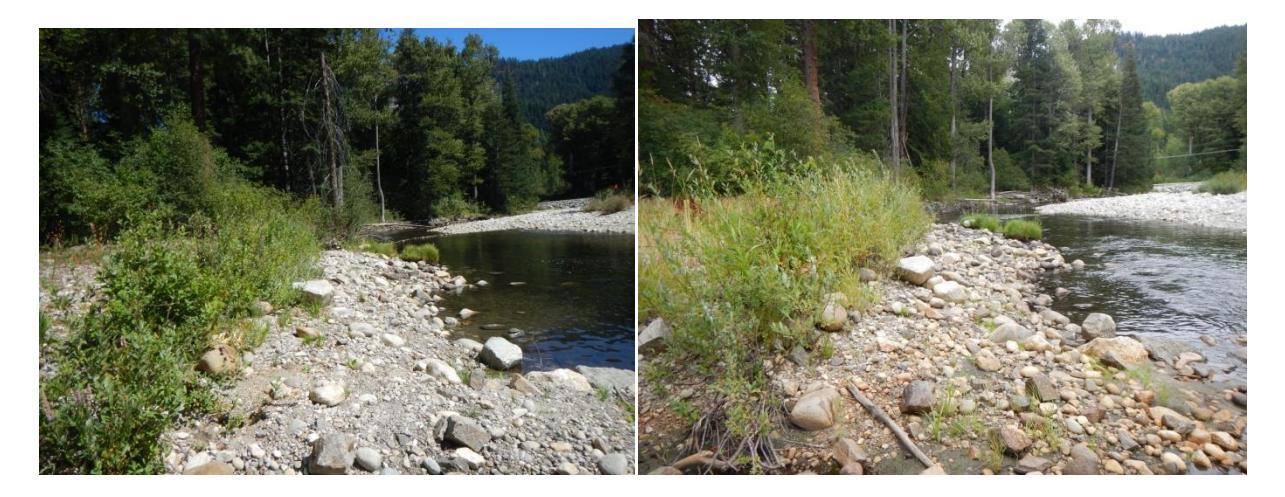
The 2015 stem count on abutment removal site indicated 92 percent survival of installed plants and was not repeated in 2016. Brush mattress cover, composed primarily of willow, was 80 - 90 percent (Table 4, Figure 16). One shade transect and two vegetation plots were established (Figure 15). Shrub cover estimates in plots indicate shrub cover ranges from 5 - 10 percent on both the upland and lowland areas, and is composed primarily of willow and cottonwood in the lowland and rose and cottonwood on the upland. 30 percent of the lowland plot was wetted at the time of the survey (Figure 17). No noxious weeds were noted in the lowland plot. However, a substantial amount of knapweed was recorded in the upland plot, and several clumps of bullthistle observed north of the plot. Shade in the lowland, upland, and stream center plots ranged from 40 - 50 %, whereas shade on the bank was 85%, due to the influence of the brush mattress (Figure 18).

Figure 16. Brush mattress on river left.

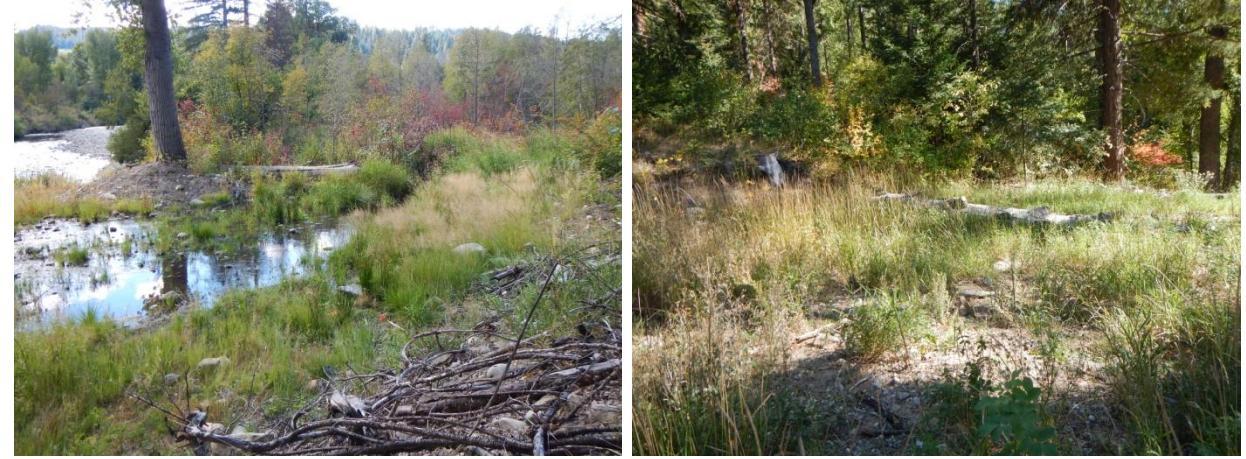
Figure 17. Lowland and upland vegetation plot established low flow 2016.

Removal of bull thistle and knapweed in the upland of the abutment removal floodplain is recommended in the spring of 2017 before flowering. No other adaptive management actions are currently recommended.

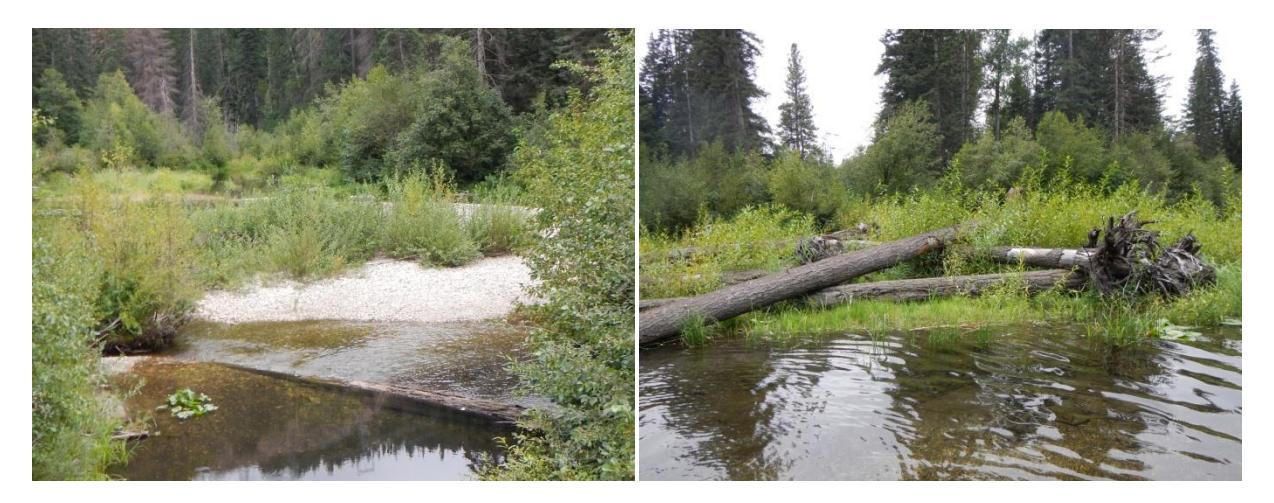
CCNRD staff observed substantial fine sediment deposition around log jams that remain in the oxbow – both on the upstream island (2 out of 8 logs remain) and the downstream island (all 8 logs remain). Vegetation recruitment has occurred in the sediment and resulted in 50 percent native shrub cover on the upstream island and 70 percent on the downstream island (Table 6, Figure 19). The downstream island is 100 percent covered in native vegetation – the other 30 percent is covered in sedge, rush and lily. Noxious weeds tansy and knapweed were observed on the upstream island.

Figure 19. Native shrub cover is 50-70 around placed wood in oxbow.
