Asotin Creek Intensively Monitored Watershed: Restoration & Maintenance Final Report**Stephen Bennett, Eco Logical Research Inc., Providence, Utah****Introduction**

Restoration Activity Summary

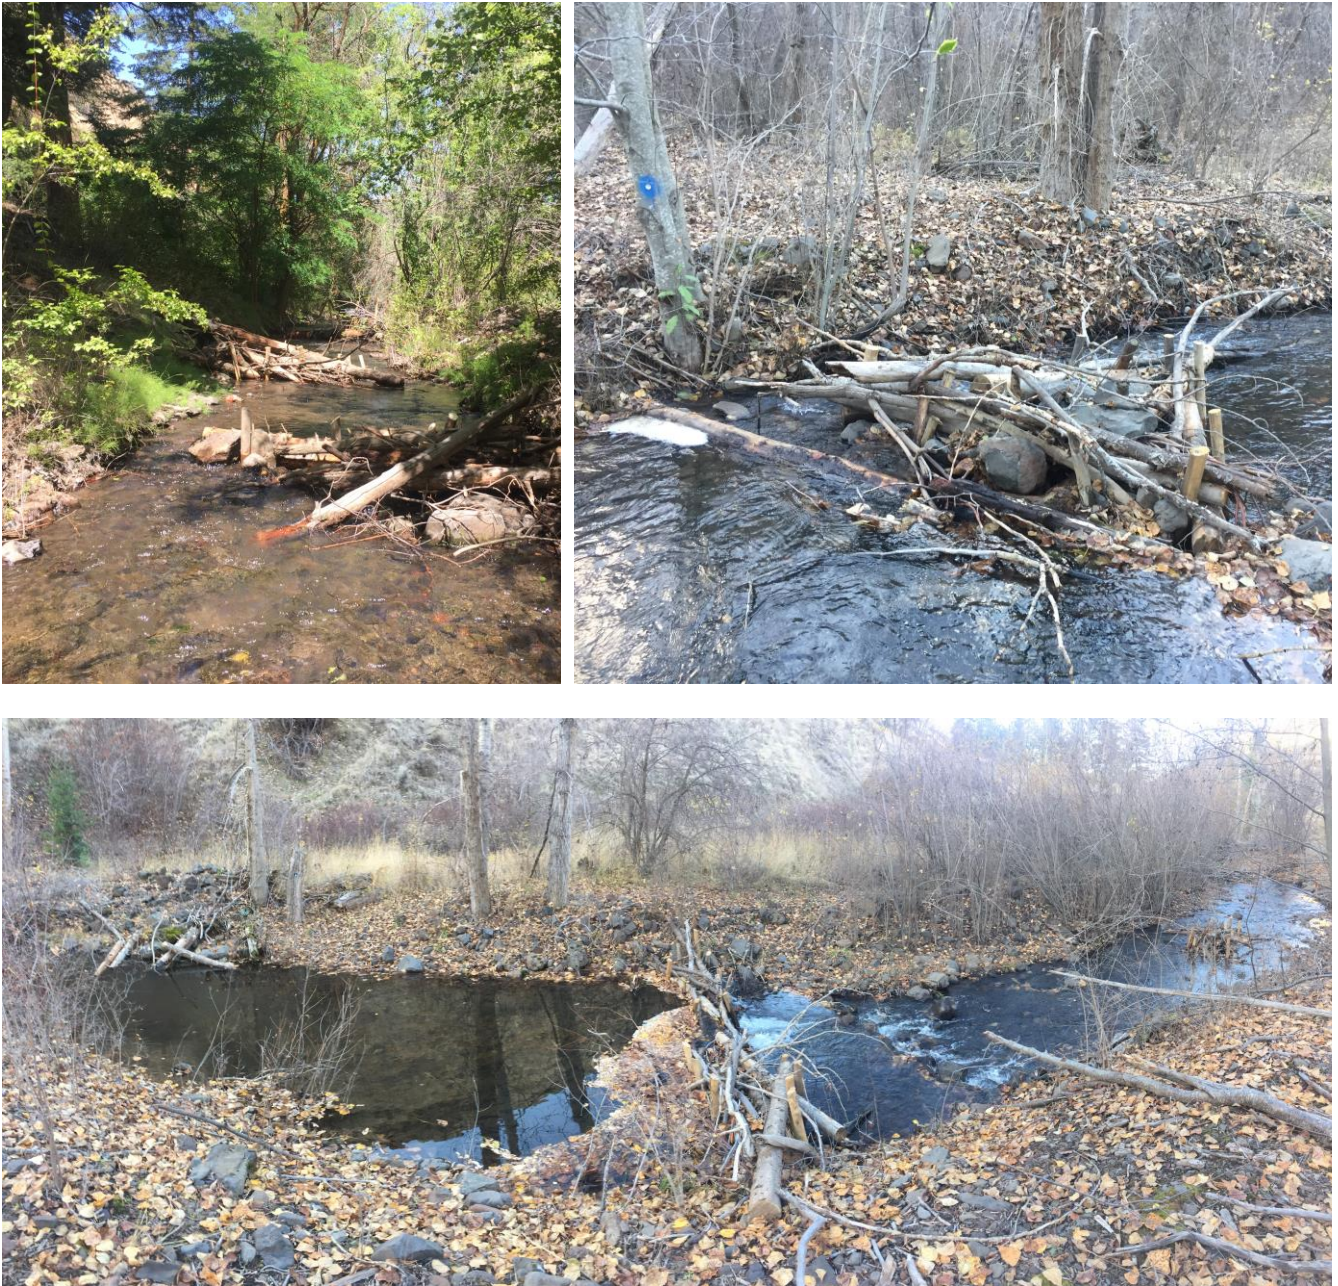
Figure 3. Example of the three most common post-assisted log structure (PALS) built in the new treatment section of the South Fork Asotin Creek in summer of 2016. Top left = series of Bank-attached PALS, top right = Mid-channel PALS, and bottom picture = Debris Jam PALS.

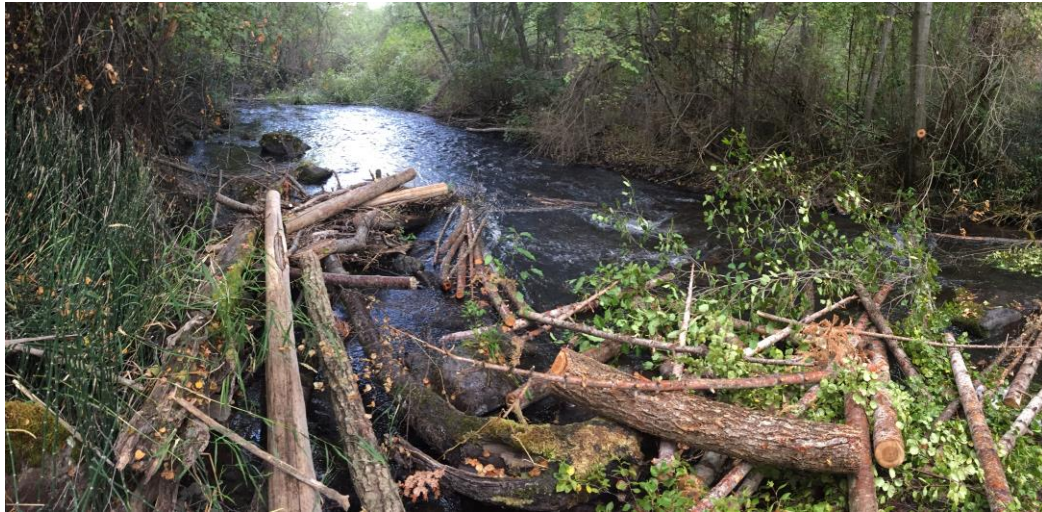
Figure 4. Example of felling a tree and adding large woody debris to an existing structure in North Fork Asotin Creek treatment section 1 to maintain high large woody debris density.

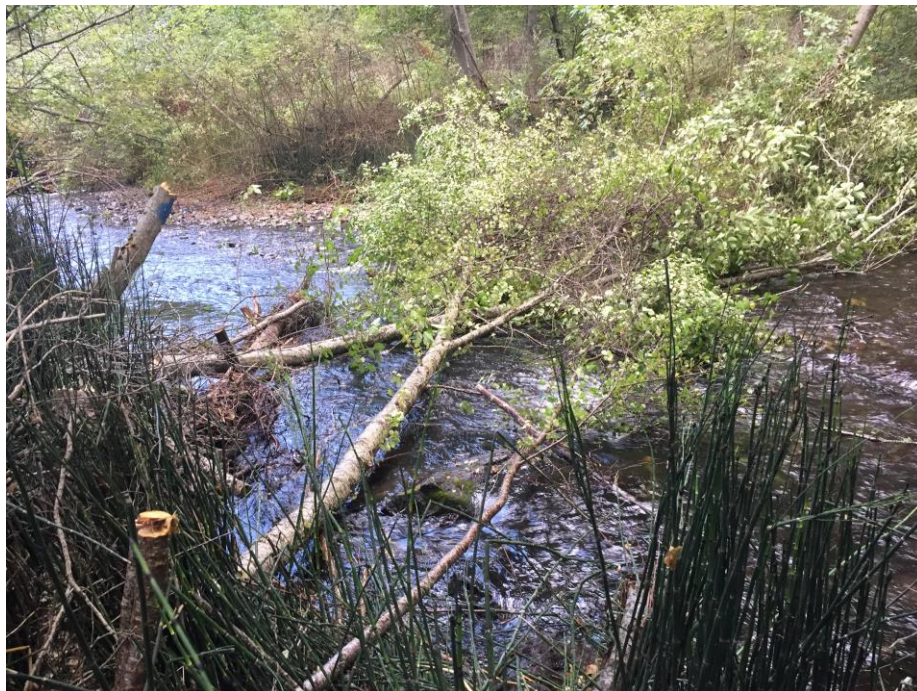
Figure 5. Example of felling a tree on an existing structure in North Fork Asotin Creek treatment section 1 to maintain high large woody debris density.

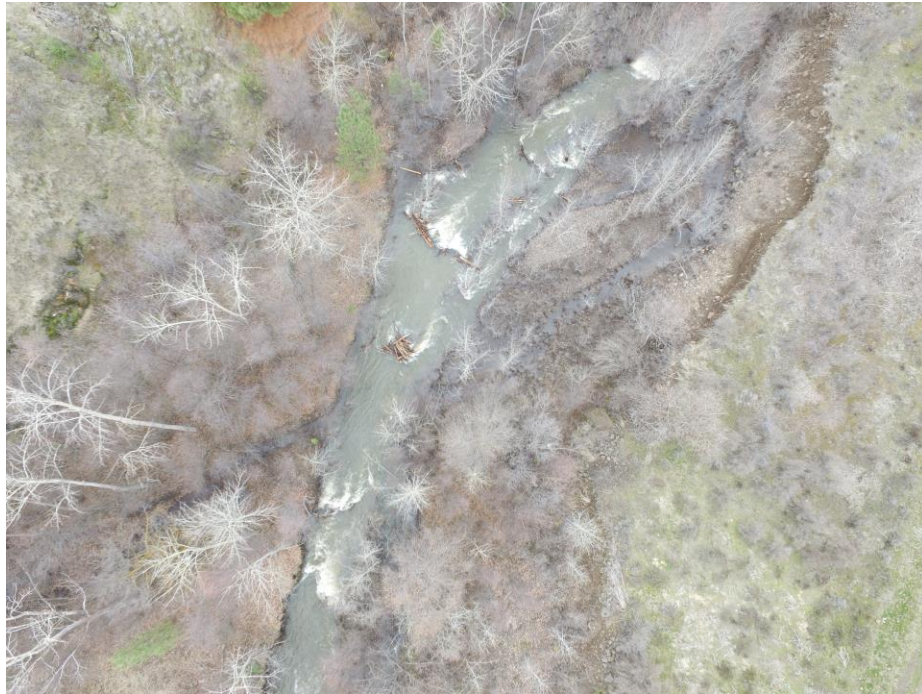
Figure 6. Aerial view of South Fork section 1 in spring 2017. We constructed this section in 2016. Water has been forced out of the main channel onto the floodplain on river right and river left.

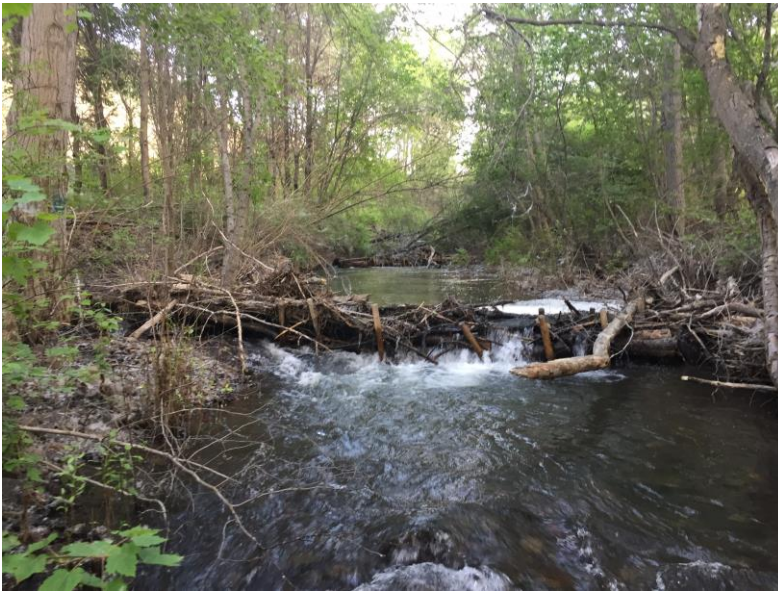
Figure 7. a) Debris jam built in 2016 and viewed in summer of 2017. Note large dam pool upstream. b) Upstream of debris jam large sediment deposit covered with cottonwood seeds.

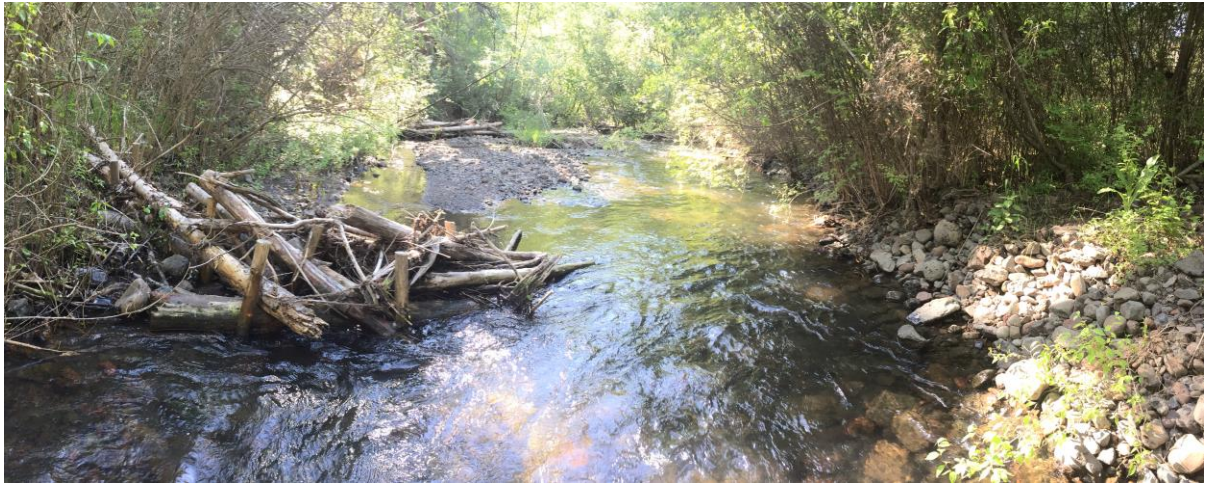
Figure 8. Example of post-assisted log structure built in 2016 in South Fork section 1 creating a large gravel and cobble bar downstream of the structure.

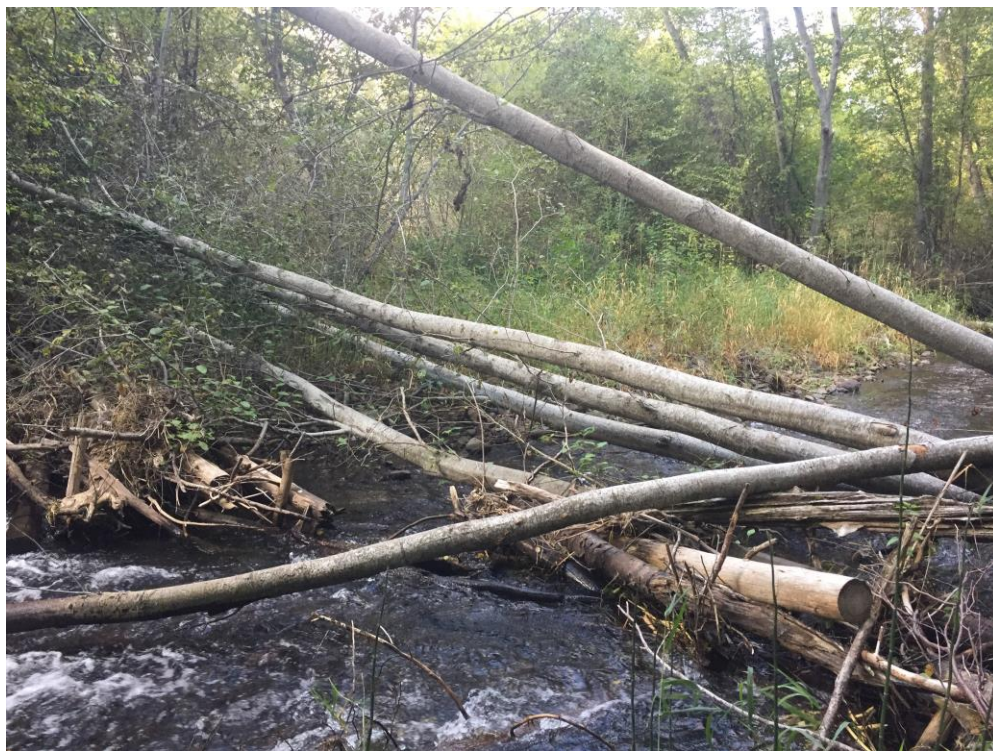
Figure 9. Example of trees that have been recruited into the stream by the strategic design of a post-assisted log structure.
