SKOOKUM CREEK RM 6.5 RESTORATION

PRELIMINARY DESIGN REPORT

Prepared by
Waterfall Engineering

June 2020

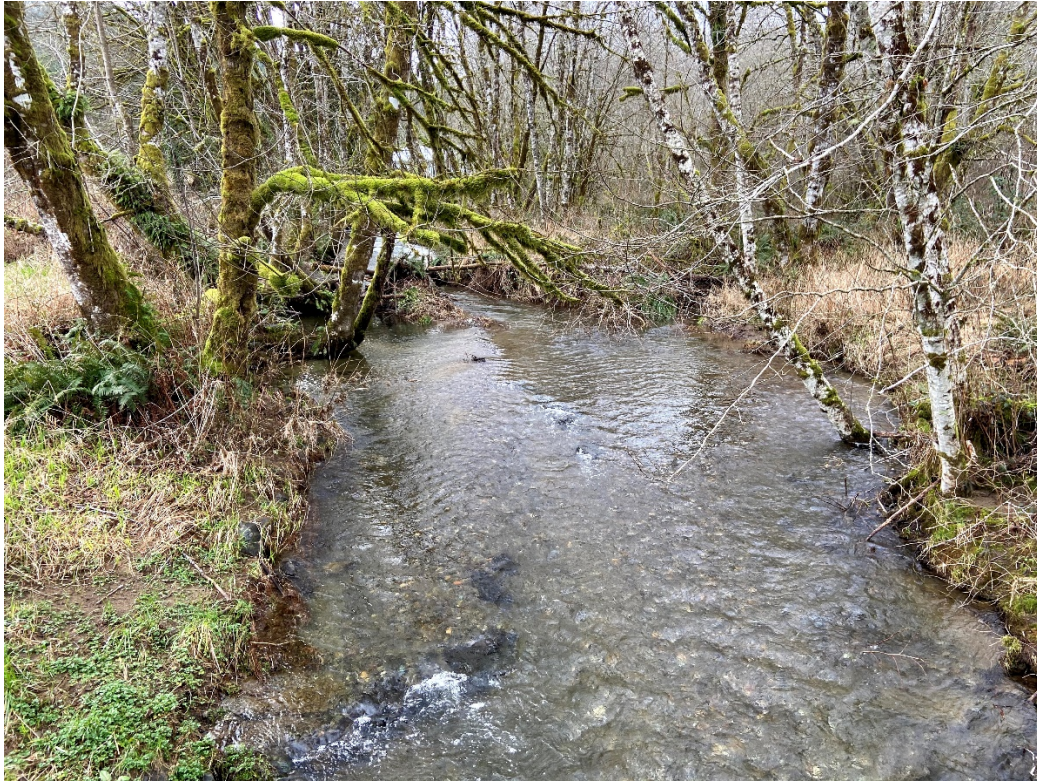
Photo 4 – View upstream of Bridge. Tributary of the right has cutthroat spawning.

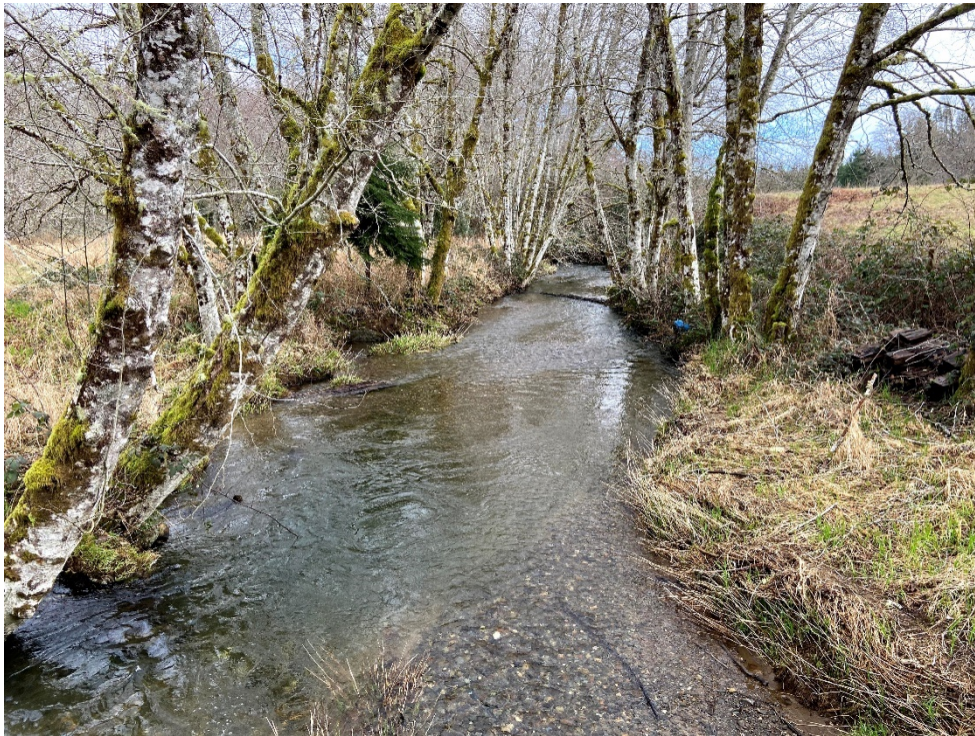
Photo 5 – View downstream of bridge showing typical lack of large woody and gravel bed.

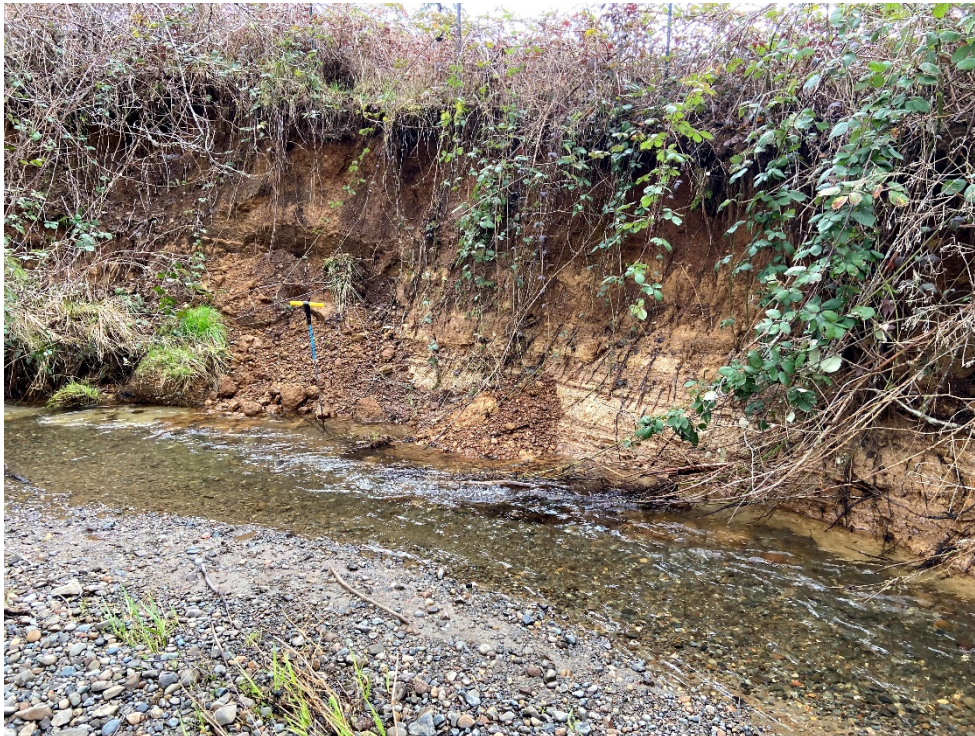
Photo 7 – Cut bank 12-foot-high just downstream of bridge.

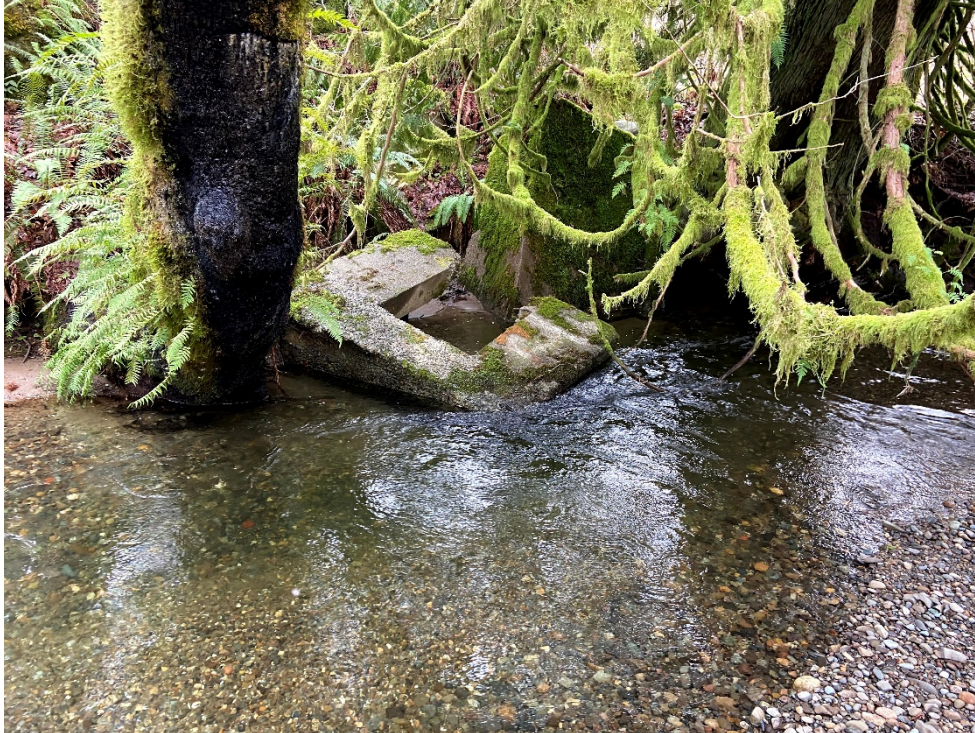
Photo 8 – Concrete along right bank of channel upstream of bridge. Typical of other concrete and rock along channel.

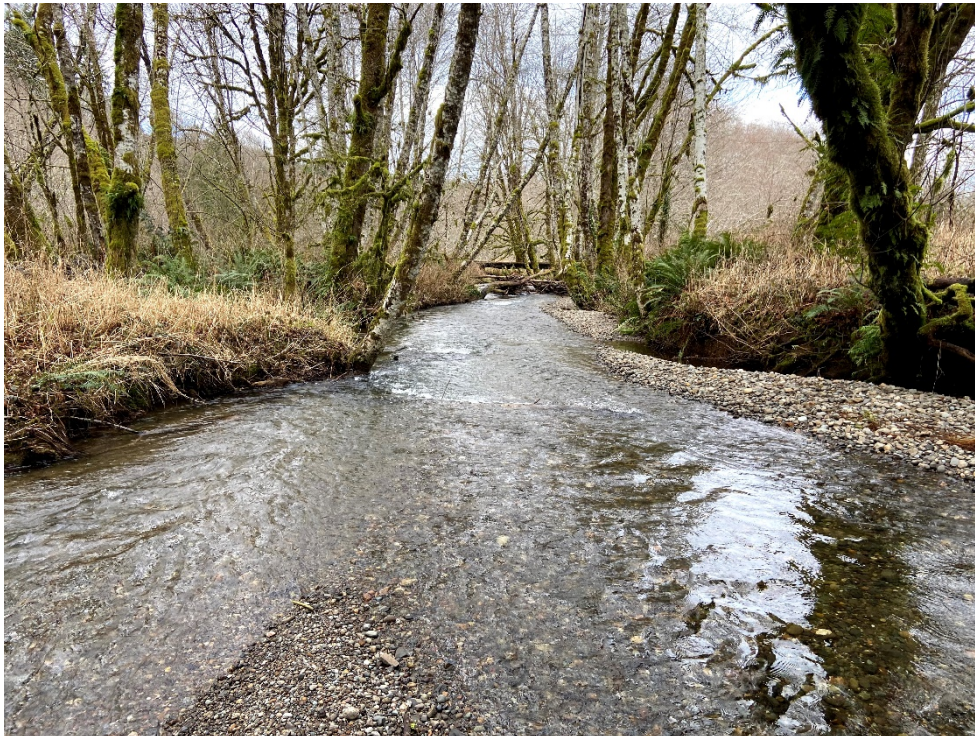
Photo 9 – Upstream channel with view of bridge downstream showing lack of large wood and active gravel movement.

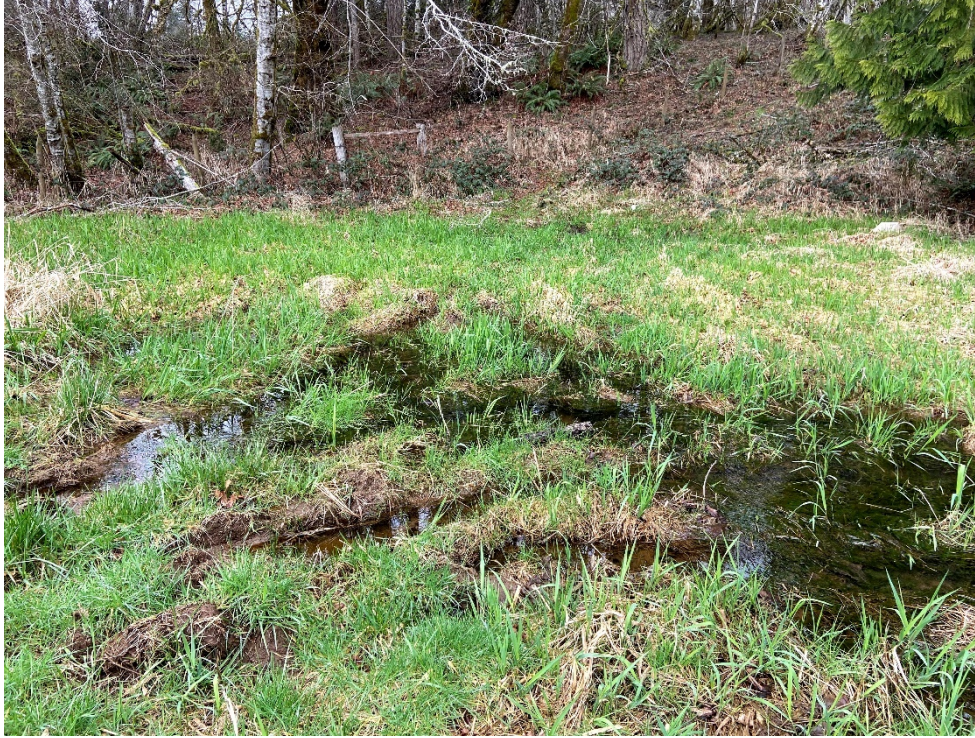
Photo 10 – Spring fed tributary along the left bank floodplain which enters the side channel. Flow is blocked by road and rock placed to shore up road.

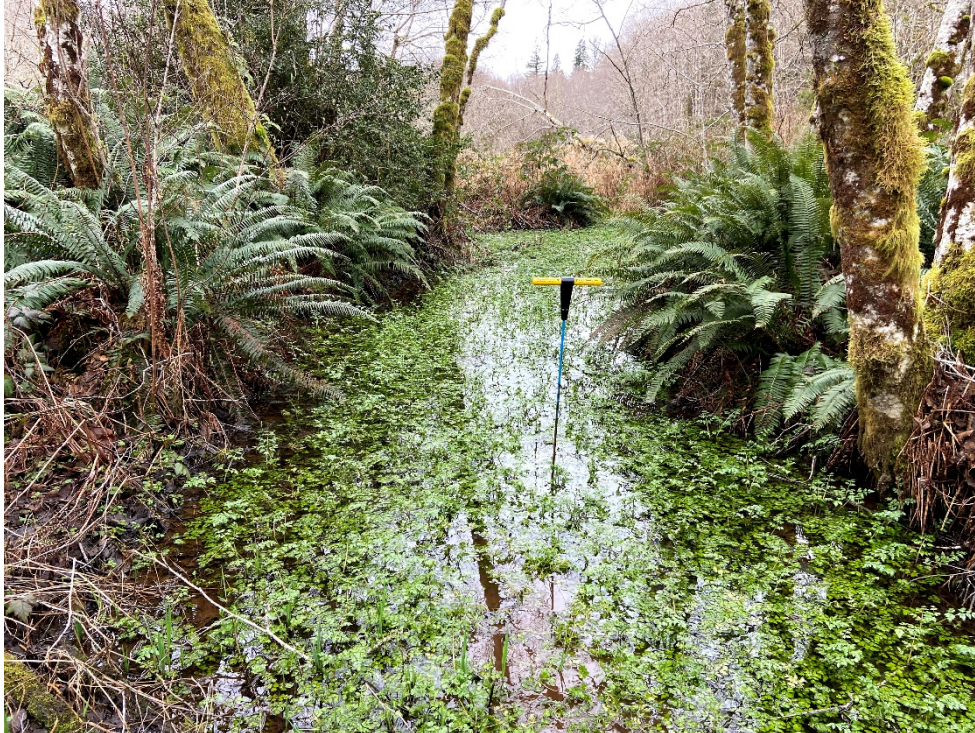
Photo 12 – Downstream end of side channel which has been disconnected at the upstream end from road fill and riprap in channel. Gravel probe is sitting on gravel bed all groundwater flow but will go dry in the summer.

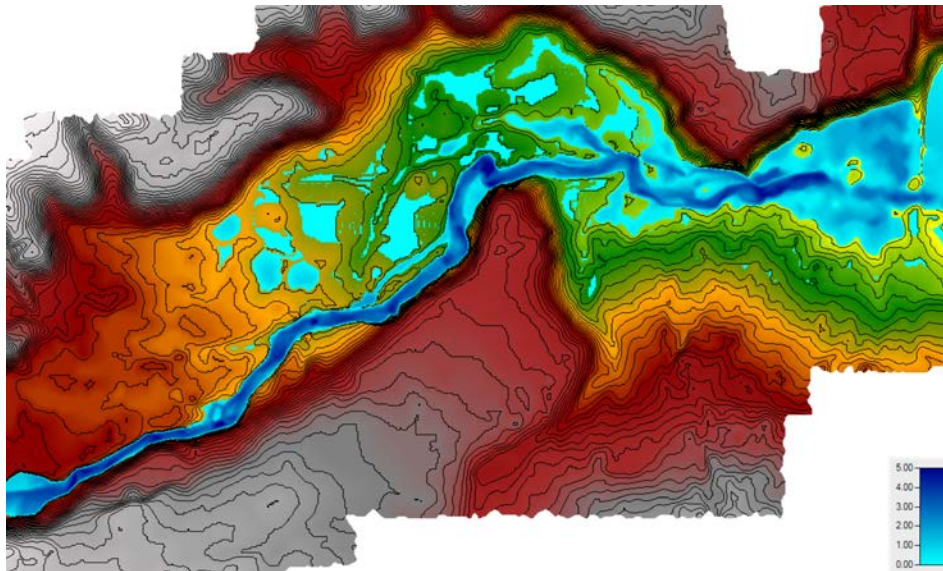
A HEC RAS 2D model of the project reach was developed for the existing LiDAR and for the surface which is a combination of the LiDAR and survey data. The model covered 2800 feet of channel length and a floodplain width of 400 feet. The modeling confirmed an on-site observation of the channel being incised and not connected to the floodplain. At the two-year flood of 350 cfs, the typical water depth is 2 to 3 feet.

Figure 2 – Two-year flood depth map.

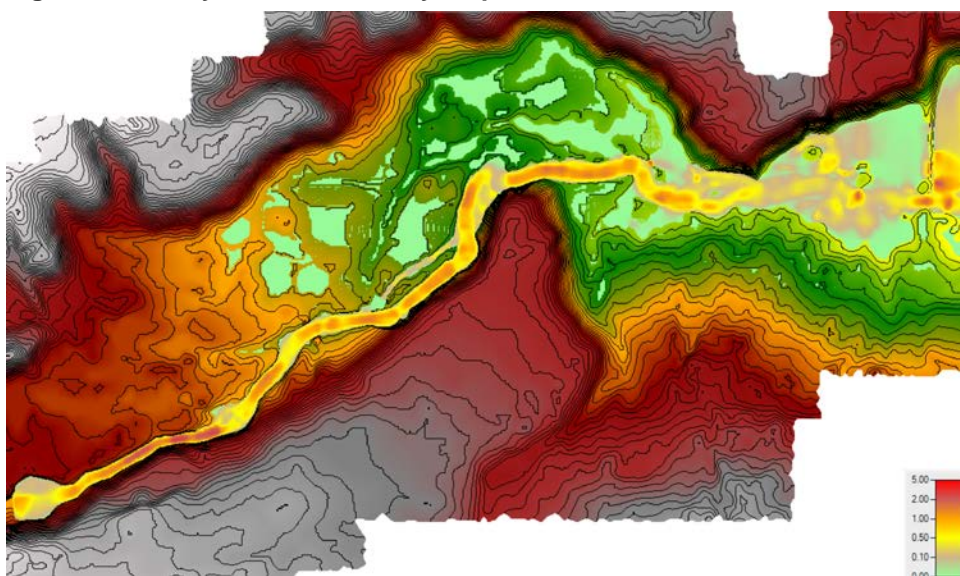
At the 2-year flood peak event, the shear stress in the channel ranges from 1.5 to 2.2, which based on an incipient motion curves would move bed material 3 to 4 inches in diameter. Pebble

counts have not yet been collected for the channel, but from observations the bed is a high percentage of one-inch sized spawning gravel which moves at a high frequency in the existing channel. The added wood will aggrade the channel 1 to 2 feet (more locally) and sort and stabilize the gravel for spawning.

Figure 5 – Two-year flood shear stress map.
