# Final Design and As-built Report

## Increasing Wood Densities in Asotin Creek Intensively Monitored Watershed

### **Grant 19-1499**

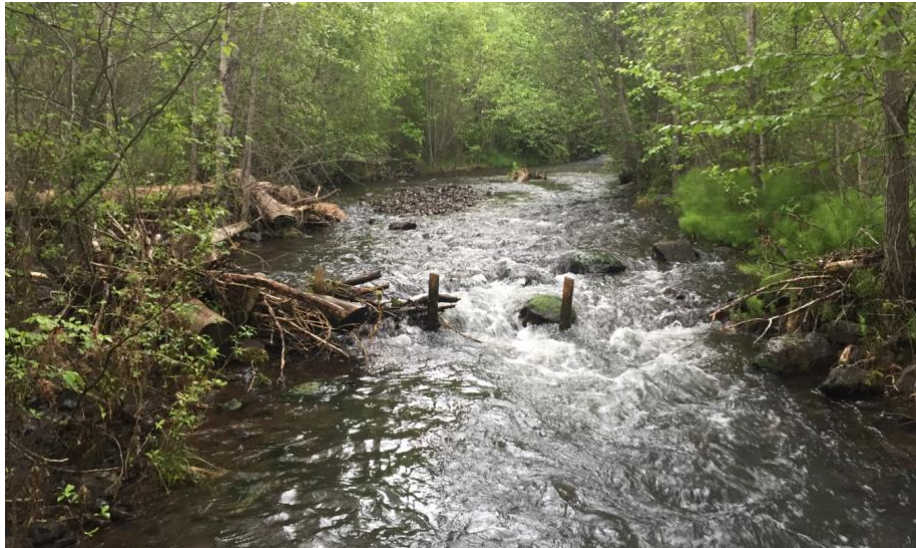
**Adding wood to existing PALS:** Some PALS were present but lost wood. This happened when wood floats off the structure or when part of the structure was washed away (Figure 3). We added LWD to increase the size of some PALS, interlocking the wood into remaining posts or live trees. Wood was harvested from the Umatilla National Forest with permission and coordination with the USFS. We thinned forest stands to reduce fire risk and transported the wood to the treatment sites. Some wood was also collected on site by harvesting subdominant trees and trimming branches from near the ground when available.

Figure 3. Example of a partly intact post-assisted log structure that were enhanced with the addition of more large woody debris.

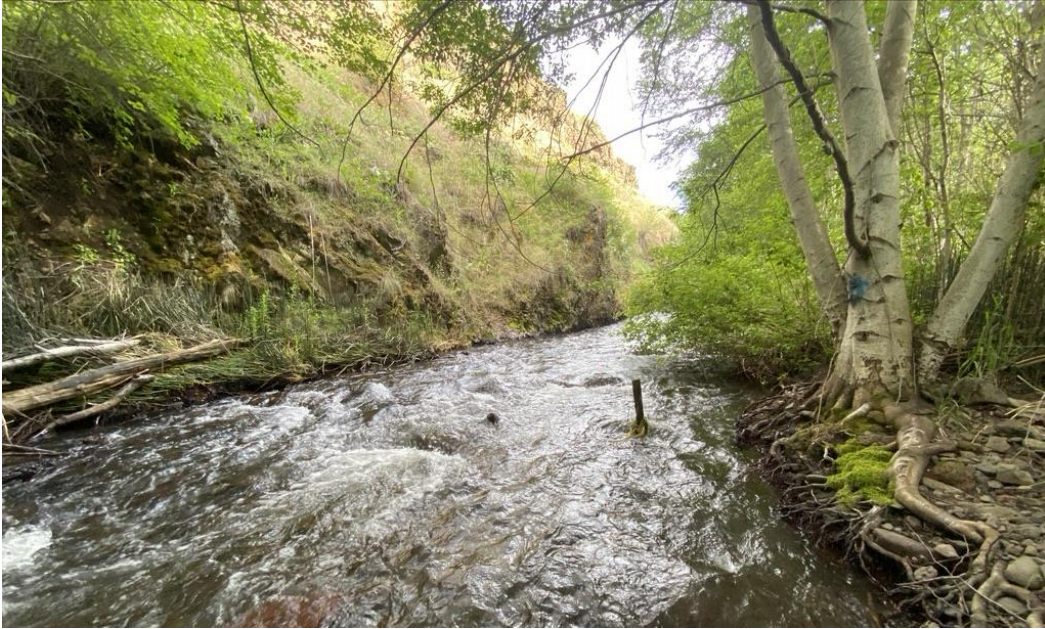
Figure 4. Example of a post-assisted log structure that has washed downstream that could be rebuilt.

**Rebuilding PALS:** Some PALS have completely moved leaving areas within the treatment where there is limited wood. Where it was logistically feasible to move the hydraulic post-driver to these locations, we rebuilt the PALS (Figure 4). Wood will be harvested from the USFS and transported to the treatment sites.

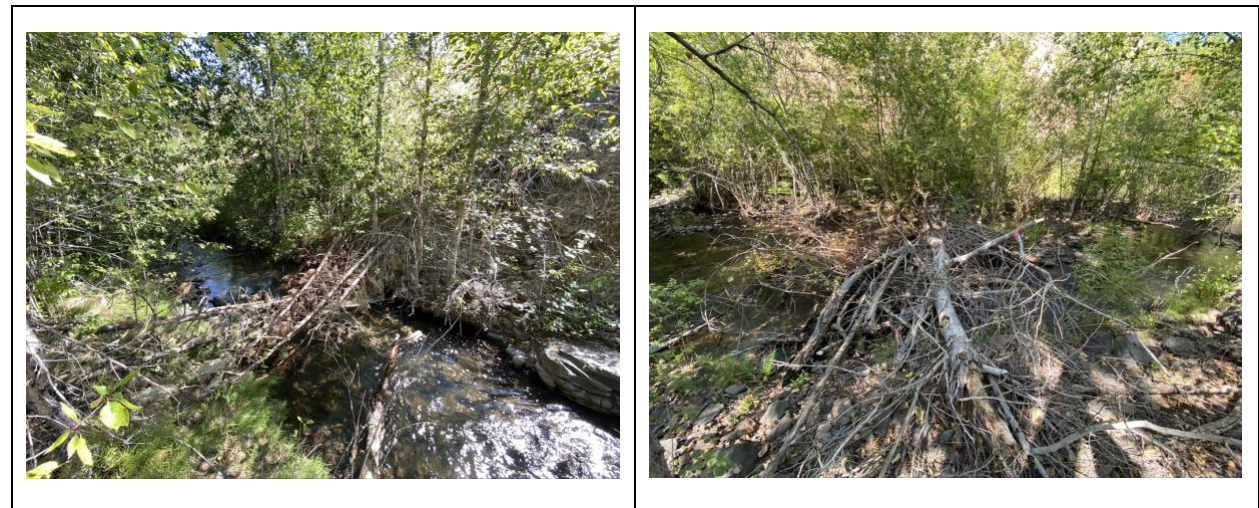
Figure 9. Example of structures enhanced with the addition of large woody debris (left – South Fork structure #124 , right – South Fork # 672). Most of the wood was collected on the Umatilla Forest and donated by the USFS but occasionally we collected trees cut down along the road by road maintenance crews.

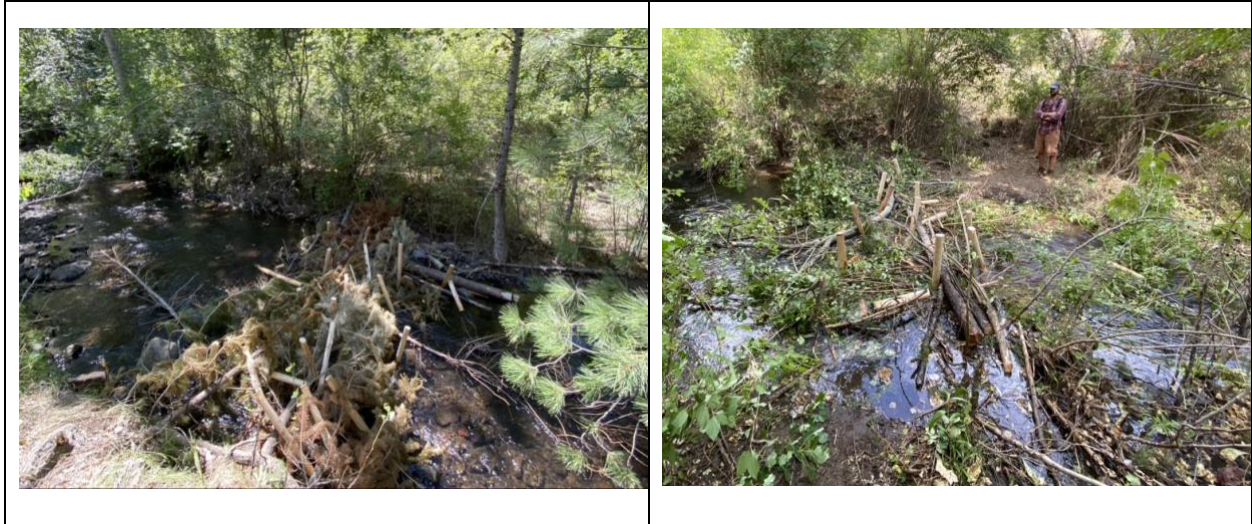
Figure 10. Example of structures enhanced with the addition of posts and large woody debris (left – South Fork structure #42, right - Charley #61) . A hydraulic post driver was used to drive posts into streambed and secure wood. Most of the wood was collected on the Umatilla Forest and donated by the USFS.

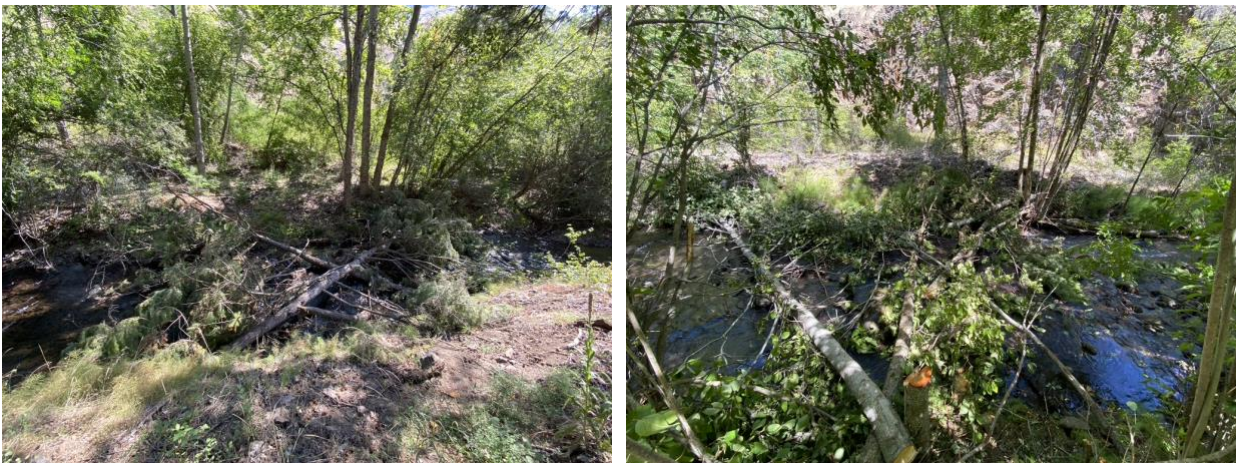
Figure 11. Example of structures enhanced with the addition tree falling (left - South Fork structure #679, right - #157). We felled mostly subdominant Douglas-fir and alder along the stream channel to maintain shading and cover.
