Response to SRFB Review Panel October 2012 Comments

Project Number: 12-1843

Project Name: Nason N1-KDIZ3 Floodplain Reconnection

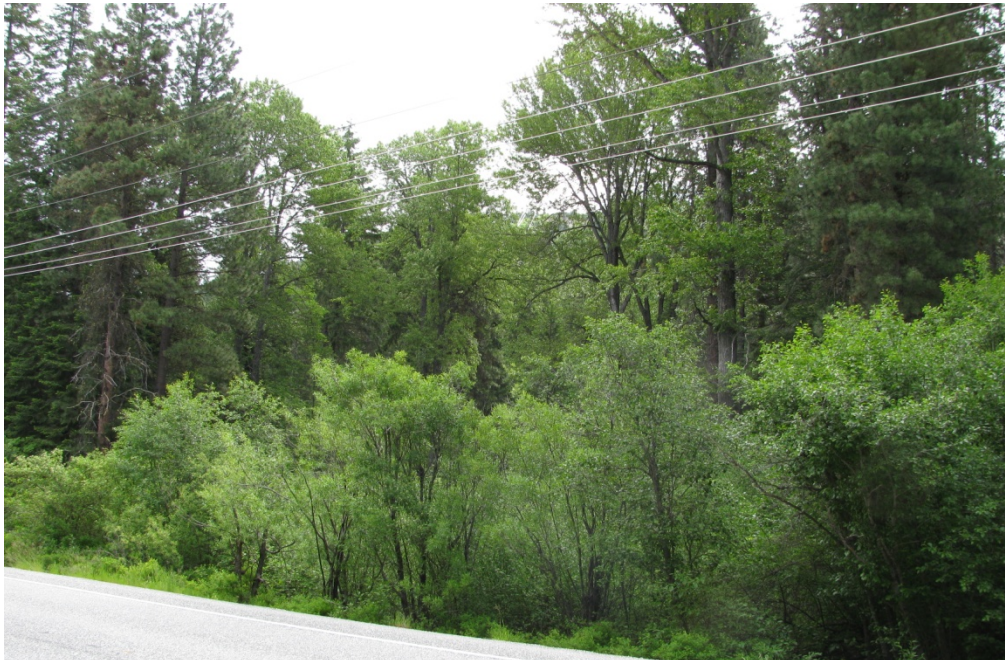
Photo 1: Break in tree canopy and shrubby vegetation located in the proposed excavation area at the downstream floodplain connection area.

No mature trees (> 6" DBH) will be removed east or west of SR 207 as part of the downstream culvert connection or floodplain excavation. West of Highway 207, the culvert location was sited so that construction would not involve tree removal. East of Highway 207, there is a band of shrubby riparian vegetation consisting of dogwood and willows that would be disturbed by project construction. Photo 1 depicts the shrubby vegetation adjacent to Highway 207.

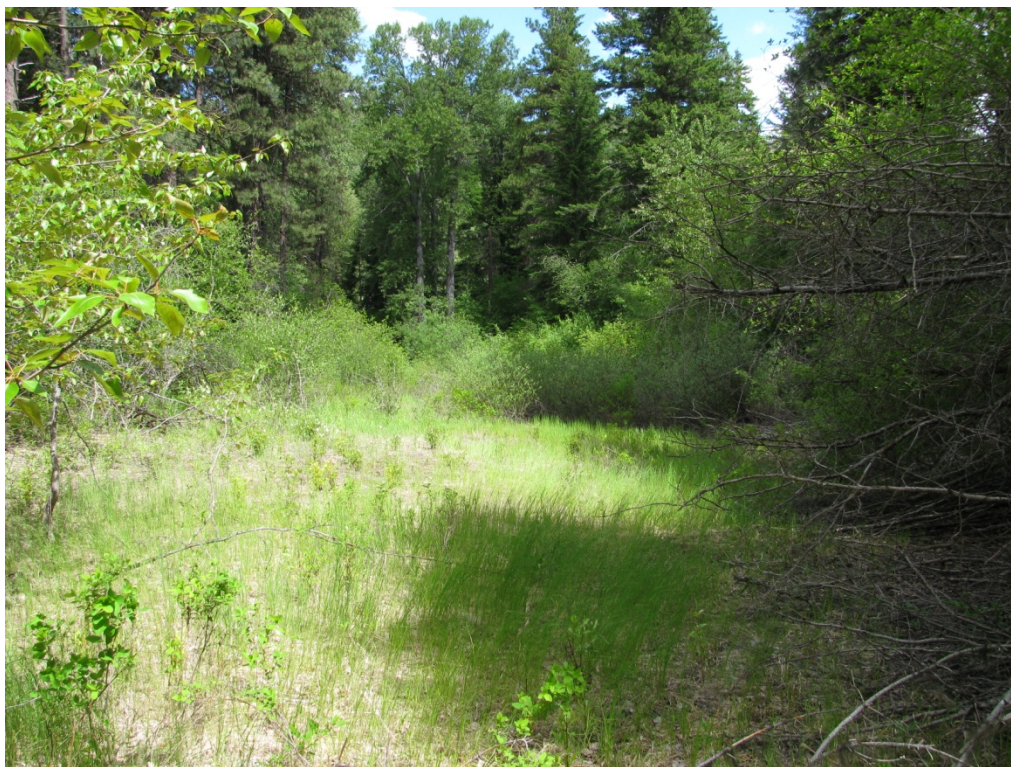
Photo 2: Break in tree canopy and herbaceous vegetation located in the proposed excavation area at the downstream floodplain connection area.

Vegetation removal resulting from excavation within this shrubby area will be less than 0.25 acres. Behind this row of shrubby vegetation, the majority of the excavation proposed east of Highway 207 (approximately 0.65 acres) is dominated by herbaceous species (See photo 2 below). All excavation proposed will be designed to minimize impacts to existing native shrubs and trees. If needed, the excavation footprint can be reduced (made narrower) to minimize vegetation impacts. Another way to minimize vegetation impacts would be to just cut, rather than remove, shrubby vegetation for site access; most of the willows and dogwood will just re-grow from cut stems. These best management practices will be developed and described in more detail as a later stage of design.

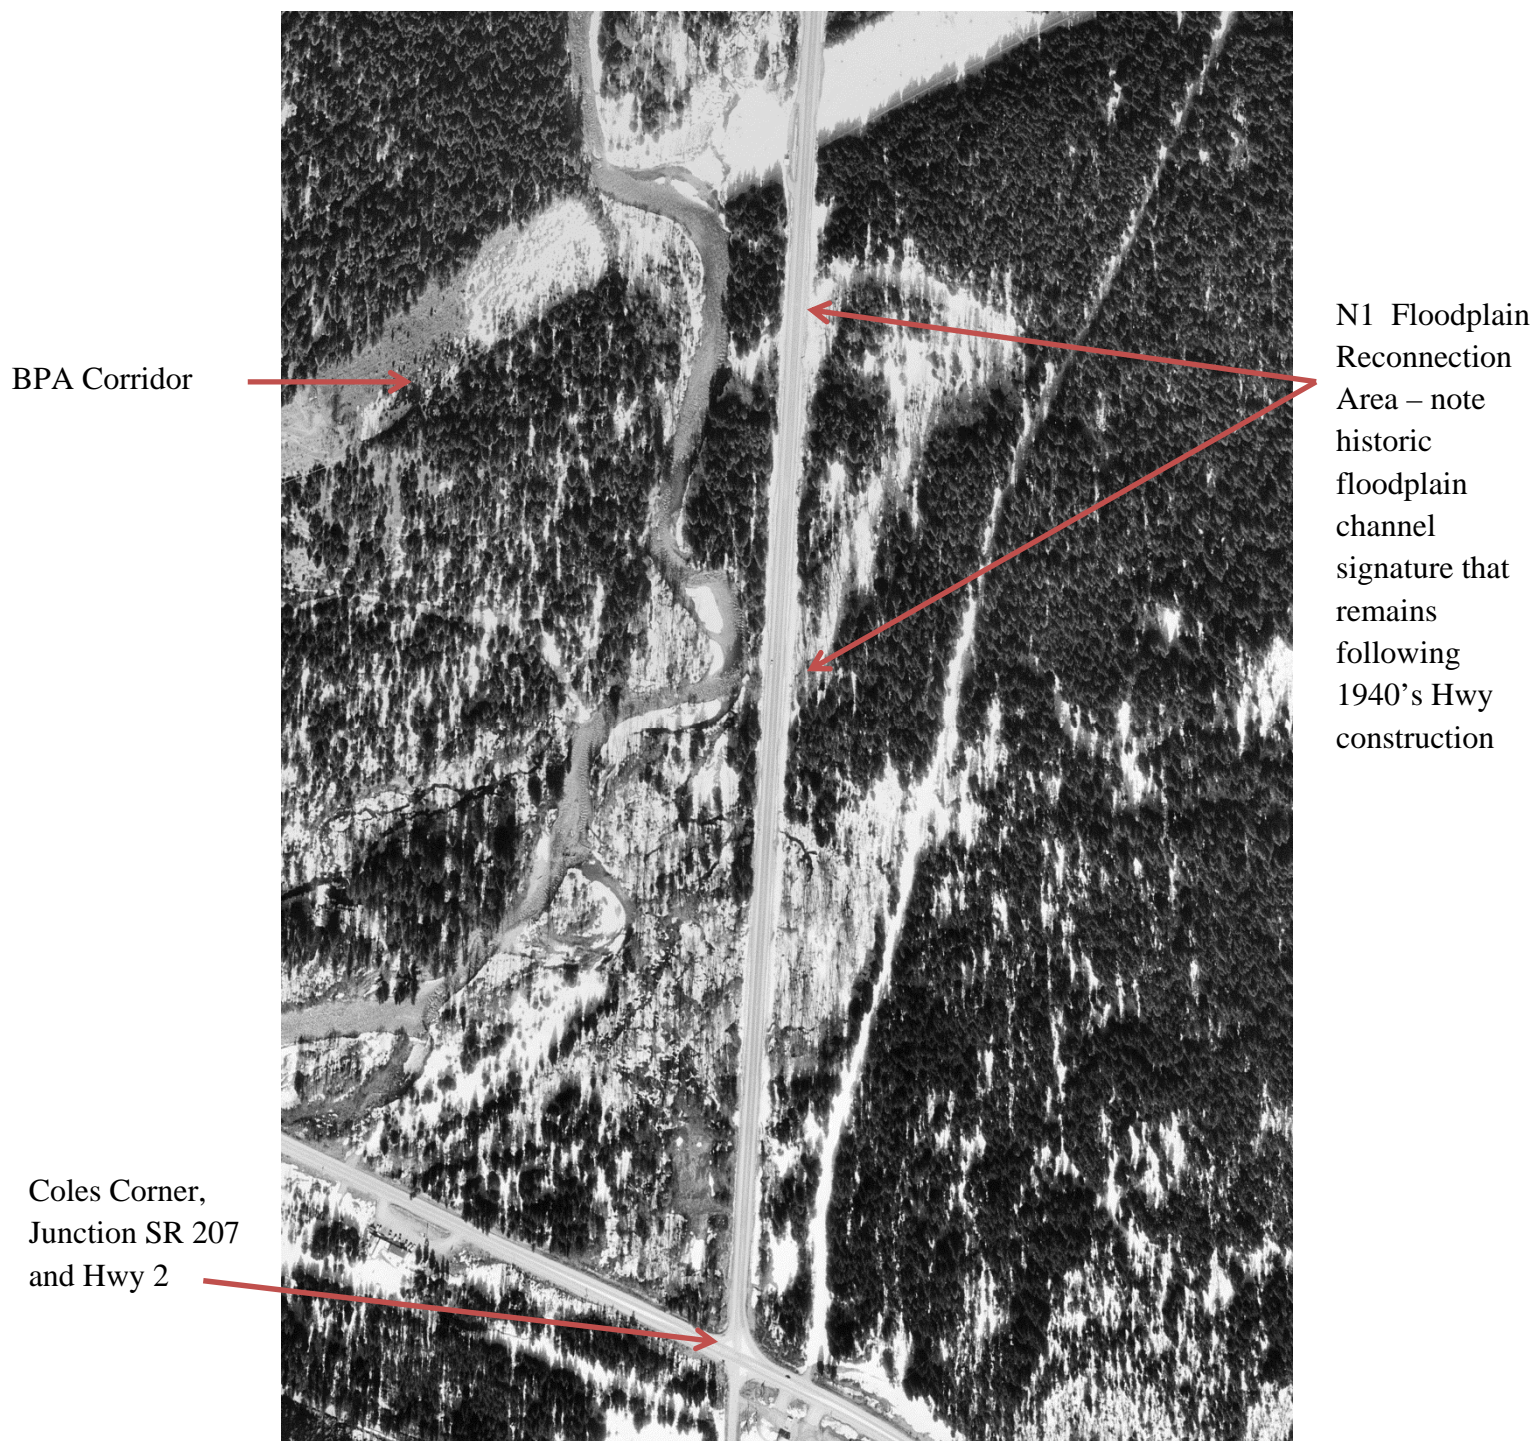
Figure 1: 1966 Aerial Photograph of the N1 Floodplain Reconnection site. Source UW. Note the active floodplain channel path in the vicinity of the project area.

In the 1940's, Highway 207 re-location disconnected the N1 floodplain area from the mainstem of Nason Creek. The active floodplain area is still visible in the 1966 aerial photograph, Figure 1. The 1966 aerial photograph is the oldest aerial photograph for the project area as the 1936 and 1949 aerial photos found during the searches do not quite cover the project area. The 1981, 1992, and 2012 aerial photographs (Figure 2-4) document vegetation succession in the floodplain that has resulted from the floodplain disconnection resulting from Highway 207 construction. However, the 50+ foot wide break in canopy cover that remains at the downstream end of the floodplain is visible in Figures 2-5. This area remains wet through the spring due to elevated groundwater discharge from the surrounding hillsides. Photo 5 in the final project proposal documents current levels of spring inundation in the floodplain area.

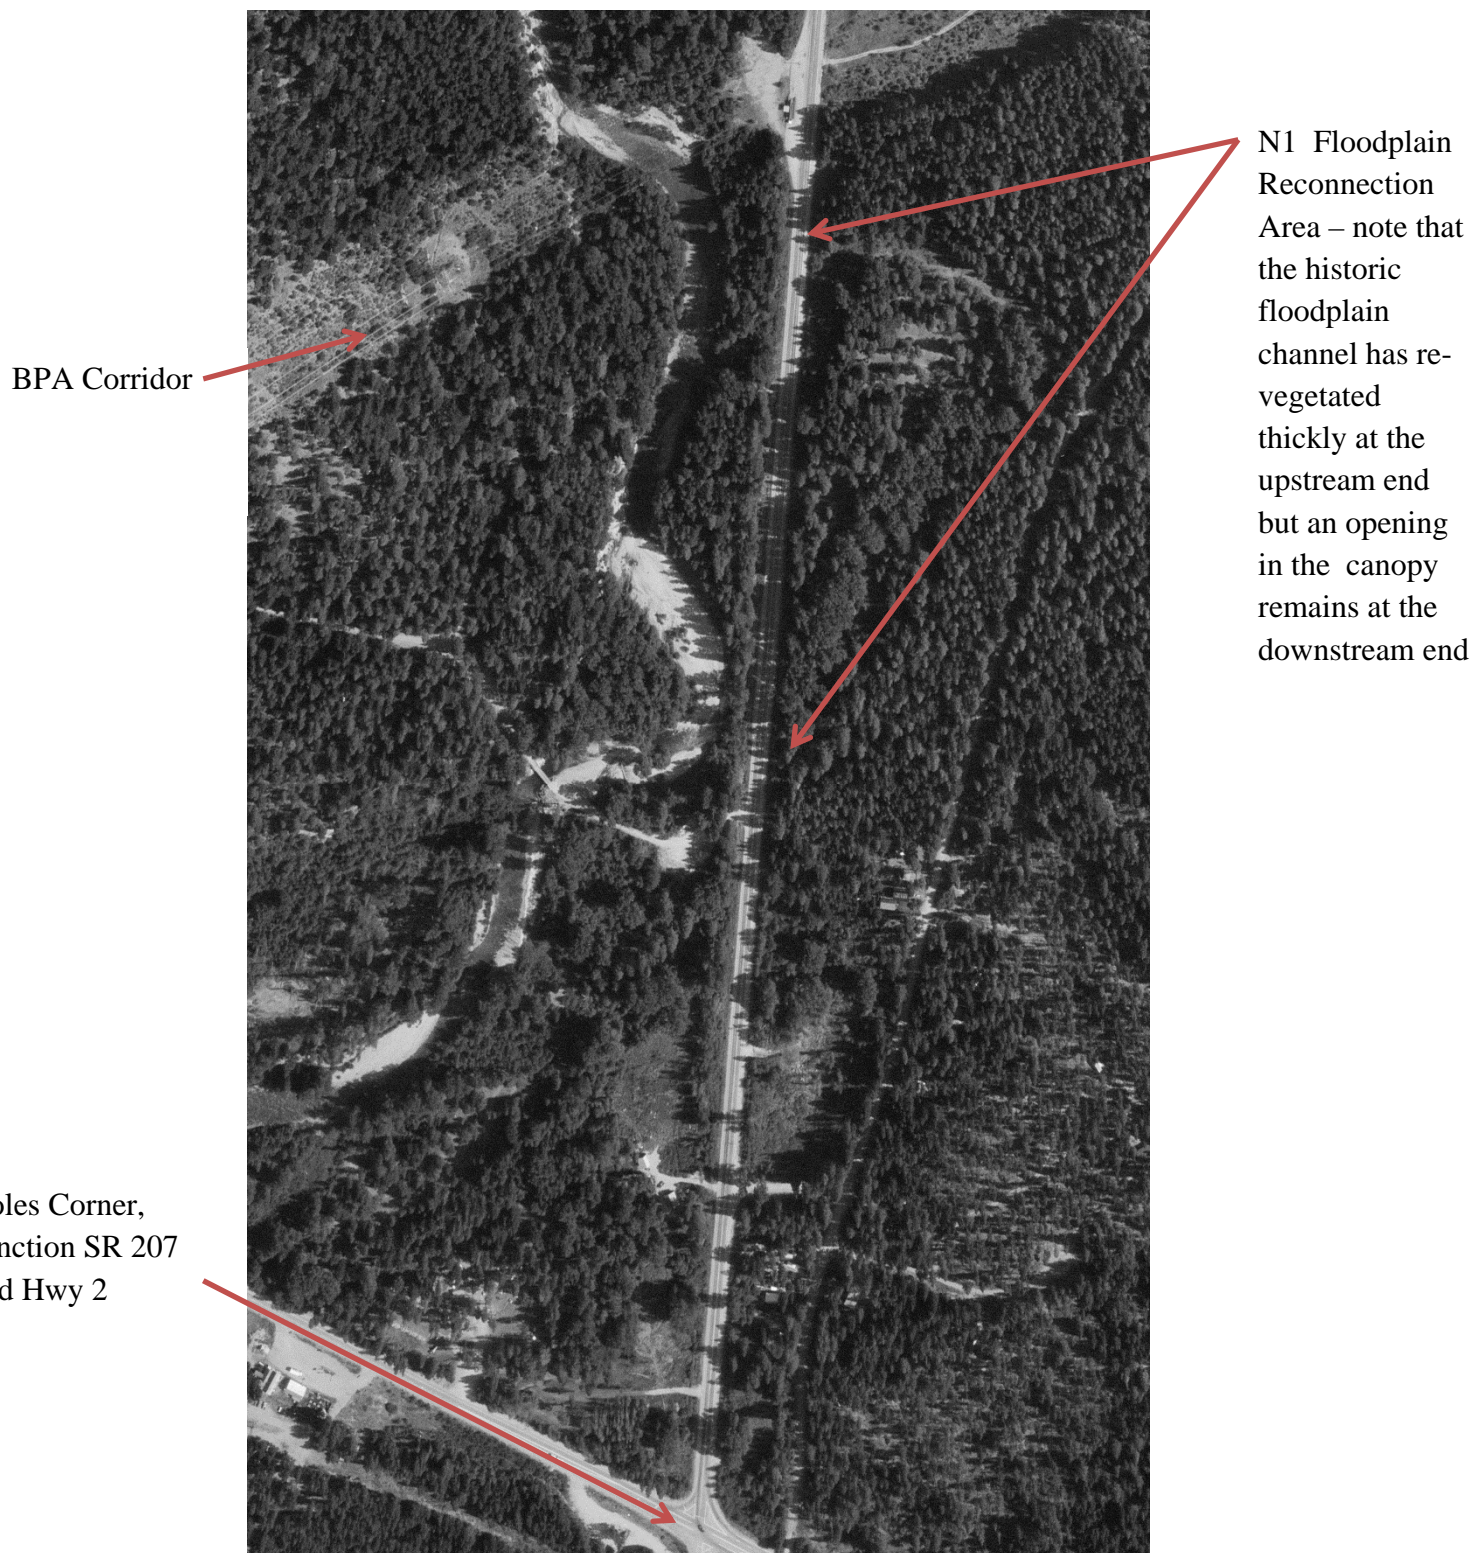
Figure 2: 1981 Aerial Photograph of the N1 Floodplain Reconnection site. Source UW.
