Nason Creek: Upper White Pine Reach Restoration Plan

January 2013

Prepared by
USDA Forest Service TEAMS and Inter-Fluve Inc.
for the
U.S. Bureau of Reclamation, Pacific Northwest Region, and the Yakama Nation

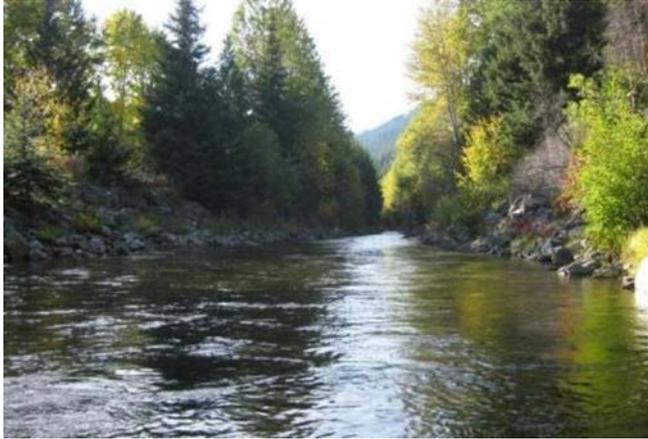
Figure 10. Typical section of subreach 2 looking upstream. The railroad grade is located to the left and the levee that protects the CPUD powerlines is located to the right. Both banks are protected with riprap.

The existing Nason Creek channel through subreach 2 was rerouted to the north to accommodate the realignment of the railroad. The creek is riprapped and dikes exist on both sides of the Nason Creek channel (figure 9, figure 10). The channel through subreach 2 is similar to subreach 1 in that it is incised and highly entrenched due to the rip-rap and dikes. However subreach 2 has a lower channel slope than subreach 1; Subreach 1 (1.7%) versus subreach 2 (0.5%). Due to the lower gradient, subreach 2 contains mostly glide habitat. Based on aerial photo interpretation (Appendix A), the stream channel throughout the entire analysis area was historically a response reach and migrated across the valley floor. The main channel from RM 14 through RM 13.5 occupied the southern extent of the valley prior to channelization. The existing realigned stream channel corridor in subreaches 1 and 2 was dredged to accommodate the realignment of the BNSF railroad prism. The historic riparian conditions that existed through subreaches 1 and 2 would have been similar to the reference areas upstream, which would have provided the reaches with essential fish habitat elements (large woody debris, pools, cover, shade, etc.). Presently, subreach 2 is a transport reach due to the confinement of the railroad prism and left bank levees. Therefore sediment is routed downstream to subreach 3 and beyond. Historically, before channel realignment, this reach was a depositional response reach similar to subreach 3.

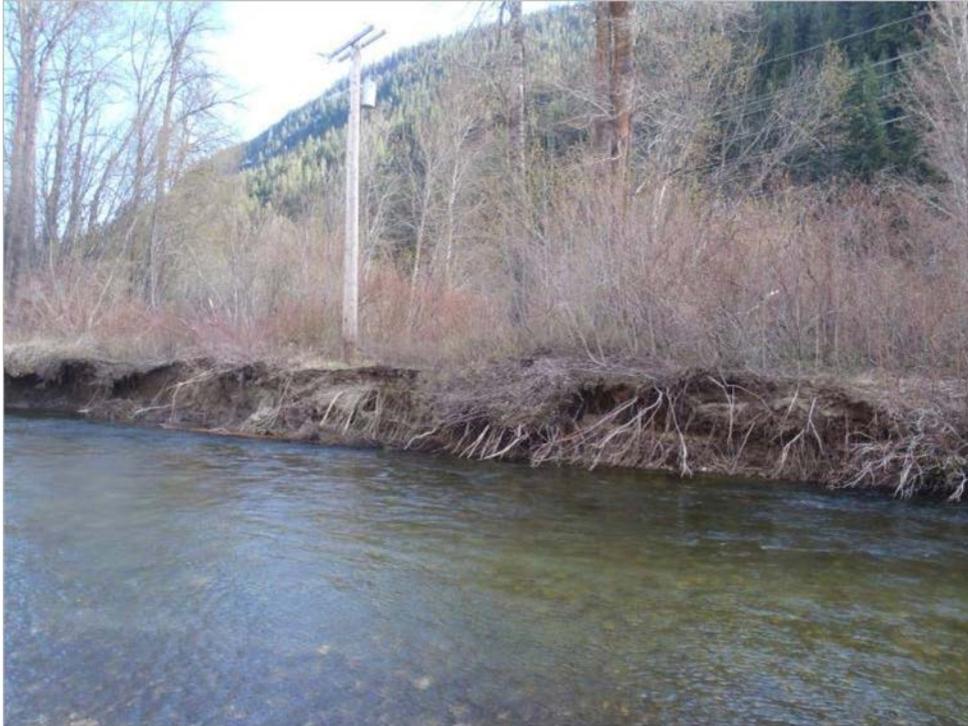
Figure 12. Power pole threatened by streambank erosion near RM 13

There is a rapidly eroding streambank on the river-right near RM 13 due to riparian vegetation destabilization caused by the PUD powerline corridor (figure 12). This erosion currently threatens a power pole. U.S. Highway 2 abuts the stream on the left riverbank at the outside bends of the meanders at RMs 12.8 and 13. The highway and associated riprap banks limit natural bank erosion and impair riparian conditions. Meander scrolling and plan form changes have occurred over the course of the historical photo record. Significant scrolling of the upstream meander since 1970 (figure 13) is likely related to channelization of subreach 2, which has accelerated delivery of bedload material to this segment.

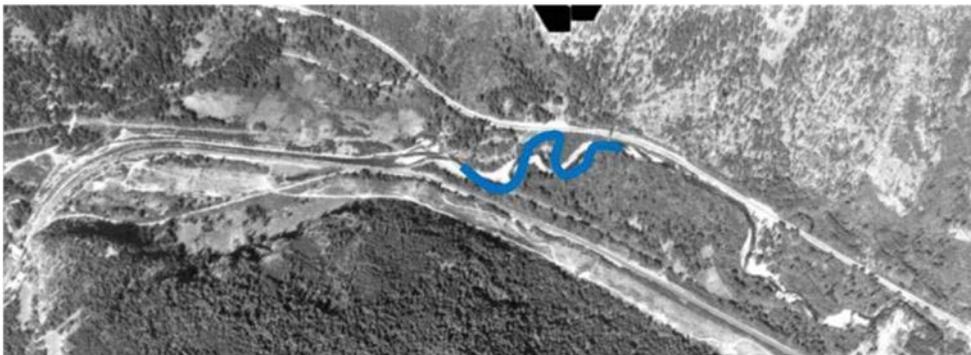
Figure 13. Illustration of changes to the migration pattern of the stream channel through subreach 3. Note that the blue line is interpreted from LiDAR data taken in 2006 and represents the approximate current stream channel. The aerial photo was taken in 1970.

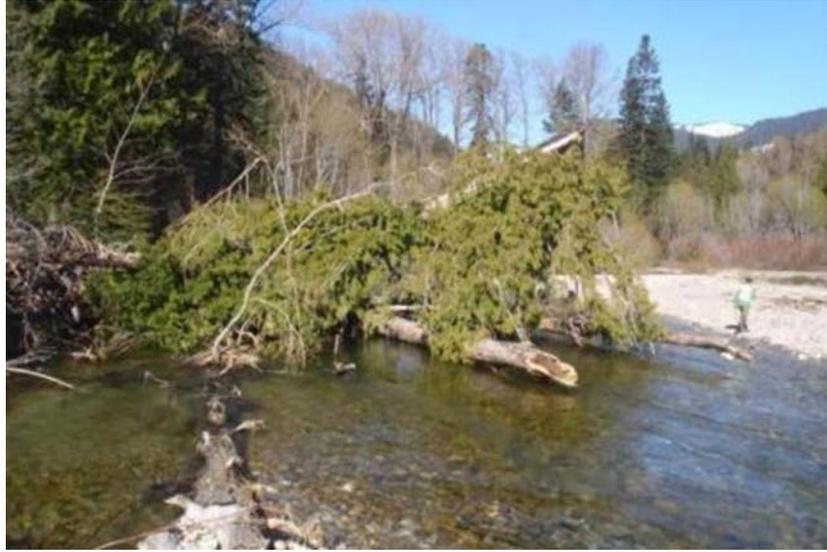
Figure 16. Newly recruited cedar tree and associated logjam near RM 12.3 (photo taken in May 2011)

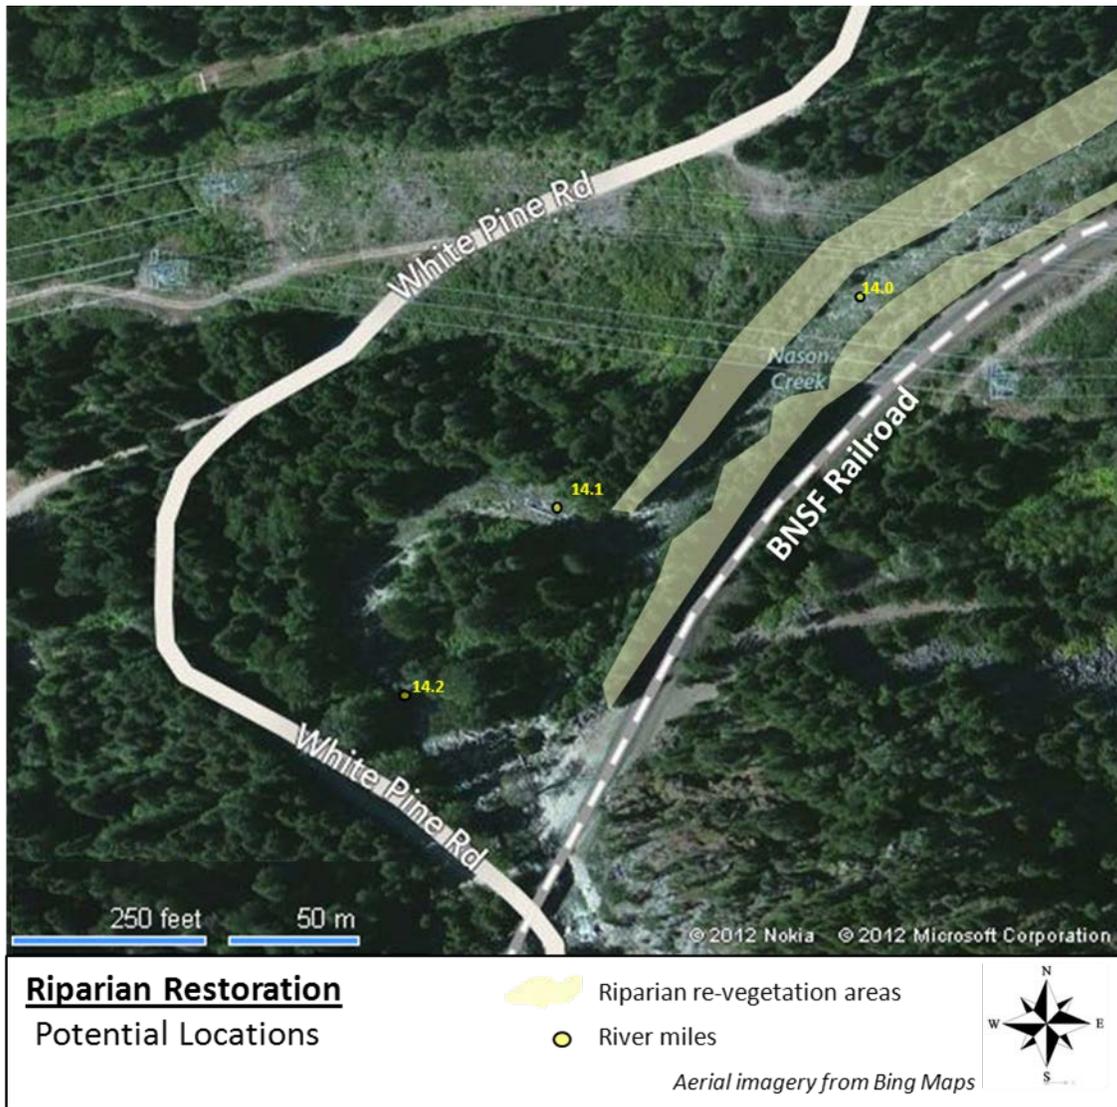
Figure 28. Aerial view of riparian conditions in subreach 1

Subreach 1. Riparian conditions within subreach 1 are in relatively good condition (figure 28); subreach 1 contains five of the six riparian tree and shrub species and 18 percent of riparian stands are in the large tree seral class compared to 26 percent within the reference area. Therefore, riparian restoration opportunities are limited to under-planting of conifers and potentially inter-planting of rip-rip along the BNSF railroad corridor.

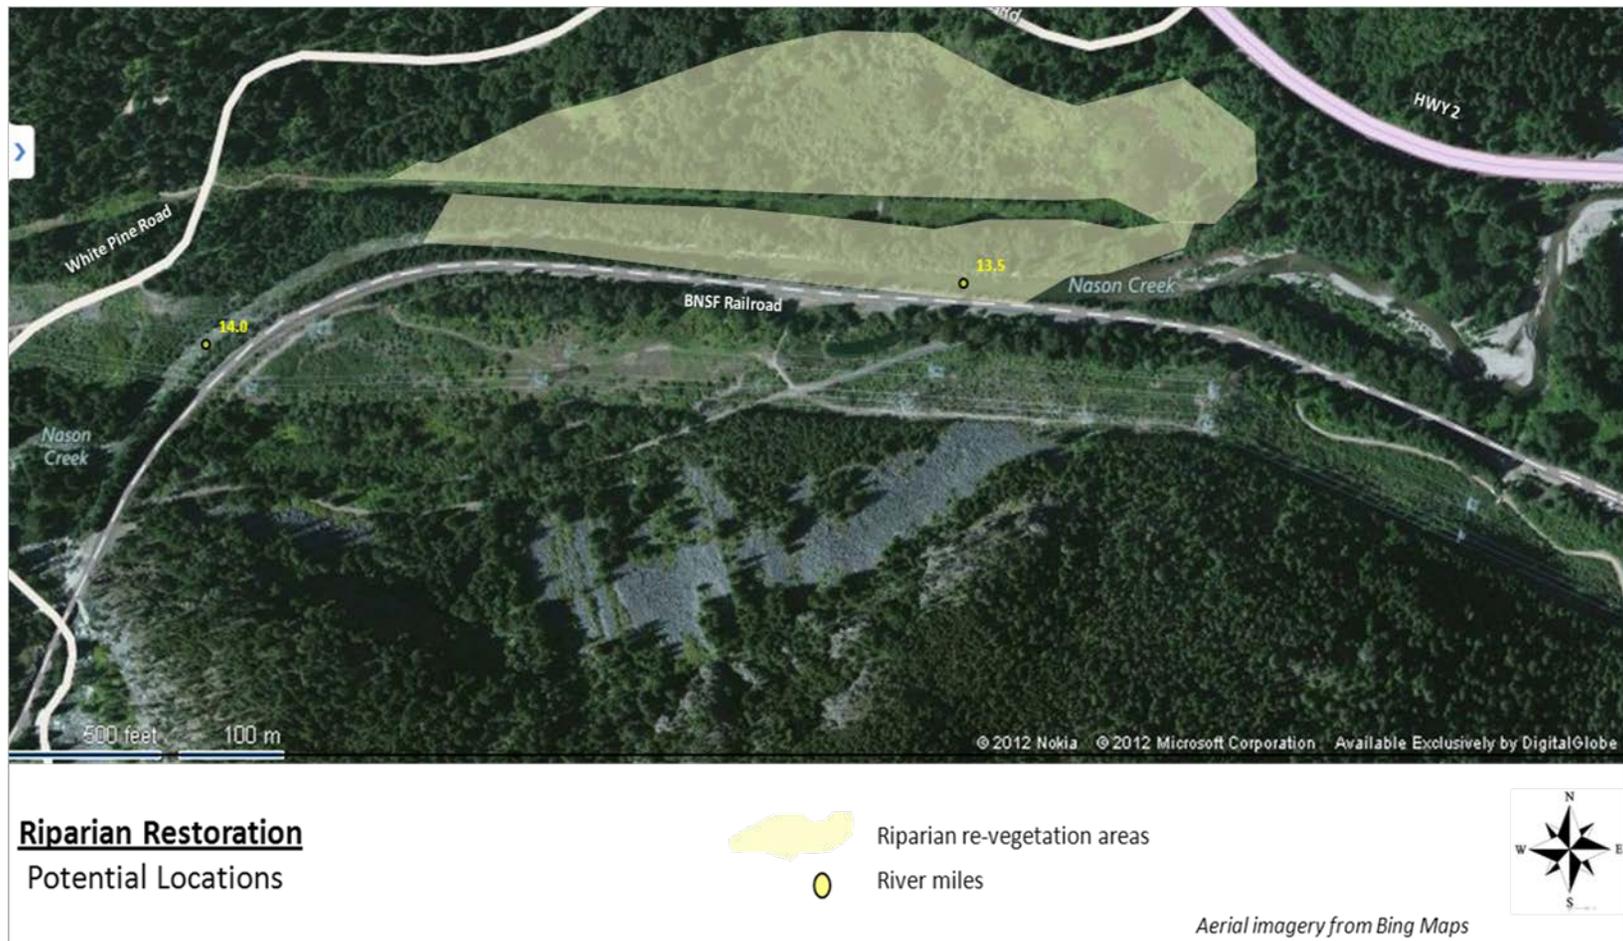
Figure 29. Aerial view of potential riparian restoration areas in subreach 2; riparian revegetation would be limited to areas disturbed by restoration actions

Subreach 2. Subreach 2 has the potential to increase the active riparian area from an existing 6 acres to between 12 to 26 acres if the stream channel corridor were reconstructed and/or PUD powerline corridor relocated (figure 29).

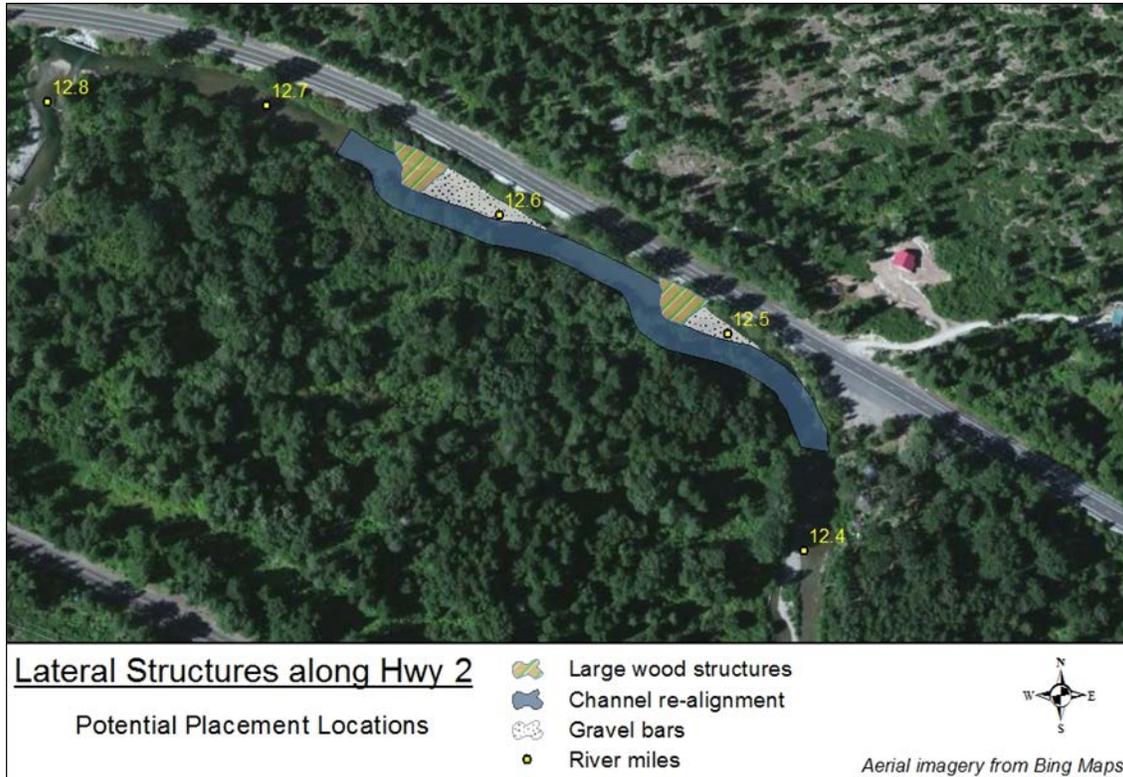
Figure 34. Potential sites for placement of lateral structures

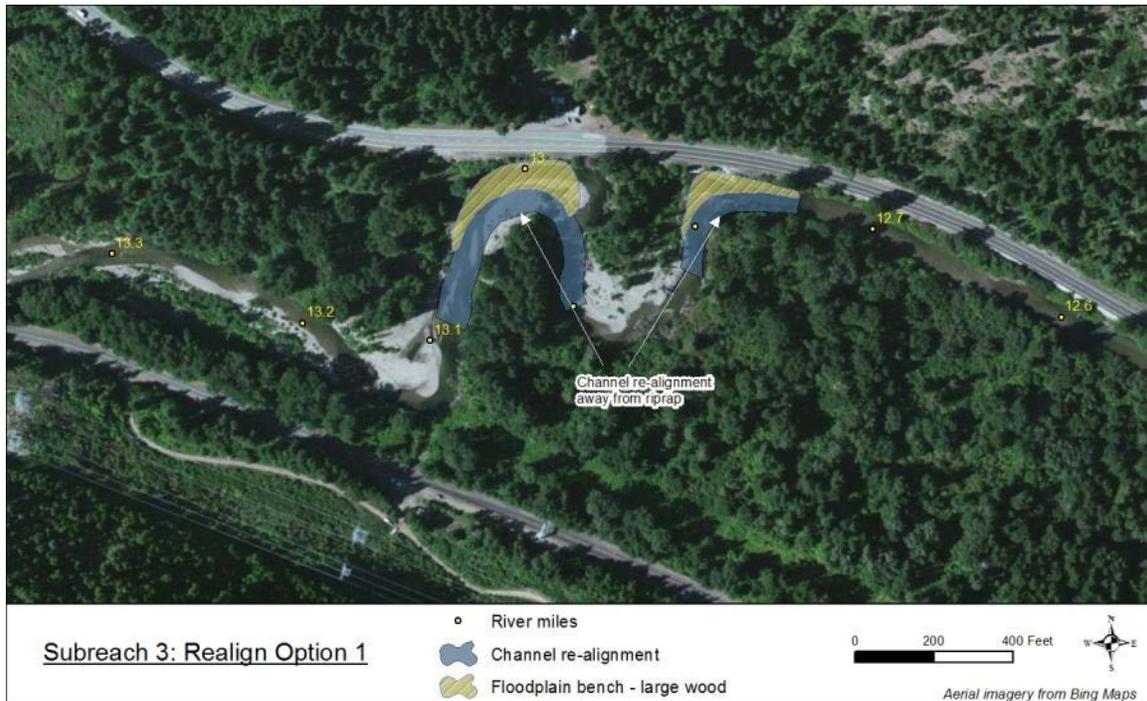
Figure 52. Plan view of subreach 3 realignment, option 1

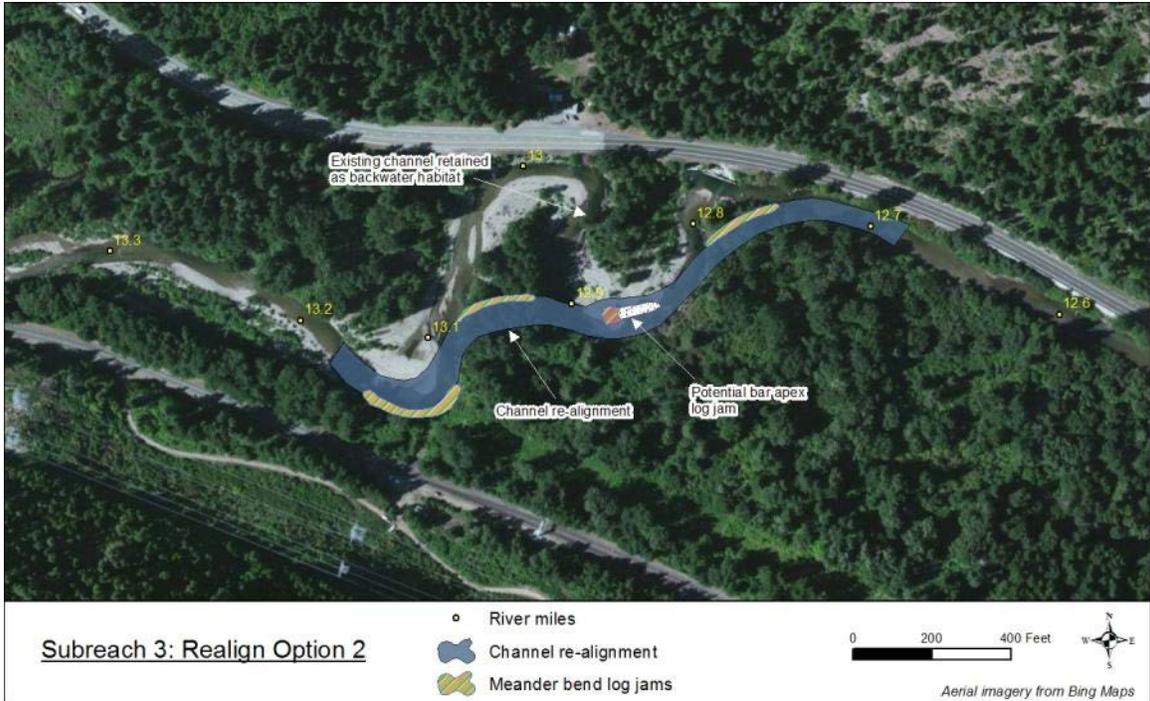
Figure 54. Plan view of subreach 3 realignment, option 2

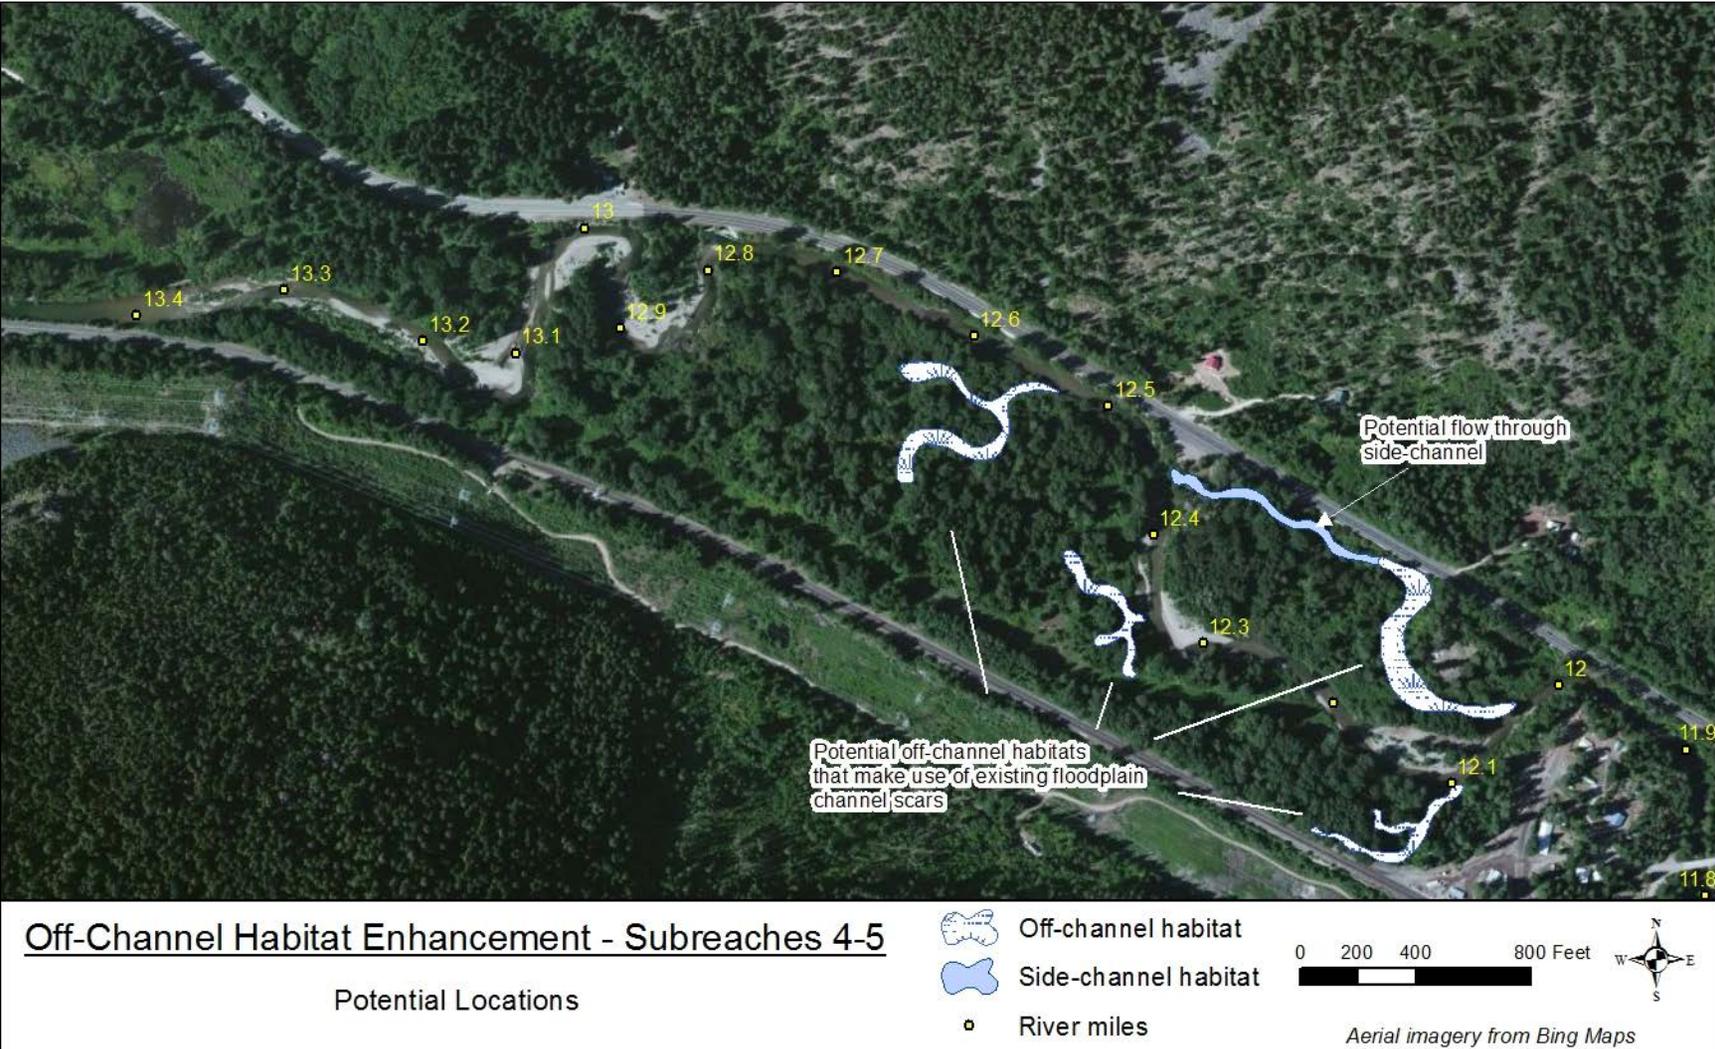
Figure 57. Off-channel enhancement opportunities in subreaches 4 and 5

Potential locations for off-channel creation and enhancement in Subreaches 4 and 5 are included in figure 57. Locations for potential off-channel projects in Subreaches 4 and 5 are based on where these types of habitats would naturally form and where existing floodplain depressions would help to facilitate construction. Off-channel areas would be created through excavation of floodplain material. In most cases, the off-channel habitats would have only one connection point with the mainstem, and would be placed in areas where groundwater contributions would be expected to maintain suitable water temperature conditions throughout the year. There is also the potential to create a flow-through side-channel (including both an upstream and downstream connection) along the north boundary of the floodplain in Subreach 5. In general, off-channel habitats would be designed to be accessible to juvenile salmonids throughout the year, providing both high flow refuge from fall through spring as well as temperature refuge in the summer. Large wood would be placed in off-channel areas for complexity and cover. A total of approximately 4 acres of potential off-channel habitat creation have been identified. The concept level construction cost estimate for subreaches 4 and 5 ranges from \$110,000 to \$160,000 per acre (see Appendix F).

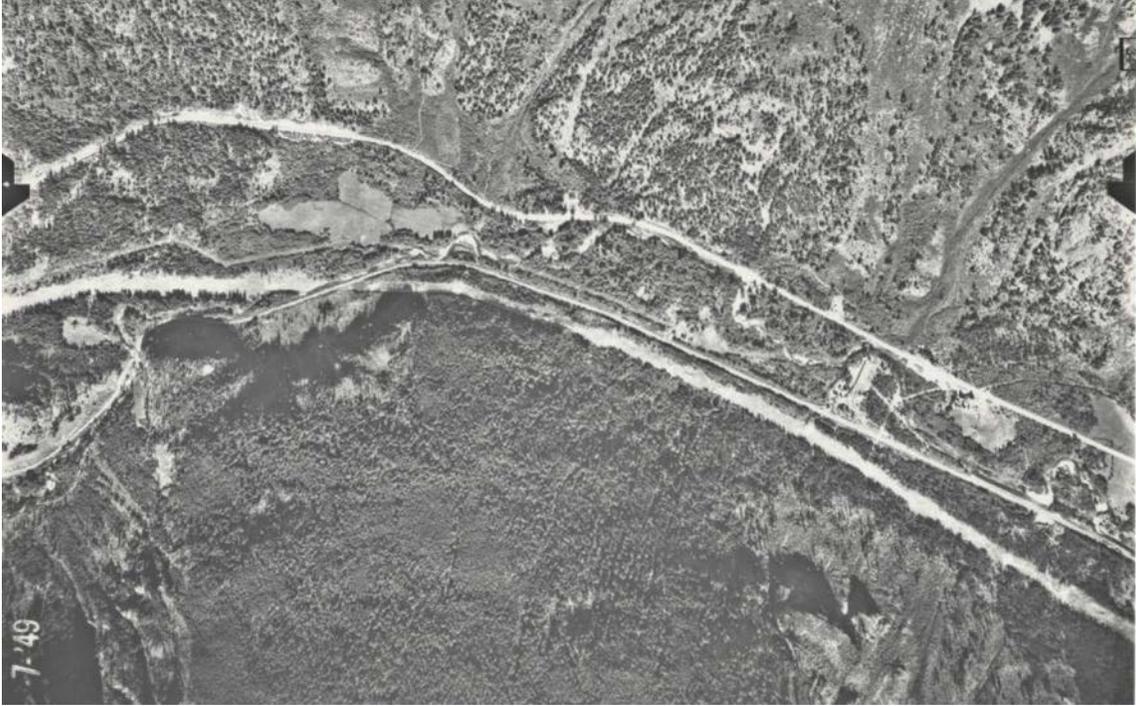
Figure 59. Aerial photo of the Upper White Pine Reach taken in 1949

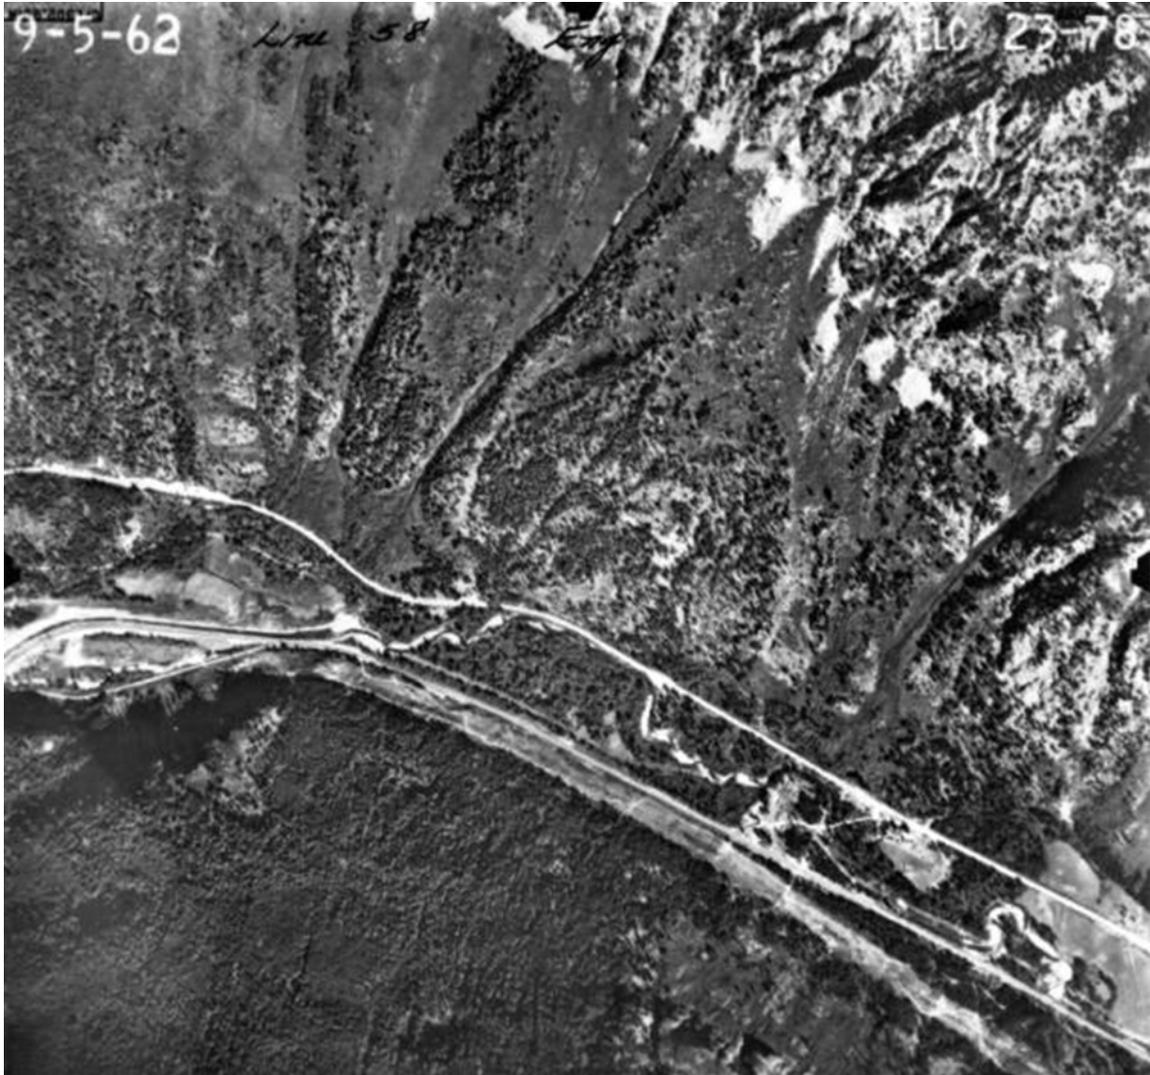
Figure 60. Aerial photo of the Upper White Pine Reach taken in 1962

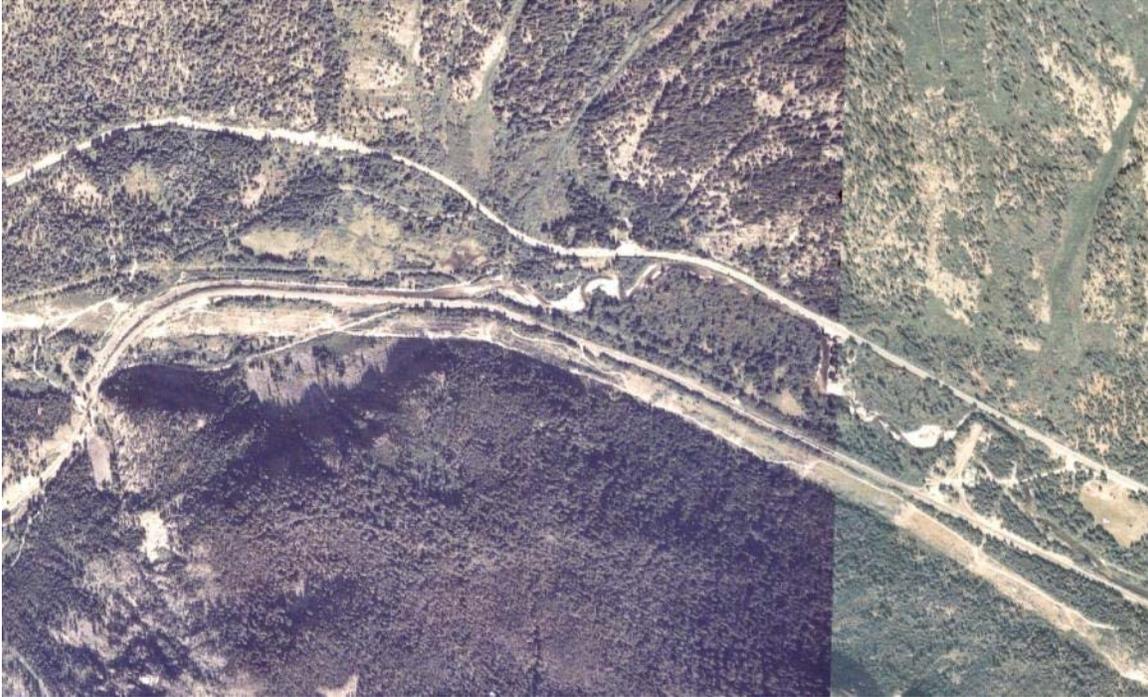
Figure 62. Aerial photo of the Upper White Pine Reach taken in 1975

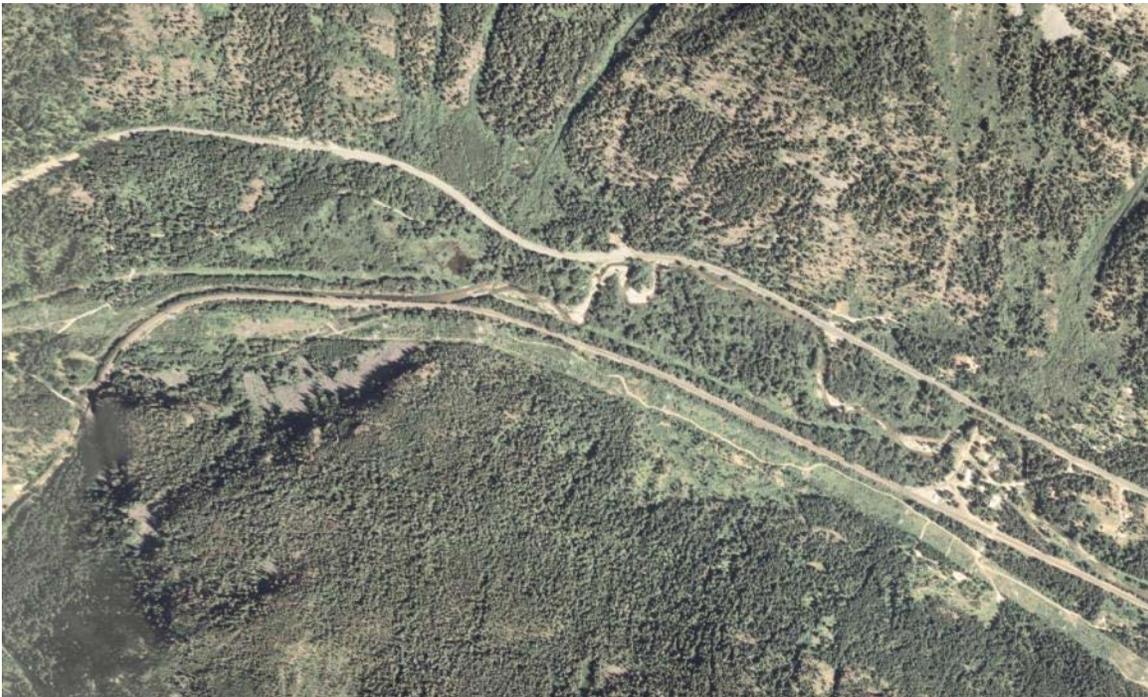
Figure 63. Aerial photo of the Upper White Pine Reach taken in 2006
