Re: Report
Environmental Site Assessment: Phase I
Barnum Point Property
Island County Parcels R33108-495-0500, R33105-065-0680, and R33105-086-1670
Camano Island, Washington 98282

**REPORT
ENVIRONMENTAL SITE ASSESSMENT
PHASE I**

**BARNUM POINT PROPERTY
ISLAND COUNTY PARCELS R33108-495-0500, R33105-065-0680,
AND R33105-086-1670
CAMANO ISLAND, WASHINGTON 98282**

February 23, 2012

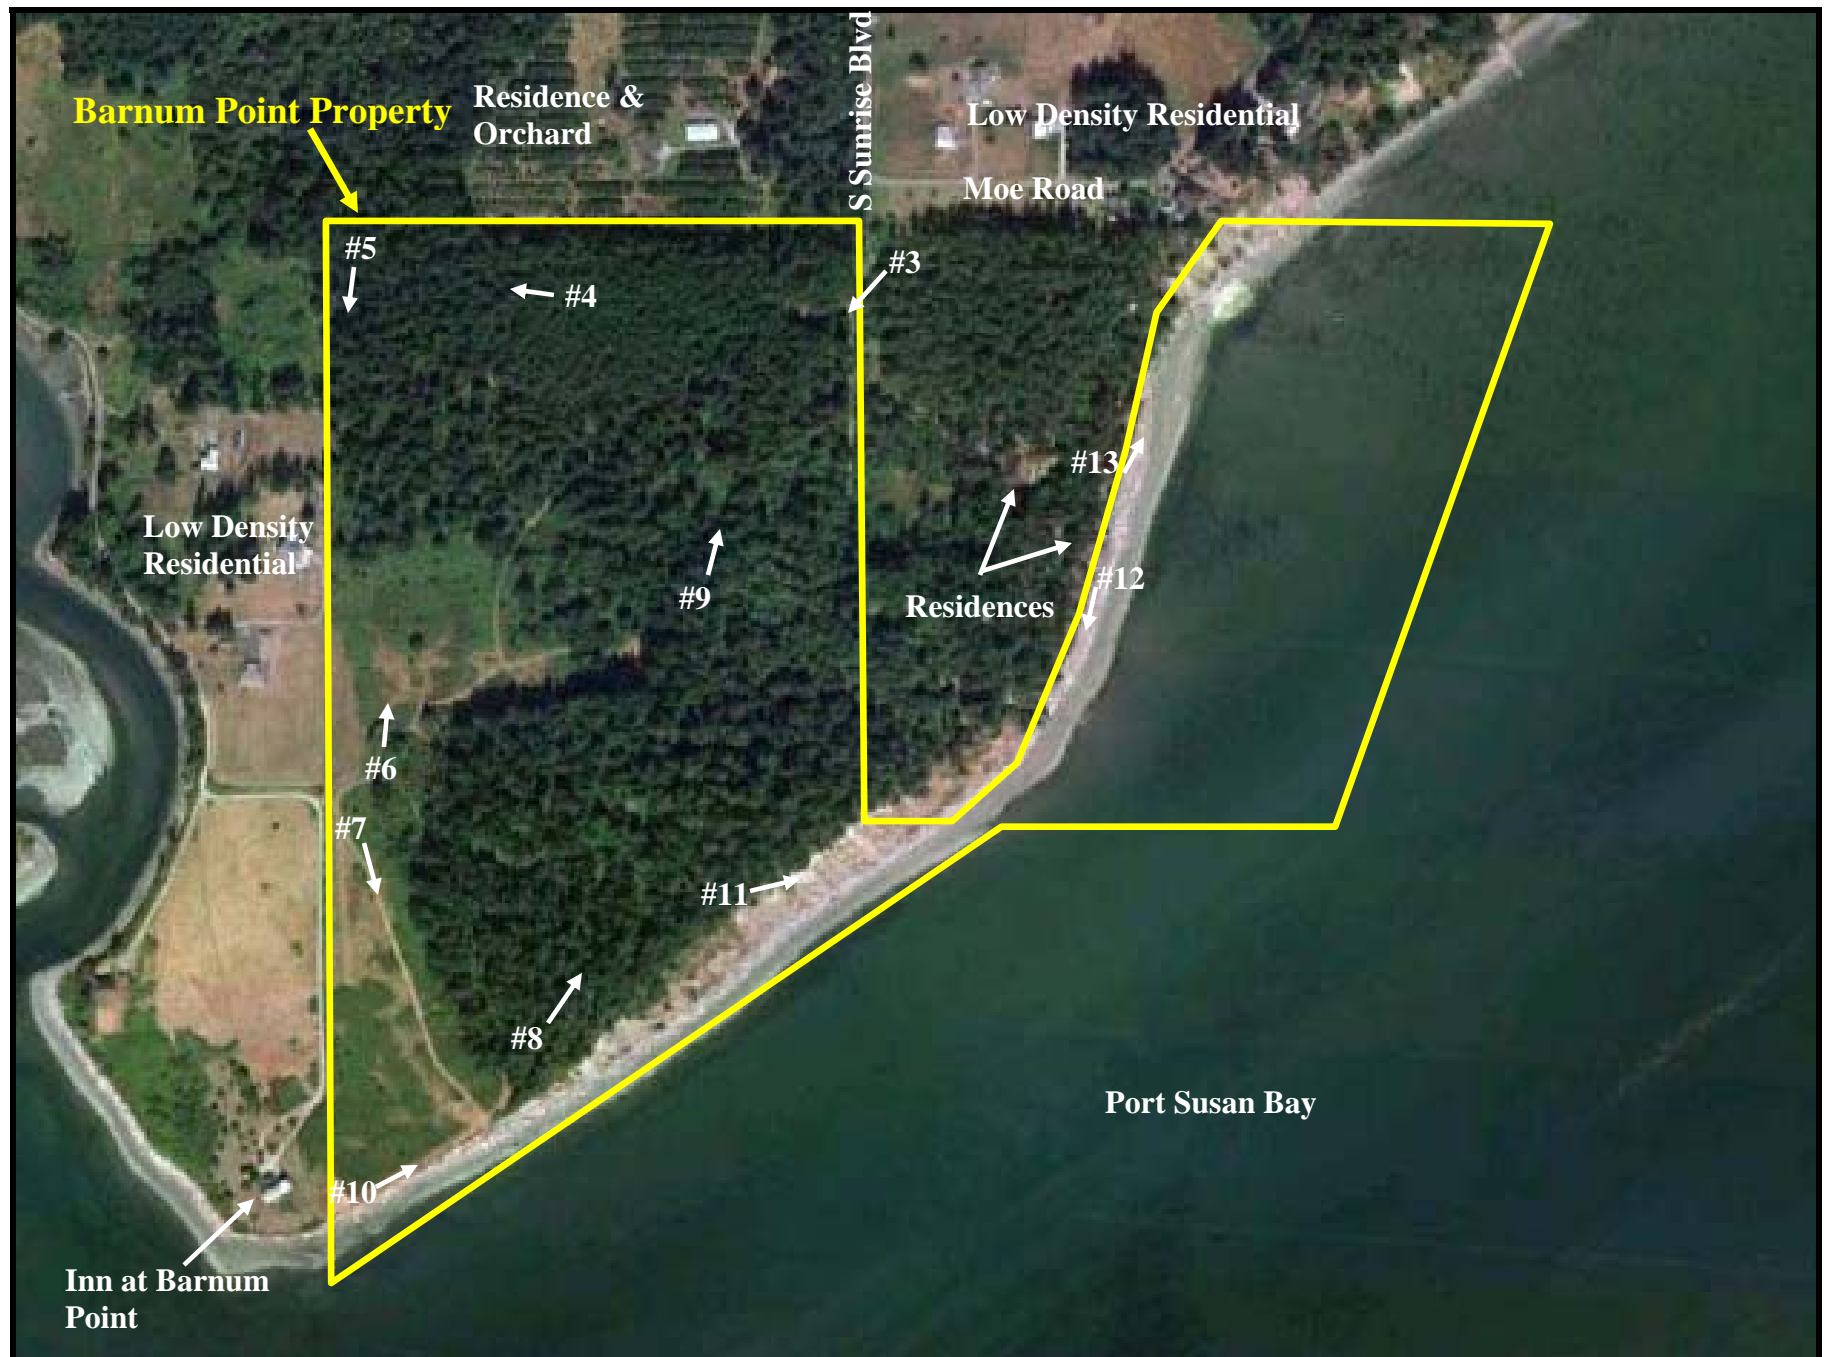
Figure 2. Aerial photograph of approximate subject property boundaries and vicinity (Google Earth, 2011). Site photographs are taken from the locations indicated (photos 3 through 13).

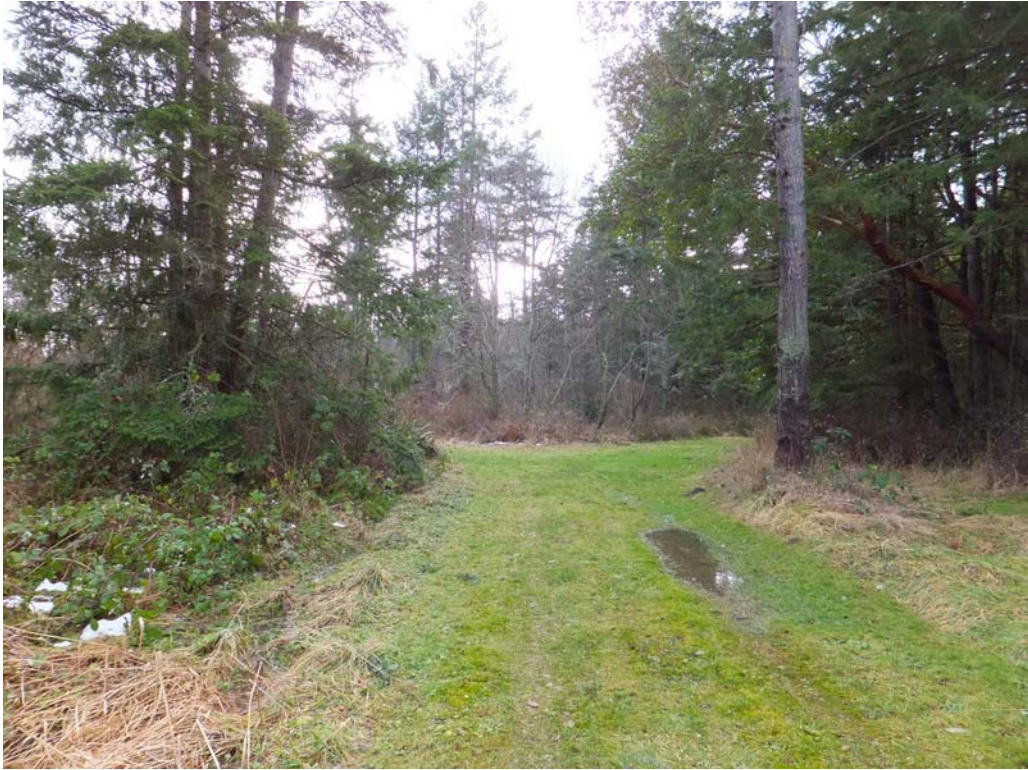
Figure 3. View of the access to the property from the northeast corner.

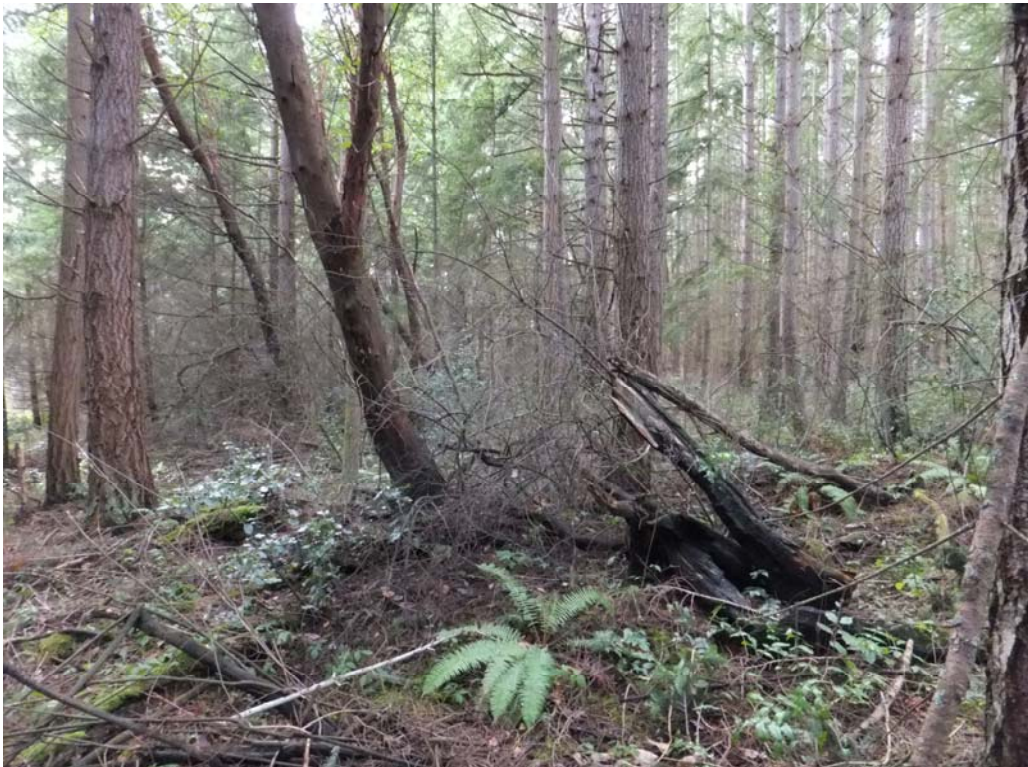
Figure 4. View of the forest in the northwest corner of the site, where logging has previously taken place.

The property has been undeveloped and vegetated with forest and meadow since at least the mid 1950s. Tree removal in the northwestern and central portions of the site took place prior to 1958 and again by 1978. The cleared areas of the property have since reforested. The northeast and

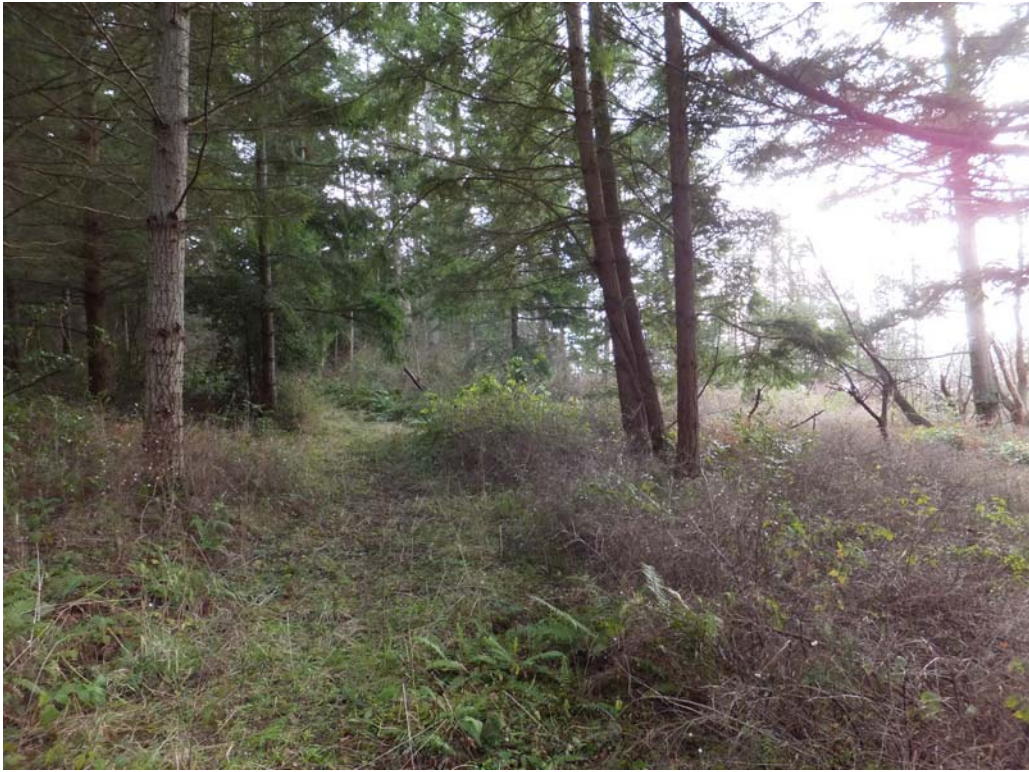
Figure 5. View of the forest along the northwestern property boundary.

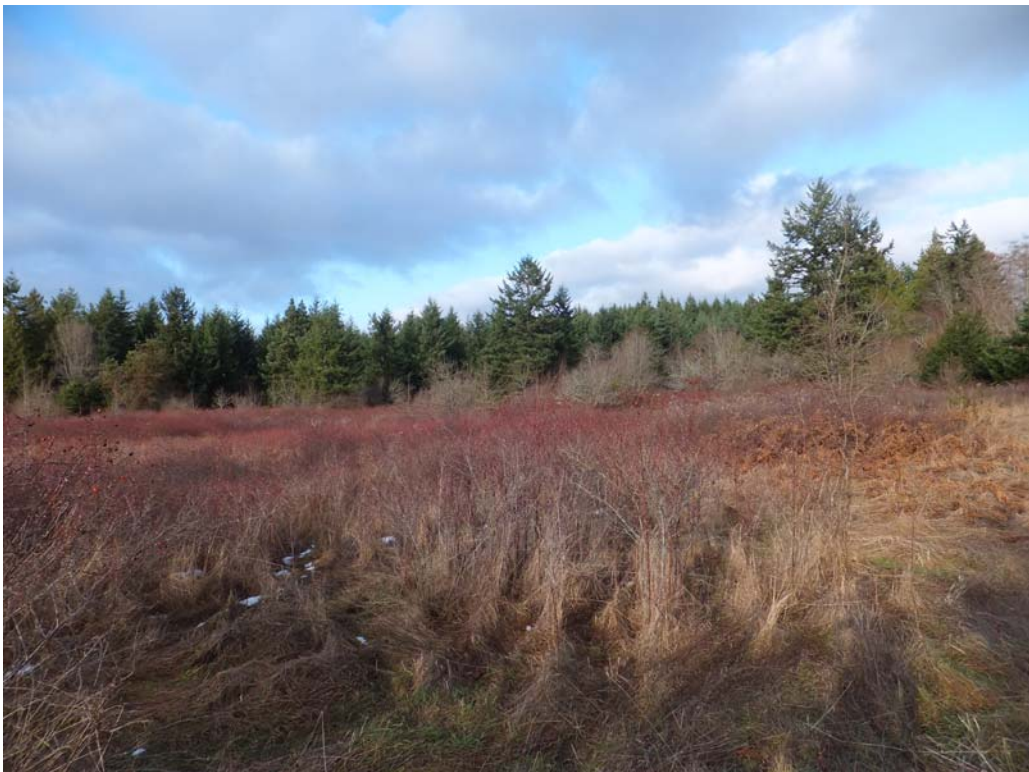
Figure 6. Meadow area in the west-central portion of the property.

An open, unforested area is located along the western boundary of the site. Grasses and thickets of Nootka rose cover the non-forested portion of the site.

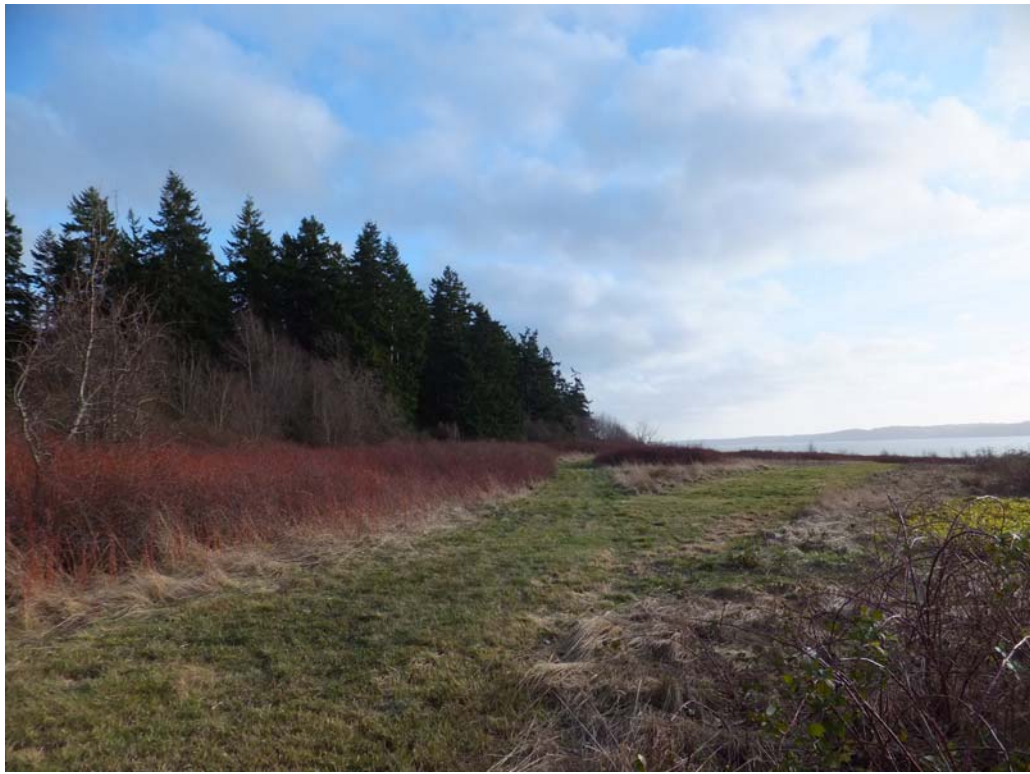
Figure 7. Southwestern corner of the property.

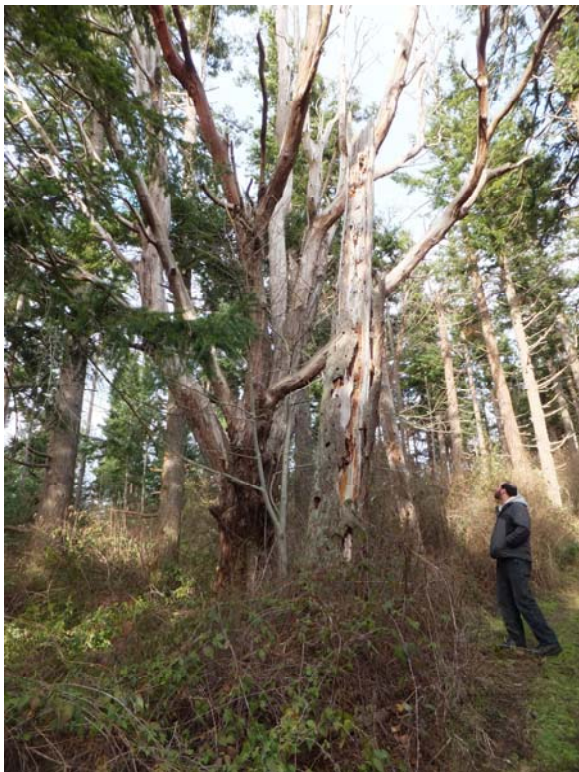
Figure 8. Mature madrone in central portion of the site

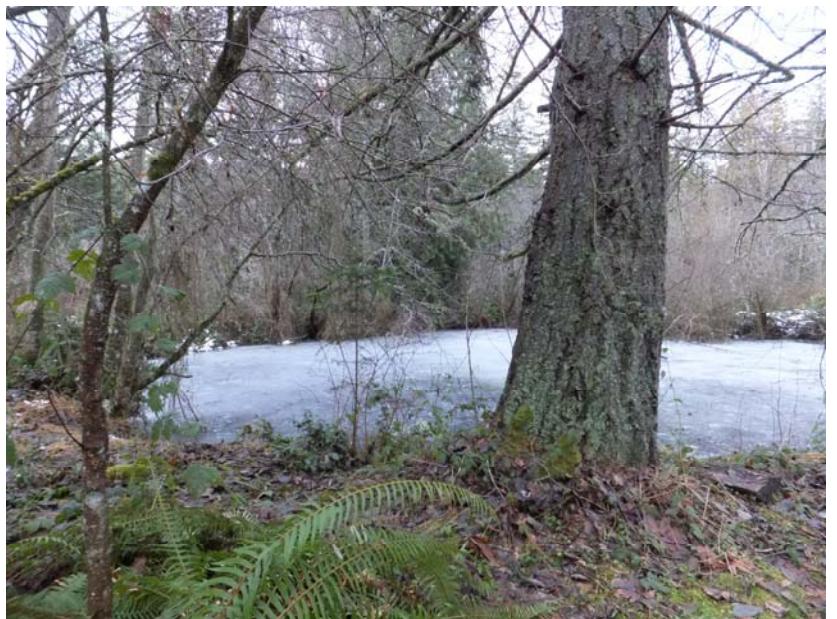
Figure 9. Pond in the northeastern portion of site.

Forest covers the majority of the upland portion of the site. The forest has numerous mown grass walking trails throughout. A pond is located on the northeastern portion of the forest.

ASTM OBSERVATION	YES/NO	COMMENTS
Hazardous Containers	No	
Storage Tanks	No	
Solid Waste Disposal	No	
Odors	No	
PCBs	No	
Pits, Ponds, Lagoons	Yes	A small pond is located in the northeast portion of the forested upland.
Stained Soil	No	
Stressed Vegetation	No	
Waste Water	No	
Septic Systems	No

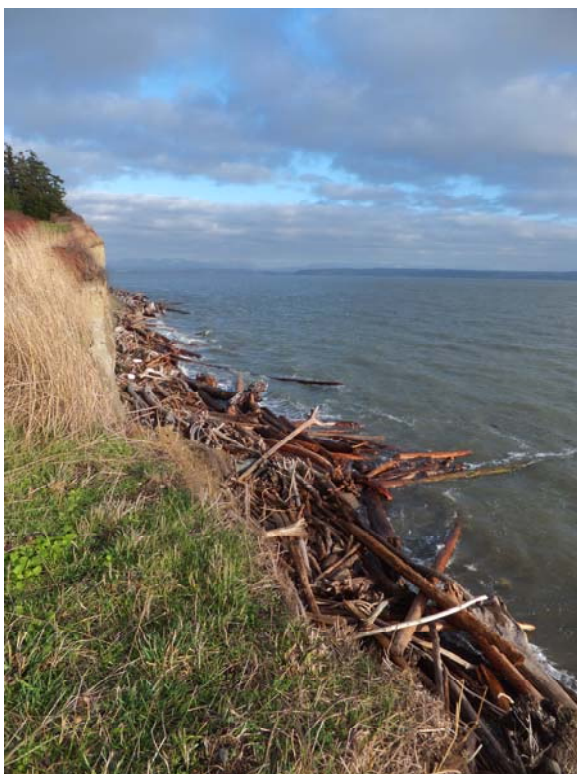
Figure 10. Beach along southern boundary.

A steep shoreline bluff is located along the southwest corner of the property, which extends down to a driftwood covered beach. Driftwood covered the beach along the entire length of shoreline. Sandy slopes were located along much of the steep portions of the shoreline bluff. The shoreline bluff is approximately 100 feet along the south-central shoreline.

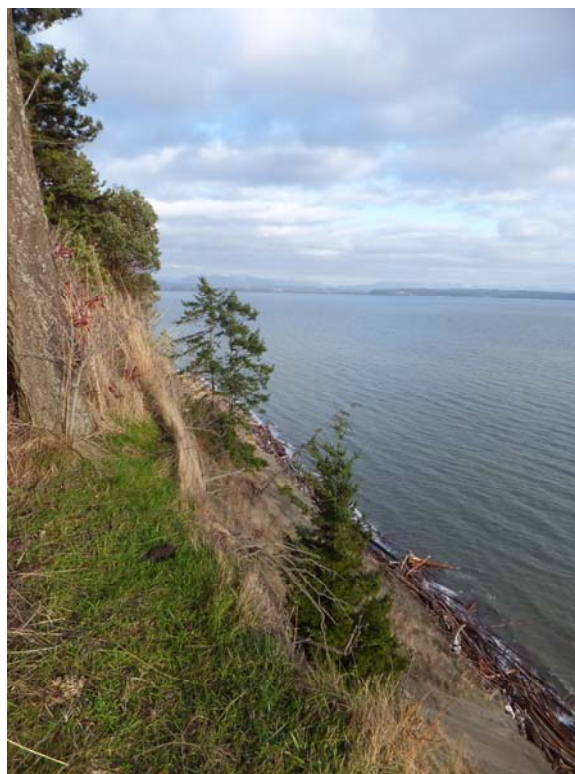
Figure 11. Bluff and beach along central boundary.

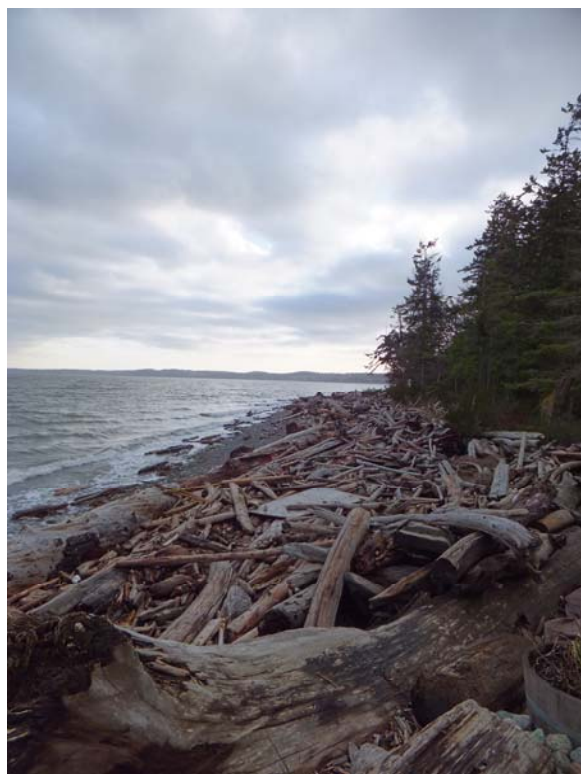
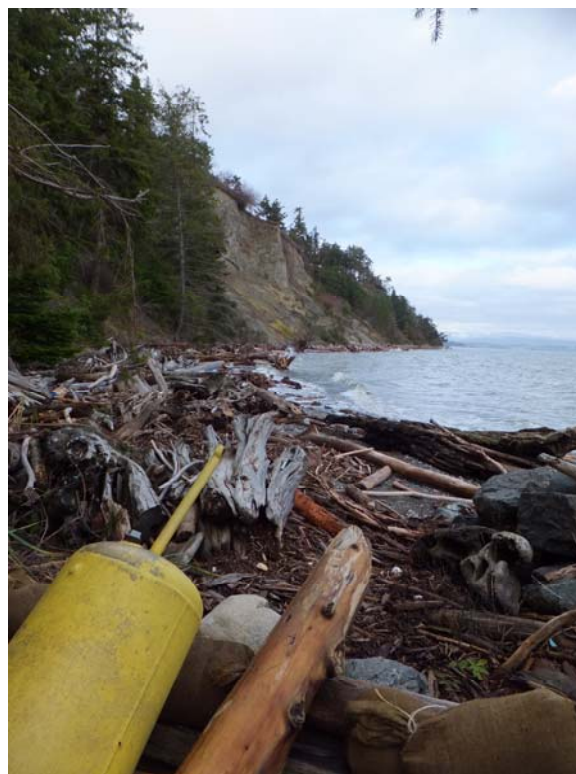
Figure 12 and 13. Views of the shoreline along the eastern property boundary.

Natural landscaping and driftwood logs that were cabled into the beach were observed adjacent to a beach front home along the eastern property boundary. The residence is not part of the subject property. A tarp-covered metal structure that was used to store some buoys, a rowboat, crab pots, some lights and other miscellaneous water-related equipment is present north of the residence, just west of the beach. No chemicals or potentially hazardous materials were observed within the storage area.
