April 9, 2013

RE: Archaeological Monitoring for the Icicle Creek Kiosk Project, Chelan County, Washington

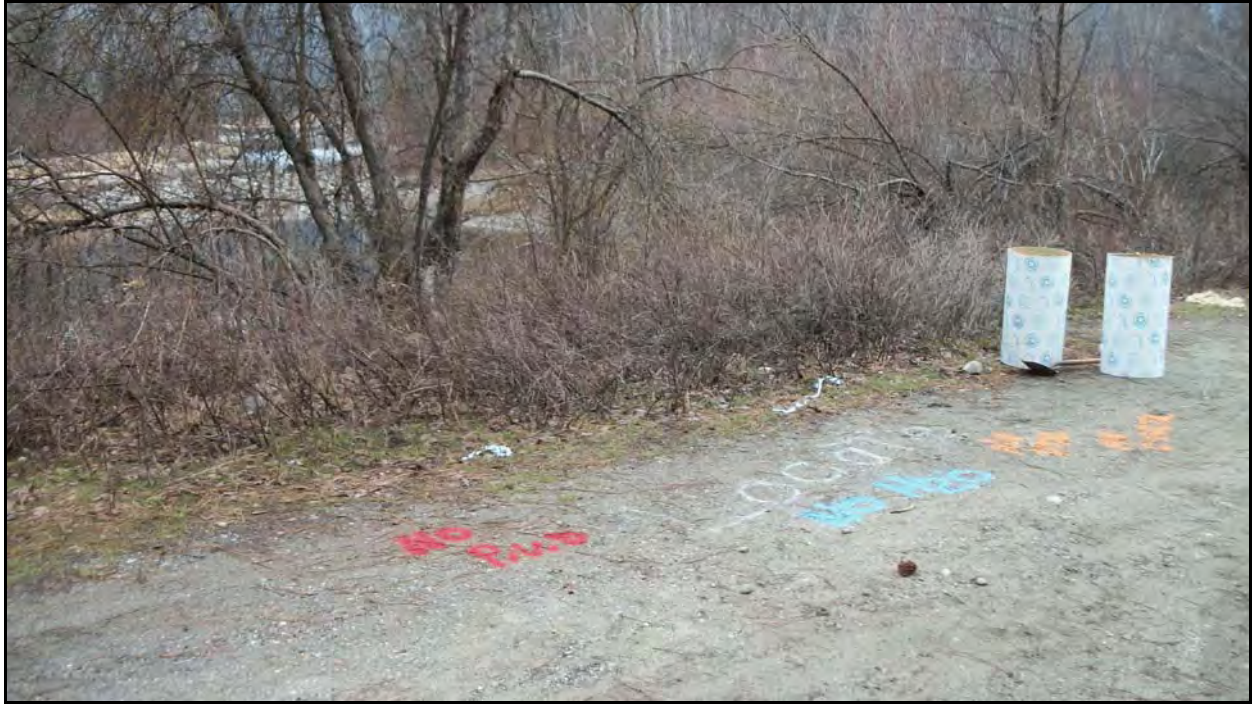
Plateau performed archaeological monitoring of the project on March 28, 2013. John Kannady was onsite for all ground disturbing activities. Roger Carlson of Roger Carlson Construction, Dennis McMahon of McMahon Excavation, and Matthew Shales from CCFEG were also present during the excavation. The location of the kiosk sign posts were marked with flagging tape at the edge of the gravel pad above the bank of Icicle Creek (Figures 3 and 4).

Figure 4. Overview of Project Area, looking west-northwest.
Note: Flagging tape and sonotubes.

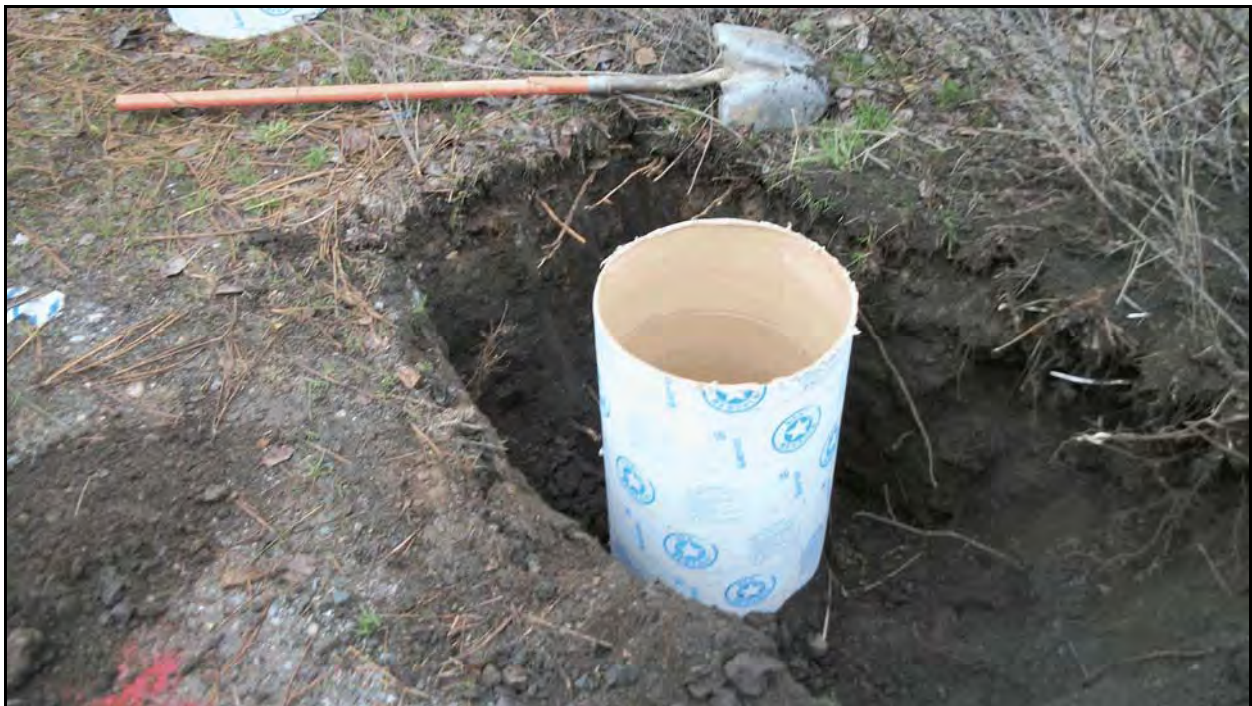
McMahon Excavation removed the soil with a Caterpillar (Cat) 420D backhoe with an approximate $\frac{1}{4}$ cubic yard (0.19 cubic meter) bucket. The two sign post trenches measured approximately 4.3 feet (ft) in length by 2.6 ft wide by 2.6 ft deep (1.3 by 0.8 by 0.8 meters [m]). The depth of the trenches was determined by Roger Carlson to accommodate the two sonotubes used for setting the kiosk posts in concrete. Each trench reached depth after excavating approximately 0.8 cubic yards (0.6 cubic meters) per trench. For a total volume of 1.6 cubic yards (1.2 cubic meters) excavated for the Icicle Creek Kiosk.

Archaeological monitoring was accomplished by viewing the excavations and trowel sorting each bucket of soil before it was dumped on a tarp. An attempt was made to screen all of the material, but it slowed down the work schedule and was too much volume for the screen. The soil profile encountered during the excavation consisted of 5.5 inches (in)(14 centimeters [cm]) of gravel and asphalt, over 26 in (66 cm) of very dark grayish brown gravelly silty sand(Figure 5). The trenches were backfilled with the spoils after the sonotubes were set and level.

Figure 5. Excavation trench profile with placed sonotube, looking southwest.
