**PRELIMINARY BRIDGE DESIGN AND CULVERT
REMOVAL DRAWINGS AND BID SPECIFICATIONS
FOR THE RESTORATION OF FISH PASSGE IN
BARNABY CREEK,
FERRY COUNTY, WASHINGTON**

**COLVILLE CONFEDERATED TRIBES
FISH AND WILDLIFE DEPARTMENT**
Nespelem, Washington

June 1, 2005

Water & Natural Resources Group
PO Box 28755
Spokane, WA 99228
(509) 468-4876 Ph
stgod1@comcast.net
Project No. 002-002-00

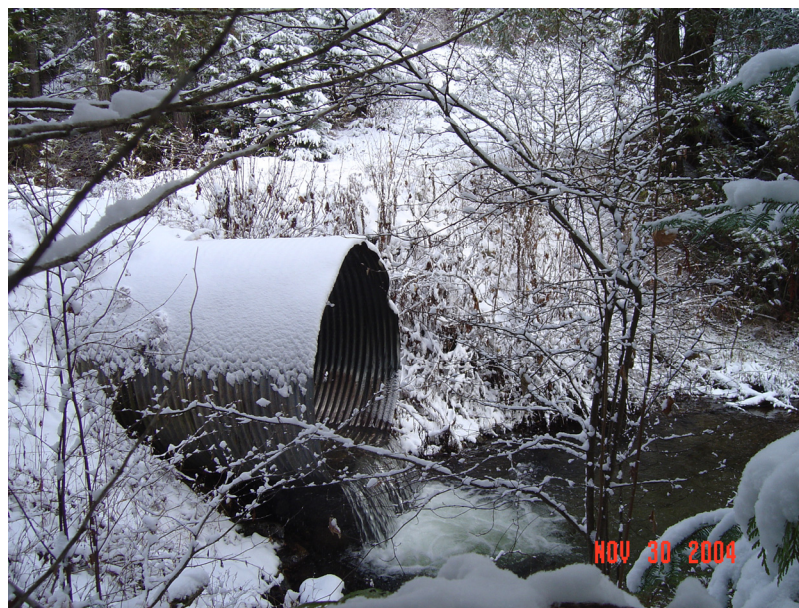
Figure 2: Fish blockage at existing culvert located approximately 1.5 miles upstream on Barnaby Creek.

A fish passage blockage, in the form of a culvert, is located within Barnaby Creek approximately 1.5 miles upstream of the confluence with the Columbia River. Figure 2 shows the elevated culvert which acts as the blockage for passage. In order to allow access for adfluvial fish to the upper portions of the watershed, the culvert needs to be removed. Access to the property across Barnaby Creek will be required by the installation of a bridge, designed under this project. Because of topography only two alternatives were feasible; bottomless culvert or bridge. Preliminary cost estimates by the CCT indicated that bridging would result in achieving the projects goals for less money. The Colville Confederated Tribe had originally proposed to install the new bridge at the current location of the culvert. However, at the request of the property owner, the new bridge location was moved approximately 200 yards down stream at the location of an existing wood bridge (figure 3). This wooden bridge will need to be removed for construction of the new concrete bridge. After inspection by the project team engineers, the enclosed recommendations for removal of the culvert and design of the bridge were proposed. Design recommendations for the Barnaby Creek Project will aid in access of the upper portions of the watershed to suitable spawning habitat for adfluvial rainbow trout.

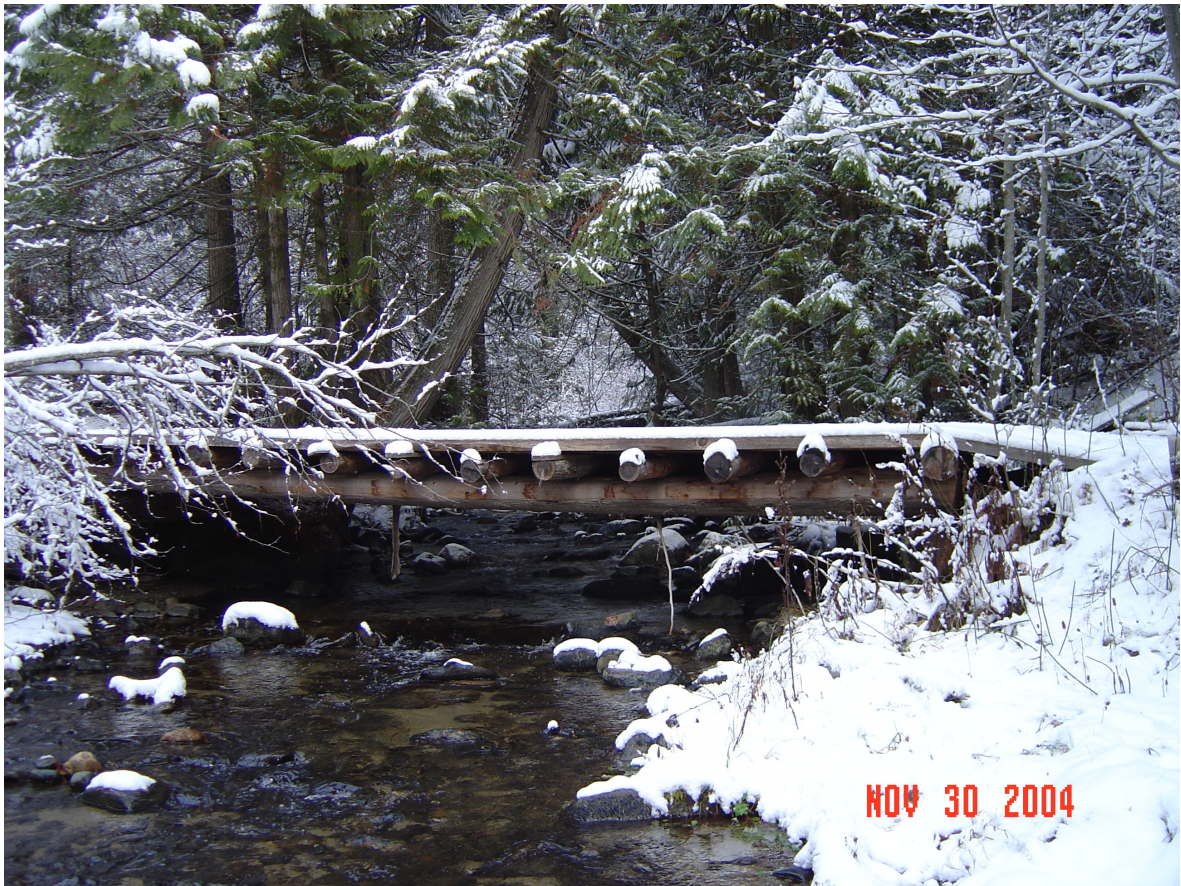
Figure 3: Existing wood bridge located at proposed bridge location. Wooden structure must be removed for installation of new bridge.

Access to the proposed bridge site is via a dirt logging road from the north valley wall. An existing wood bridge is currently located at the proposed bridge location, which was constructed from planks placed on boulder footing. The bridge deck is currently located approximately 4-feet above the stream.
