PHASE I ENVIRONMENTAL SITE ASSESSMENT

May 20, 2013

CLICK and PARKER PROPERTIES – Nason Creek

Portions of Section 3, Township 26 North, Range 16 East, W.M.
Chelan County, Washington

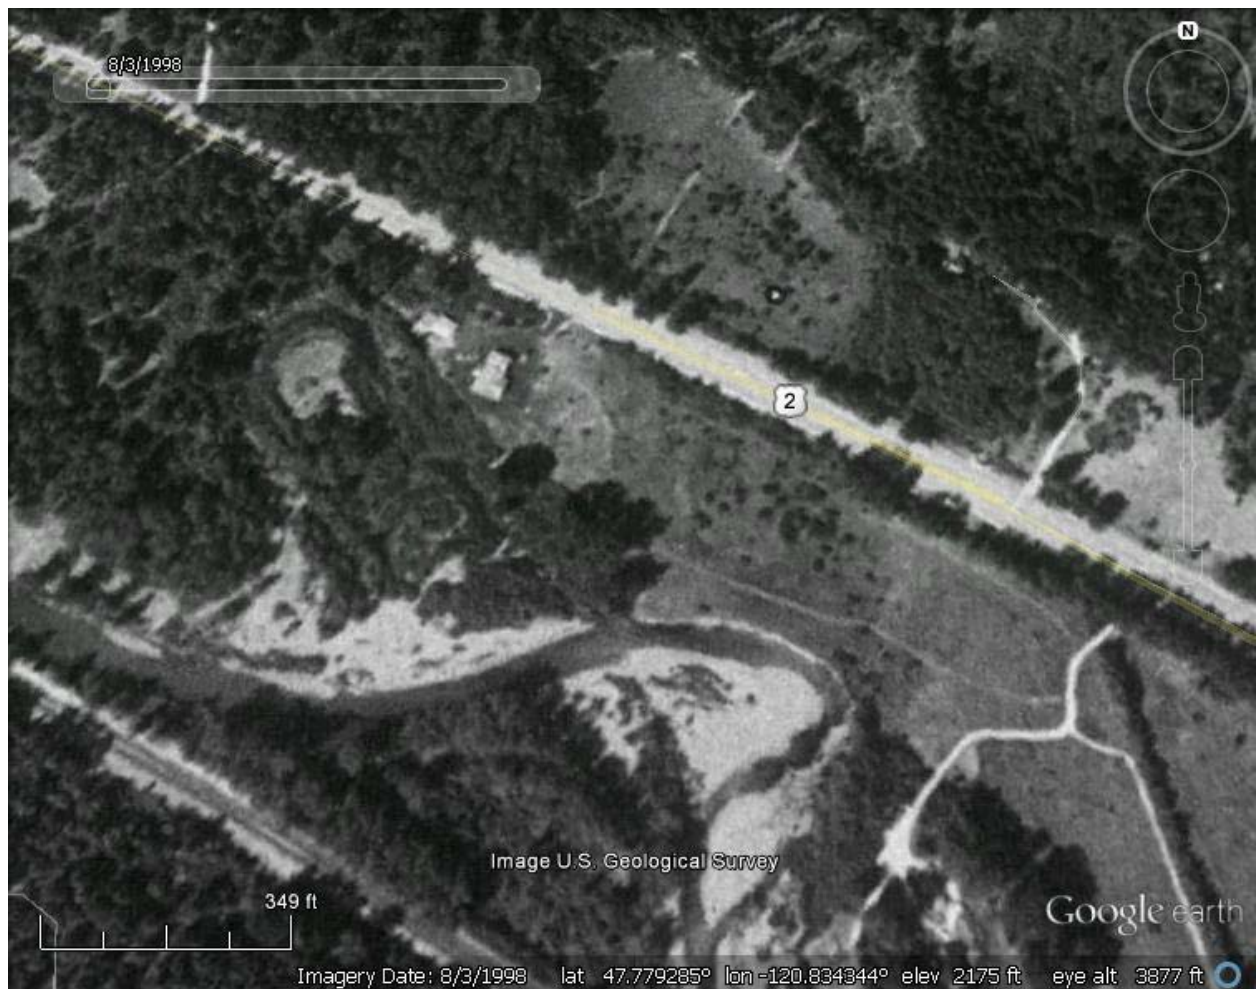
1998 Aerial Photograph (Google): This black and white aerial photograph shows Subject features similar to existing conditions. Surrounding land use included fewer homes (particularly on the north side of the Highway). The Nason Creek oxbow southwest of the house, was more defined, log deck was not present, distance between the Creek bend and Highway 2 may have been less, but the point bar appeared to be very similar to present conditions. No evidence of potential recognized environmental conditions (RECs) is observed at the scale of the photograph.

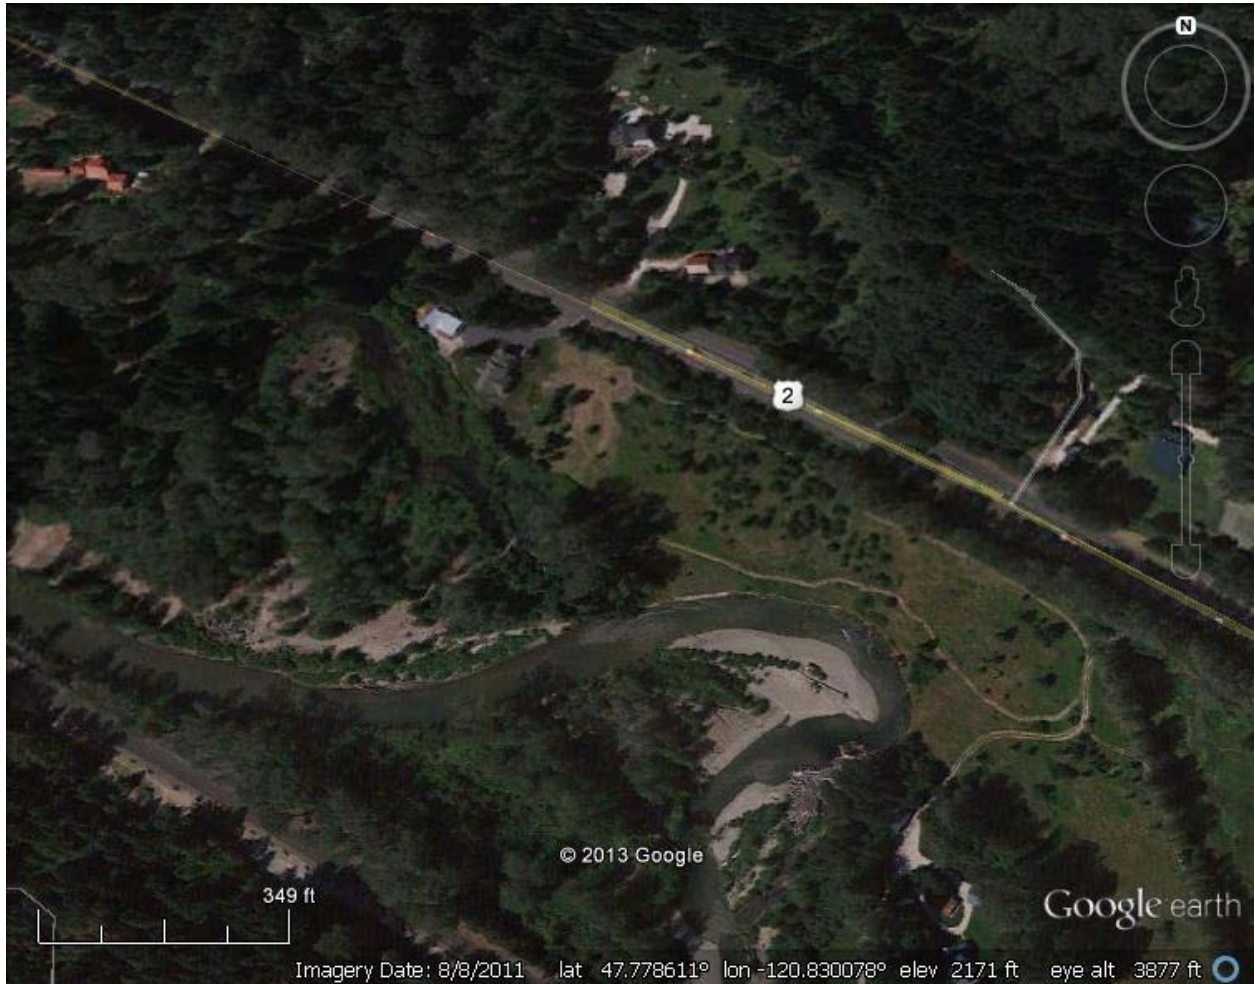
2011 Aerial Photograph (Google): This color aerial photograph shows Subject features similar to existing conditions. No log deck was present, and potentially different property access road on the east (compared to the existing conditions). No evidence of potential recognized environmental conditions (RECs) is observed at the scale of the photograph.
