DAILY OBSERVATION REPORT

PROJECT NO. 476670
PROJECT NAME Nason Creek

(1) DAY: Sunday DATE: 7/28/2013 WORK PERIOD: 9:30 ☒ a.m. ☐ p.m. TO 2:15 ☐ a.m. ☒ p.m. REPORT: 28

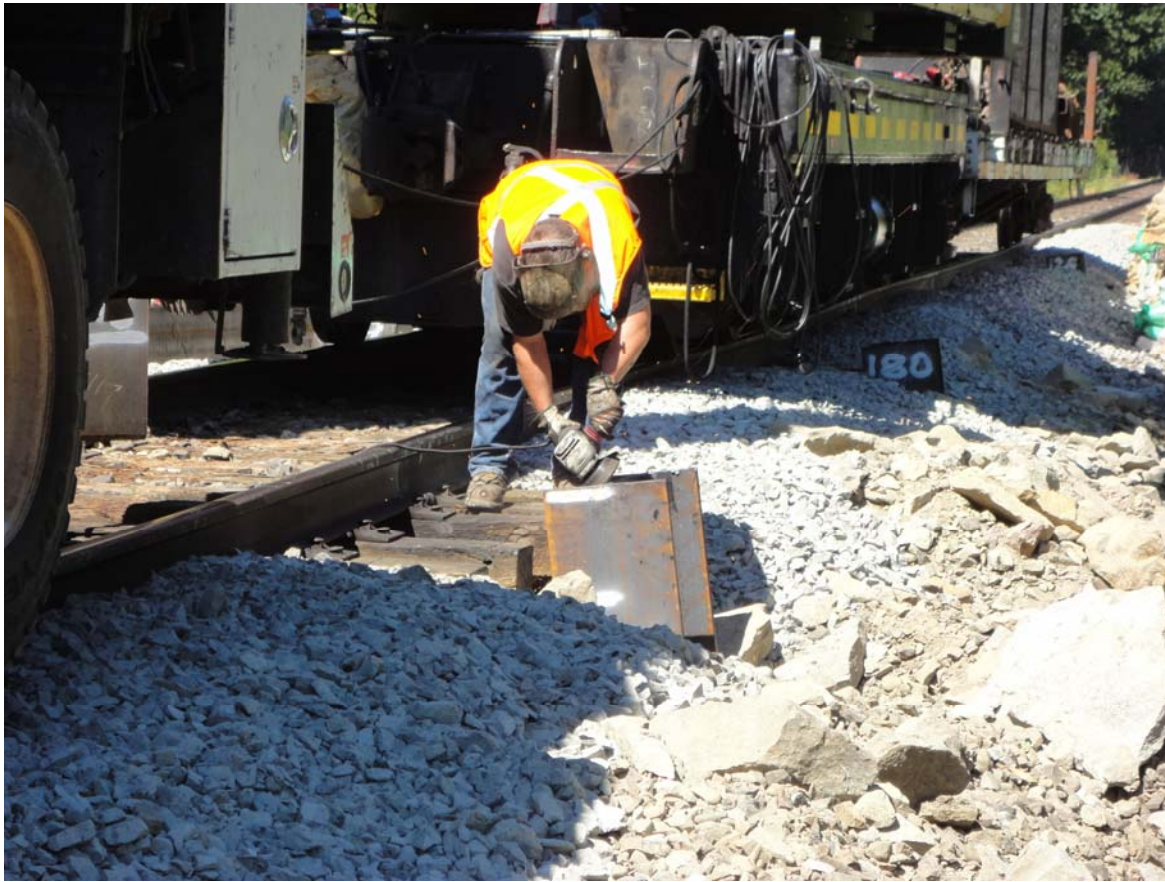
Photo 1: View of the top of Bent 1 Pile 4 being ground off in preparation for pile welding.

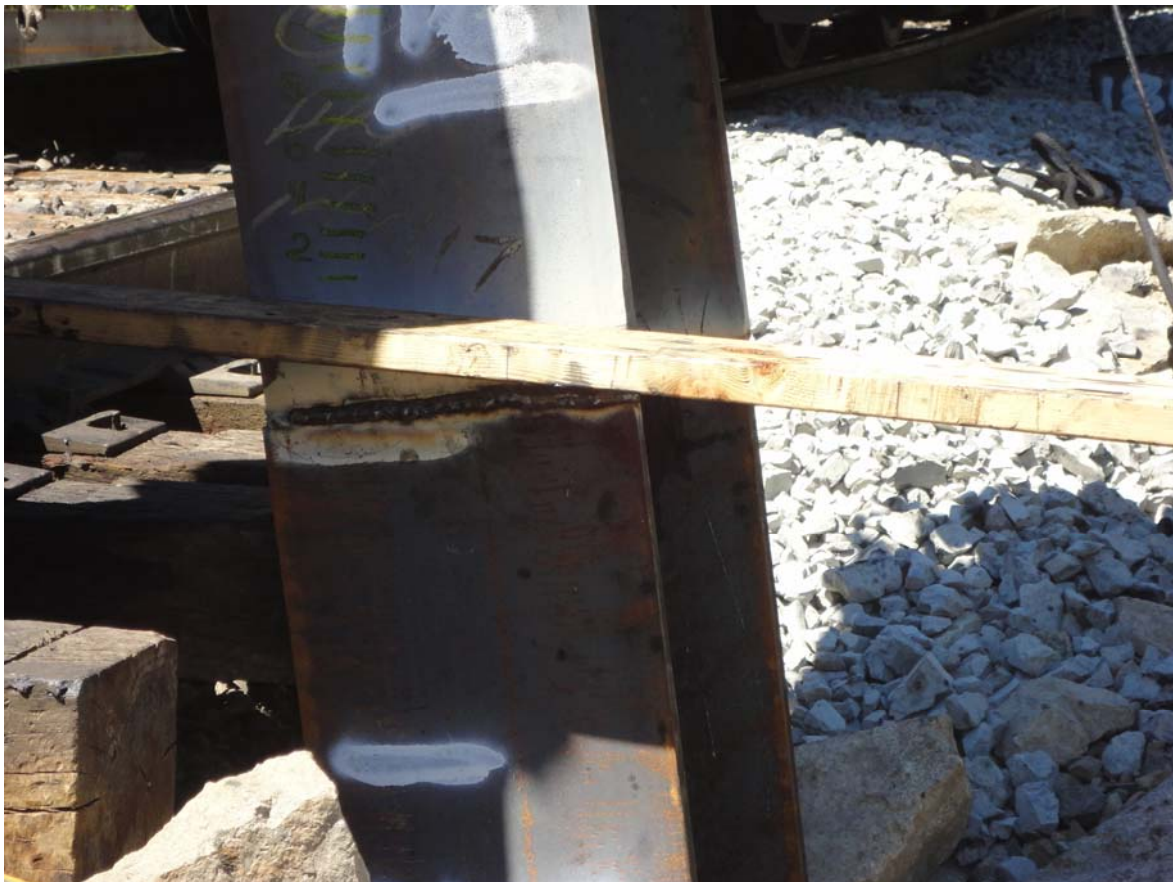
Photo 2: View of the Bent 1 Pile 4 weld at 117 feet. Yellow crayon marks used for collecting restrike data are visible on the pile.

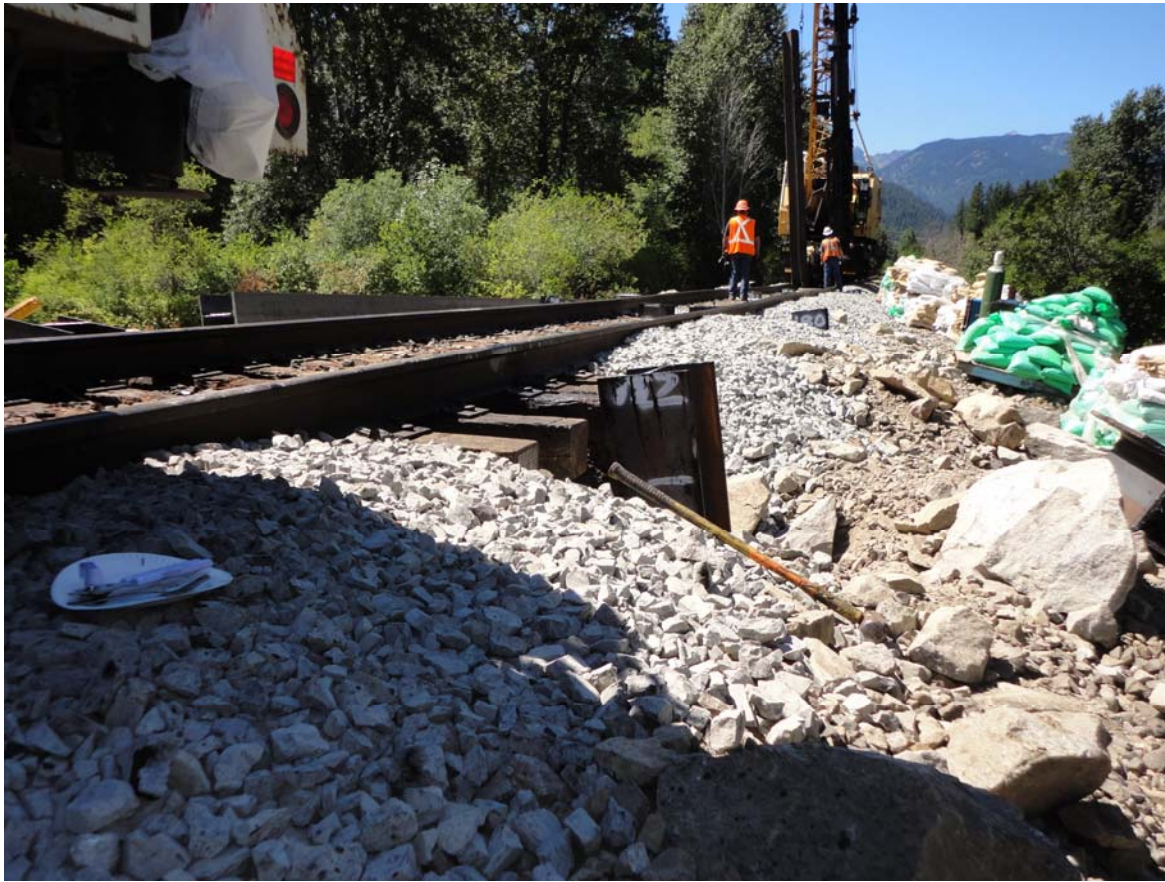
Photo 3: View of Bent 1 Pile 4 (center of photo) at the end of pile driving.

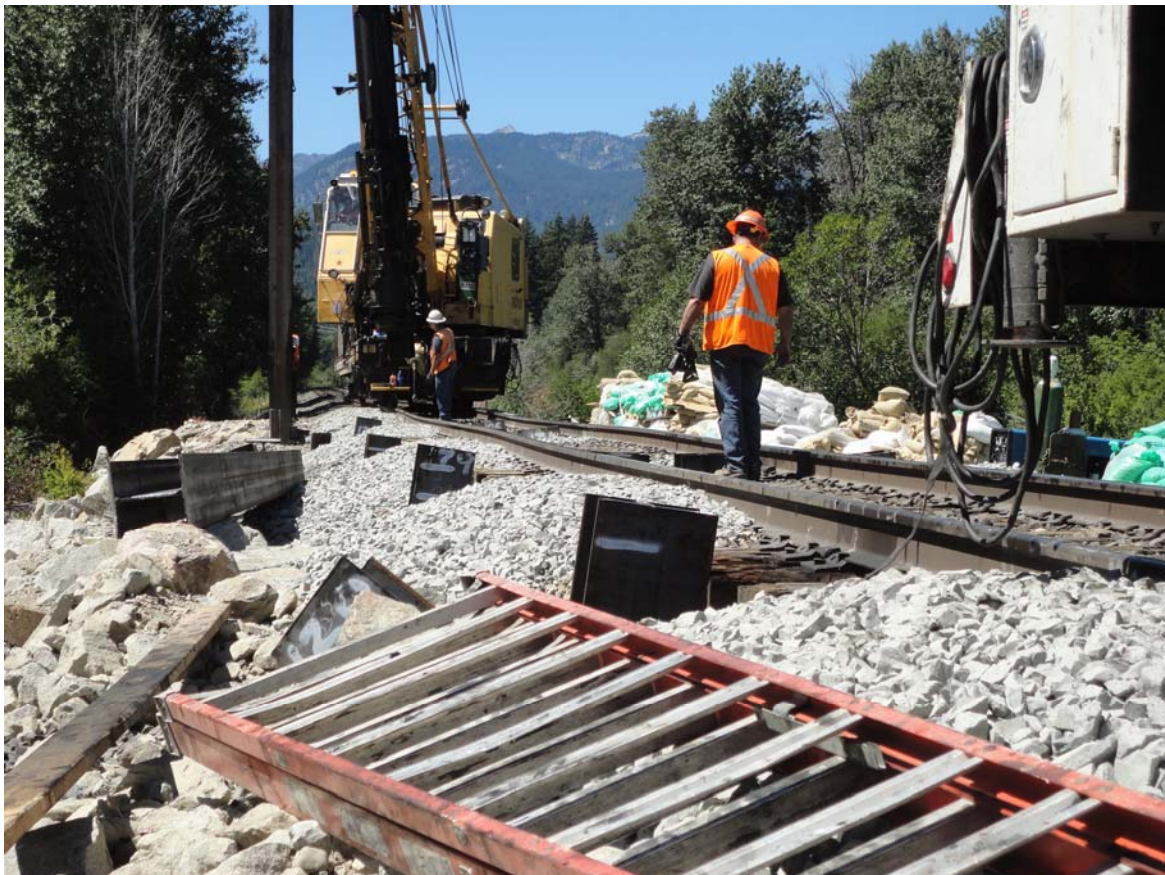
Photo 4: View of the railroad tracks. Note the deflection in the railroad tracks that has been caused by pile driving.

I met the the BNSF foreman, Brick Wall, when I arrived onsite. We waited until 11:00am for a track access window. While we waited, the BNSF crew worked to cut apart some of the unused piles into the lengths we needed to achieve the required depths. Once we received track access, the BNSF crew advanced Bent 1 Pile 4 Segment 3 to a depth of approximately 157 feet. No problems were encountered during pile driving. Alan Schmidt was onsite and collected some survey data along the railroad tracks that will be used to determine if settlement is taking place. We got off the tracks at 2:00pm.
