# ASOTIN CREEK INTENSIVELY MONITORED WATERSHED:

### **2013 PROGRESS REPORT**

**JANUARY 15, 2014**

**Stephen Bennett**

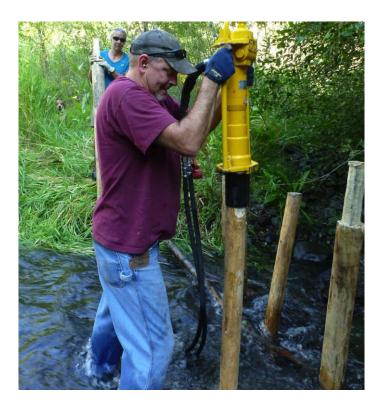
Figure 7. Example of the hydraulic post driver that is used to install large woody debris structures in Asotin Creek.

We are adding pieces of LWD that were small enough to carry by hand instead of using heavy machinery to minimize potential damage to the existing riparian vegetation. The pieces of LWD were installed at each site and usually secured in place with wooden fence posts driven into the stream bed with a hydraulic driver (Figure 7 and Figure 8). Three structure types are secured in place with posts: deflectors, mid channel, and debris jams (Figure 9). Some LWD was installed with no posts to act as seeding (allowed to move) and some very large pieces (often with rood wads) were installed using an excavator to act as "key pieces" more resistant to high flows. See Wheaton et al. (2012) to see how the treatments were designed and the specific hypotheses developed for each structure type.

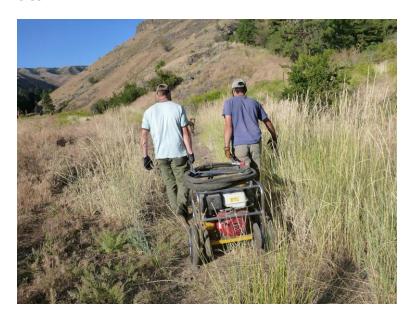
Figure 8. Example of the hydraulic power unit used to power the post driver for installing DWS in the Asotin Creek Watershed. The post driver can be manipulated by two people and has a 25 m hose connected to a gas engine power unit. The driver weighs approximately 30 kg and the power pack weighs approximately 75 kg. The power unit has large rubber wheels to improve transport over rough terrain. The power unit can also be carried by 2-4 people when the terrain is too rough for wheeling.

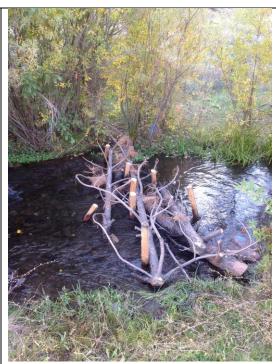
Debris jam Charley Creek

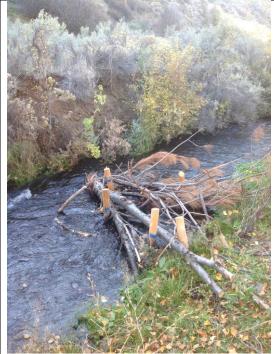
Deflector structure Charley Creek

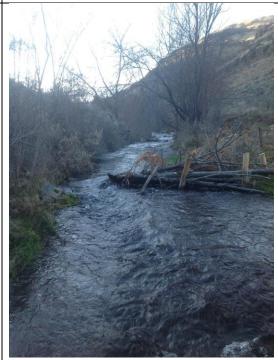
Deflector structure Charley Creek
