**RE: GEOTECHNICAL ENGINEERING SERVICES, COUNTY ROAD
IMPROVEMENT, WALDRON ISLAND, WASHINGTON**

SITE AND EXPLORATION PLAN

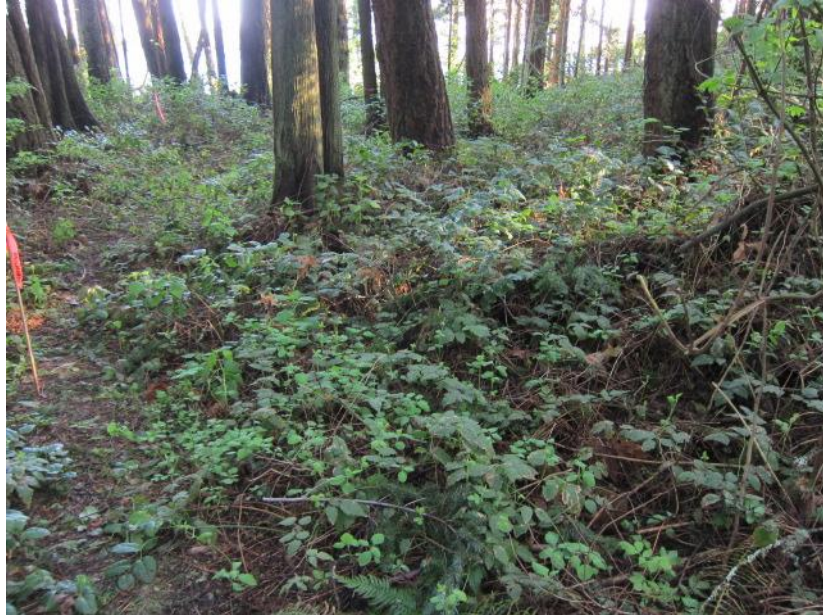
The site is forested with a moderately thick understory (see Photograph 1). We understand that the forest is second-growth and was logged in the early 1900s. From south to north along the property line, the site slopes gradually downward at an approximate 10 percent grade. At about 100 feet from the OHWM, the slope changes to about 1.5 Horizontal to 1 Vertical (1.5H:1V) or 67 percent grade, starting at elevation 30 feet and going down to elevation 10 feet. The 75-foot-wide area from the toe of the slope to the OHWM is mostly flat (see Photograph 2). The spring is located within a horseshoe-shaped notch into the bank.

Photograph 1. The site is forested with a moderately thick understory, taken looking north

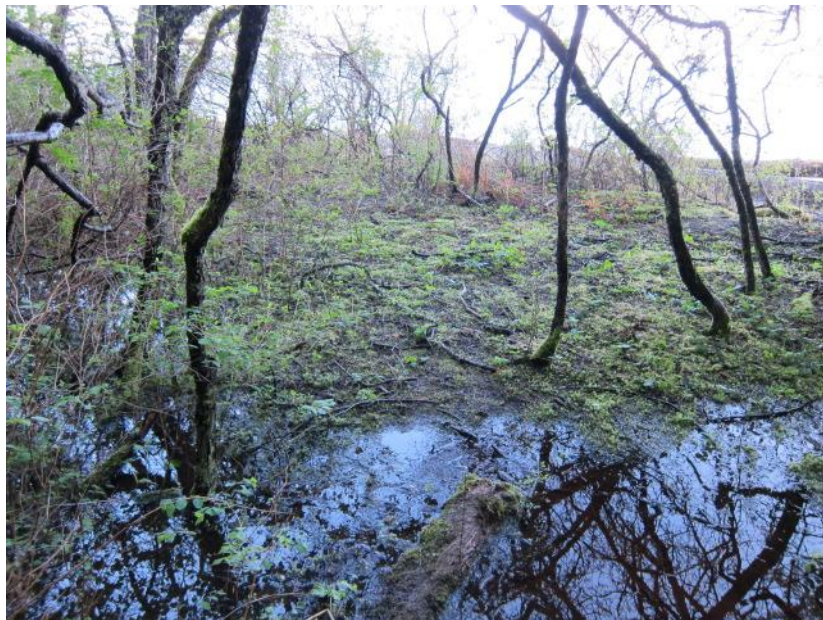
Photograph 2. Flat area north of the spring

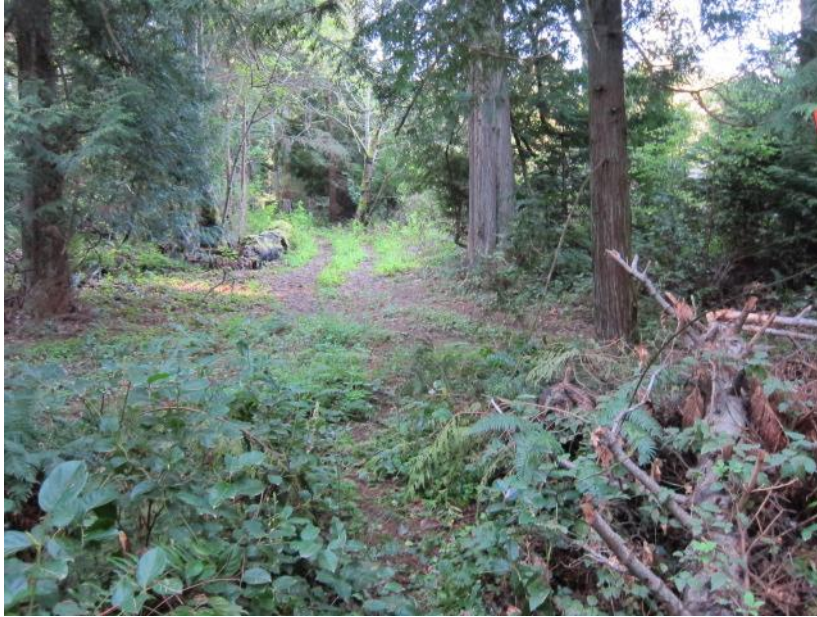
As shown in the site plan (Figure 2), an unimproved, two-track road approaches the site from the south. South of the site the road turns to the west (Photograph 3). At the turn in the road, a private footpath leads north paralleling the property line (Photograph 4) for approximately 450 feet. As the path approaches the grade change, it turns to the east slightly and stays above the spring area. The path then splits, and one trail heads east and the other, less traveled, heads northwest down to the spring area and beach. As shown in Figure 2, an old barbed wire fence runs parallel to and approximately 30 feet east of the property line. The fence is in disrepair and covered with vegetation. About 270 feet south of the OHWM on the property line, we observed an area where rocks were piled. The pile is approximately 4 feet wide and consists of approximately 20 large cobble- and boulder-size rocks (Photograph 5).

Photograph 3. Unimproved, two-track road approaches the site from the south then turns to the west

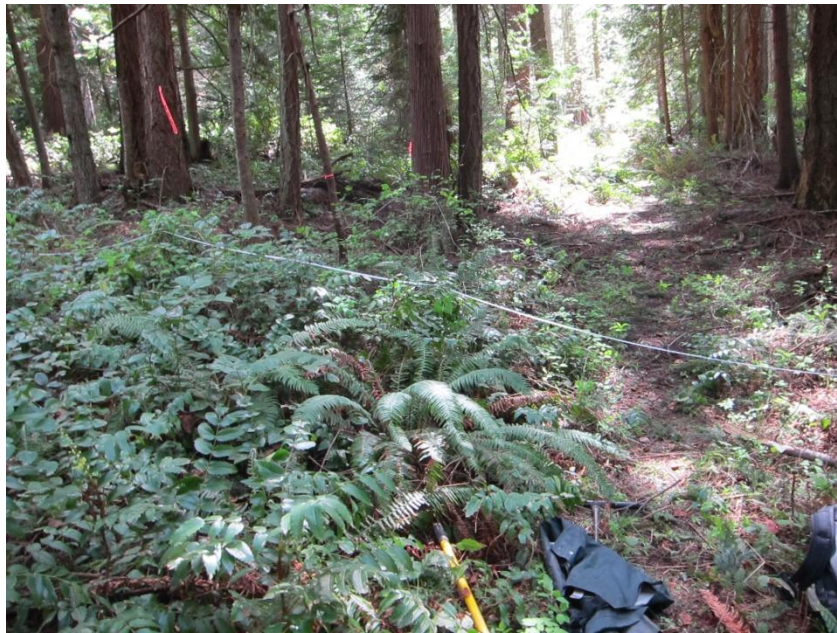
Photograph 4. Footpath near Section B-B', orange flagging marks property line

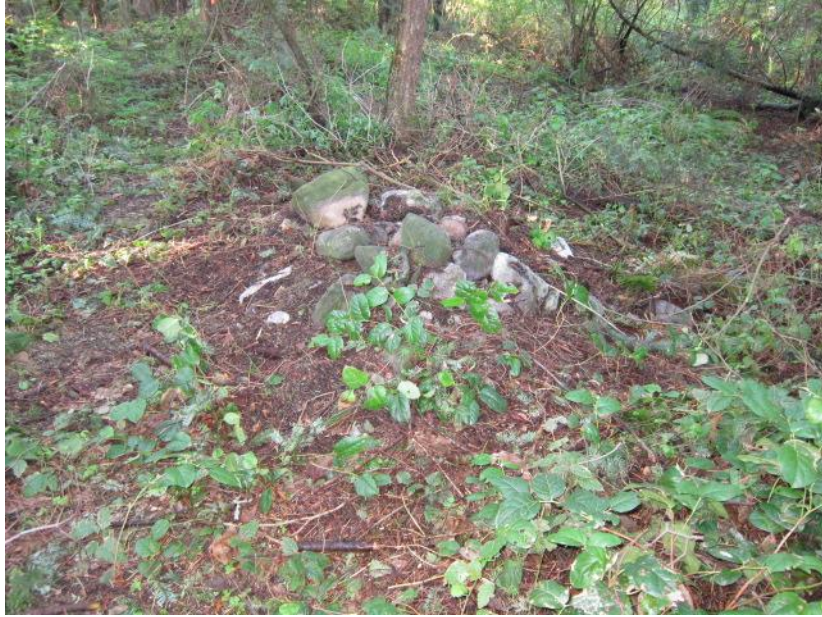
Photograph 5. Pile of rocks

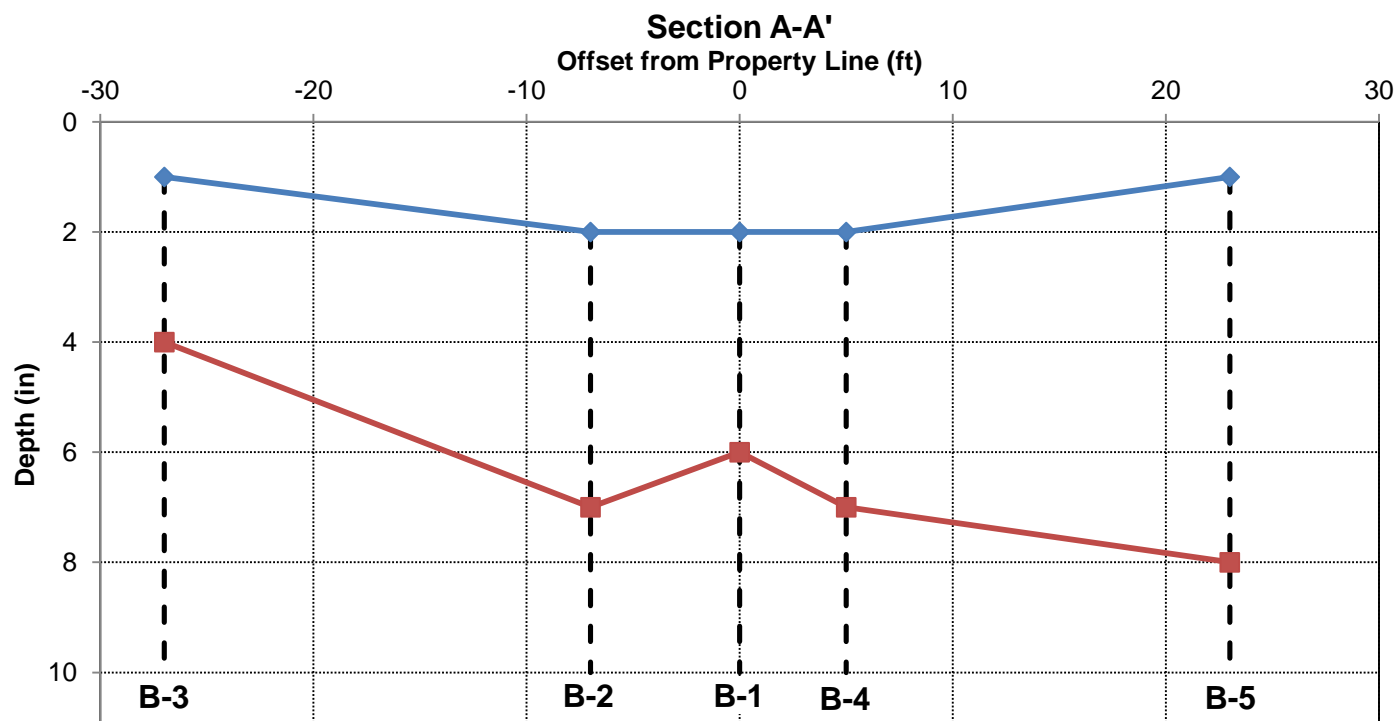
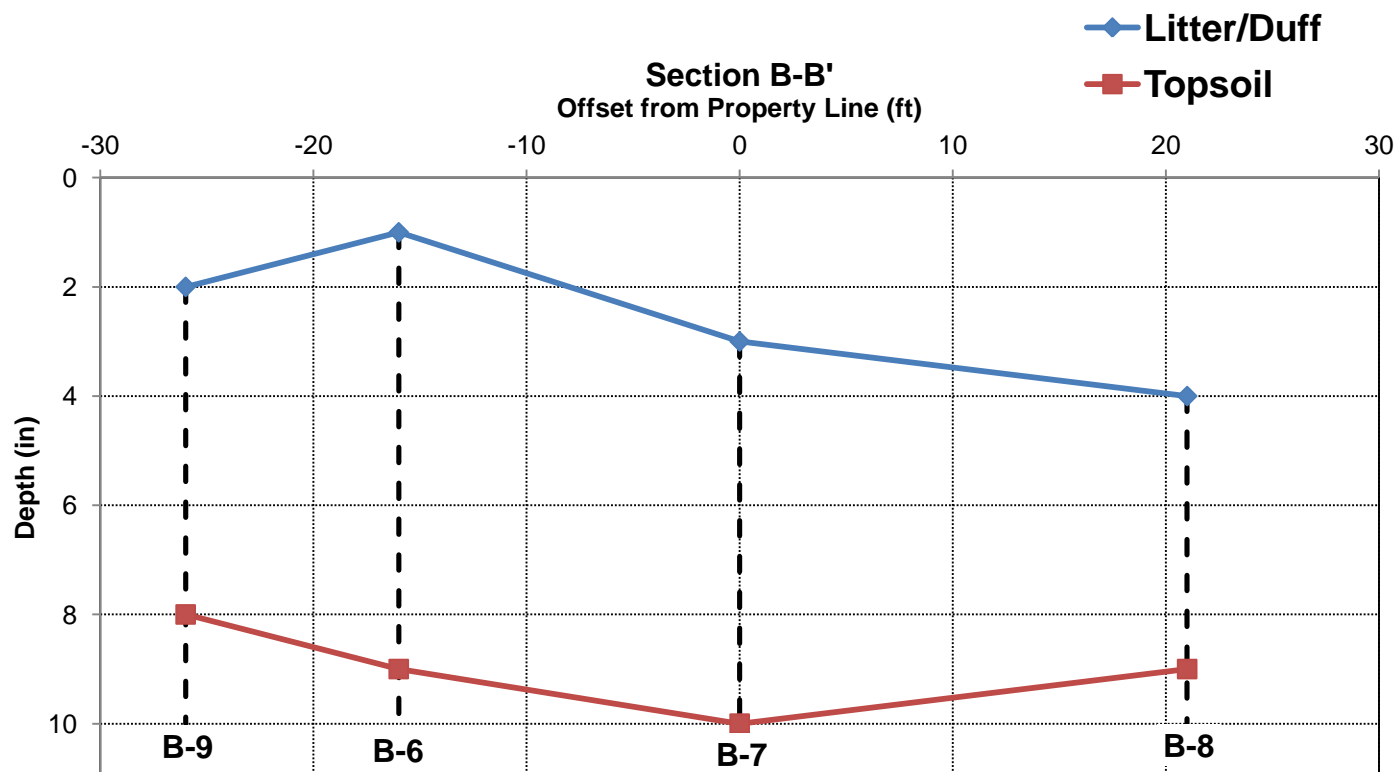
FIG. 3

Thickness of duff and topsoil at each boring are summarized in Figure 3. The thickness of the duff varies from 1 to 5 inches and the depth to the bottom of topsoil varies from 4 to 10 inches.

Results of explorations revealed a consistent topsoil layer ranging in depth from 4 to 10 inches, more typically 8 inches along the sections across the property line. Based on the observed consistent topsoil layer thickness, it is our opinion that it is unlikely a road was constructed along the Burns property line in the past. There is no evidence of densified soils or imported granular base materials.

TOPSOIL DEPTH
