## Gold Creek Habitat Assessment & Conceptual Design

Gold Creek Habitat Assessment and Conceptual Design  
Current Bank Condition Map

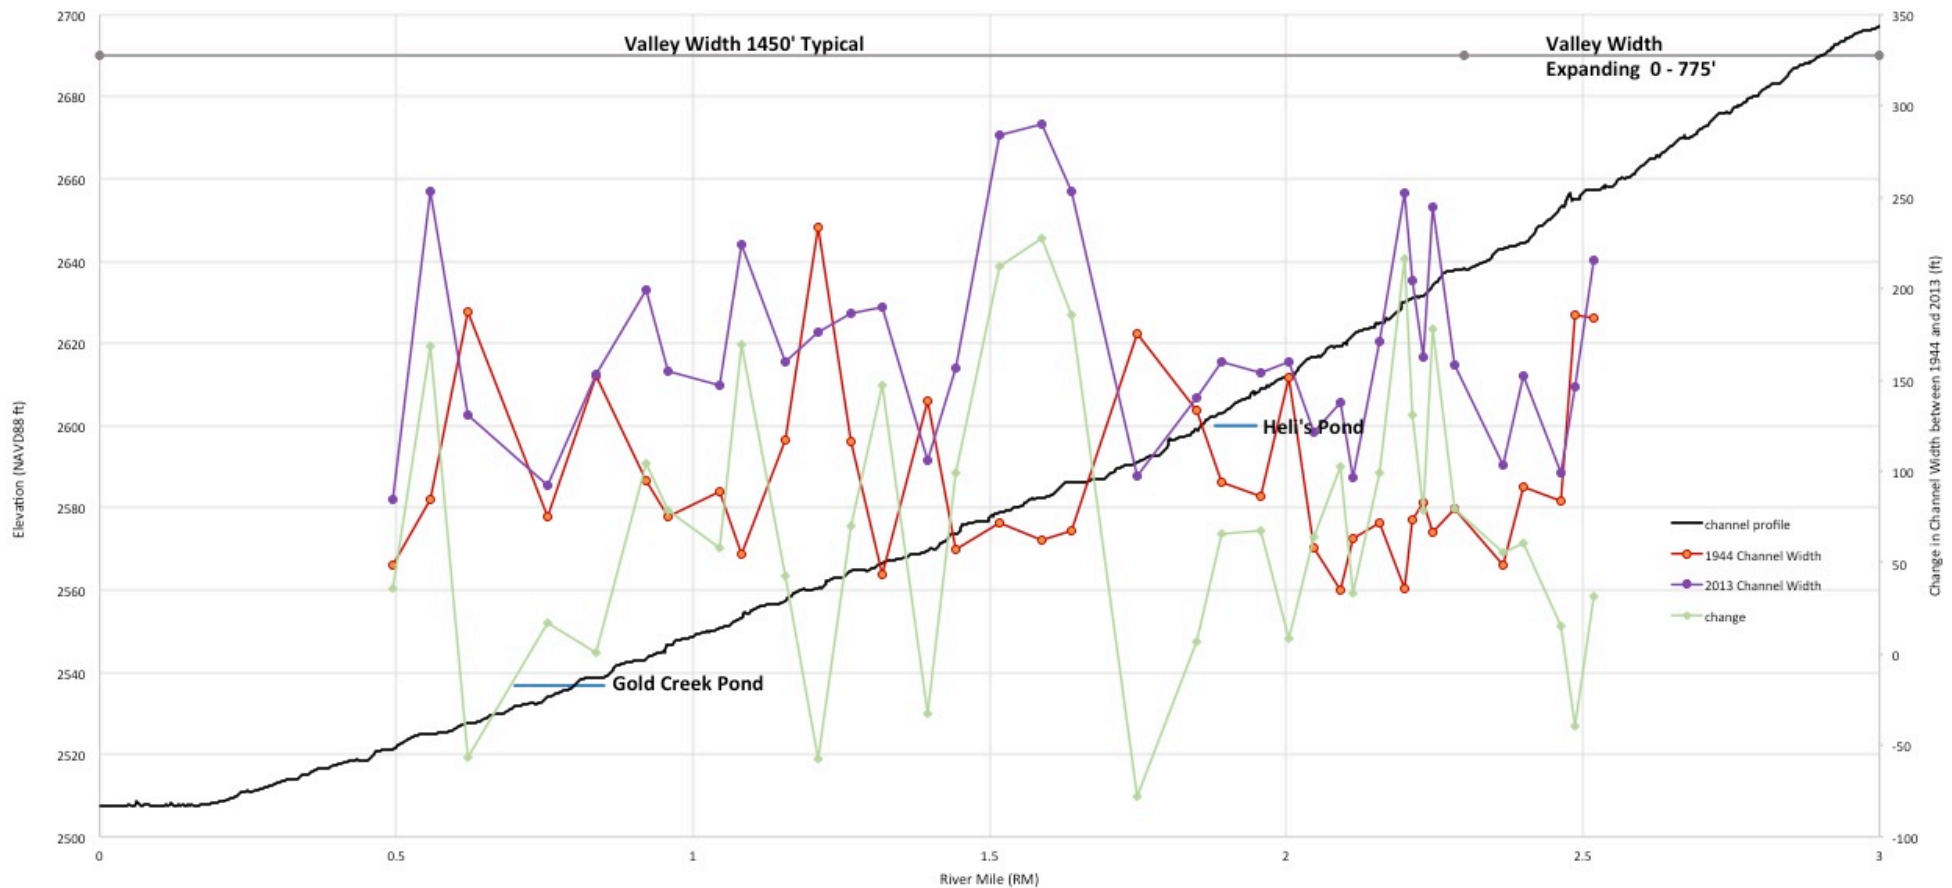
FIGURE 13 – Change in Channel Width From 1944 to 2013

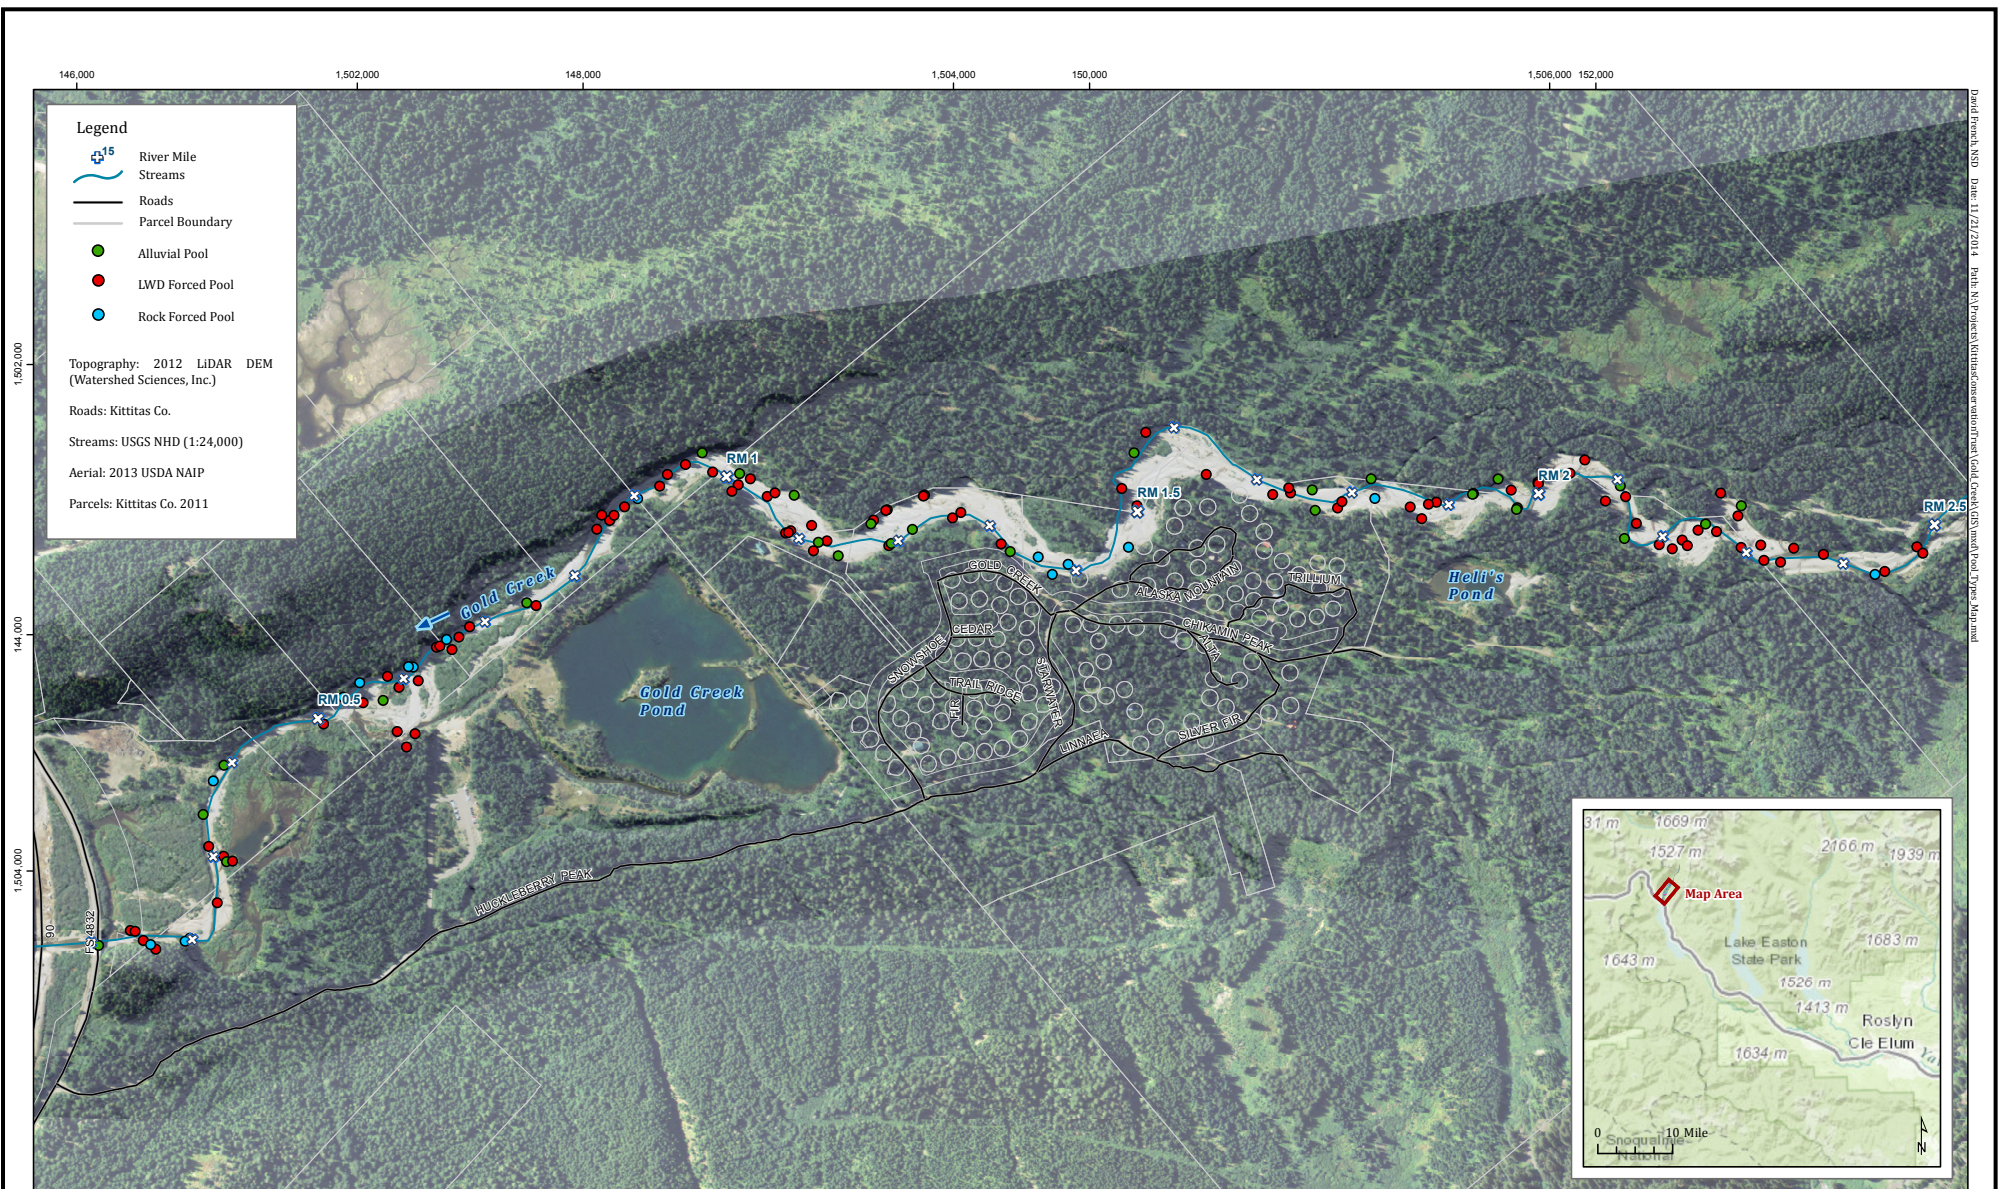
FIGURE 14 – Pool Locations and Types

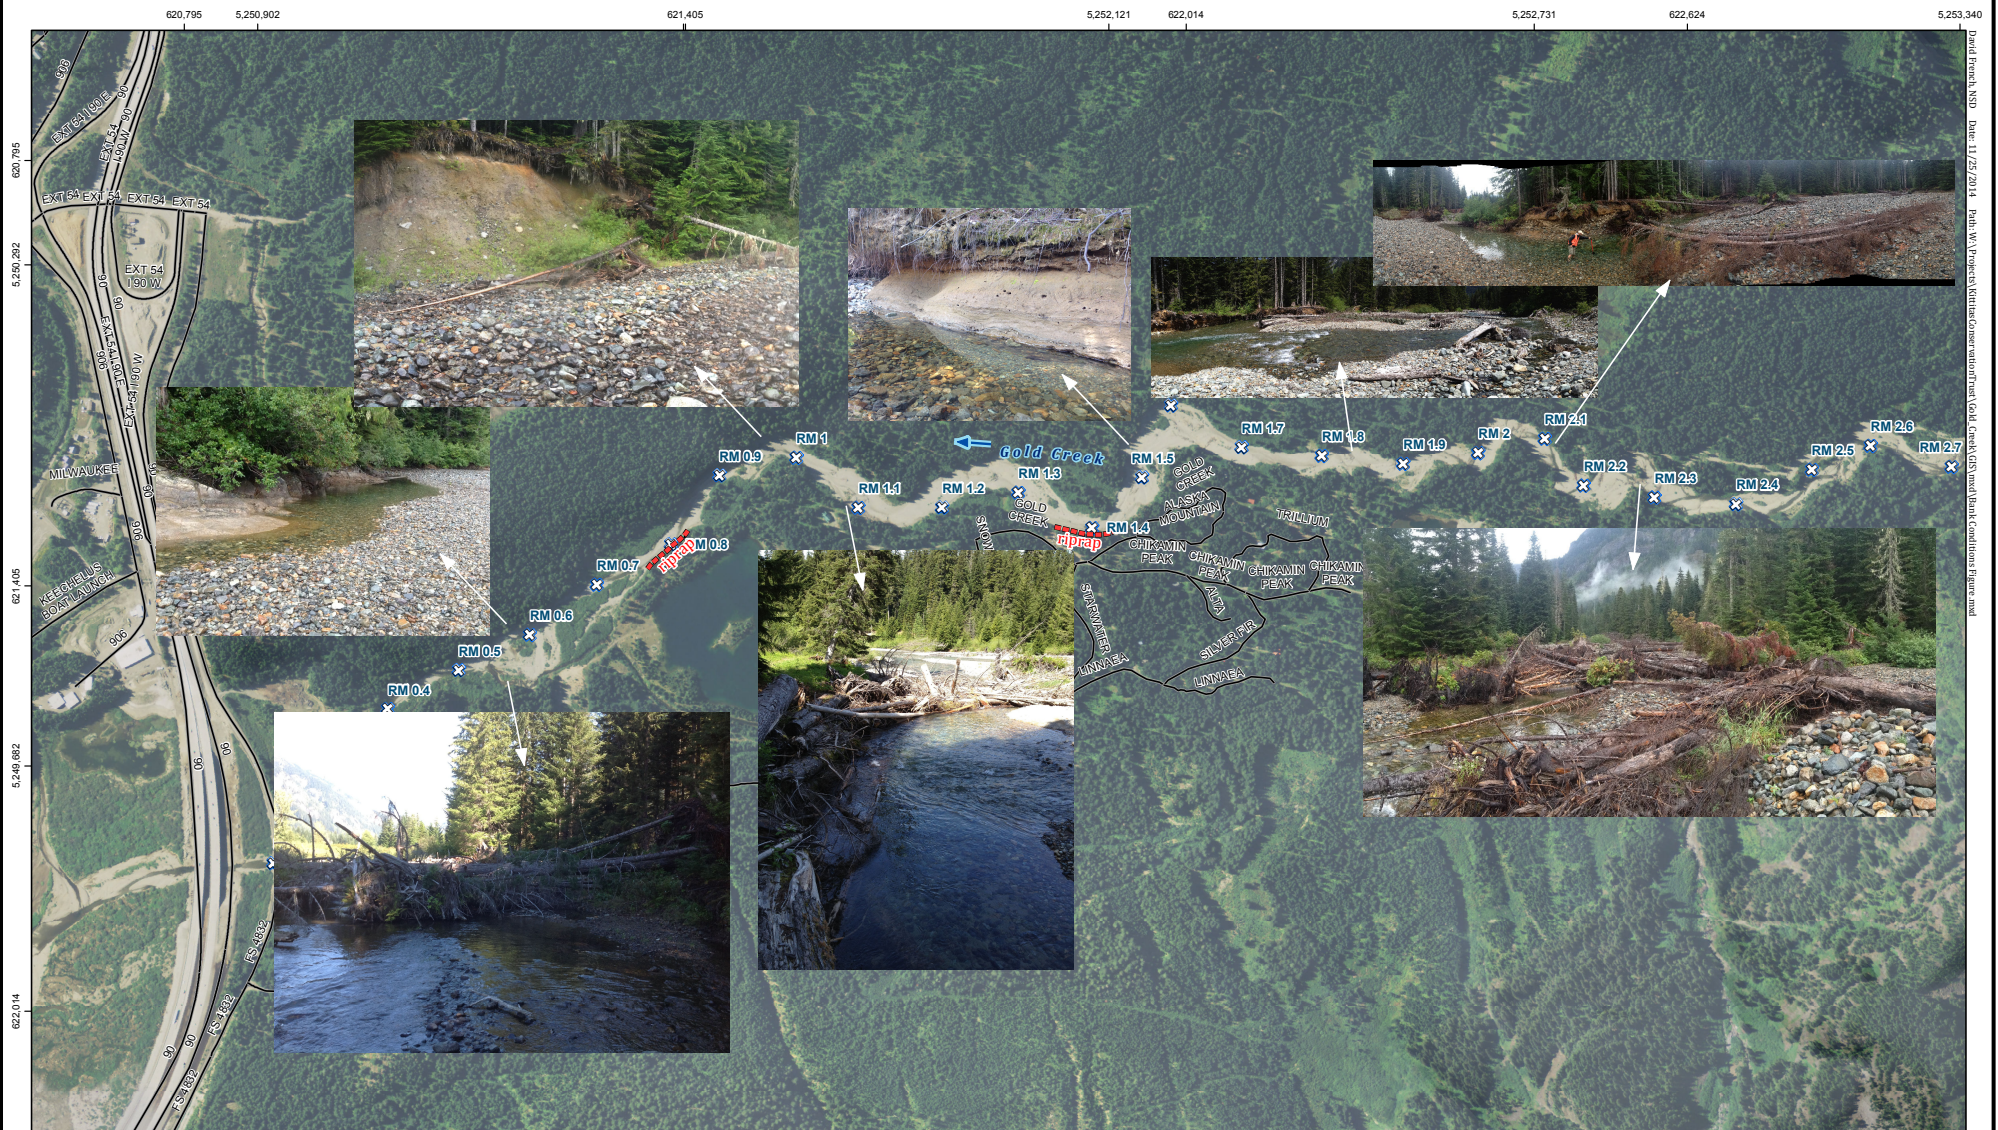
FIGURE 15 – Current Bank Condition
