**Gold Creek  
Monitoring Network Locations**

**Northeast of Snoqualmie Pass  
Kittitas County, Washington**

## Gold Creek Concept Design

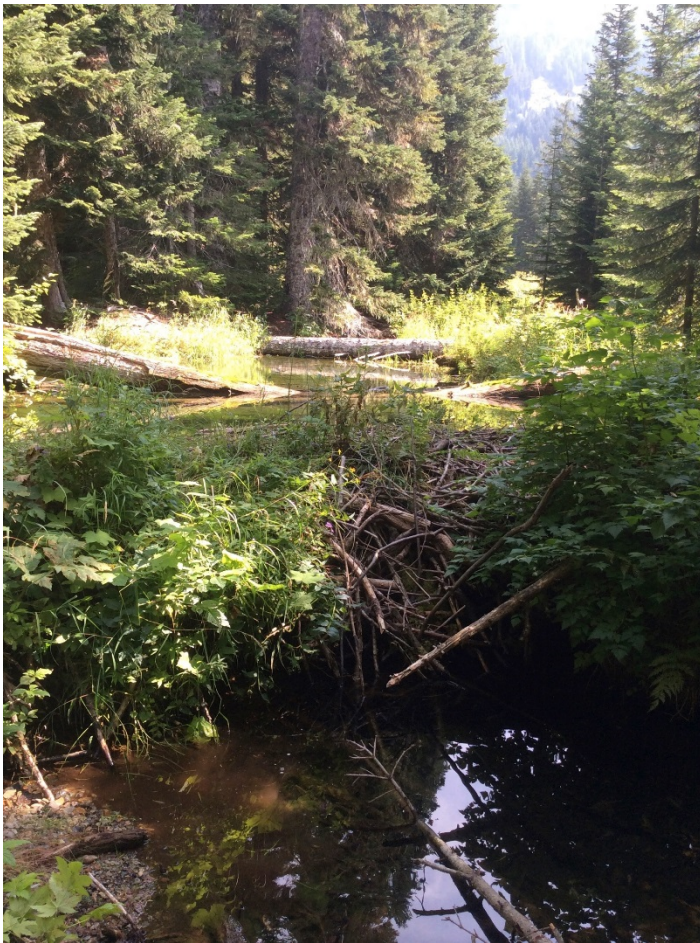
Off-channel wetland complex on western floodplain near RM 1.1.  
Beaver dam creating 2-ft difference in water elevation in foreground

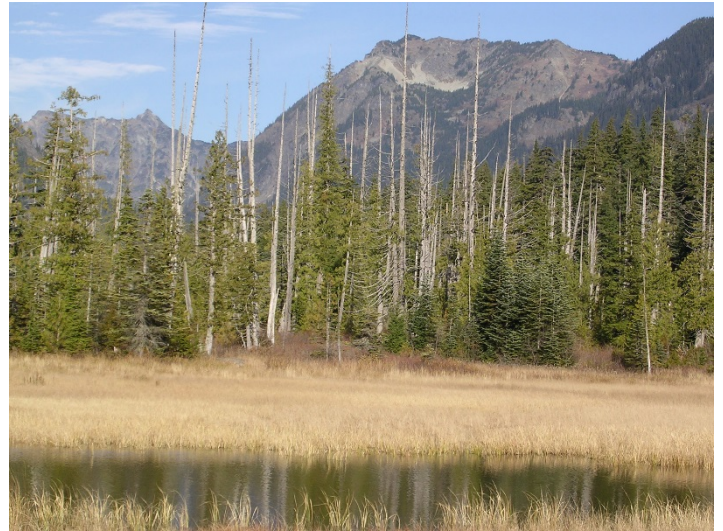
Mardee Lake open water wetland with emergent wetland edge.  
West of Gold Creek Valley approx. 0.3 miles.

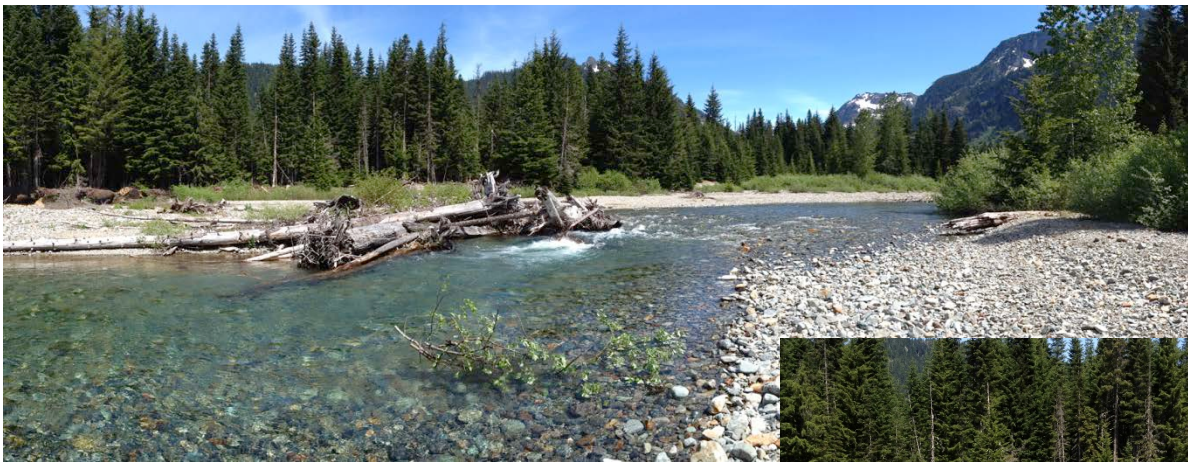
Example of existing natural wood accumulation in Gold Creek near RM 1.25 creating deep pool with cover. Logjam is 40-ft wide X 40-ft long and is creating a stable hardpoint in the channel that has persisted for 6-9 years.

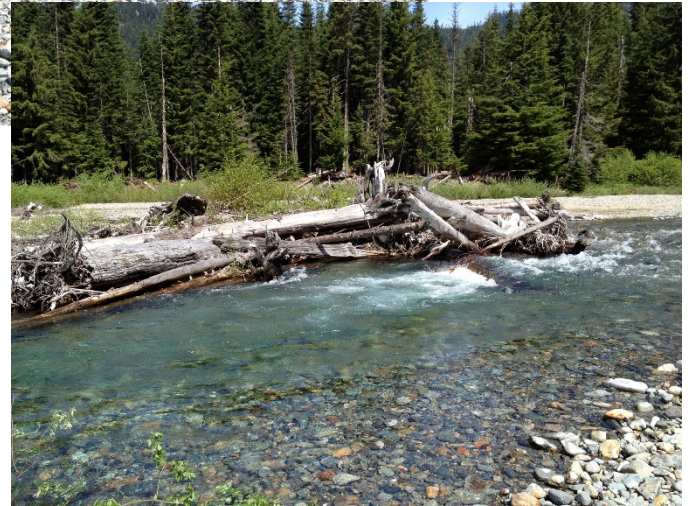
FIGURE 8 – Gold Creek Restoration Reference Photos

View of current channel near RM 2.25 where channel has eroded adjacent channel banks and recruited multiple large trees. This site serves as a reference condition location for the proposed roughened floodplain structure. Tree placement is a varied, forming a complex arrangement on unvegetated gravel bars where proposed. Vertical and/or inclined posts, combined with partial to complete backfilling, will be used to stabilize the structure.
