**Asotin Creek Intensively Monitored Watershed:
Summary of Monitoring October 31, 2015
Final Progress Report: 14-2229
Stephen Bennett, Eco Logical Research Inc., Providence, Utah**

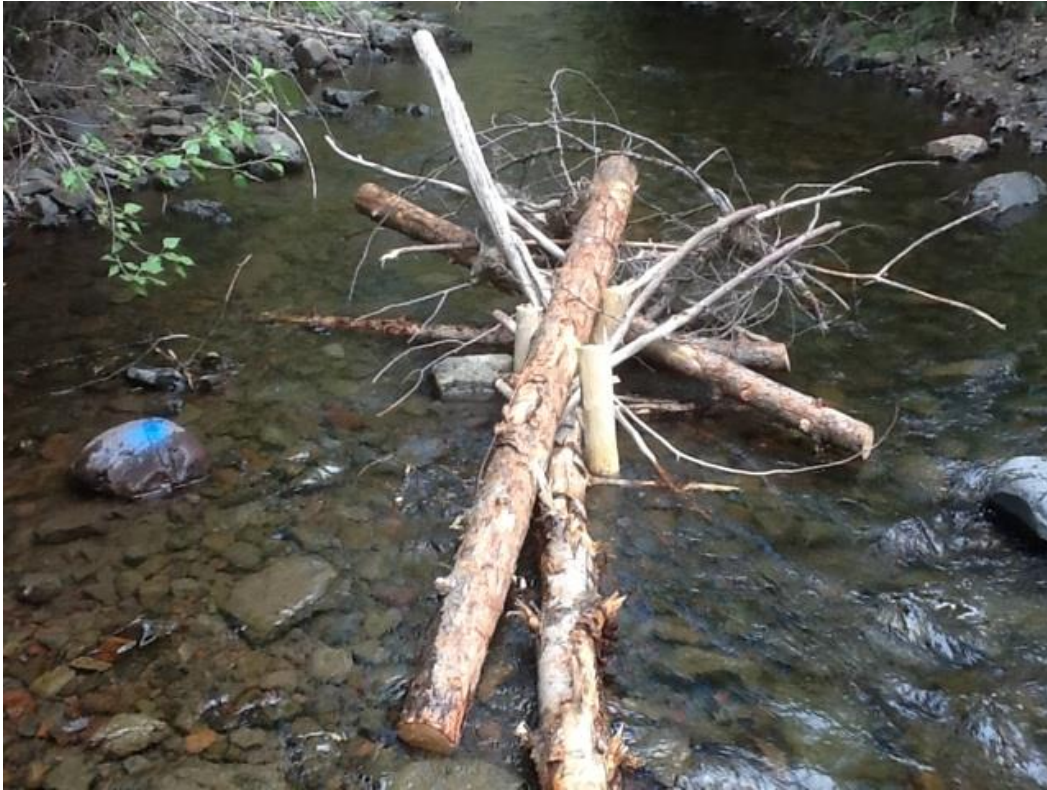
a) South Fork Asotin Creek, Mid-channel structure

Figure 3. Examples of the restoration treatment using post-assisted log structures (PALS) installed in a) South Fork (197 structures in 2012), b) Charley Creek (208 structures in 2013), and c) North Fork (135 structures in 2014) to simulate natural large woody debris loading.

- We began our annual effectiveness monitoring of large woody debris (LWD) structures using customized iPad applications (~ 550 large woody debris structures total). All three existing 4 km long treatment areas were visited and each structure was assessed for its effect on hydraulic and geomorphic conditions (Figure 3 and 4).

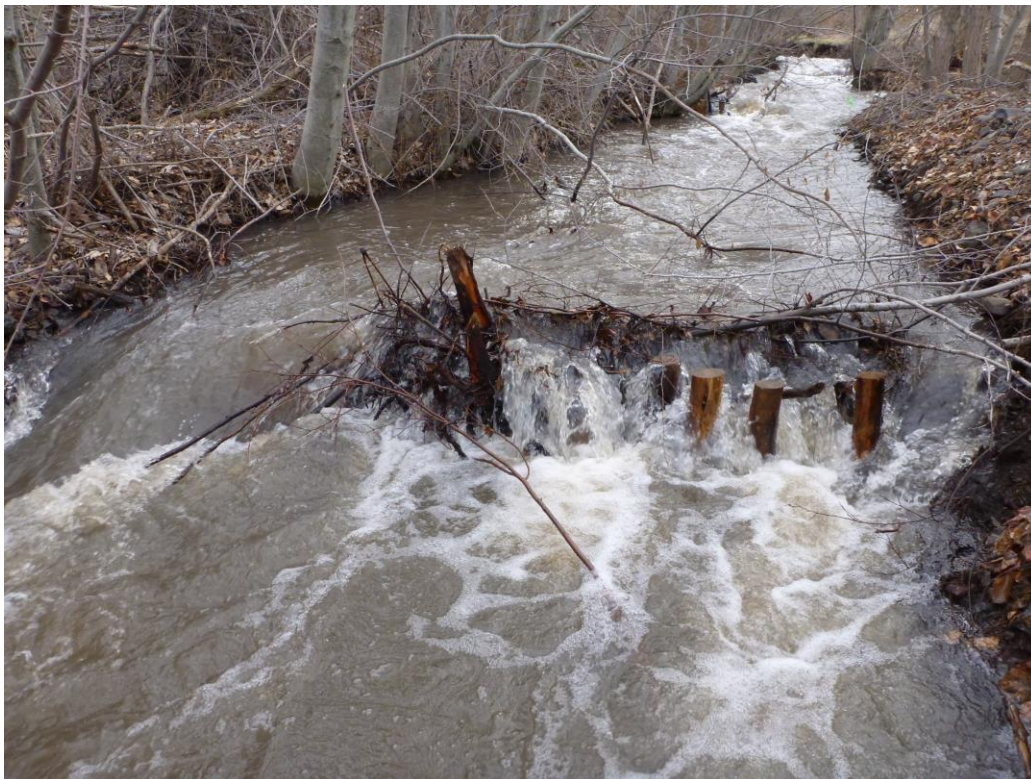
b) Charley Creek, deflector.

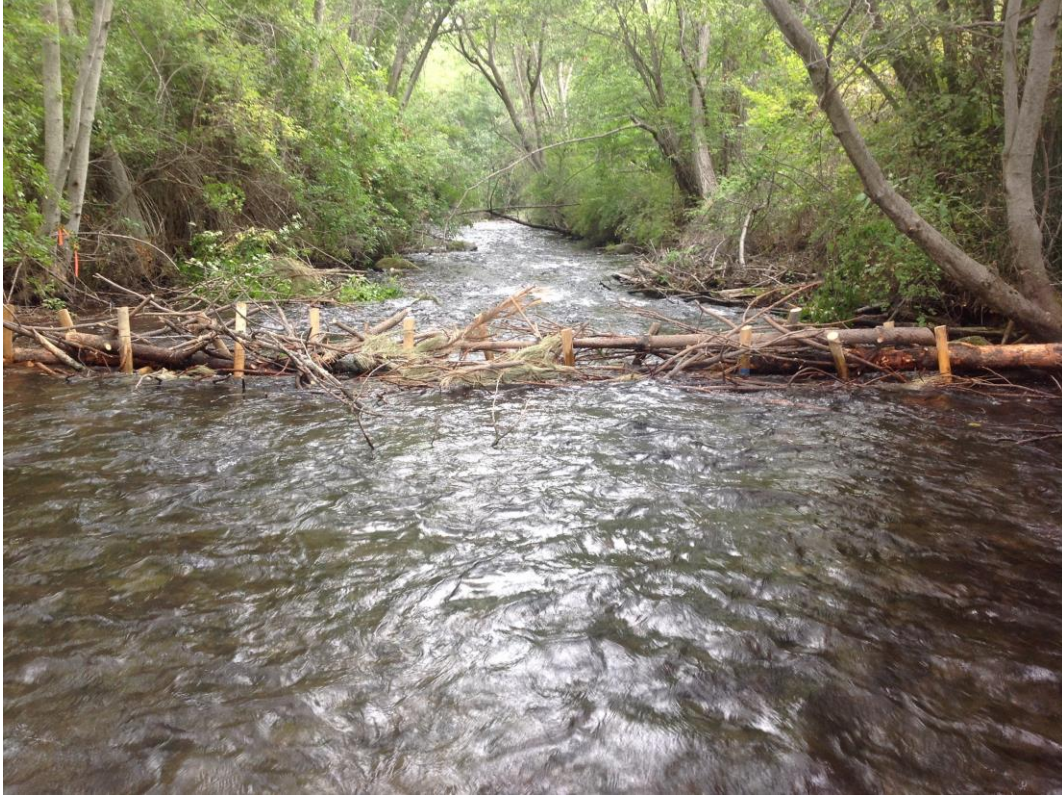
c) North Fork Asotin Creek, Debris jam.

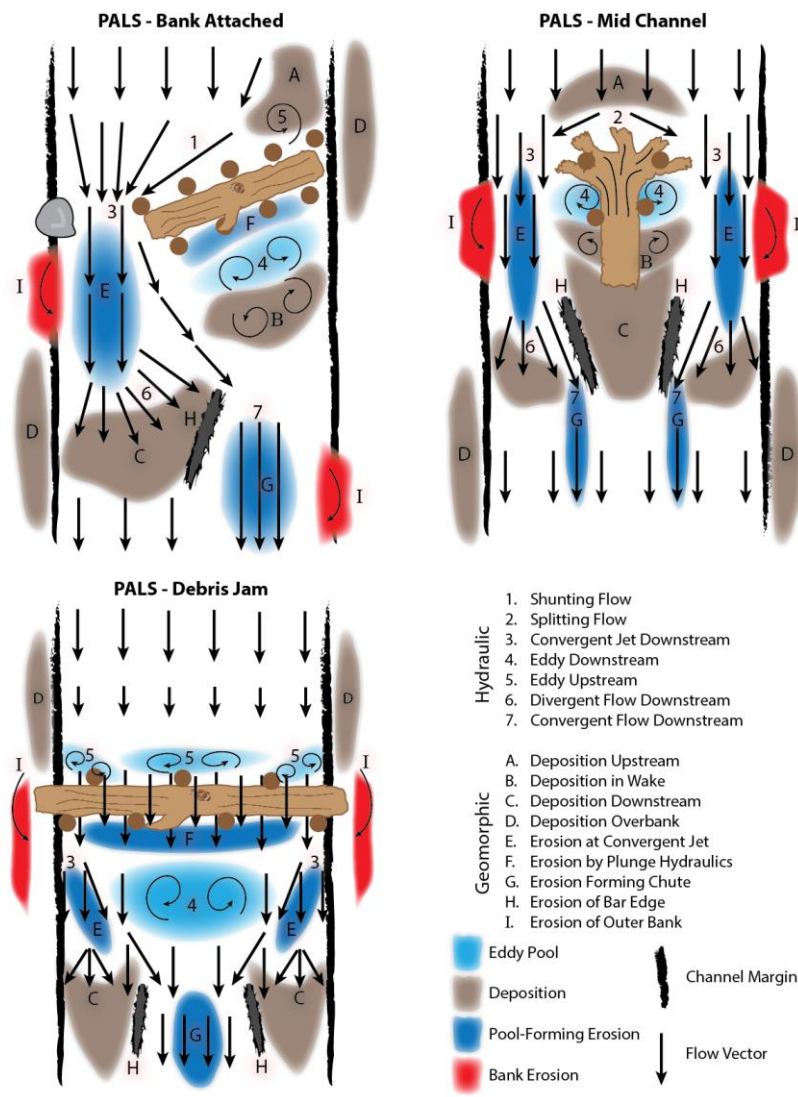
Figure 4. Design hypotheses for the three main post-assisted log structures built in the Asotin IMW.
