To: Chelan County Natural Resource Department

From: Shawn Higgins, Mike (Rocky) Hrachovec, John Soden, Tim Abbe, and Kelvin Andrews, Natural Systems Design

Date: October 26, 2015

Re: Baseline Reach Characteristics: Peshastin Creek at RM 8.8 Project Site

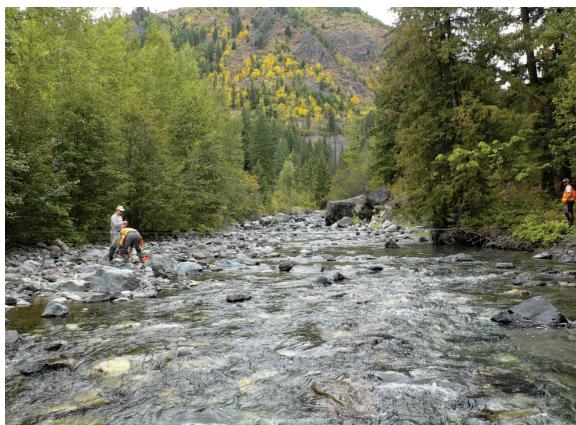
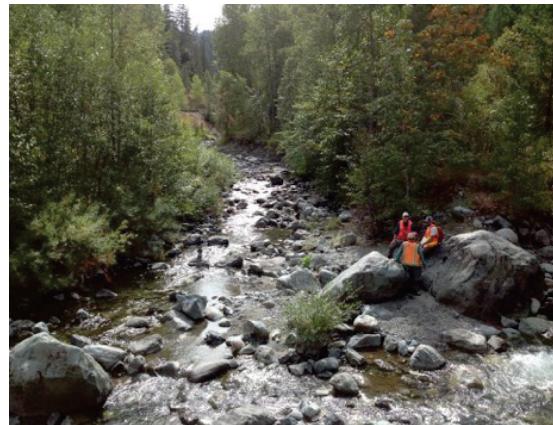
Photo 1 Forested Riparian Edge, Peshastin Creek (NSD, 9/2015)

Within the project area, trees line almost the entire riparian edge of the existing creek channel. However, in many places, this riparian buffer is just one or two trees deep, with large areas of cleared open space behind. In the areas with continuous tree cover, from river edge to road, the forest composition is dominated by young cottonwood trees and saplings. There are some mature and sapling Pondersa pine, Douglas fir, big leaf maple, and western red cedar scattered along the riparian edge and into the adjacent floodplain. Willow, red-osier dogwood, and mountain alder represent the shrub layer in the understory, mostly along the riparian edge.

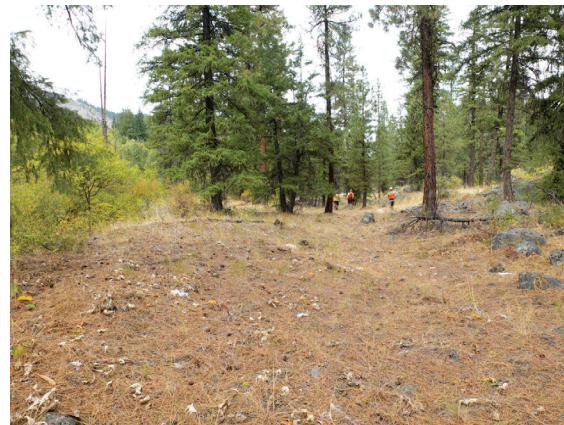
Photo 2. Upland clearings, (NSD, 9/2015)

NSD staff conducted field work to assess existing habitat conditions on September 15, 2015. During this site visit, four main vegetation areas were identified: a) forested riparian edge and floodplain, b) wetland, c) forested upland and clearings, d) un-vegetated, heavily-utilized gravel borrow-pit and storage-pile areas. In

general, a scarcity of large trees was observed in the forested riparian and floodplain areas. The wetland areas were all ponded with mature wetland species present. Lastly, the un-vegetated gravel-pit and storage areas will require significant restoration design work in order to re-engage them as a part of the restored Peshastin Creek habitat. Detailed existing conditions and design considerations are described below.

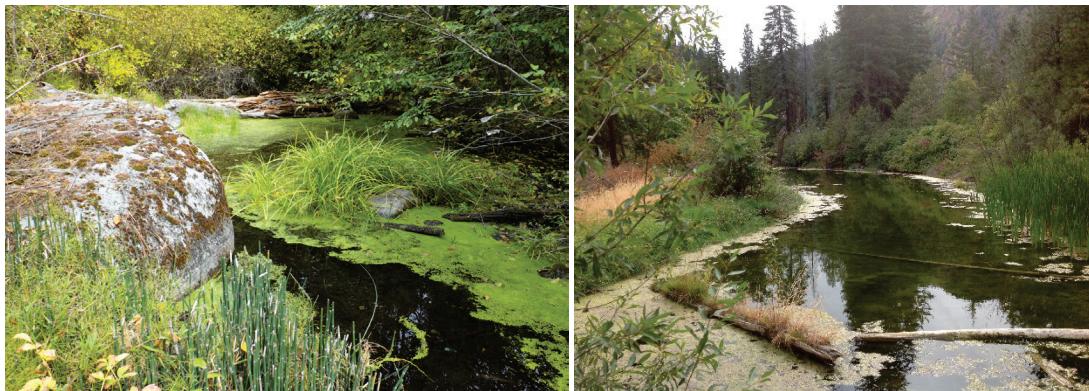
Photo 3. Wetland within historical channel alignment (NSD, 9/2015)

Wetlands onsite are limited to the historical channel alignment. No wetlands were identified within floodplain areas. Wetland hydrology is provided by hillside runoff and likely a shallow groundwater table. These wetlands have a diversity of plant species including western red cedar, red-osier dogwood, big leaf maple, willow, mountain alder, smallfruit bulrush, horsetail, and cattail, among others. Reed canarygrass was observed in some areas but, it was not growing as a monoculture.
