**Asotin Creek Intensively Monitored Watershed:
Summary of Monitoring October 1, 2015 – August 1, 2016
Progress Report: 15-1443
Stephen Bennett, Eco Logical Research Inc., Providence, Utah**

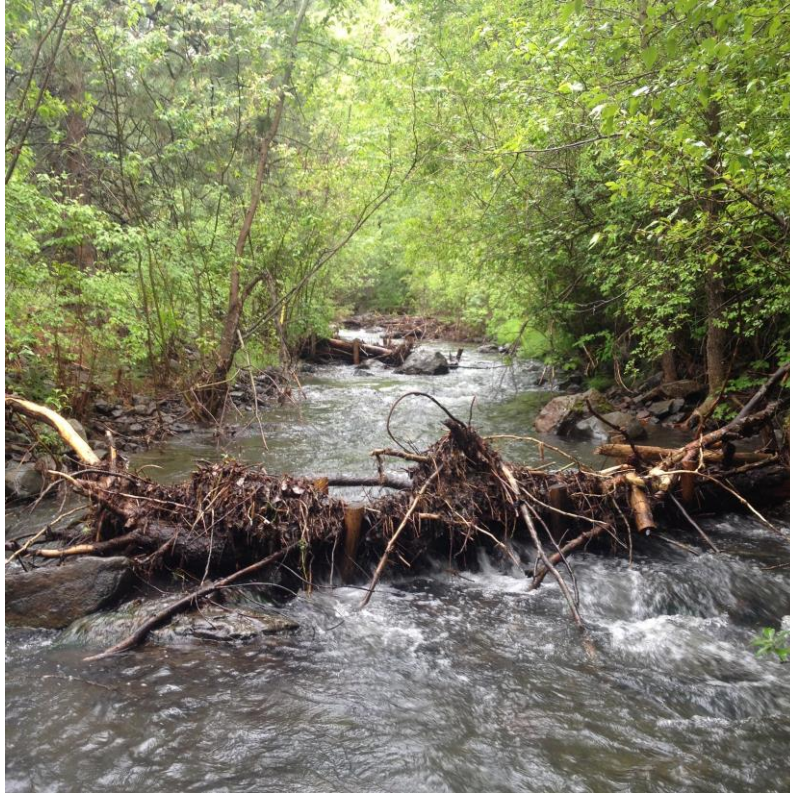
a) South Fork Asotin Creek, bank-attached PALS

Figure 3. Examples of the restoration treatment using post-assisted log structures (PALS) installed in a) South Fork (197 structures in 2012), b) Charley Creek (208 structures in 2013), and c) North Fork (135 structures in 2014) to simulate natural large woody debris loading. Approximately 120 new PALS will be built in the summer of 2016 on the lower section of South Fork Asotin Creek to complete the large woody debris restoration.

- We uploaded all PIT tag detections to PIT Tag Information System (PTAGIS).
- We completed our annual effectiveness monitoring of large woody debris (LWD) structures using customized iPad applications (~ 550 large woody debris structures total). All three existing 4 km long treatment areas were visited and each structure was assessed for its effect on hydraulic and geomorphic conditions (Figure 3 and 4).

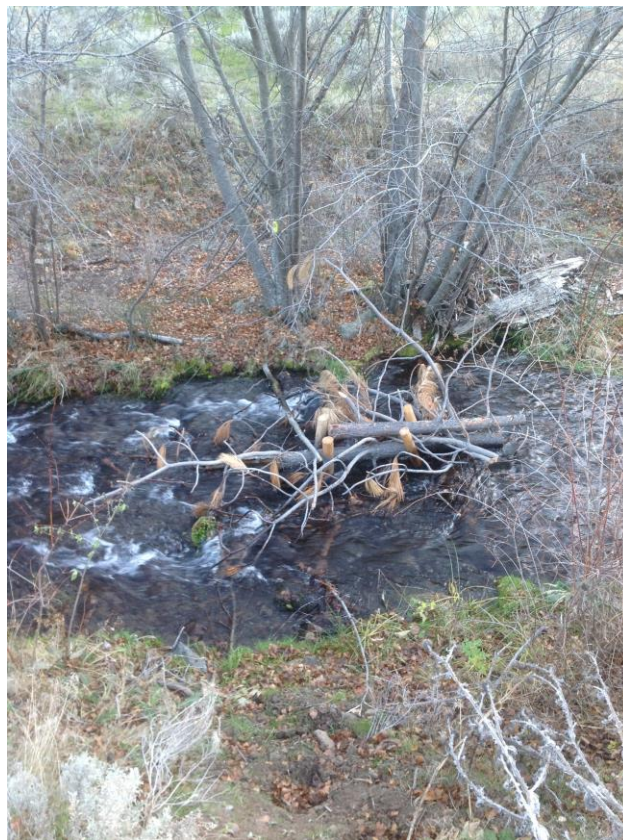
b) Charley Creek, mid-channel PALS.

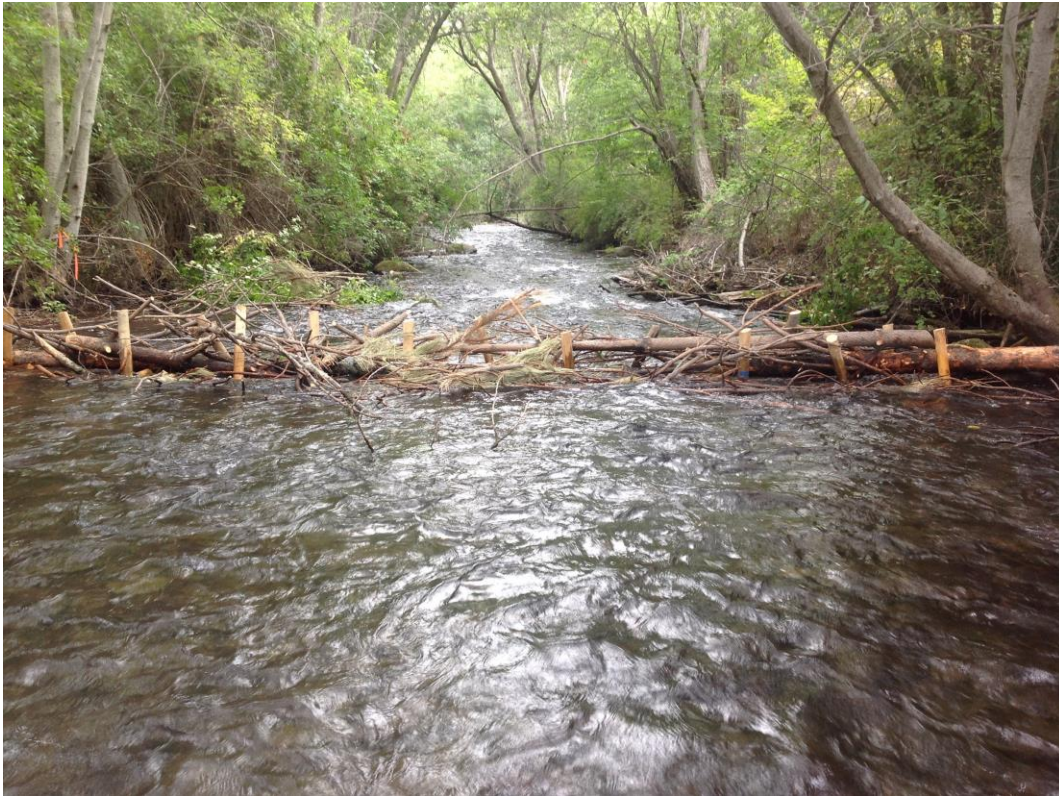
c) North Fork Asotin Creek, debris jam PALS.
