Nason Creek Properties

Stewardship Plan Updated January 2018

Nason Creek Properties
Stewardship Plan

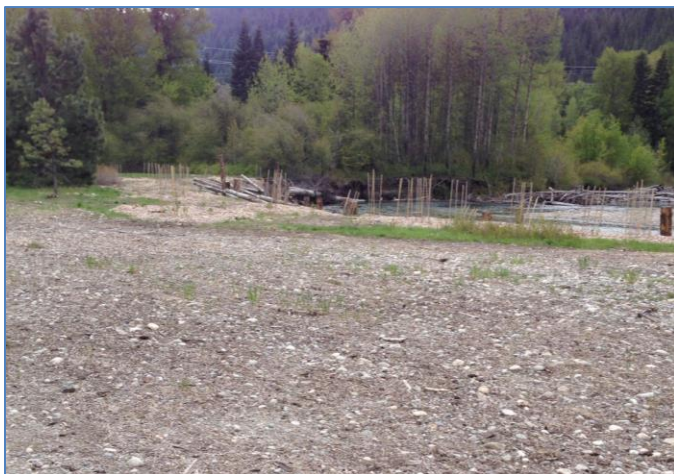
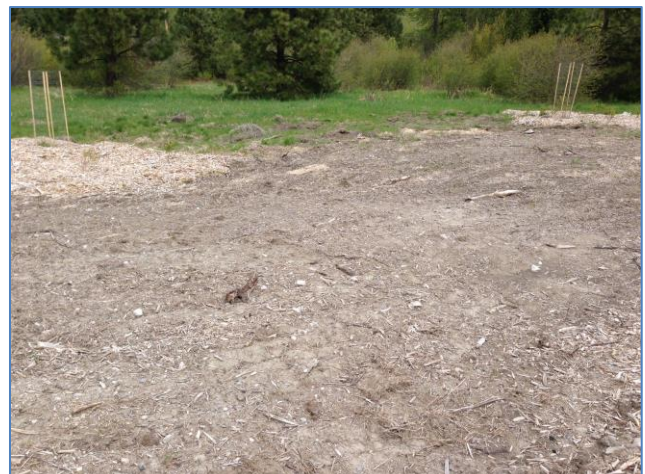
Photos 1 and 2: Site Condition, Early May of 2014

During the first site visit, on May 30, 2014, WildLands observed numerous newly germinated grass seedlings at the 1-2 leaf stage. Density of these seedlings appeared to vary according to soil type, with higher densities occurring in the darker, loamy soils compared with the lighter-colored, sandy silts. The second site visit, on June 13, 2014, found seedlings in the 3-4 leaf stage, with apparently increased densities across the site. Discrepancies between densities in different soil types were still in evidence, though densities appeared increased even in the lighter-colored, sandy silts. The third site visit took place on June 26, 2014. WildLands noted that grass seedling vigor and densities continued to increase, but at a reduced rate. Grasses in the darker, loamy soils still appeared to be performing better. Weed species, in particular knapweed (*Centaurea* sp.), were also noted and hand-pulled by WildLands' personnel during each site visit. Following these three (3) site visits, WildLands concluded that grass germination on the Project site was likely influenced by both microclimate and soil conditions. We also pointed out that non-irrigated native grasses take longer to establish, and recommended additional monitoring following one (1) full year of growth (spring of 2015). Weed monitoring and control was also recommended at that time.

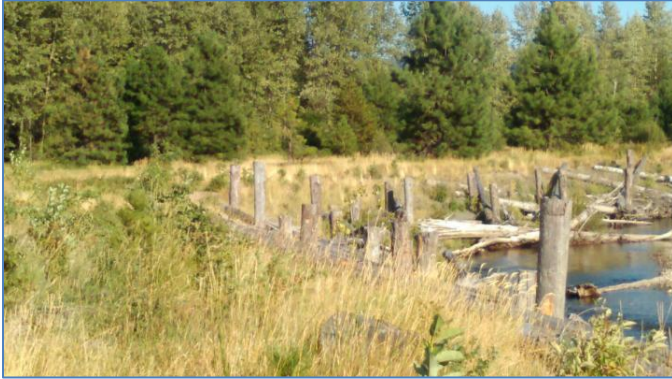
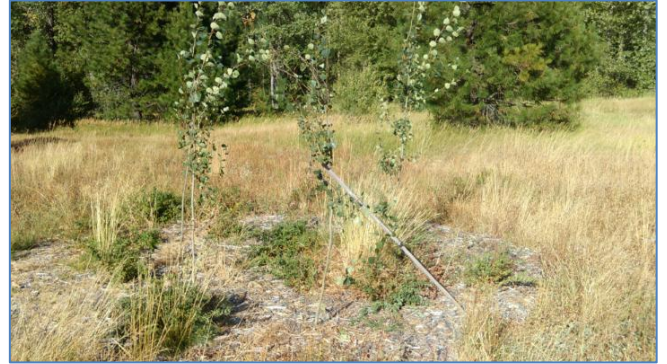
Photos 3 and 4: Site Condition, Late August of 2015

Upon our return to the site in August of 2015 (see Photos of the Site, below), grasses appeared healthy and well established, and were producing seed heads. It is WildLands' professional opinion that sparse areas across this Project will be filled in over the next 1-2 growing seasons, as established grasses seed out and new seed germinates. No erosion was visible on-site, but WildLands recommends periodic walk-throughs, especially following storms and other heavy precipitation events, to ensure that no erosion problems develop in the future.
