## **Asotin Creek Intensively Monitored Watershed: 2017 Progress Memo, December 31, 2017**

**Stephen Bennett, Eco Logical Research Inc., Providence, Utah**

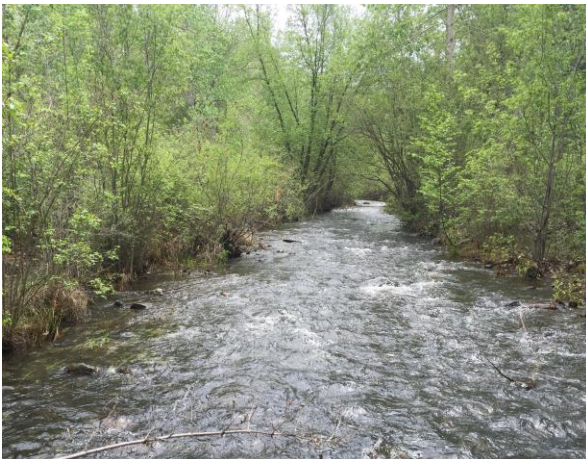
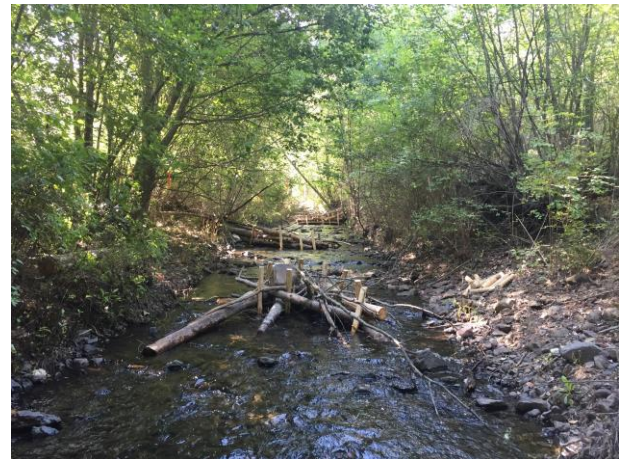
**Figure 3. Example of treatment section before restoration (left) and after restoration (right) in South Fork Section 1. Treatment took place in summer of 2016.**

and/or geomorphic change. Figure 3 shows an example of a stream reach before treatment and after treatment and Figure 4 shows examples of the common structure types we built.

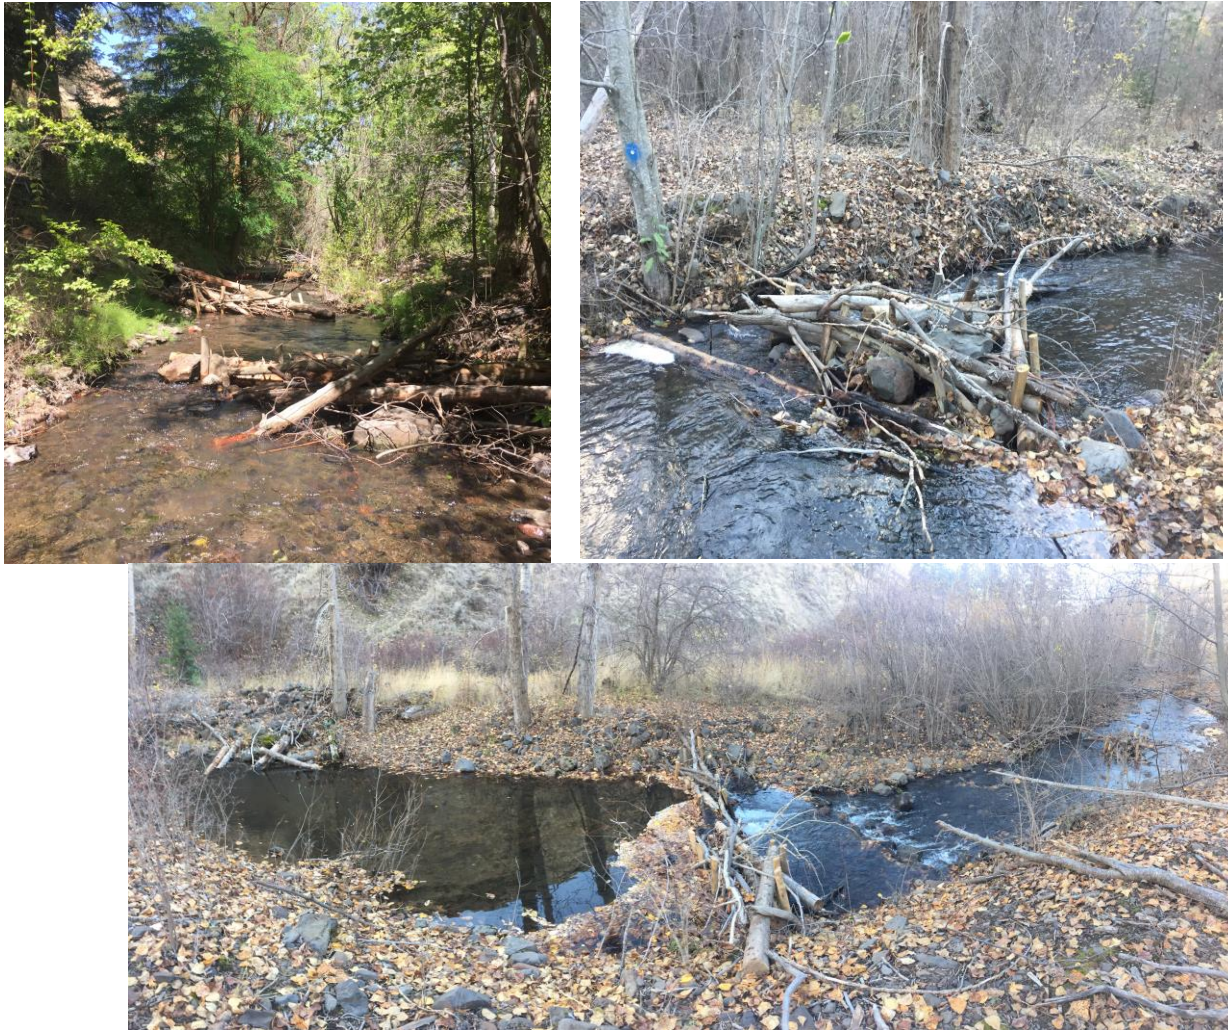
**Figure 4. Example of the three most common post-assisted log structure (PALS) built in the new treatment section of the South Fork Asotin Creek in summer of 2016. Top left = series of Bank-attached PALS, top right = Mid-channel PALS, and bottom picture = Debris Jam PALS.**

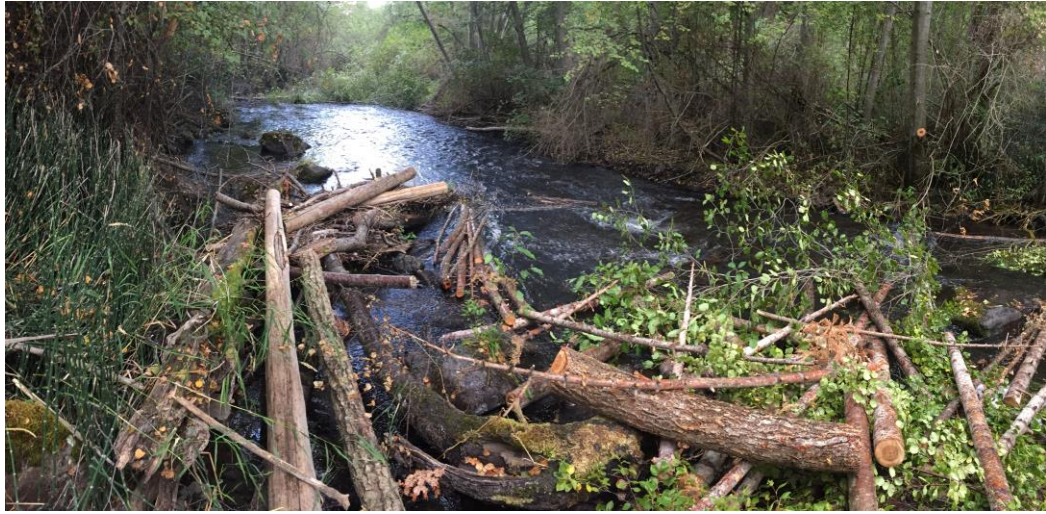
**Figure 5. Example of felling a tree and adding large woody debris to an existing structure in North Fork Asotin Creek treatment section 1 to maintain high large woody debris density.**

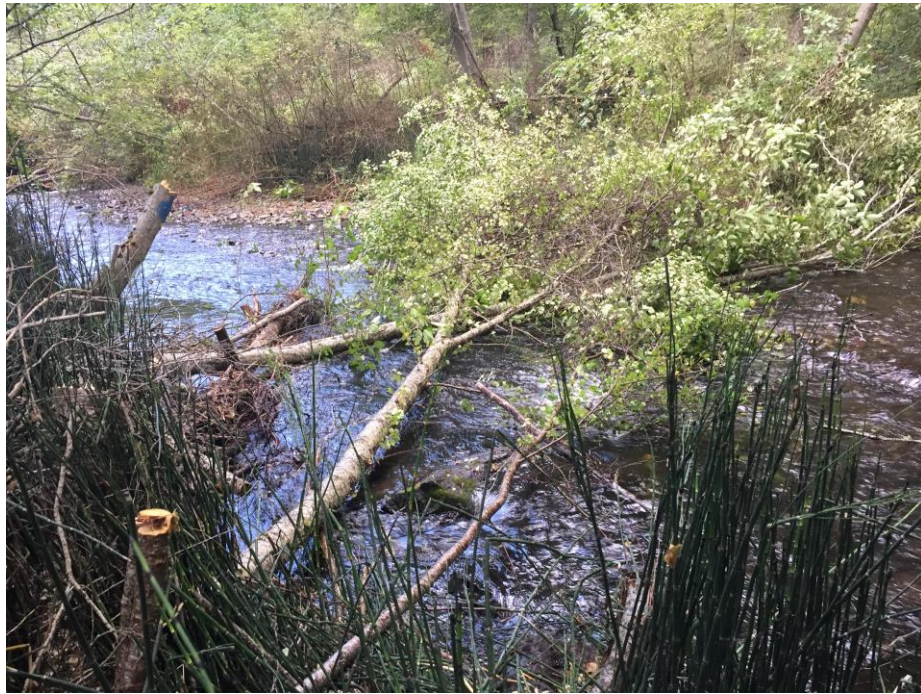
**Figure 6. Example of felling a tree on an existing structure in North Fork Asotin Creek treatment section 1 to maintain high large woody debris density.**

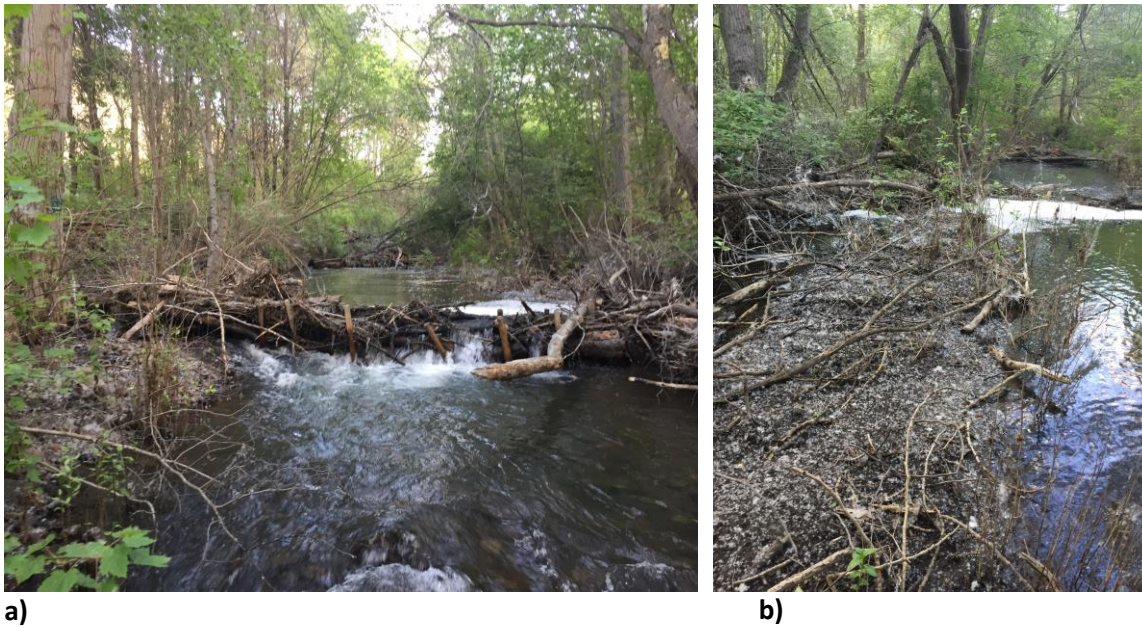
**Figure 7. a) Debris jam built in 2016 and viewed in summer of 2017. Note large dam pool upstream. b) Upstream of debris jam large sediment deposit covered with cottonwood seeds.**

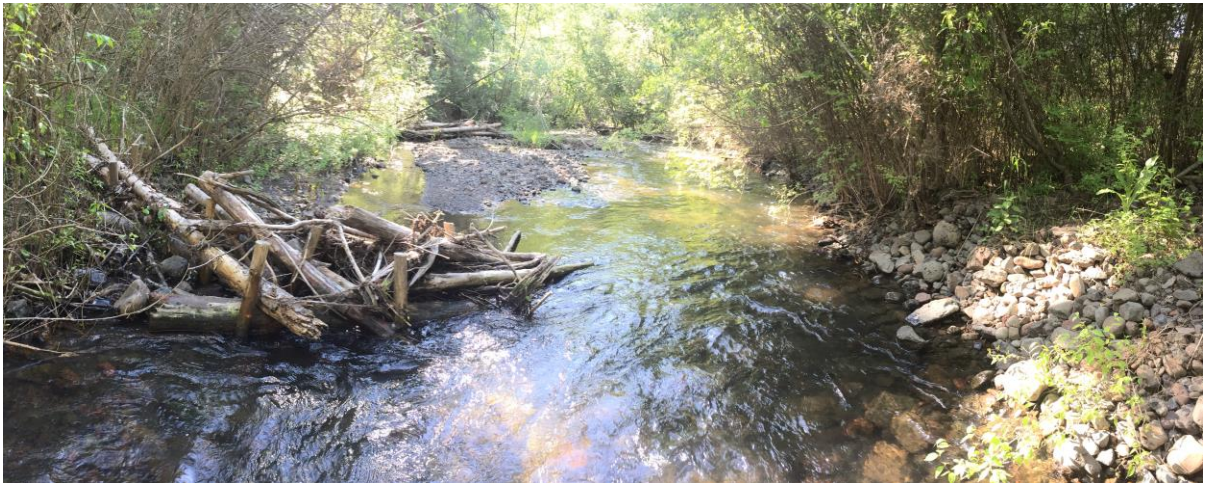
**Figure 8. Example of post-assisted log structure built in 2016 in South Fork section 1 creating a large gravel and cobble bar downstream of the structure.**

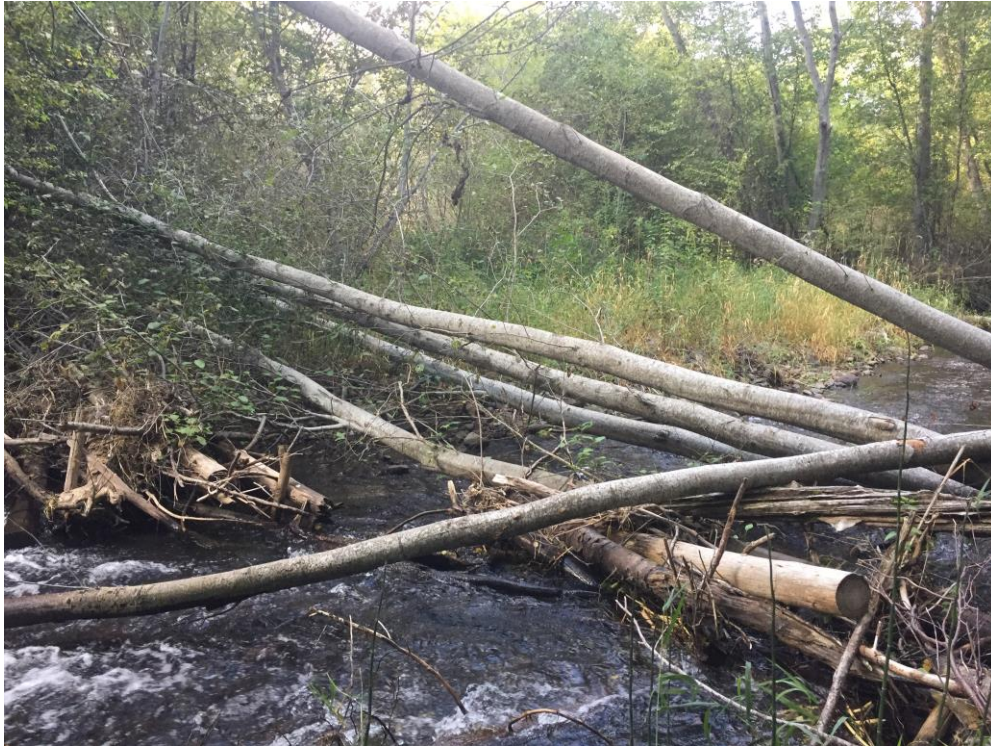
**Figure 9. Example of trees that have been recruited into the stream by the strategic design of a post-assisted log structure.**

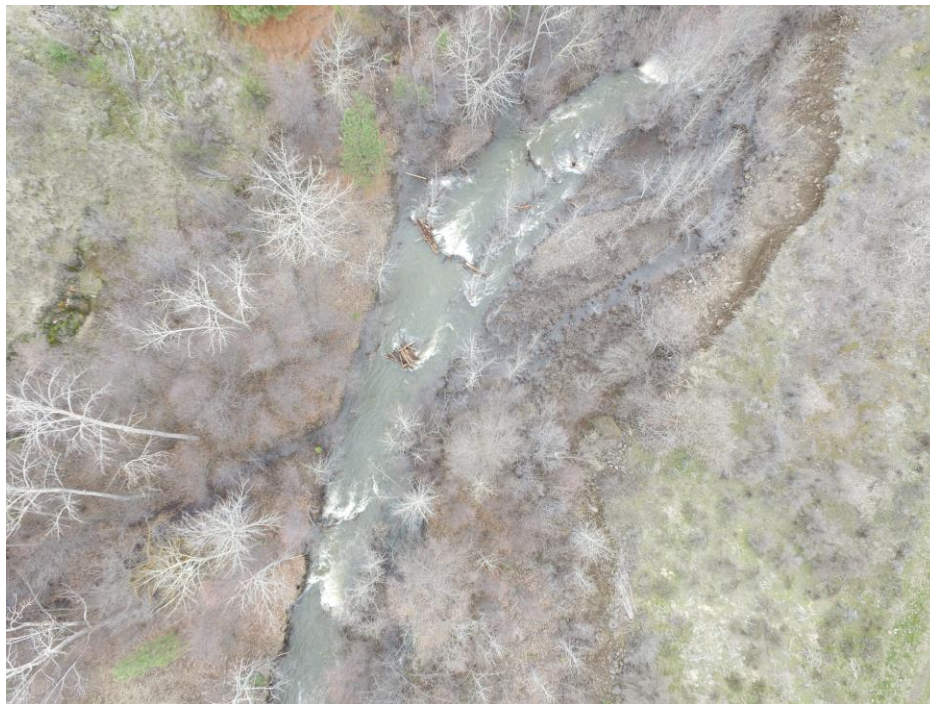
**Figure 11. South Fork Asotin Creek treatment section 1 in the spring of 2017 overflowing the banks and reconnecting with the floodplain. We had not observed overbank flow in the South Fork since the IMW started in 2008. Note the high-density of large woody debris that is causing the response.**

Prior to the start of the IMW in 2008 there were several years of low peak stream discharge and high temperatures (Figure 10). Water temperatures were cooler at the start of the IMW which is correlated with higher peak flows observed from 2008 through to 2012. However, since we began restoration in 2012, peak flows have decreased and average 7-day maximum temperatures have increased. Consistent low peak flows since the start of restoration in 2012 are suspected of limiting the effectiveness of the LWD structures to cause large changes to the channel and floodplain connection. Thankfully we observed the third largest peak flow in 17 years in the spring of 2017 and for the first time since restoration saw some extensive overbank flow, side-channel reconnection, and substantial sediment movement and sorting (Figure 11).

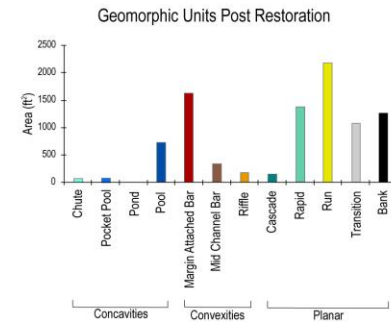
Charley Creek: Fan Controlled with Discontinuous Floodplain  
 Condition: Poor  
 Latitude: 46.28218167  
 Longitude: -117.3583958

Condition: Moderate

**Figure 14. Geomorphic unit delineation of Columbia Habitat Monitoring Protocol (CHaMP) topographic data for a Charley Creek treatment site before restoration (top panel) and after restoration (bottom panel). Graphs show area of geomorphic units organized by concavities (i.e., pools), convexities (i.e., bars), and planar topographic features (i.e., runs, rapids, etc.). Geomorphic units are delineated by the geomorphic unit tool (GUT) developed by Joe Wheaton and the Ecohydraulics Laboratory at Utah State University (<http://www.joewheaton.org>). Area of pools and bars has increased since restoration.**

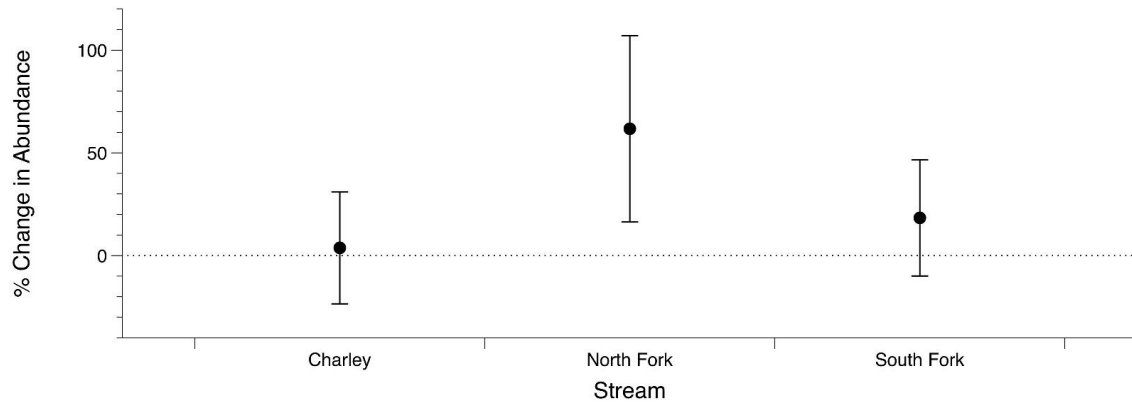
**Figure 18. Results from the staircase model analysis comparing change in juvenile steelhead abundance in the treatments compared to the controls before and after restoration. Estimates are the percent change in juvenile steelhead abundance (fish/100m) within each study stream in the Asotin Creek IMW: 2008-2017. Confidence intervals are 90% ( $\alpha = 0.1$ ). The estimates were derived using the Impact 0/1 response contrasts because there is not strong evidence for choosing any specific response. All estimates of a response were positive and ranged from 3.8% (Charley Creek,  $p = 0.19$ ), 61.7% (North Fork,  $p = 0.002$ ), and (South Fork,  $p = 0.19$ ).**

We also used the staircase model to look at responses of the individual streams (Figure 18). There is a positive trend in abundance in treatment areas compared to control areas in all the streams. However, like the habitat changes, the fish response in the North Fork appears to be greater than the other two streams despite being treated last (i.e., we are observing a Year 3 response in North Fork, Year 4 in Charley, and Year 5 in South Fork). This would tend to suggest that it is geomorphic change that is causing the change in abundance and not other factors such as cover or refugia from high flows since there are similar densities of LWD structures in each stream. The
