GIS Census of Pocket Estuaries Accessible to Juvenile Salmon in the Whidbey Basin & Western Shore of Whidbey Island, 2014

June 2018

Eric M. Beamer, Karen Wolf, Kate Ramsden

Skagit River System Cooperative, LaConner, WA

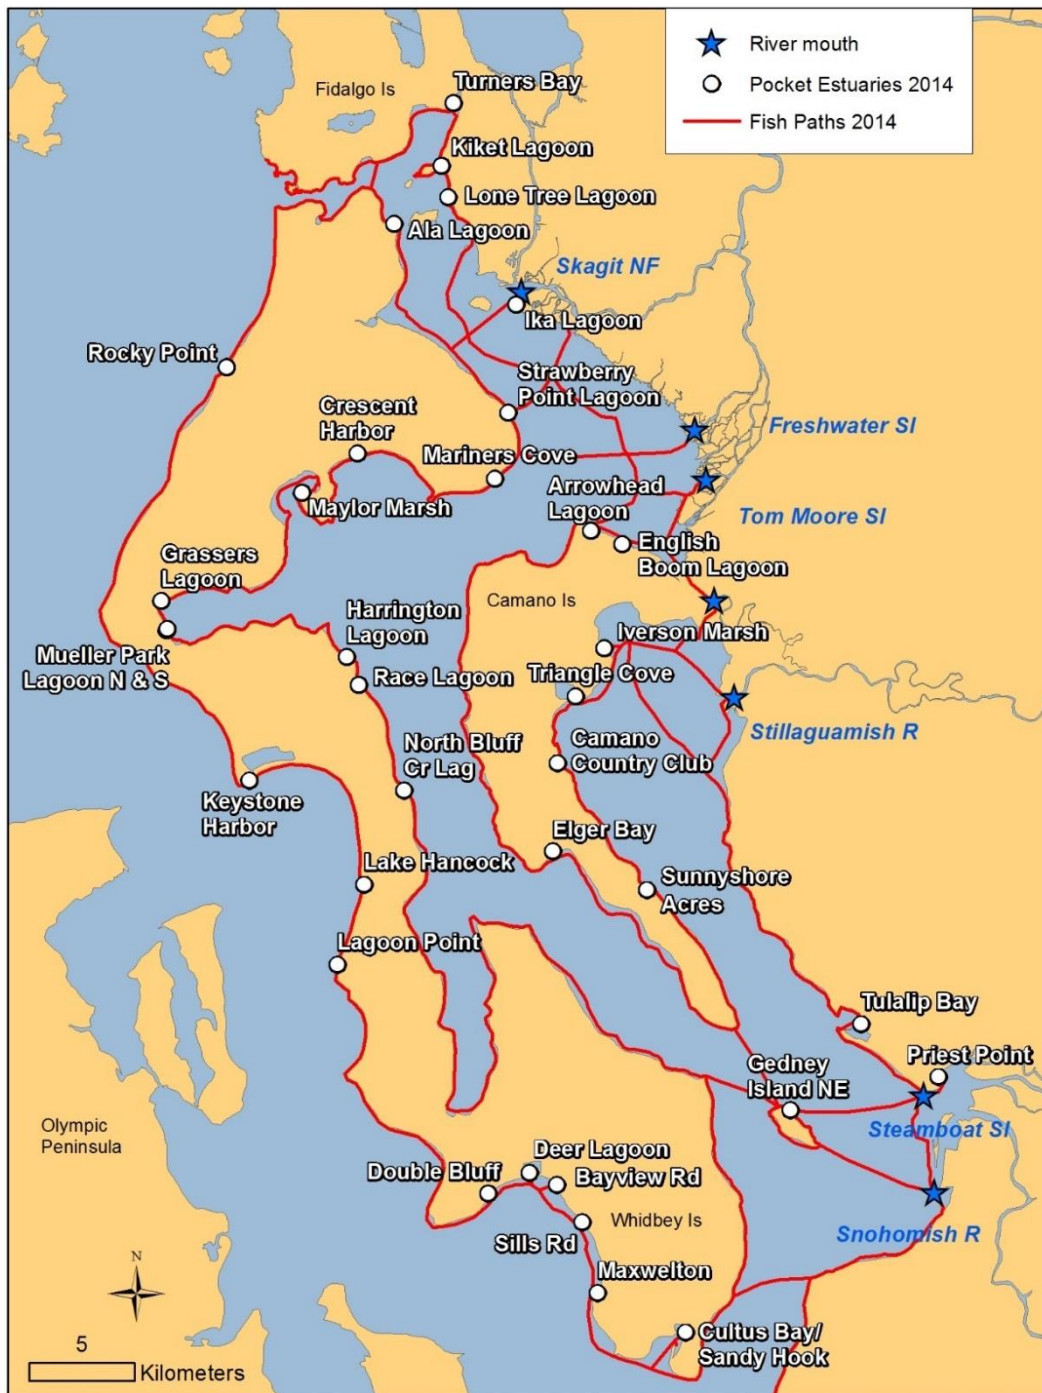
Figure 2.1. West Whidbey Island and Whidbey Basin pocket estuaries that were accessible to juvenile Chinook salmon in 2014. Red lines are fish migration pathways used for landscape position analysis and blue stars represent river mouths (see section 2.3 of this report).

We found 35 pocket estuaries accessible to juvenile salmon in the Whidbey Basin and west Whidbey shoreline in 2014 (Figure 2.1). Twenty-five pocket estuaries were within the Whidbey Basin and ten were in West Whidbey. The 25 accessible pocket estuaries within the Whidbey Basin is one more than was identified in 2005 (Beamer et al 2015) and is due to restoring connectivity to Crescent Harbor Saltmarsh. Of the 35 accessible pocket estuaries, 17 in the Whidbey Basin and 4 in West Whidbey have known juvenile salmon presence (Table 2.1).

Table 2.1. Summary of pocket estuaries accessible to juvenile salmon with known juvenile Chinook salmon use. Names of pocket estuaries coincide with names on Figure 2.1.

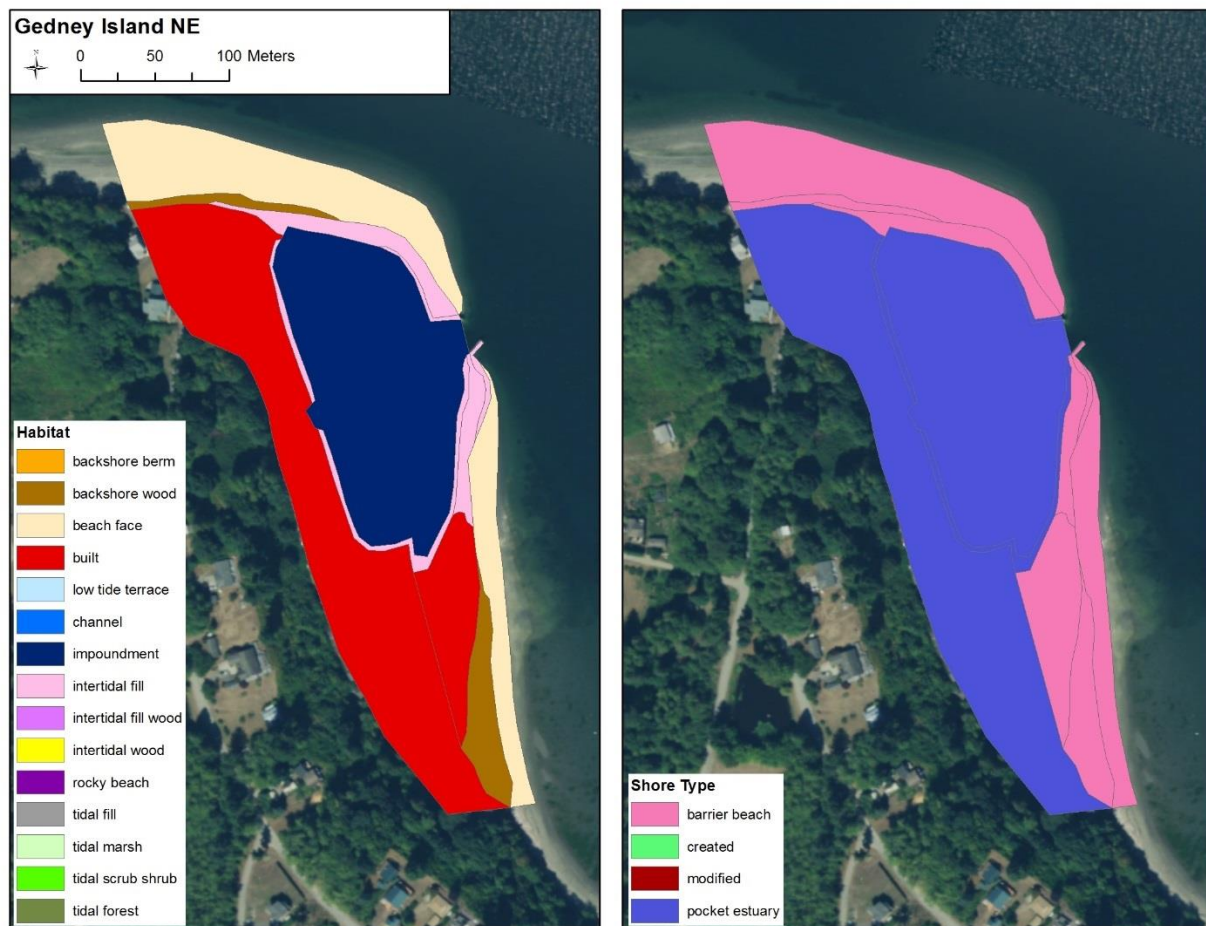
Gedney Island NE

Figure A7. Nearshore habitat within the pocket estuary at Gedney Island NE, 2014.

This site is highly modified with dredging, rock jetties, and overwater structures. The T-sheet for this area did not map Gedney Island. We would need to look at photos earlier than 1990 to determine what natural shoreline conditions were at this site. Between 2011 and 2012, the harbor was expanded by 0.4333 hectares of intertidal/subtidal area.

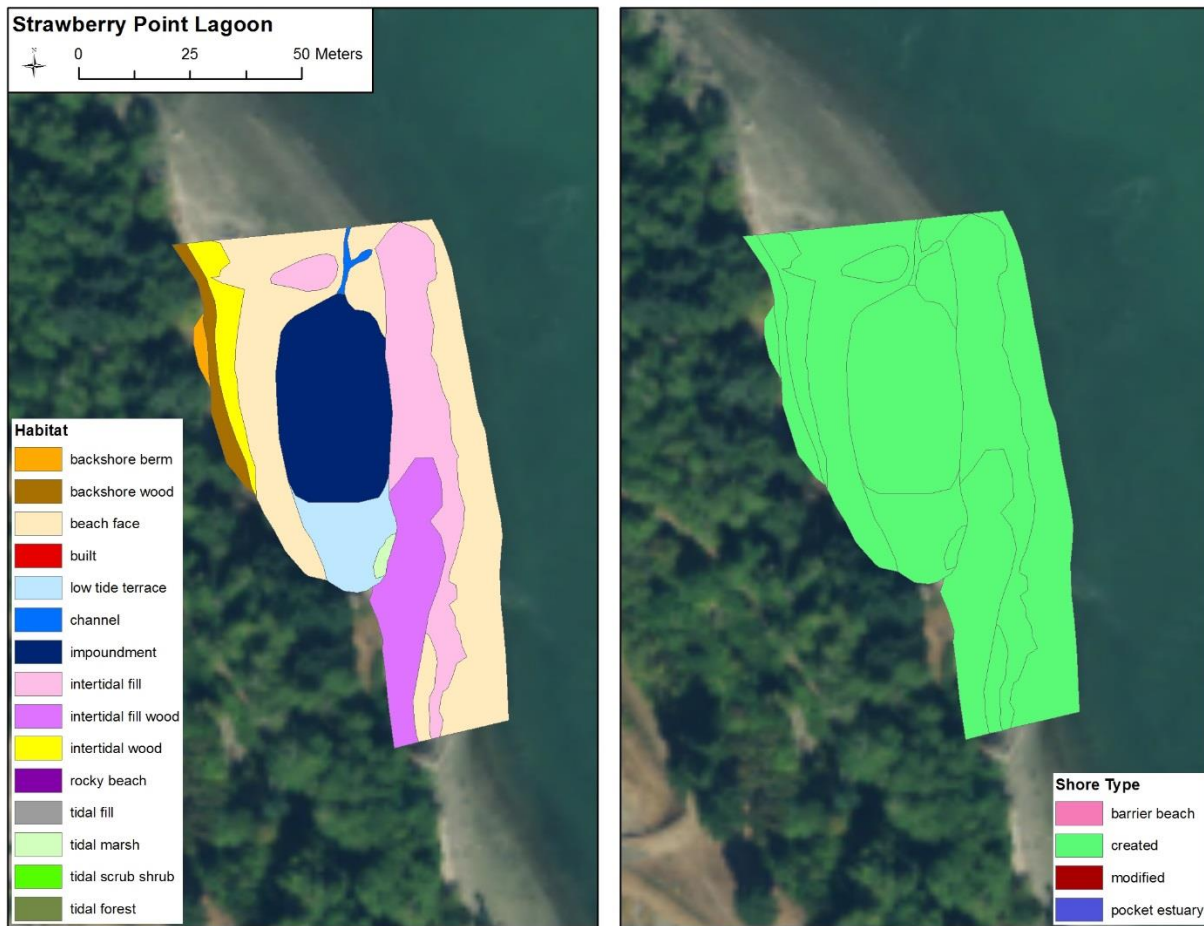
Strawberry Point Lagoon

Figure A20. Nearshore habitat within the pocket estuary at Strawberry Point Lagoon, 2014.

This site is not on the T-sheet. It was created by two rock groins. Since the site is artificial there is still a remnant bluff back beach, including some backshore habitat, within the artificial pocket estuary.

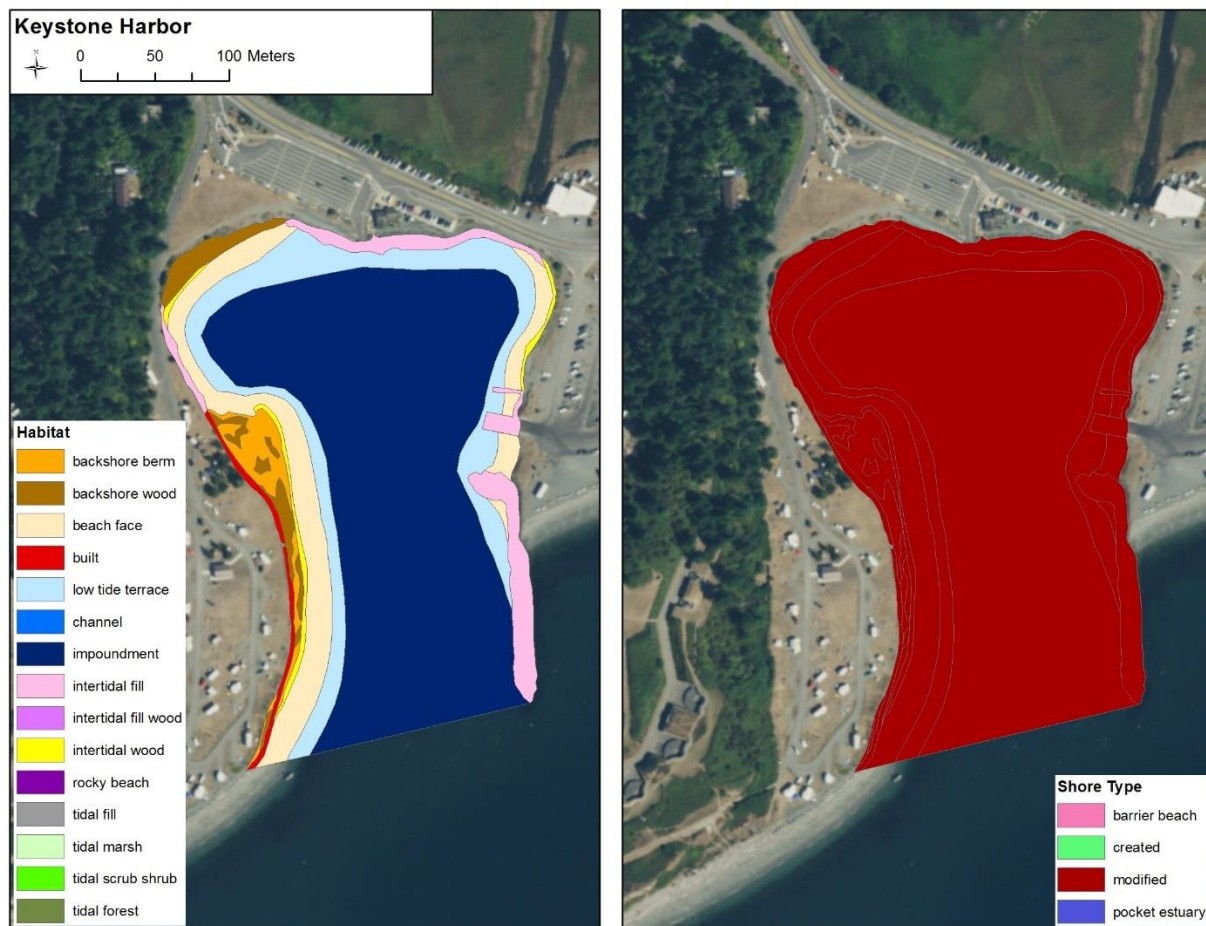
Figure A29. Nearshore habitat within the pocket estuary at Keystone Harbor, 2014.

Keystone Harbor is an artificial embayment associated with Crockett Lake. Historically, Crockett Lake is thought to have been a closed lagoon system (Herrera Environmental Consultants Inc. 2007; Park 2014). The T-Sheet shows Crockett Lake with a dredged channel flowing into Admiralty Inlet at the site of Keystone Harbor. This channel persists in its present condition. However, the channel is controlled by a tide gate which prevents unobstructed tidal flow and fish passage into the lake (Wait et al 2007).
