Peshastin Creek Fish Passage Barrier Removal – Scotty Creek Road

*Chelan County Natural Resources Department
411 Washington Street Suite 401
Jennifer Hadersberger
PRISM # 18-1815*

SRFB Grant Regional Application Materials

Project Number	18-1815
Project Name	Peshastin Creek Fish Passage Barrier Removal
Sponsor	Chelan County Natural Resources Department (CCNRD)

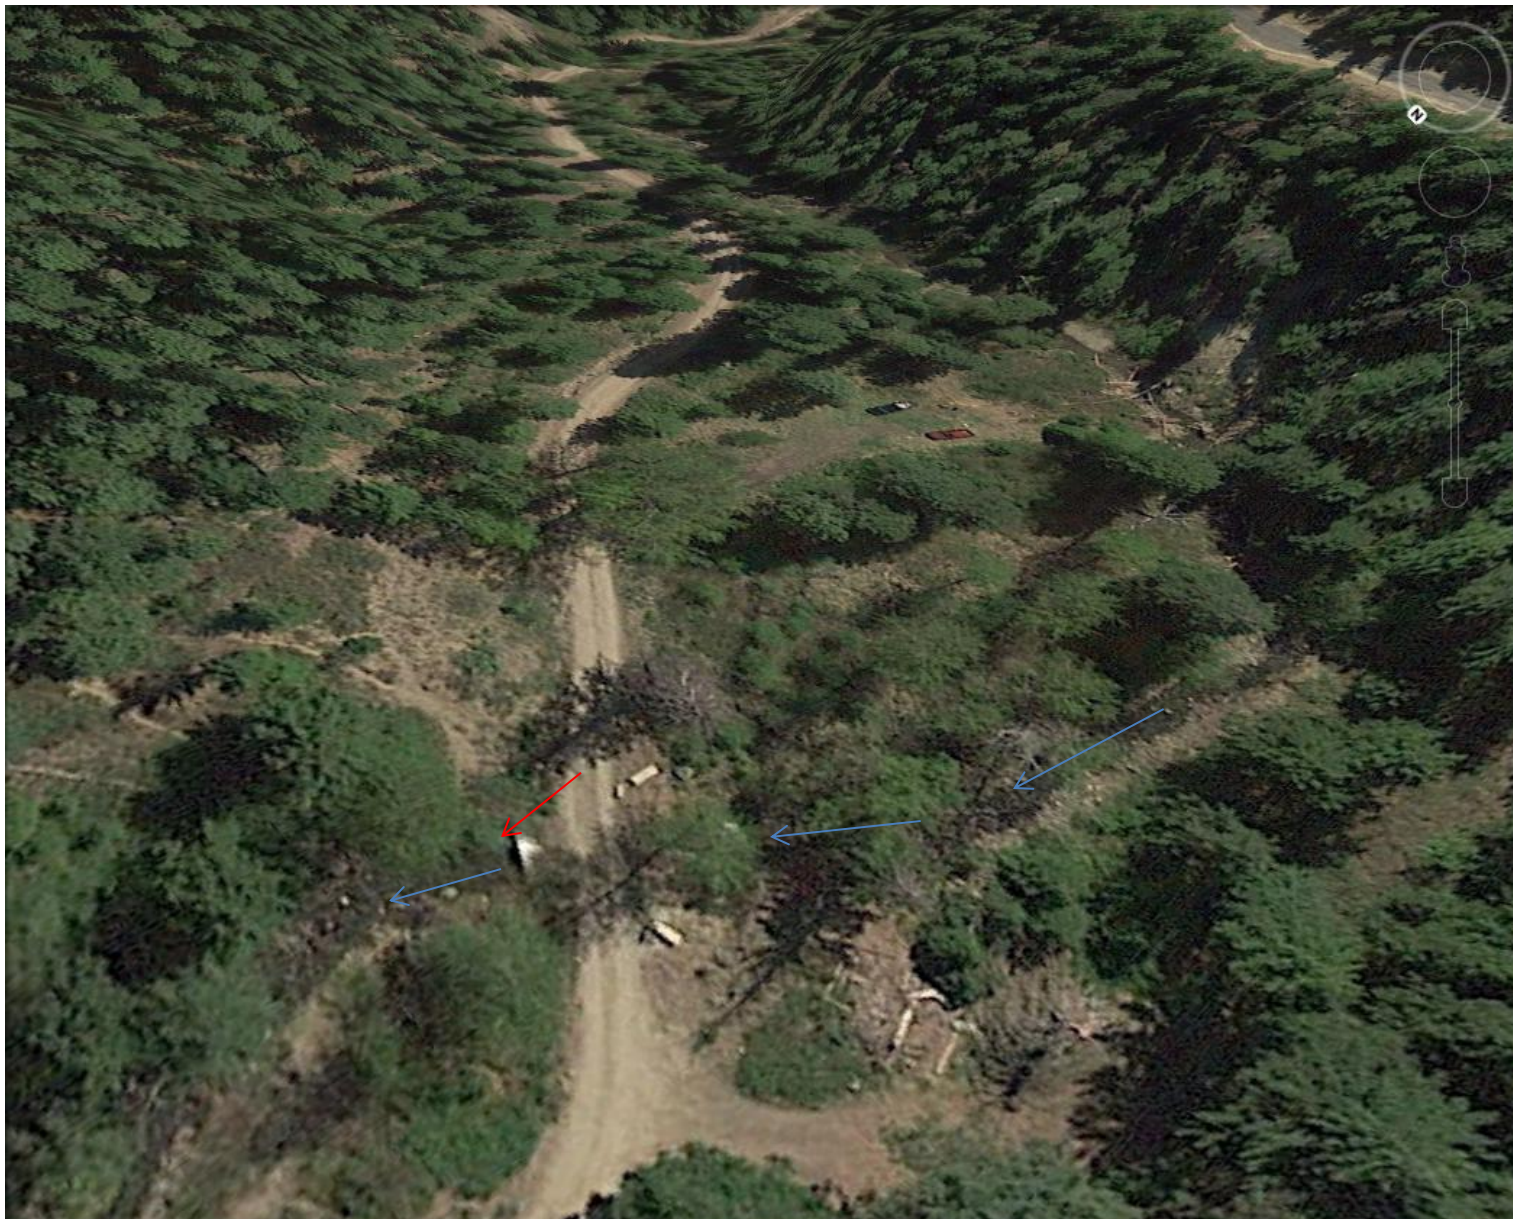
Figure 2: Google earth oblique image of the project area (May 2015). Note the angle of the culvert crossing is not perpendicular to flows. Blue arrows depict stream flow. Red arrow depicts overland flow due to channel constriction. Overland flows are eroding/comprising the current structure and causing increased fine sediment deposition to the stream.

The existing culvert is a corrugated aluminum arch culvert that does not cross the stream at a perpendicular angle. It is also partially damaged likely due to the angle.

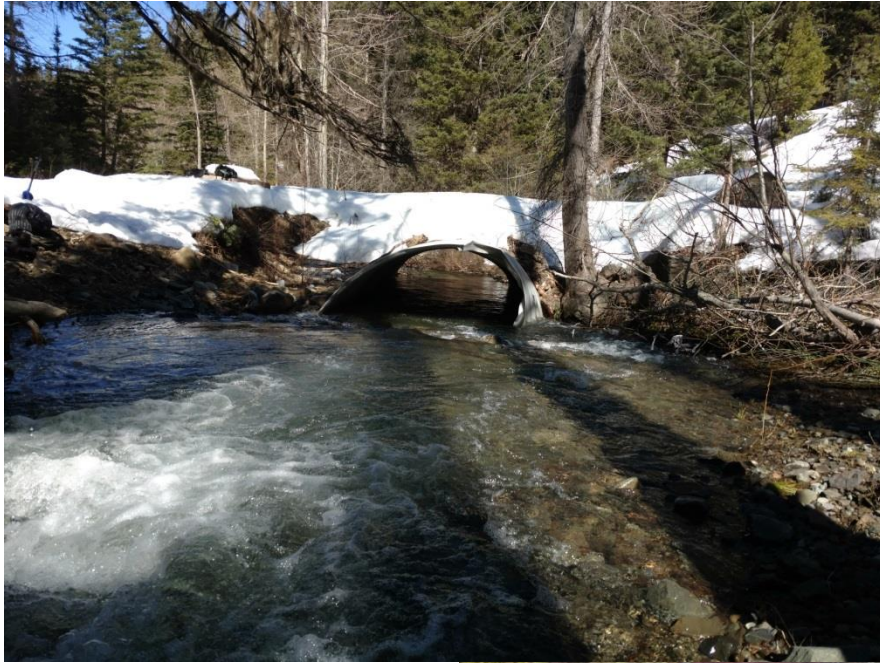
Figure 5: Site Photos

Photo 1 taken upstream looking downstream at the culvert showing the flow constriction under current conditions and deformed shape of the culvert.

Photos in Figure 5 depict existing site conditions. The US Forest Service prepared a preliminary design for a culvert replacement, however, that design will be revised by a US Forest Service Regional Bridge Engineer or an engineering design consultant hired by CCNRD. The proposed structure will be a bridge with an opening designed to pass 100-year flows and achieve stream simulation design to include passage for juveniles. The design will include the new bridge, but it will also show any road, floodplain and/or channel reconfiguration needed to achieve stream simulation design. The culvert removal and bridge installation will occur during the in-water work window. The project will include site restoration actions including revegetation in the fall following culvert replacement.

The existing culvert has a 10.5' wide span and is 6.13' tall. The bankfull width is 43' and the .43 culvert:stream width ratio creates a velocity barrier. The slope was measured at - 0.83% which is likely due to the partial failure of the existing structure (see Photos in Figure 5). See the attached barrier evaluation form (note all measurements are in meters).

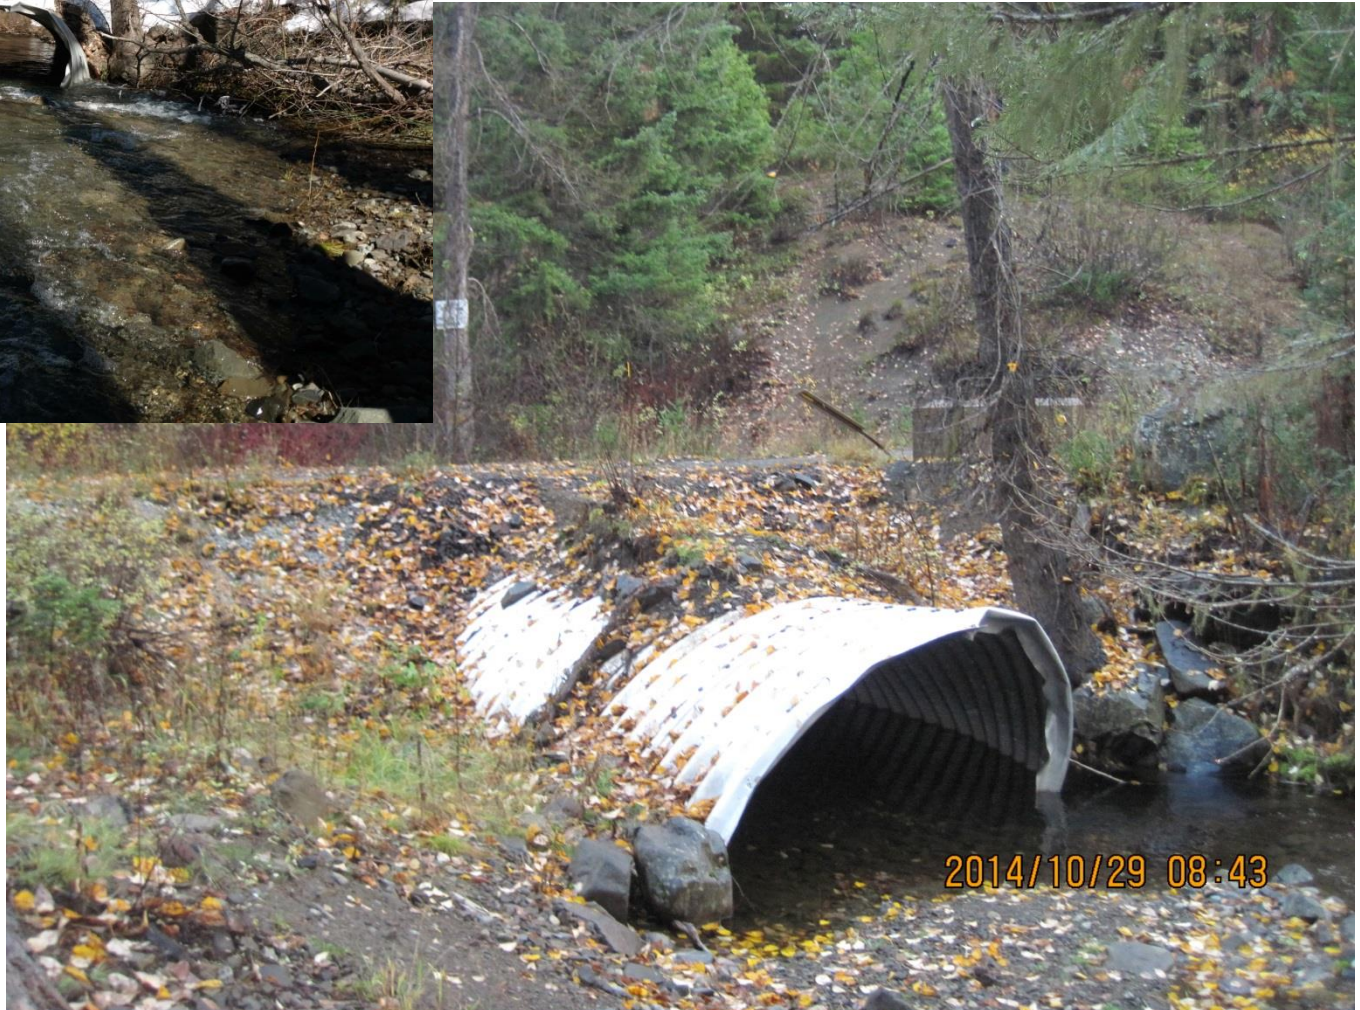
Photo 2 taken under low flow conditions showing the damage to the structure.

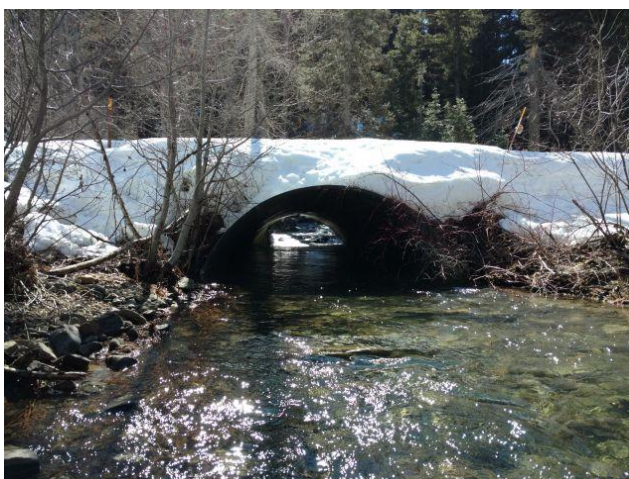
Culvert Details								Level A Parameters				
ID	Shape	Material	Span	Rise	Length	WDIC	Apron	WSDrop	Location	Countersunk	Backwater	Slope (%)
1.1	ARCH	CAL	3.20	1.87	13.10	0.16	NO	0.00		Yes	0	-0.82
All dimensions in meters

Channel Description	
Toe Width (m):	3.1
Average Width (m):	8.80
Culvert/Stream Width Ratio:	0.43
Plunge Pool	
Length (m):	0.00
Max Depth (m):	-99.99
OHW Width (m):	-999.99
Road	
Fill Depth (m):	3.00

Comments
Culvert is not perpendicular to stream. Slope measured from top of culvert. Span record at inlet where damaged = 3.2 m, span at outlet = 4.3 m. [LvIB-Barrett,2/6/2018,FishXing. Depth Crit N/A]. Level B run using culvert span from inlet.
