**REPORT
ENVIRONMENTAL SITE ASSESSMENT
PHASE I**

**BARNUM POINT PROPERTIES
440 & 464 SOUTH BARNUM ROAD
ISLAND COUNTY PARCELS
R33107-4435240, -4665220,-4915130,
& -5215310
CAMANO ISLAND, WASHINGTON 98282**

January 17, 2018

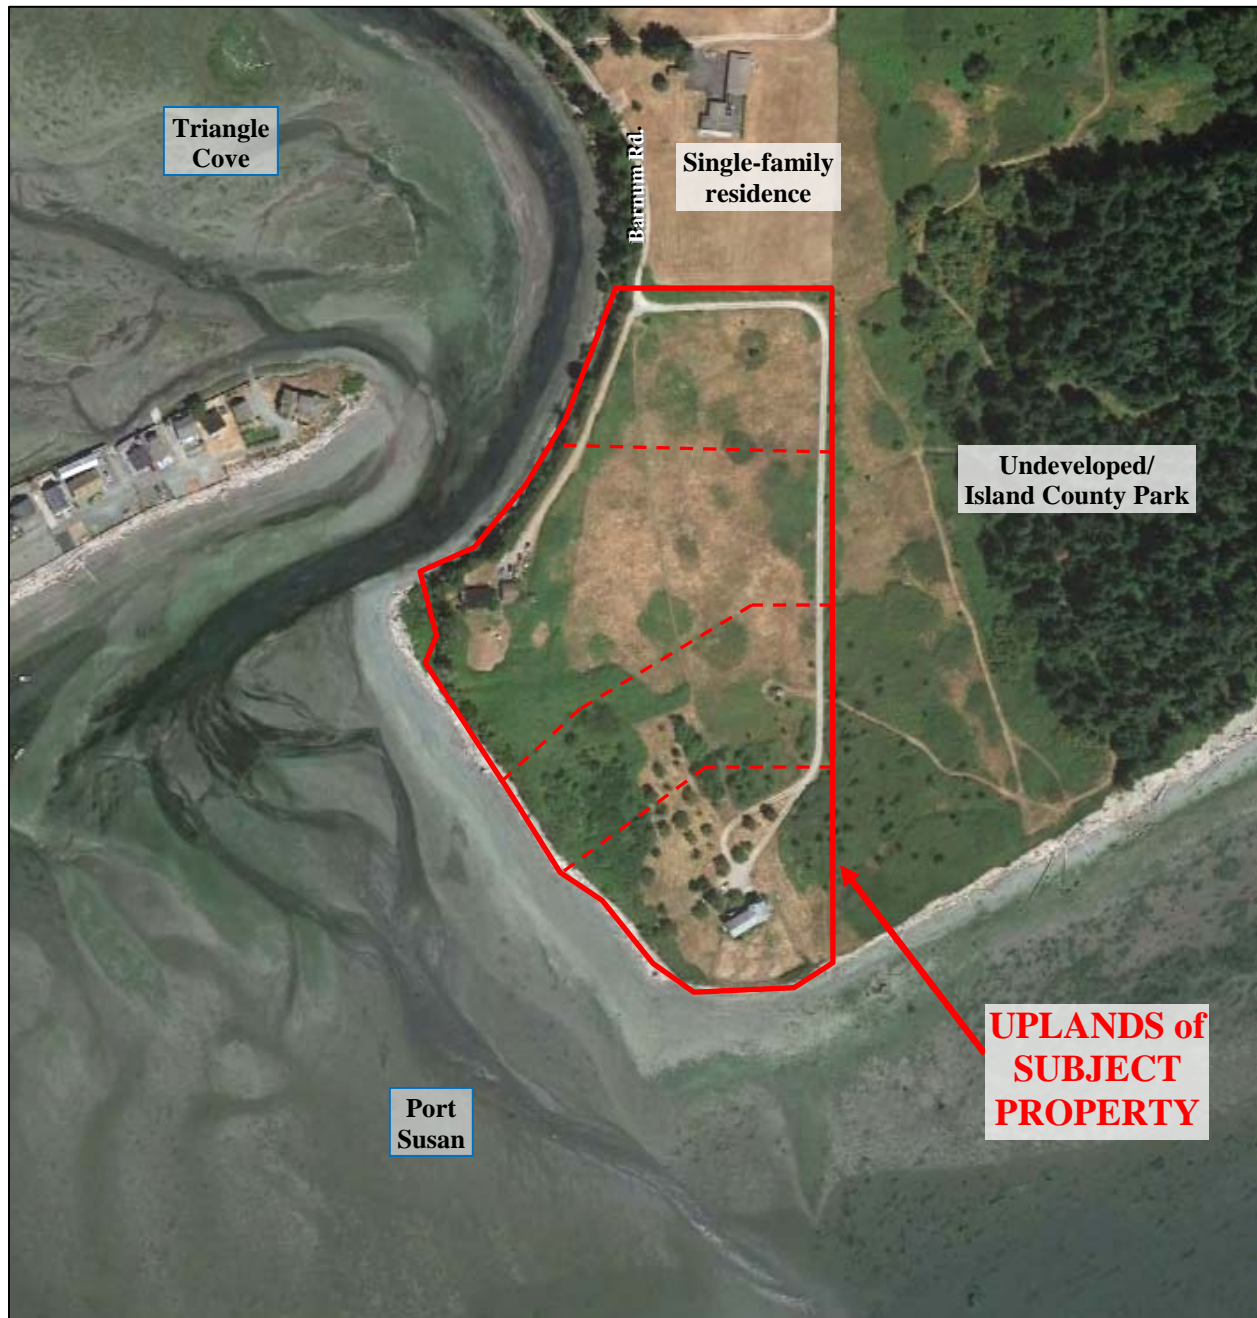
Figure 2. Aerial photograph of subject property and vicinity (Google Earth, 2017). The upland portions of the subject property is outlined in solid red. Parcel boundaries, shown in solid and dashed red lines, are as provided by Island County parcel viewer. Parcels are numbered as identified in this report.

A water well pump house for the residence at 464 South Barnum is located north of the house, on Lot 2 (see Figure 2). The door to the well structure is locked.

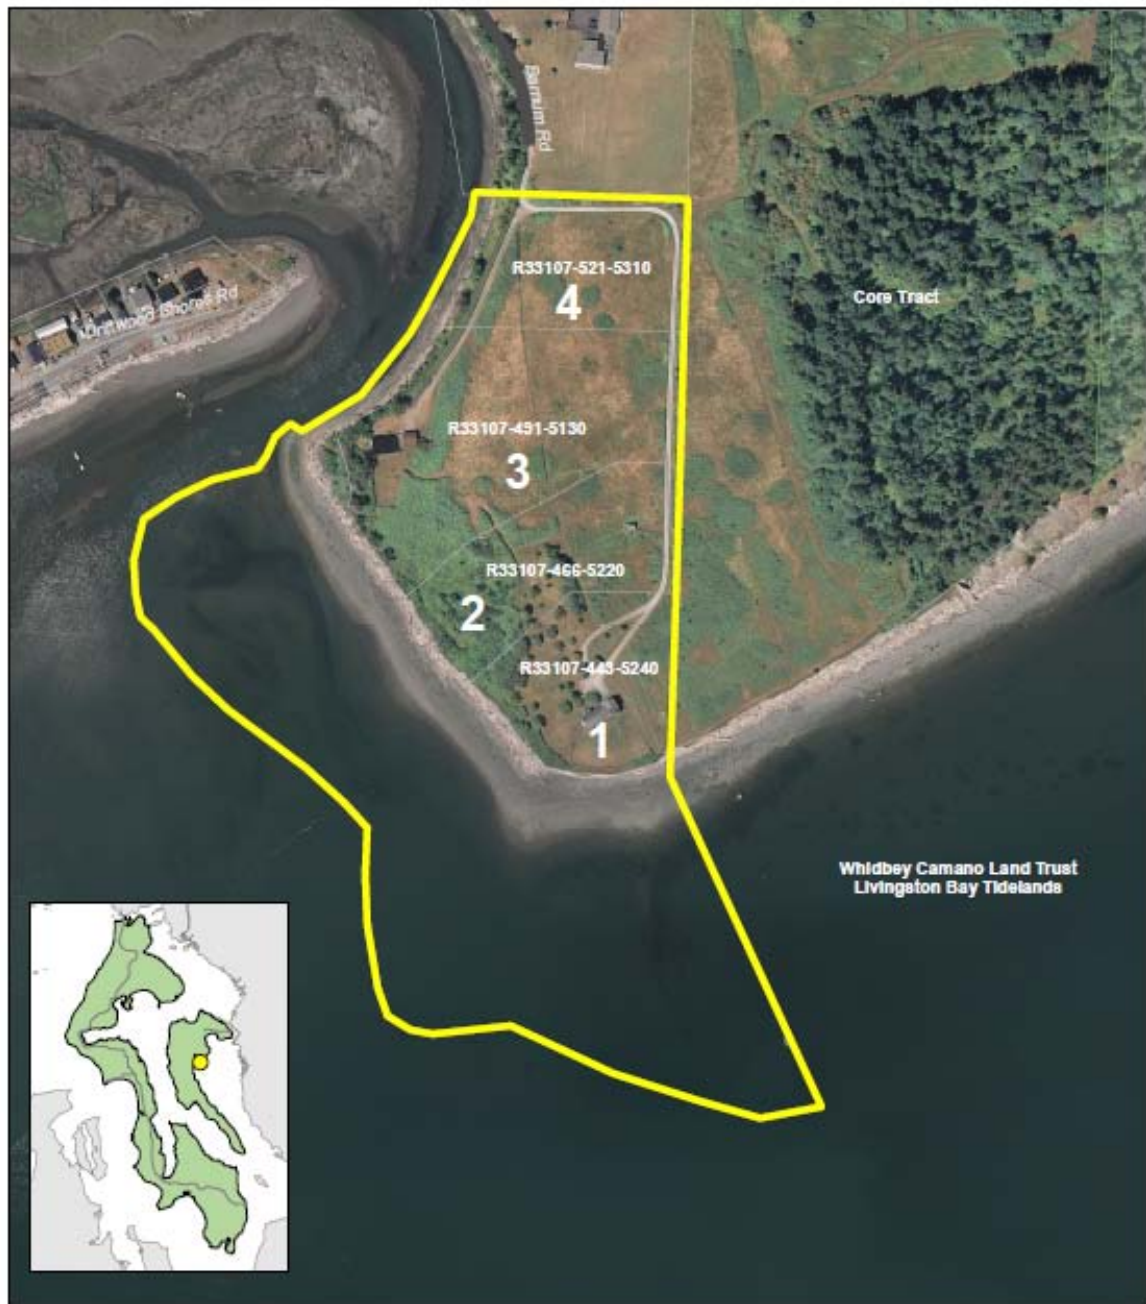
Barnum Point: Site Map

Figure 3. View of the subject parcels, including tideland areas and parcel numbers.

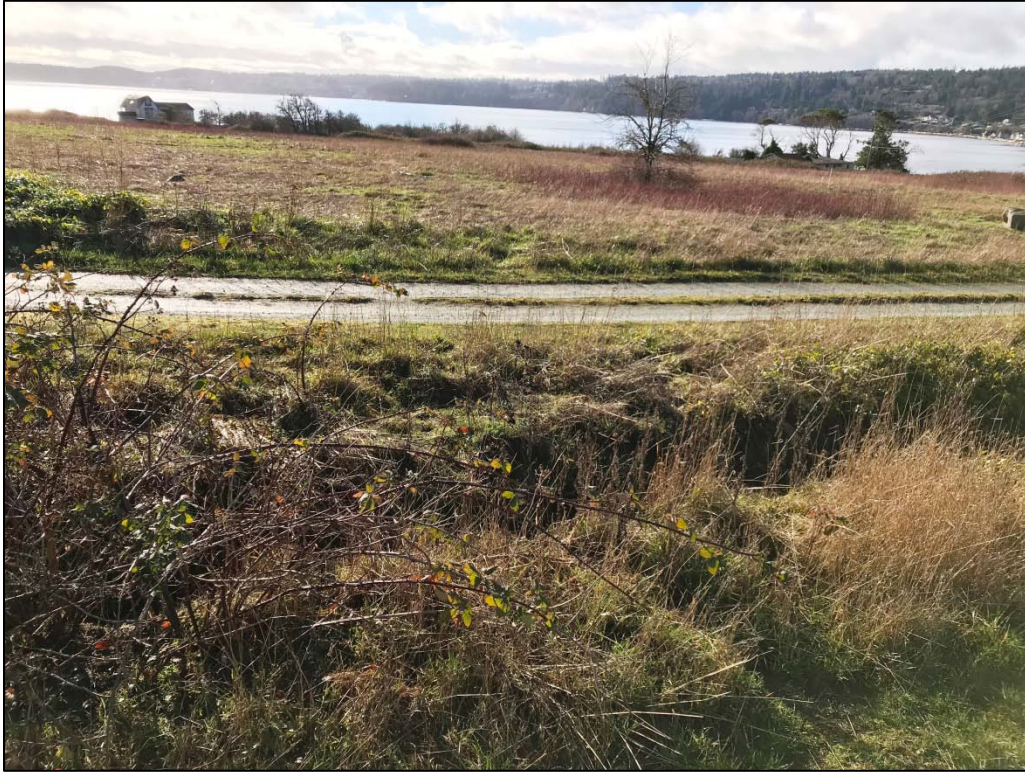
Figure 4. View of the subject property from near the northeast corner, looking southwest. The two houses on the property are visible in the background.

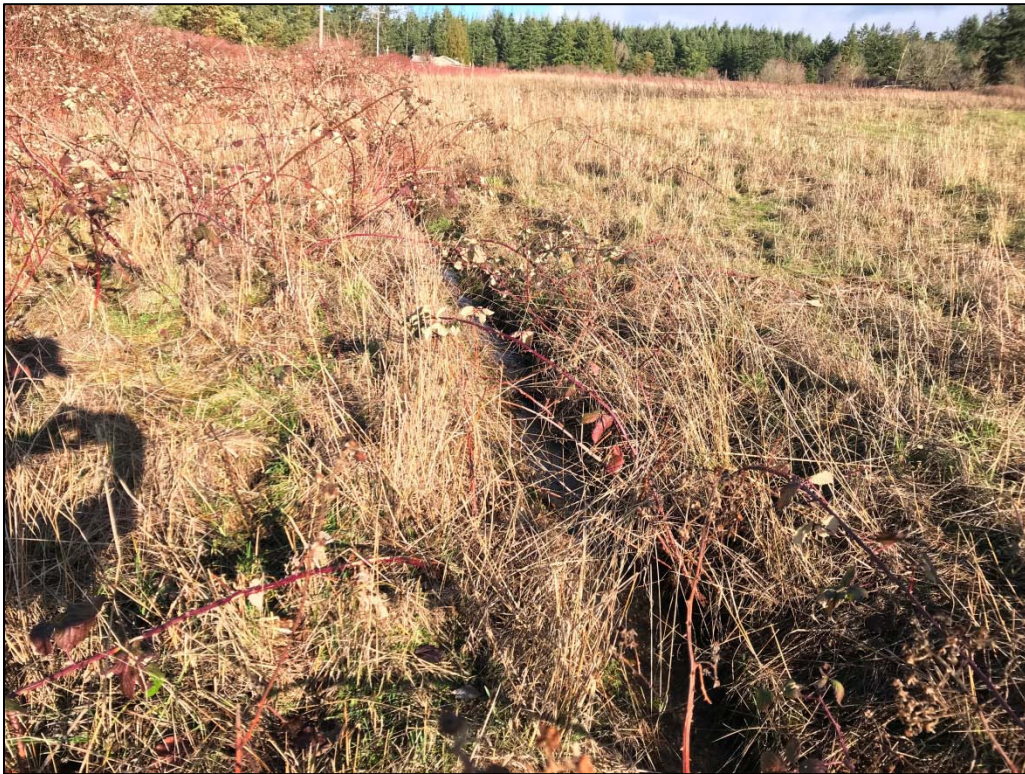
Figure 5. Surface water flows in a ditch on the west side of the property. View is looking northeast.

Surface water flows in ditches along the north and east property boundaries. A west-flowing ditch extends on the north property boundary and then turns to the southwest to flow through the west side of the property. Water within the ditch along the eastern property boundary flows to the south. Both ditches drain into Port Susan.

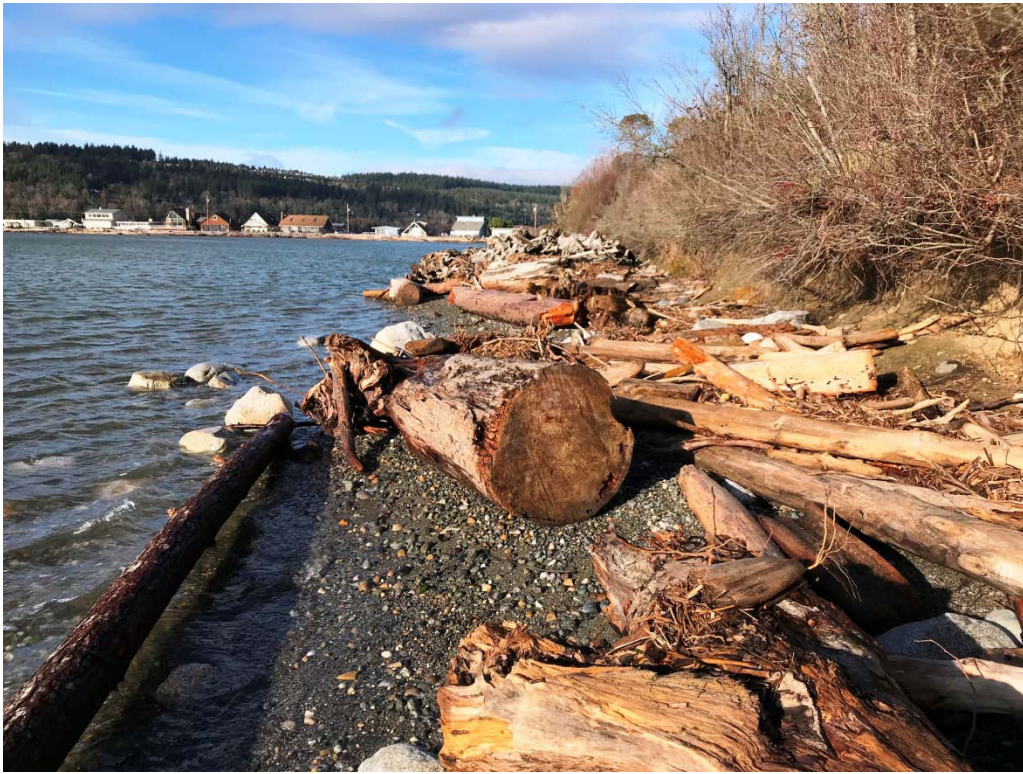
Figure 6. The beach on the southwest side of the property, looking northwest

A beach is at the foot of the bluff that surrounds the property to the northwest, the southwest, and the southeast. Due to high tide, the steepness of the bluff, and a significant amount of beached logs, we only had access the beach on the southwest property boundary, between the two houses. Small quantities of plastic bottles, Styrofoam, and other nonhazardous solid waste are observed along this section of beach.

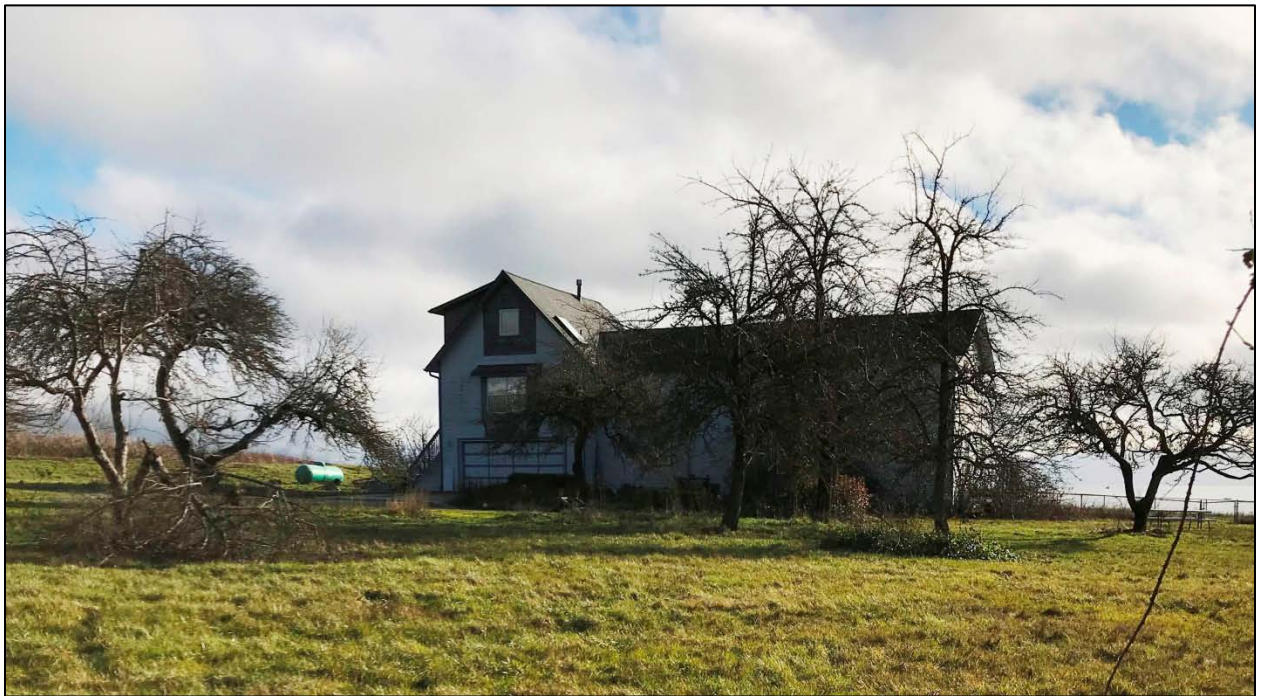
Figure 7. The house at 464 Barnum Road, on the south end of the subject property. View is looking southeast.

A house on the south point of the subject property, which uses the address 464 South Barnum Road, is constructed with a wood frame on a concrete foundation with wood siding. The house has two stories and a third-story loft. We did not access the house interior, but observations through windows indicate the house was nearly empty of furnishings.

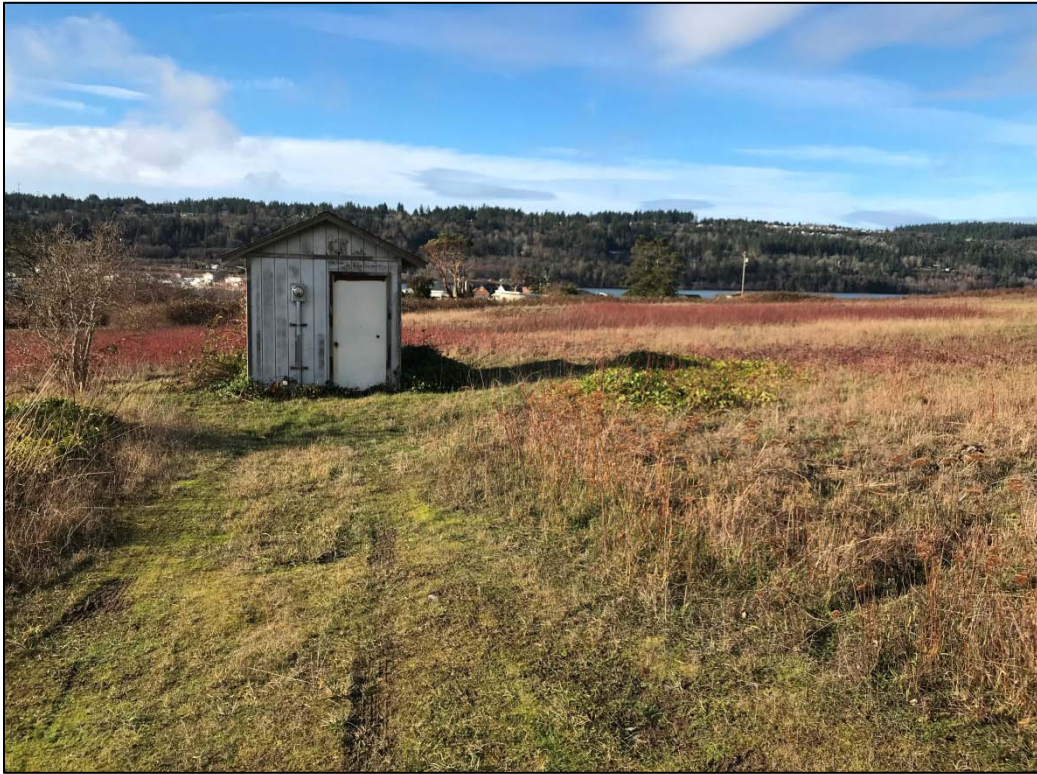
Figure 8. Well structure north of the 464 Barnum Road house. View is looking west.

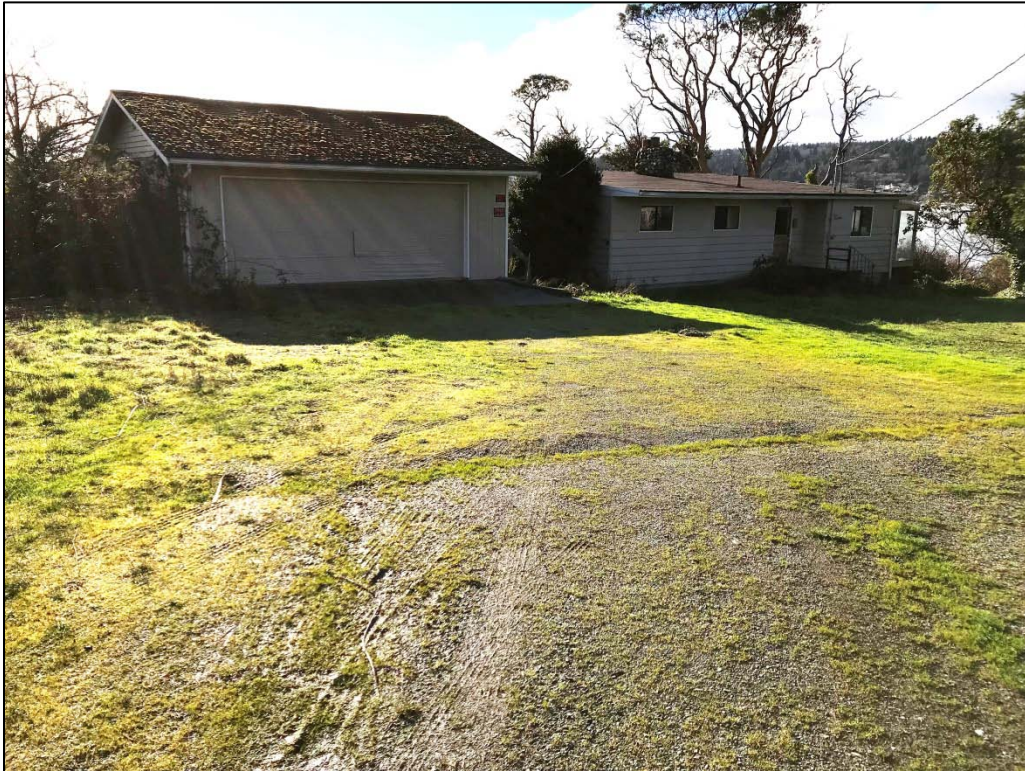
Figure 9. House and detached garage at 440 Barnum Road, on the west end of the subject property. View is looking southwest.

The other three buildings are located at the west point of the subject property and use the address 440 South Barnum Road. The structures include a one-story, wood-frame house with a basement on a concrete foundation, a detached garage, and a water well structure. We observed the interior of the well structure and detached garage. The garage has a small quantity of gasoline, about 1 gallon, in an EPA-approved red container; and a 5-gallon bucket with a lid containing an unidentified liquid. No drains are in the garage, and no evidence of leaks or spills from containers is apparent. Well equipment, plastic storage bins, at least two 20-gallon bags of salt pellets, and shreds of foam insulation are located inside the well building. No hazardous materials are observed in the well building.

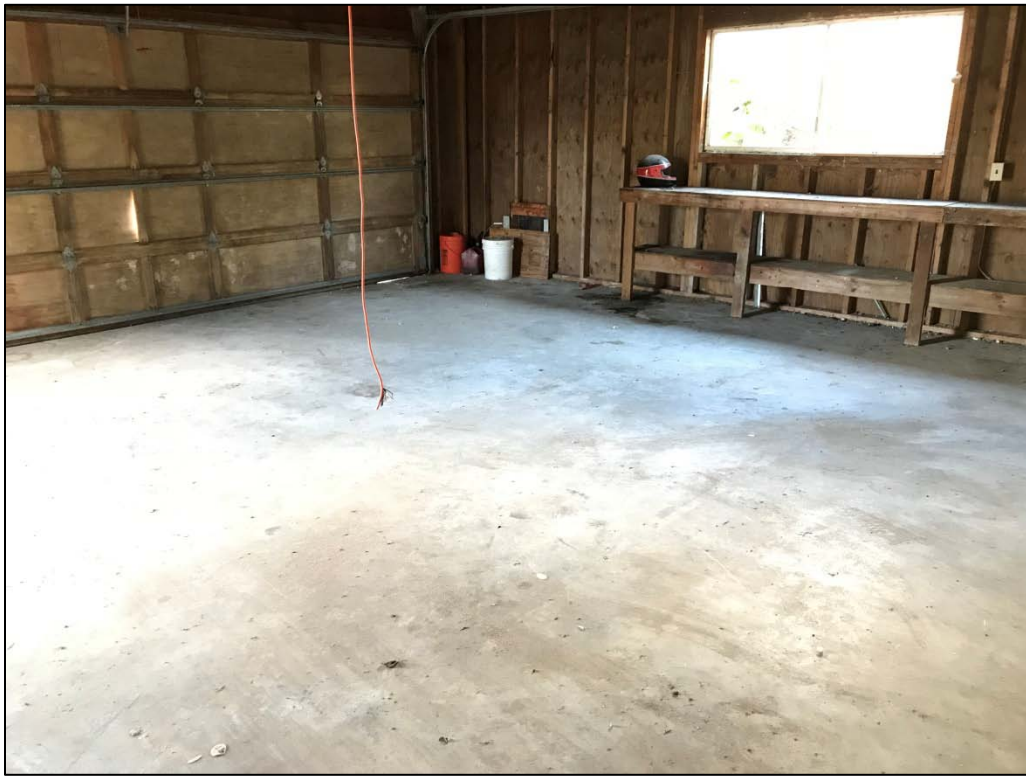
Figure 10. Interior of garage at 440 Barnum Road

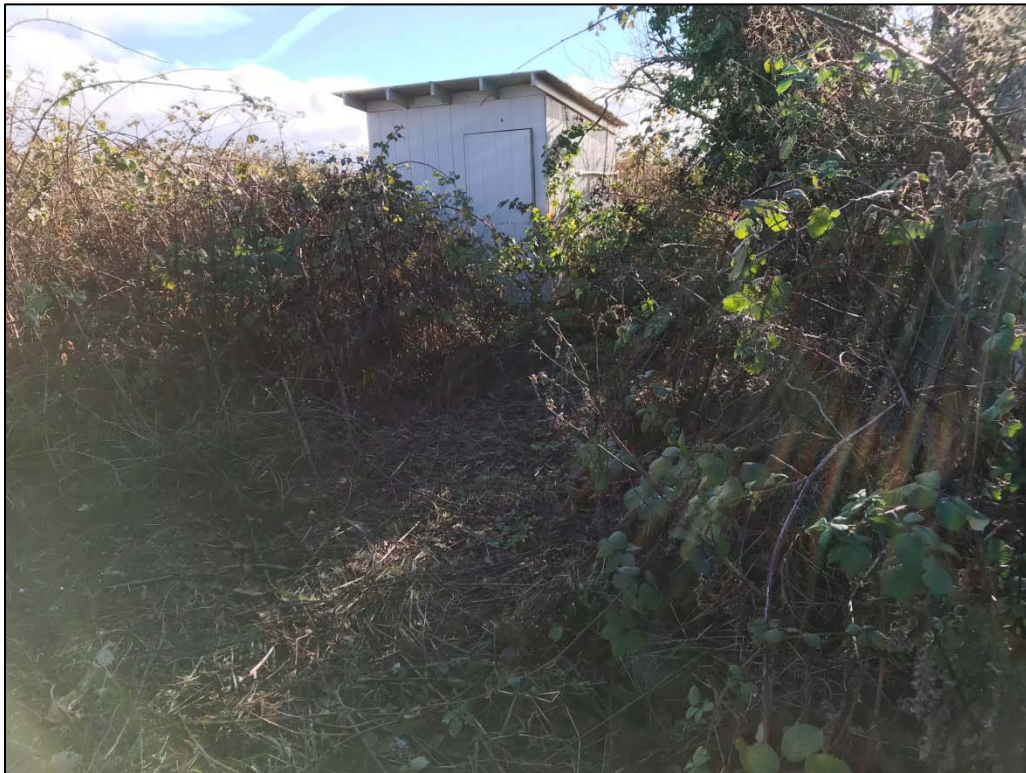
Figure 11. Well structure at 440 Barnum Road. Building is immediately east of 440 garage.
View is looking southeast.

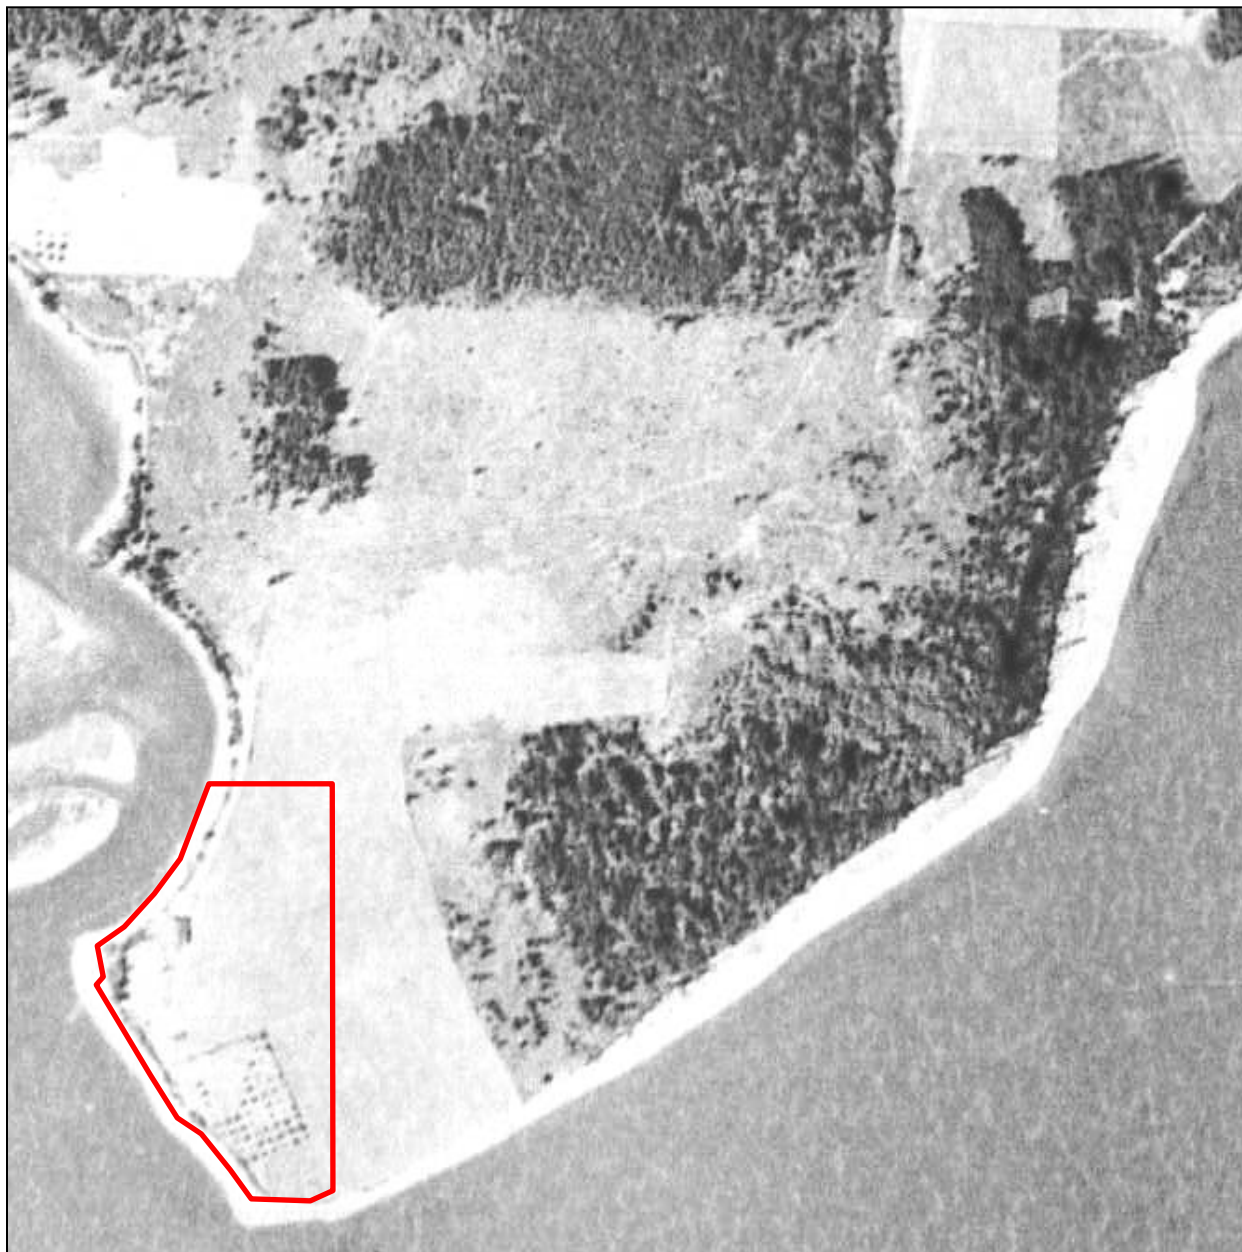
1941

Historic Aerial Photographs
(approximated upland area identified in red)

Historically, the subject property was used as a rural residential farm by at least 1941, and possibly back to 1914. The current residential homes were constructed in 1956 and 1993. No recognized environmental conditions are suspected in connection with historical uses of the site.
