## Connecting Salmon Recovery Strategies

# Goals and Objectives

## Recommended Alternative

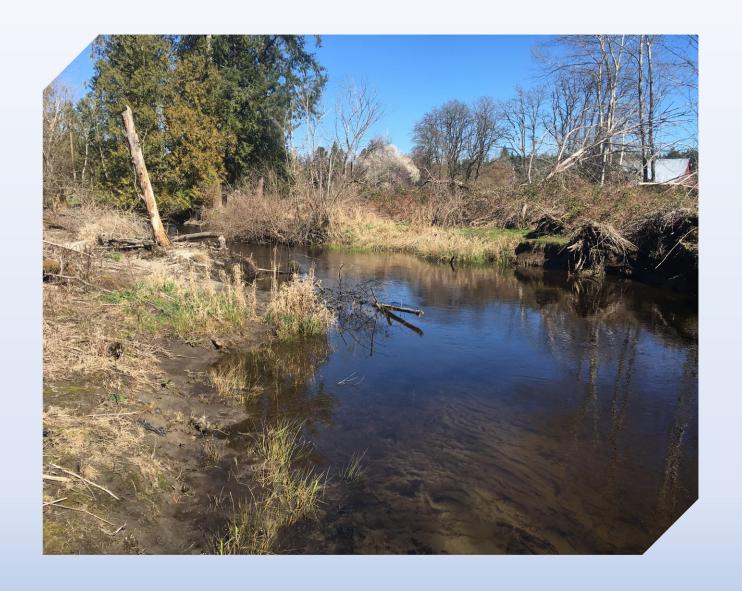
#### **Site Characteristics**

- Low-functioning riparian area
- Eroded streambanks
- Sparse native riparian vegetation

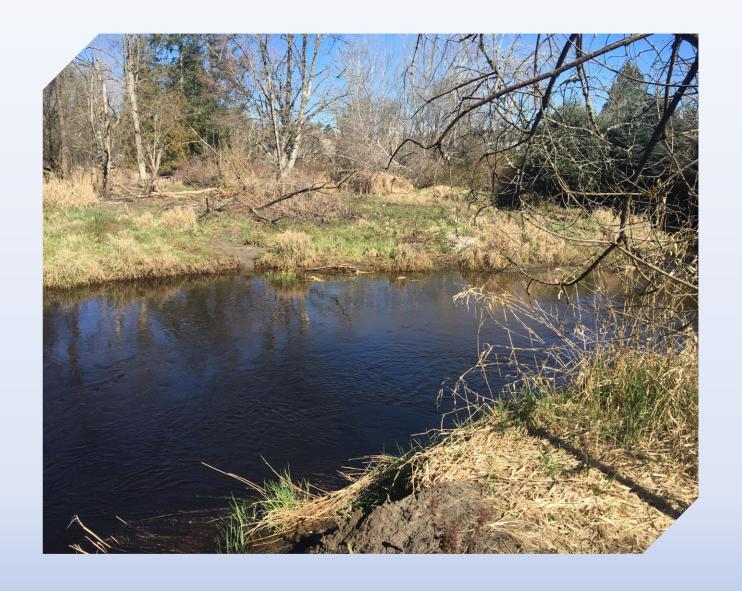
- Reed canary grass dominates riparian floodplain habitat
- Japanese knotweed & loosestrife also present
- Lack of quality shadeproducing cover

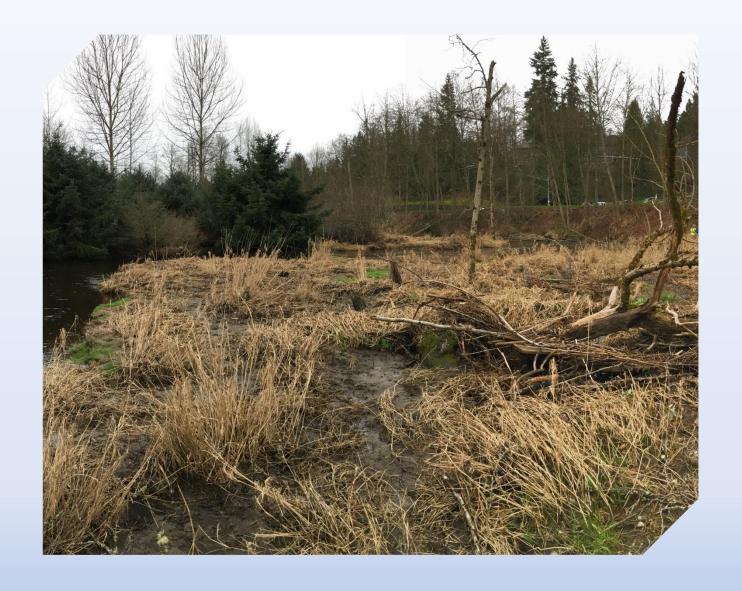
#### Floodplain Areas

- Limited wood
- Clear opportunity to improve connectivity to floodplain habitat

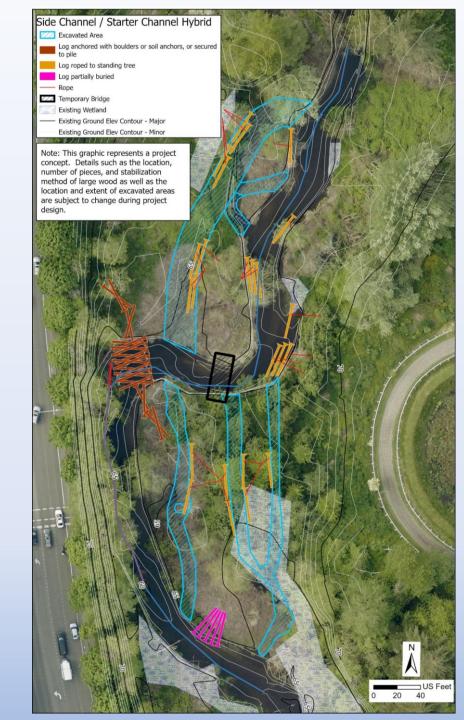
- Provide a variety of freshwater rearing habitats
- Side channel excavated in upstream segment
- Smaller "starter" channels excavated in downstream segment
- Wood placed throughout
- Jam placed to drive flow into starter channels
