# Technical Memorandum

**To:** Gina Austin, PE (City of Bellingham Parks and Recreation Department)  
**From:** Younes Nouri, PE, PhD (Moffatt & Nichol)  
**Date:** 6/7/2019  
**Subject:** Coastal Engineering Assessment - FINAL  
**Project:** Squalicum Pier at Little Squalicum Park  
**CC:** Bruce Ostbo, PE, SE and Margaret Schwertner (Moffatt & Nichol)

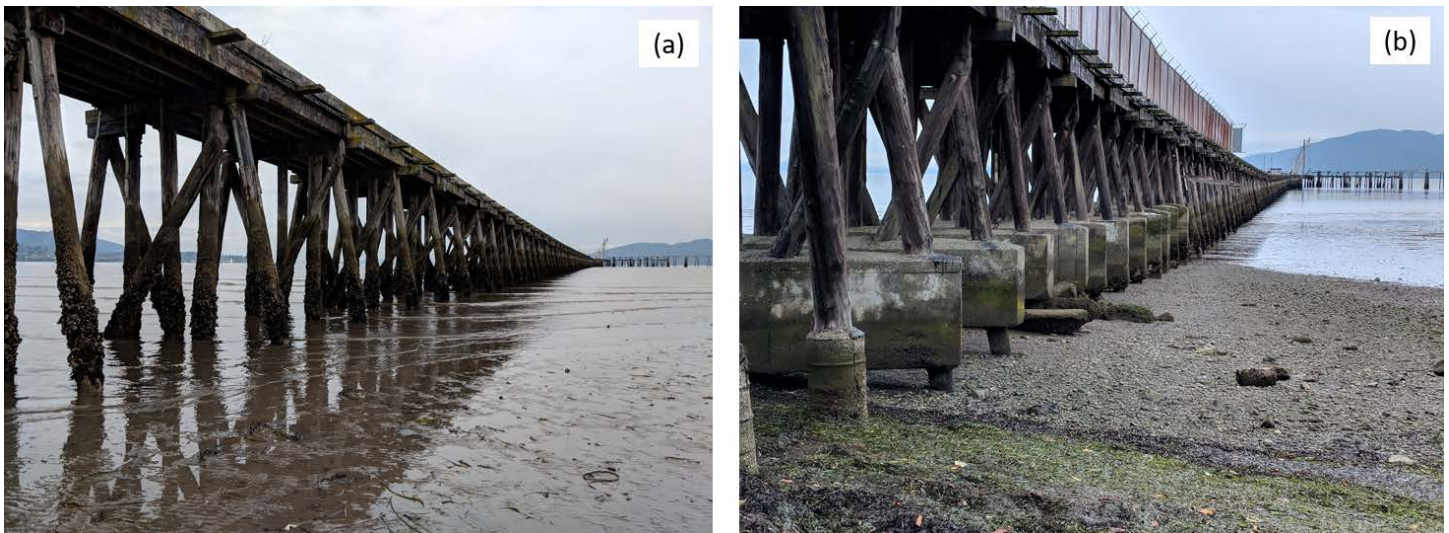
**Figure 1: Squalicum Pier consists of a timber deck supported by structural piles. Photos taken by a M&N coastal engineer on Oct 5, 2018 show (a) pile density, looking southwest and (b) concrete footing encasing the first few rows of structural piles, looking southwest.**

Squalicum Pier consists of an approximately 1,800-foot-long by 14-foot wide timber trestle, a 120-foot-long by 50-foot-wide timber wharf, a 2,300-foot-long supply line trestle, 14 timber dolphins, and timber catwalks, see M&N (2013) for further details. The trestle and wharf consist of approximately 1,200 structural piles. The first few rows of piling on the landward side are encased in a concrete footing. The functionality of the concrete casing is most likely to prevent damage to piles from impact by floating woody debris.

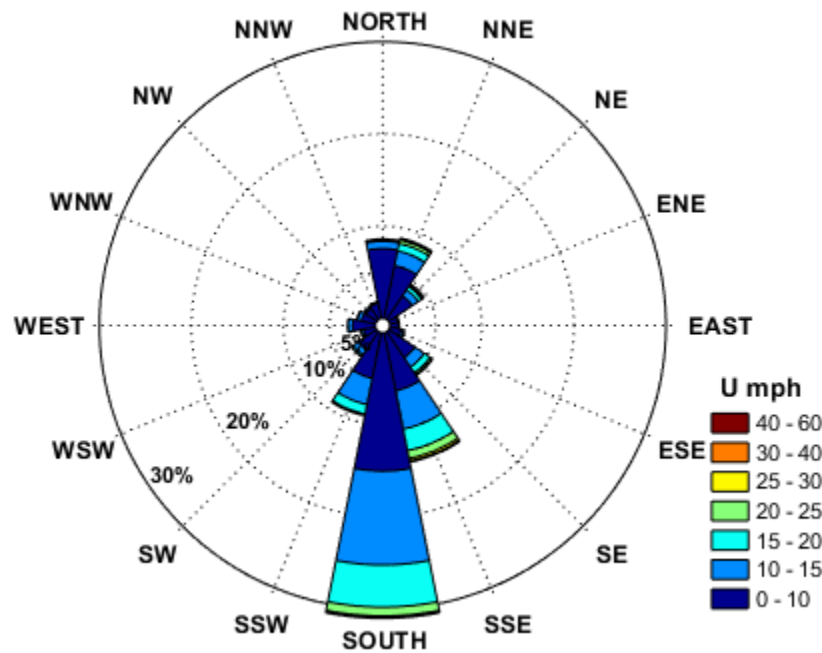
**Figure 2: Wind Rose for Bellingham Airport based on hourly measurements of wind speed and direction from 1948 to 2018.**

Predominant (strongest) and most frequent storms over Puget Sound are southerly followed by occasional northerly storms. Hourly measurements of wind speed and direction near the project site are available at Bellingham Airport. Hourly records of wind for the years from 1948 to 2018 were used to develop a wind rose, see Figure 2. This wind rose indicates that predominant winds at Bellingham Airport are southerly.

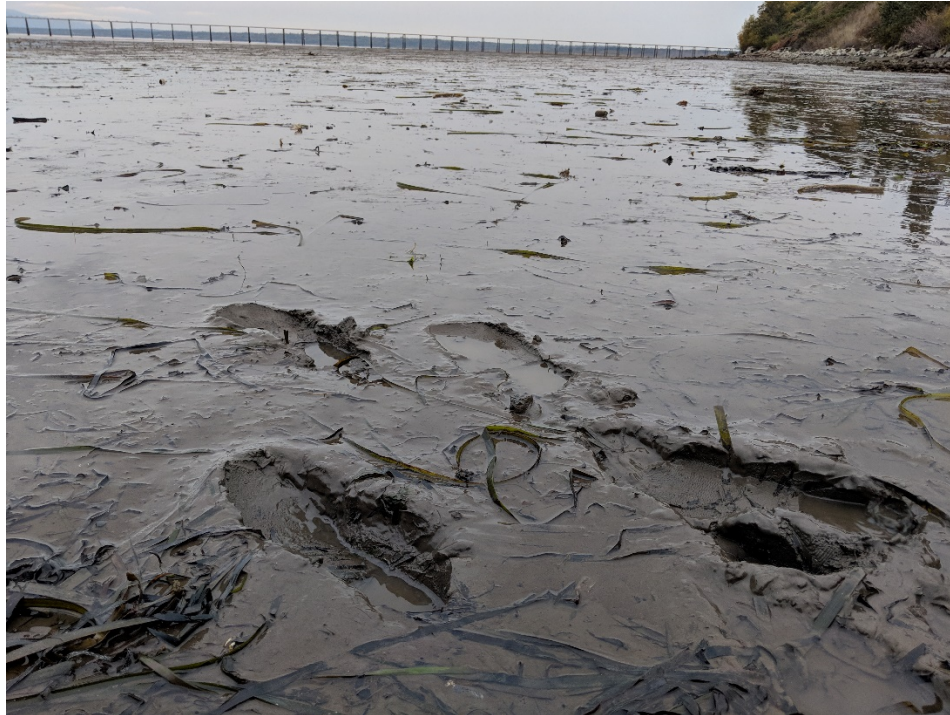
**Figure 4: Sunken footprints during a 2018 site visit by a M&N coastal engineer indicate abundance of cohesive fine material on the northwest side of the pier, photo taken between the pier and the supply line looking north.**

The Nooksack River deposits the mud fraction of the river's sediment load throughout Bellingham Bay. Google Earth Aerial images during low tide events indicate that the Nooksack River delta and resulting mudflats extend all the way to the pier. These muddy, fine sediments were observed during a 2018 site visit by a M&N coastal engineer as depicted by the sunken footprint in Figure 4.

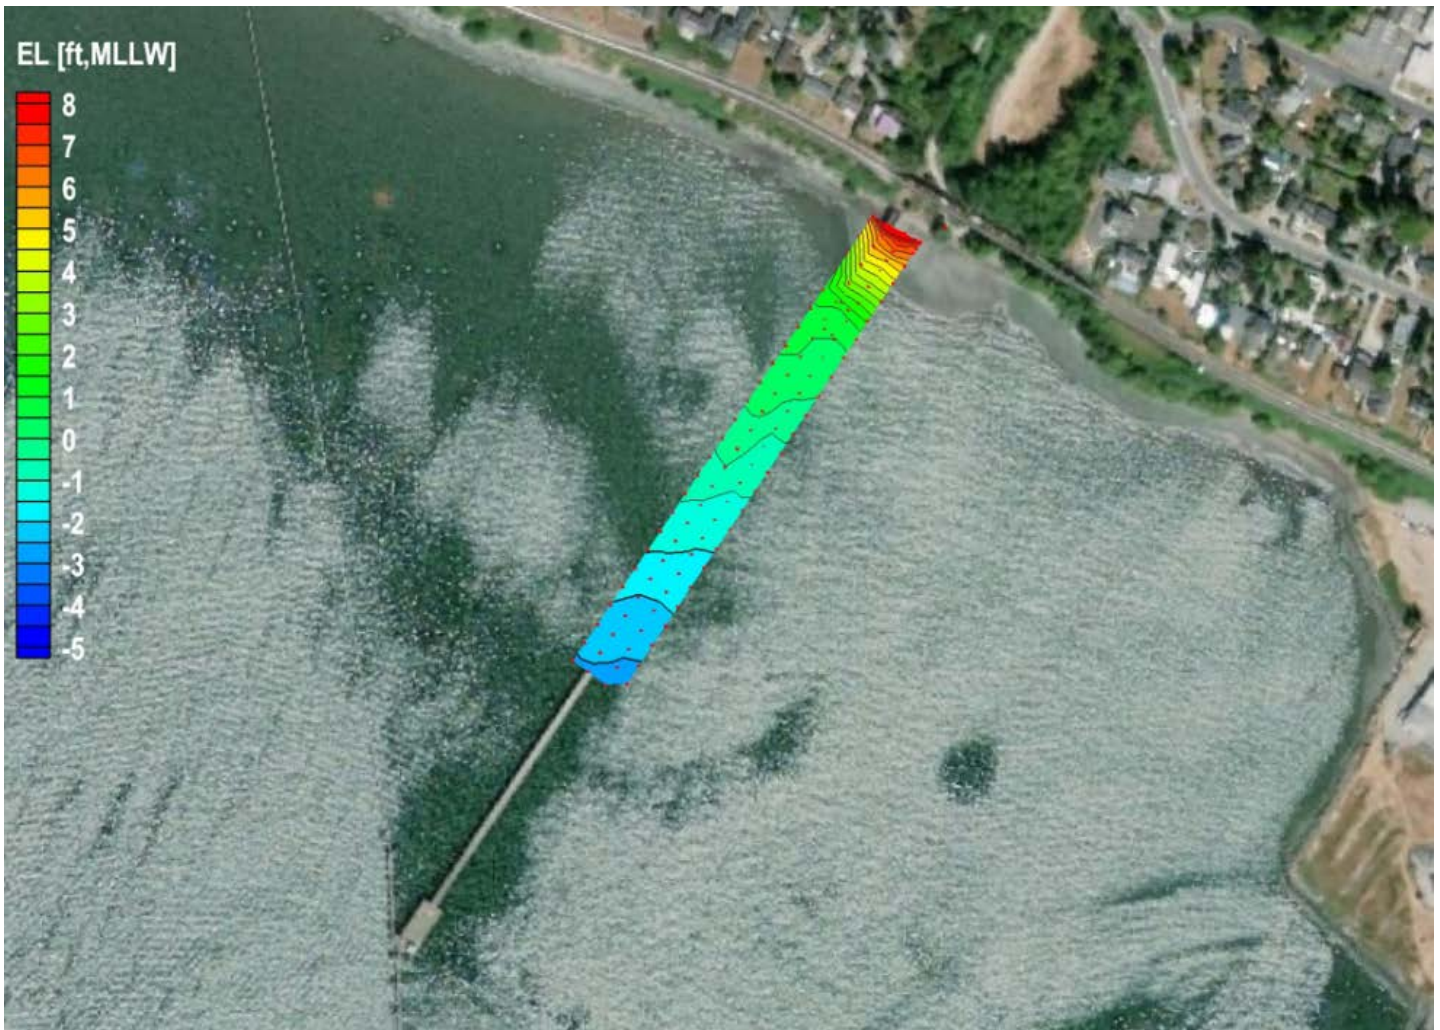
**Figure 6: Ground elevation (EL) referenced to MLLW in feet based on a 2018 nearshore survey specifically conducted as part of this project.**

A nearshore ground survey was conducted as part of this project in 2018. This survey identified elevations at half-foot contours along approximately 1,200 feet of the pier within 50 feet of either side of the pier. These Elevations ranged from -2.5 to + 8 ft, MLLW. Elevation contours from this ground survey are shown in Figure 6.

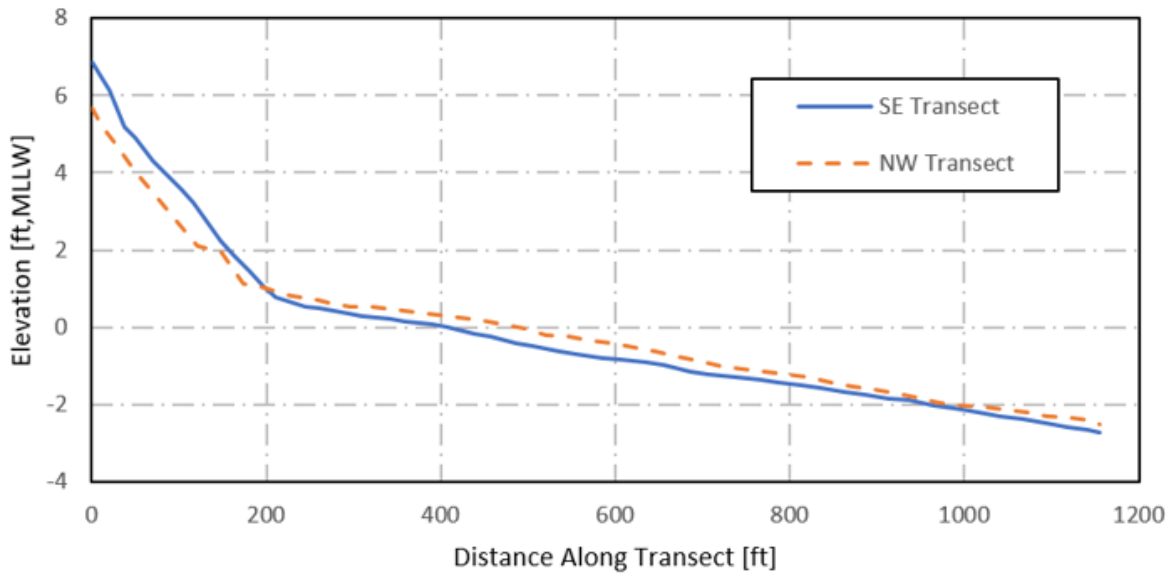
**Figure 7: Ground elevation for survey transects on NE and SE side of Squalicum Pier based on the 2018 nearshore survey.**

Ground elevation transects on each side of the pier confirmed that ground elevation on the northwest (left) side of the pier is approximately 0.25 ft (3 inches) higher than the southeast (right) side of the pier for elevation between -2.5 and +1.0 ft, MLLW (Figure 7). This is consistent with the discontinuity in the waterline observed in aerial images (Figure 5). For elevations > +1.0 ft, MLLW, ground elevation on the southeast side is higher than northwest side because of the Little Squalicum Creek delta.

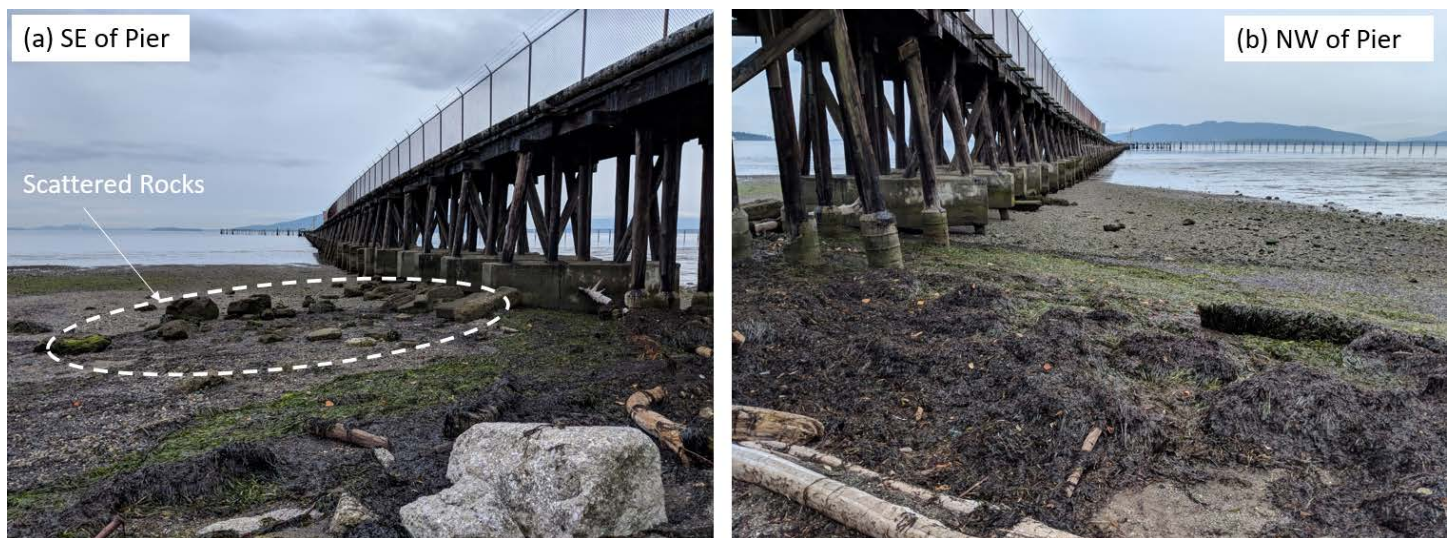
**Figure 10: Ground photos on southeast (SE) and northwest (NW) sides of the pier from an October 5, 2018 site visit by a M&N coastal engineer.**

Scattered rocks on the southeast side of the pier within the first five landward rows of piling were observed by a M&N coastal engineer during a 2018 site visit, see Figure 10. In addition, several aerial images show accumulation of large woody debris (LWD) and trapped debris on the southeast side. Accumulation of logs and scattered rocks on the southeast side of the pier indicate the pier's hinderance of sediment and LWD transport in the northwest direction. Trapped logs and rocks on the southeast side of the pier were observed on multiple occasions by CGS (2009) as well.
