# 2020 State of Our Watersheds Report

## Green-Duwamish River, White-Puyallup River and Lake Washington Basins

# Muckleshoot Indian Tribe

## Lake Washington, Green-Duwamish & White-Puyallup River Basins

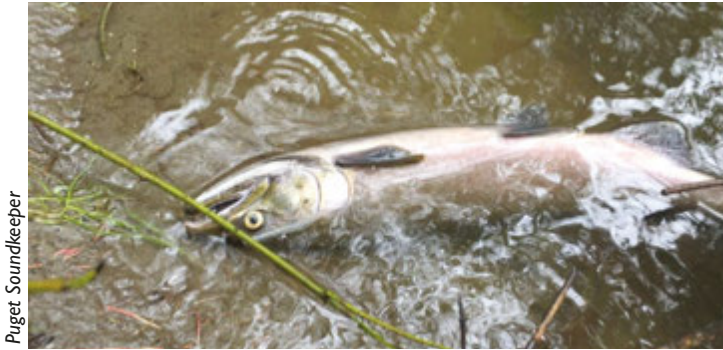
A coho salmon in Longfellow creek exhibits signs of stress.

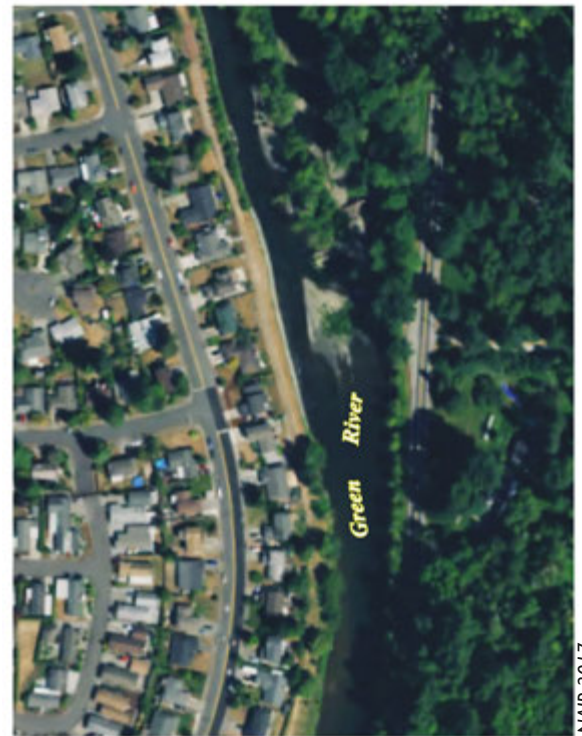
NAP 2017

The lower Green River between Auburn and Tukwila has severe shade deficits along each side of the river, elevating water temperatures to levels known to cause disease outbreaks and pre-spawning mortality in migrating salmon and trout.

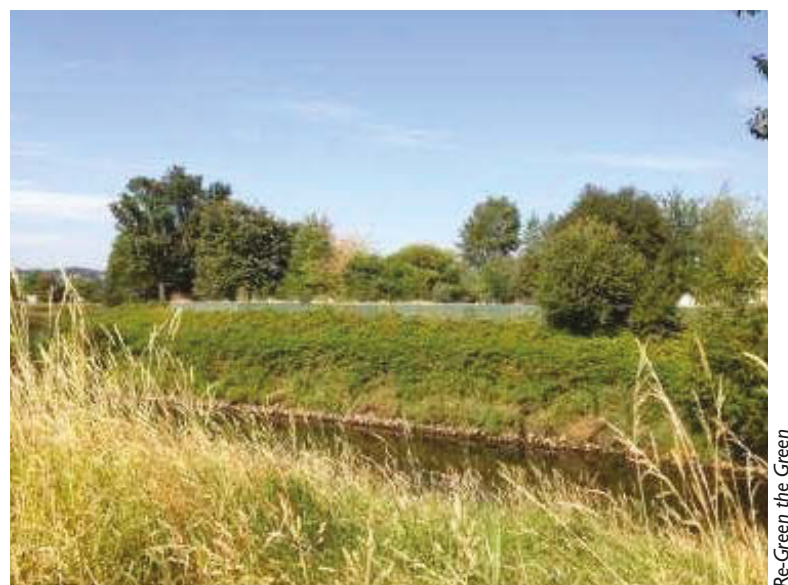
Typical levee on the Lower Green River, with nonnative shrubs offering very little shade.

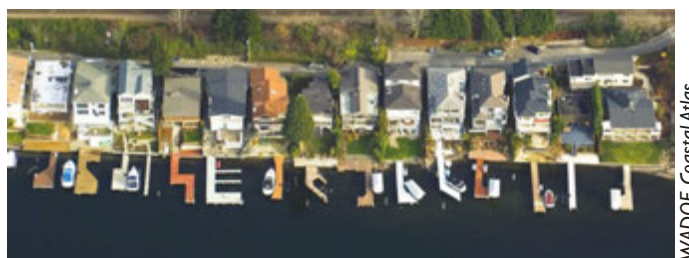
Example of large numbers of docks on the shore of Lake Washington.

Docks cause overwater shading that harms bottom habitat and disrupts the movement of young fish, such as salmon. Docks also disrupt the natural flow of sediments, causing beach erosion, creating shallower water around neighboring docks, and eliminating places for fish to spawn and feed.<sup>2</sup> The most critical area for juvenile salmon is the first 30 feet from the edge of the shoreline.

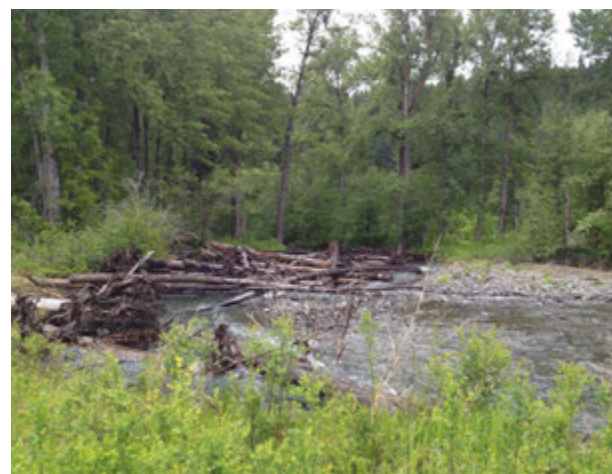
NOAA, Northwest Fisheries Science Center

Large wood such as logs and root wads has always played a natural role in most river systems, and most studies have concluded that wood placed in rivers remains stable, improves habitat conditions and increases fish numbers – particularly for salmon and trout. Woody debris often improves habitat quality by creating pools and providing cover. Wood also increases the retention of organic matter and nutrients and helps create islands and new channels that provide additional refuge and habitat, especially for rearing juvenile fish.<sup>8</sup>

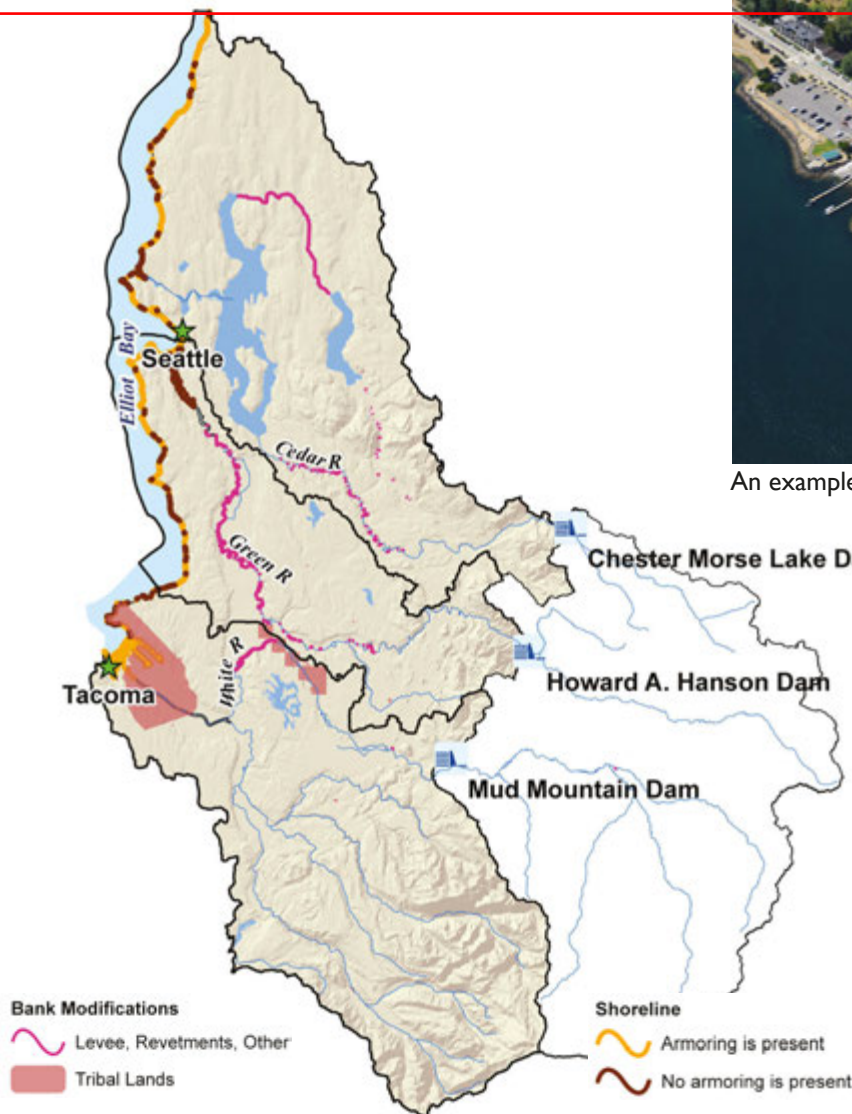
An example of shoreline armoring in King County.

Bulkheads and other forms of armoring line 92% of Seattle's marine shoreline. From 2015-2018, 750 feet of armoring was removed while 235 feet of new armoring was constructed. Three Hydraulic Project Approval (HPA) projects were issued for new bulkheads, 2 HPA projects were issued to remove bulkhead, while 43 projects were issued to replace bulkhead in King County.

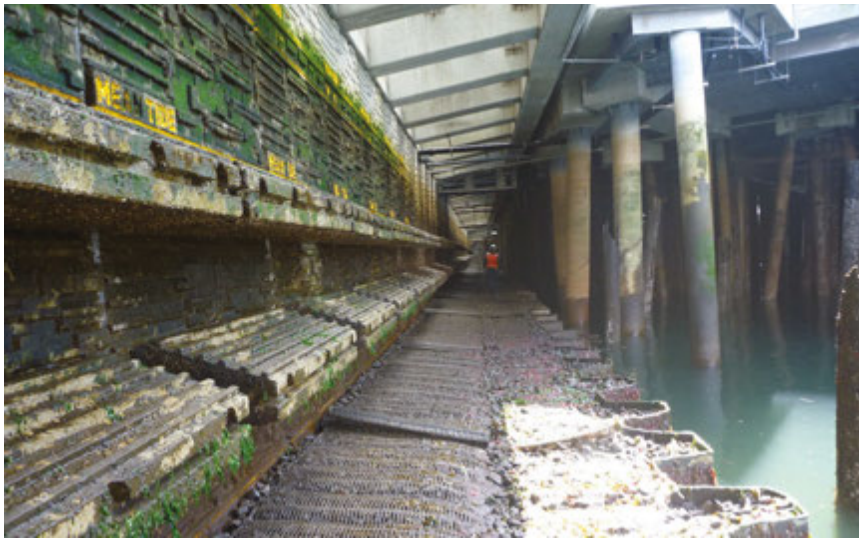
The new Seattle seawall below the sidewalk at low tide.

Instead of encountering a barren slab of concrete, salmon can now swim across a “bench” in front of the seawall. The bench forms a narrow strip of intertidal habitat, effectively providing a shallow-water pathway for juvenile salmon. Glass blocks in the sidewalk above the seawall allow light to penetrate to the water below, and a rough surface on the wall itself has horizontal shelves to encourage the growth of algae and invertebrates. New scientific findings about marine organisms growing on or near the seawall, plus behavioral changes in young salmon swimming through the area suggest a real payoff from these enhancements. After construction, researchers observed a notable increase in feeding behaviors under the piers, where the fish had never been known to feed before.<sup>6</sup>

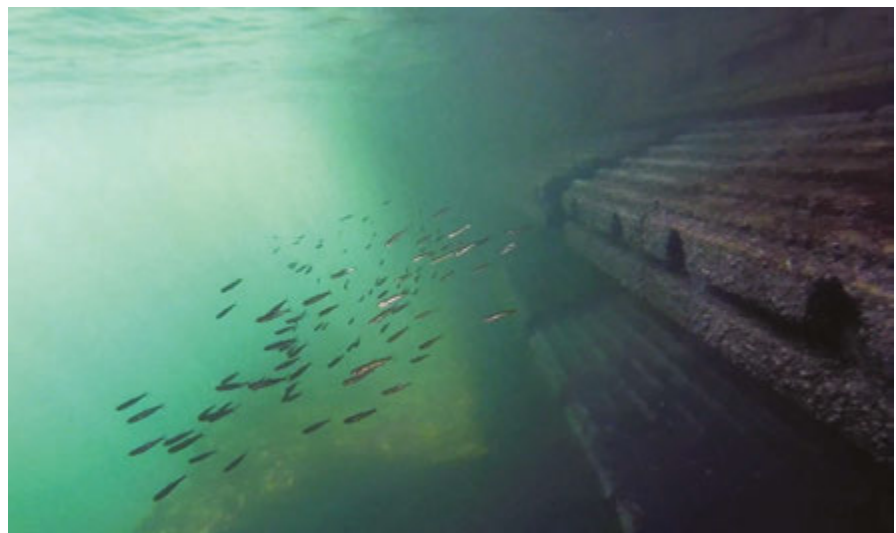
Juvenile chum salmon swim along the new Seattle seawall.
