**GEORGE DAVIS CREEK
FISH PASSAGE PROJECT**

**HYDRAULIC REPORT
PRELIMINARY**

City of Sammamish
Sammamish, WA

Northwest Hydraulic Consultants Inc.
Seattle, WA

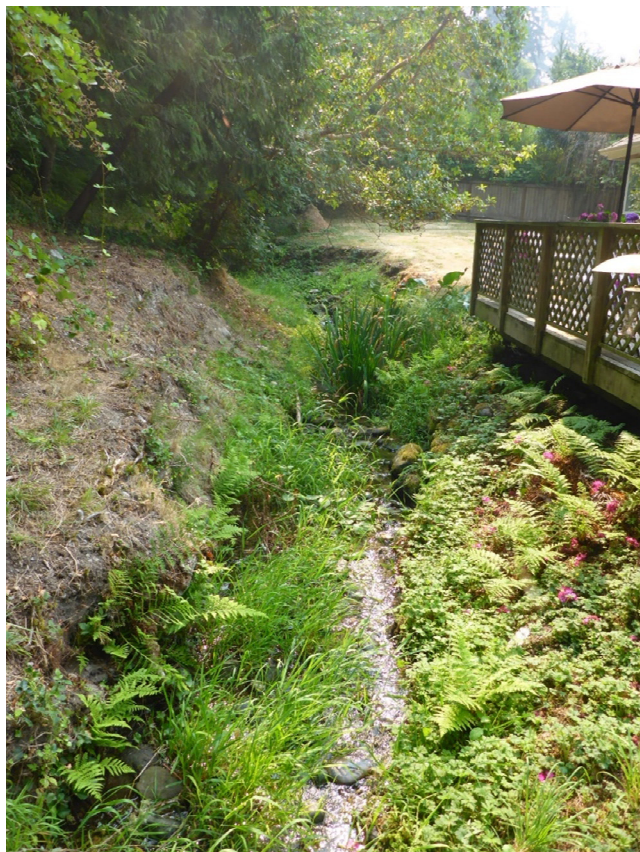
Photo 1. Creek channel at exist of ravine

Upstream of ELSP, where George Davis Creek exits the ravine, the stream is channelized through a private property¹ (Photo 1), then confined between NE 7th Court and additional private residences to the south. A sharp bend with high outside bank occurs where the creek turns westward. Downstream, the

¹ During the site assessment, the resident here reported to NHC that the highest stream level they had observed had reached just below the back deck (Photo 1).

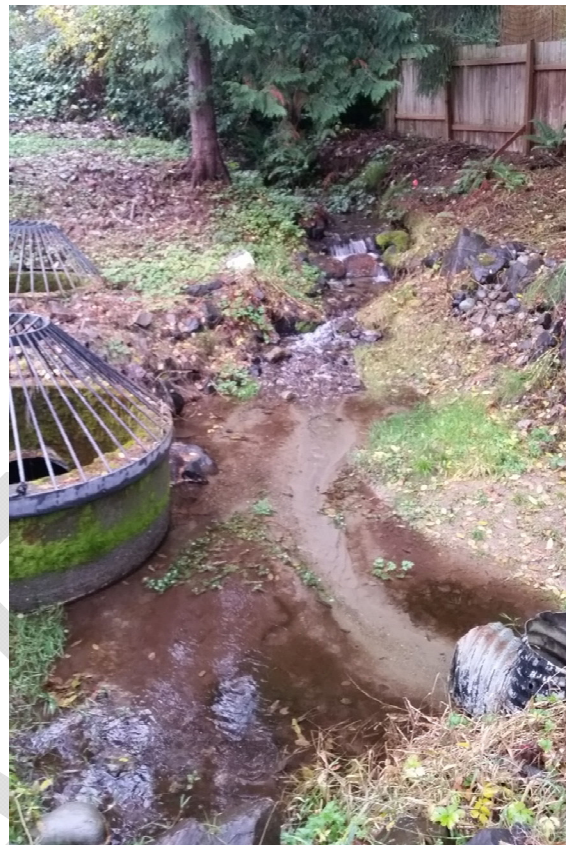
Photo 2. Sedimentation basin upstream of ELSP

stream corridor is narrow, approximately 35-feet wide, with near vertical banks, 2 to 6 feet high. Evidence of moderate bank erosion was observed along the entirety of this reach. Stream grade upstream of ELSP is controlled by boulder and log steps installed as part a sedimentation basin (Photo 2) constructed by the County in 1994-95, after the previous undersized crossing experienced severe flooding during a high flow event in January 1990 (Parametrix, 2011). The sedimentation basin measures approximately 30-foot long, 25-foot wide, and is four to five feet deep, and has a storage volume of approximately 60 cubic yards. City staff report that the basin typically requires maintenance once or twice a year to remove trapped sediment (Pers. Comm. 10/20/18). In addition to trapping sediment, the basin also functions as a high flow bypass. The bypass consists of two elevated manhole overflows fitted with birdcages located on the right (north) side of the pond (Photo 2). Overflow into these structure diverts George Davis Creek flood waters through a bypass culvert that follows ELSP northward and ultimately discharges to Lake Sammamish approximately 550 feet north of the existing creek mouth (Figure 1 and Photo 3)².

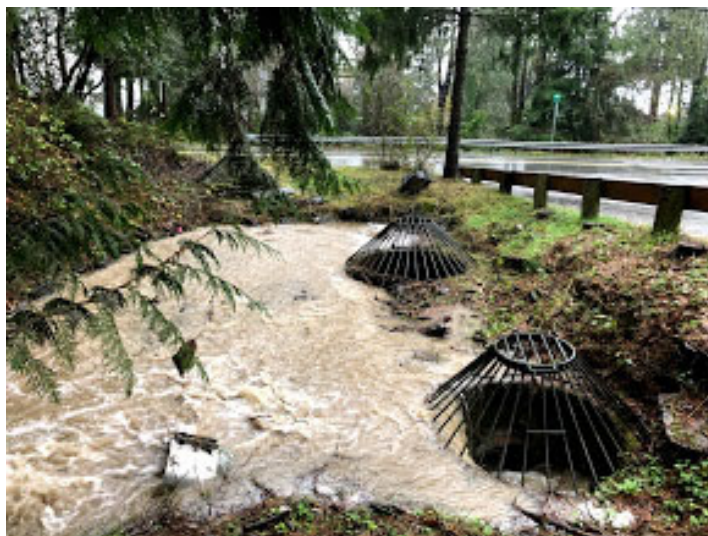
Photo 3. Bypass activated during high flow event (12/20/19)

² The sedimentation basin and high flow bypass was recently activated during a storm event in December 2019. NHC visited the site and observed that the inlet to mainstem George Davis Creek became plugged with sediment further reducing

downstream flow through the control structure. The majority of flow was observed to be entering the bypass. City maintenance staff were monitoring the site during the event to make sure it was functioning properly.

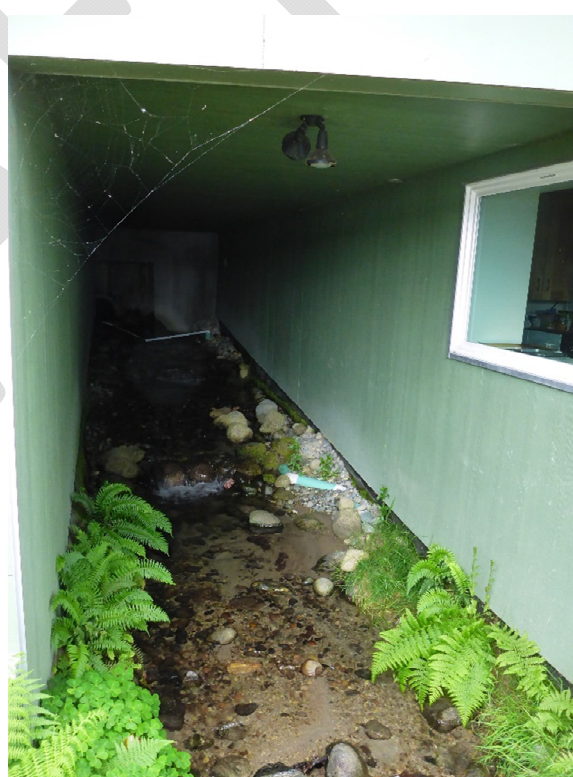
Photo 4. Creek corridor through Linde residence, facing upstream

Downstream of the trail, George Davis creek enters an approximately 150-foot long, 24-inch diameter clay pipe that crosses under East Lake Sammamish Lane and two lake front properties. The estimated elevation drop through the culvert is 10-feet, with a slope of approximately 7-percent. The culvert discharges at the eastern foundation of the Linde residence (Figure 1) then flows through a 40-foot enclosed corridor underneath the home (Photo 4) followed by approximately 60-feet of open channel to Lake Sammamish. This lower segment was restored circa 2009 to provide fish habitat (Parametrix, 2017). The homeowner has observed Kokanee in this lower 60-foot reach, but the series of upstream culverts effectively function as barriers

preventing passage further upstream. It should be noted the lower segment of George Davis Creek, downstream of the trail, currently relies on the high flow bypass at ELSP to prevent potential flood damage, especially within the Linde property reach.

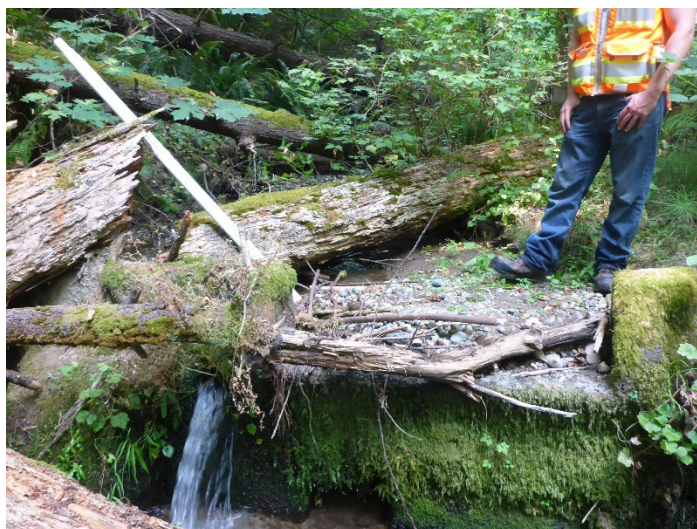
Photo 5. Diversion dam 500 feet upstream of ELSP

In addition to the Shore Lane and ELSP culverts, the City project includes removal of a diversion dam located in the George Davis ravine, approximately 500 feet (Photo 5). The dam consists of an approximately 20-foot wide channel spanning concrete weir with a 3.5 foot drop. It is estimated that 125 to 200 cubic yards of sediment is captured behind the dam. These deposits extend approximately 150 feet upstream.

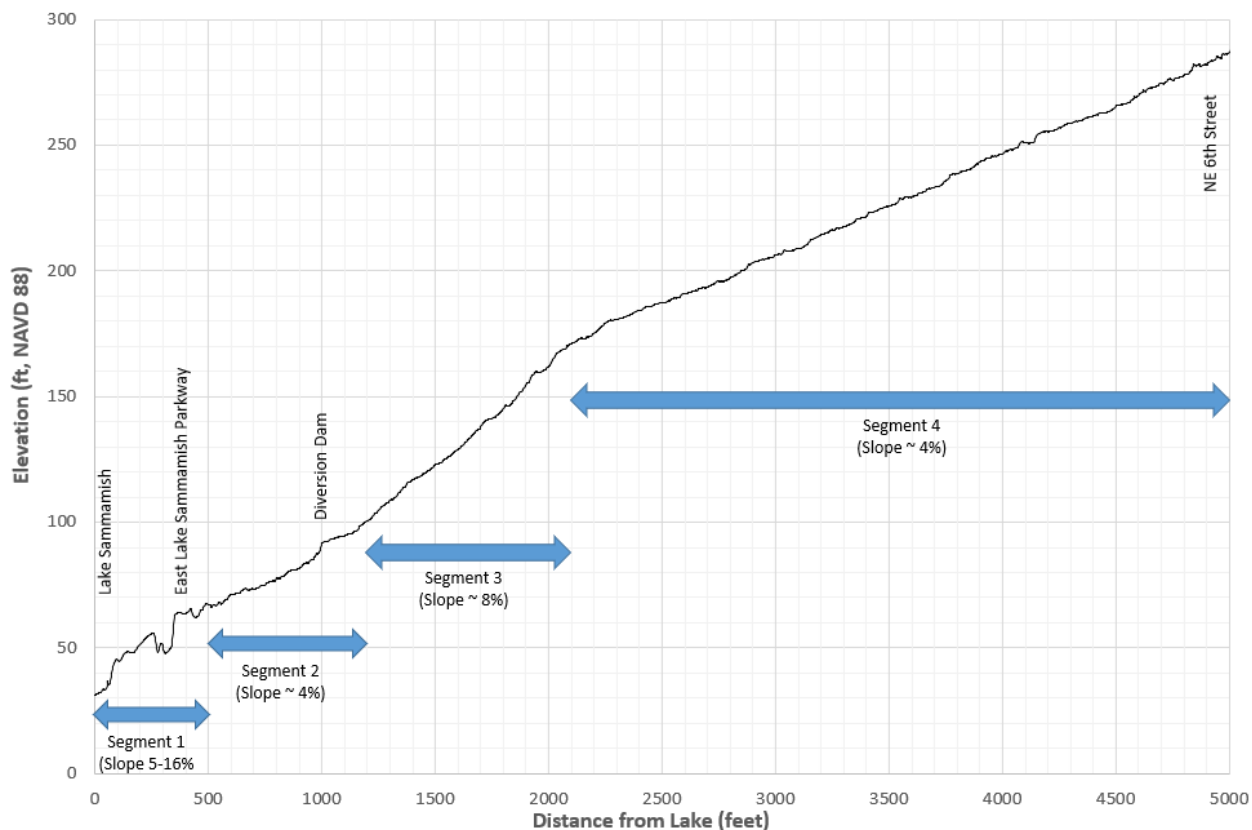
Figure 3. Longitudinal profile of lower George Davis Creek based on 2016 King County LiDAR topography.

Figure 3 shows the longitudinal profile of lower George Davis Creek extracted from 2016 King County LiDAR topographic data. The reach is subdivided into four segments at distinct grade breaks in the longitudinal profile. Segment 1 is located from Lake Sammamish to just upstream of ELSP. Coinciding with the project reach, this is the steepest segment on lower George Davis Creek, with slopes varying

from five to 16 percent. The steep slopes along this 500-foot long reach can be attributed to extensive manipulation through channelization, regrading, and grade control provided by existing stream crossings.

Segment 2 extends upstream of ELSP approximately 700 feet to just upstream of the existing diversion dam. The reach-averaged slope is fairly uniform at four percent. The relatively low slope could be attributed to either grade controls in the vicinity of ELSP, but may also reflect some controls from underlying geology. Segment 2 coincides with the transition between alluvial fan and compacted pre-glacial deposits. Although not conclusive, the lower gradient observed in this reach may be associated with refusal to further channel incision as the stream has encountered a more stable underlying geology. The existing diversion dam is located toward the upper extent of Segment 2. As previously noted, the LiDAR data indicates a sediment impoundment extending approximately 150 feet upstream of the dam.

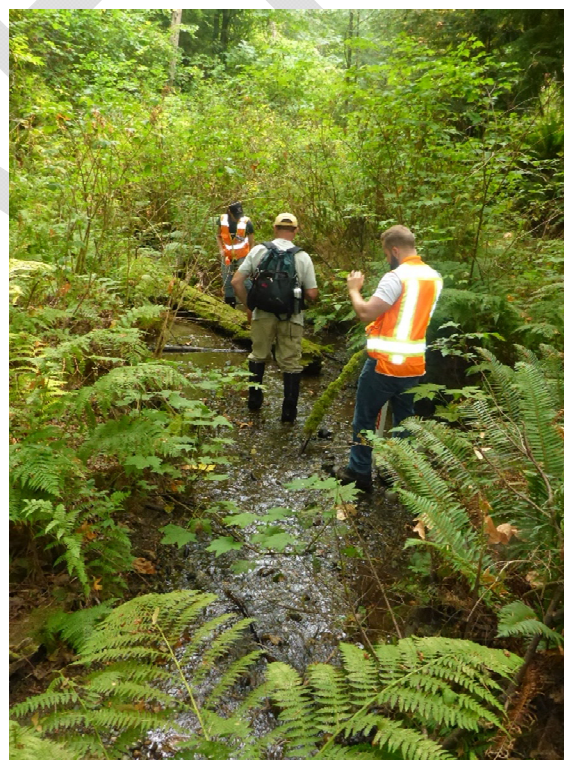
Photo 6. Channel in Segment 2

A more natural stream morphology begins in Segment 2 where George Davis Creek enters the relatively undisturbed upland ravine; however, some anthropogenic influence is found in the ravine. In addition to the previously described diversion dam, a 12-inch stormwater tight-line discharges stormwater from the northside of the ravine Segment 2 (Parametrix 2011). Furthermore, installations of man-made log jams begin in Segment 2. In tandem construction of the high flow bypass and sedimentation basin, King County also undertook a ravine stabilization project with the placement of approximately 70 large woody debris (LWD) structures primarily in Segments 3 and 4 of lower George Davis Creek (King County, 1994b). Naturally occurring large woody debris deposit were also observed along the entirety of the ravine. Channel morphology in the lower gradient portion of Segment 2 is not well defined, likely owing to a combination of active sedimentation, vegetative controls, and influence of LWD. Alternating cascade, pool-riffle, and step-pool morphologies were observed and bank widths fluctuated widely. Bed composition varied from cobbles and small boulders to small to medium gravels. Well defined pools were generally not observed in Segment 2 (Photo 6).

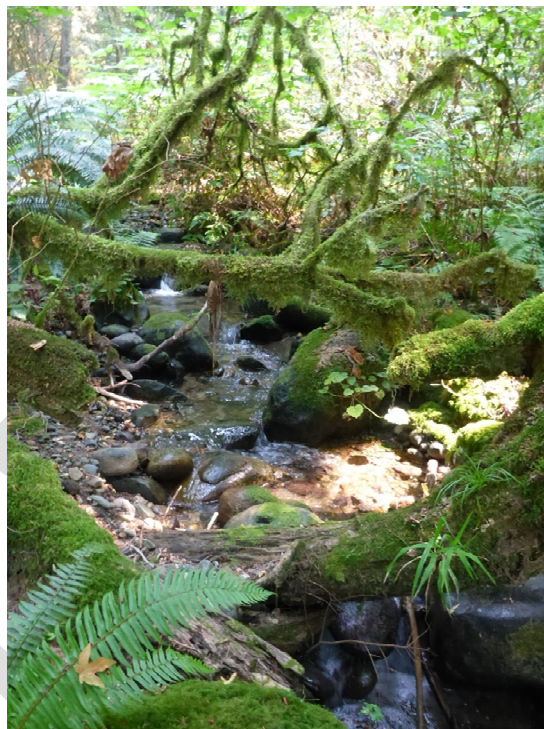
Photo 7. Channel in Segment 3

Segment 3 begins approximately 200 feet upstream of the former diversion dam and the channel gradient noticeably steepens as suggested by the presence of boulder-sized material (> 256 mm) armoring a narrowed channel (Photo 7). Boulder-sized materials are likely lag deposits originating from previously overlying glacial till or outwash. Channel morphology varied from step-pool to cascade in Segment 3, but again, well formed pools were generally not observed. Near stream station 1,900 the channel reaches maximum confinement between a narrow 50-foot wide section of the ravine. Channel incision here has exposed underlying densely consolidated (likely) pre-glacial material from which seepage was observed. Narrow conditions continue upstream for another 200-feet with nearly vertical banks and evidence of the previously described landslide along the south bank of the ravine.

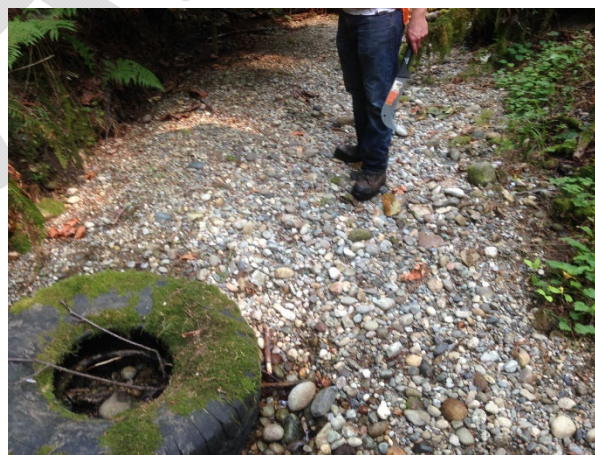
Photo 8. Channel in Segment 4

Segment 4 begins at approximately stream station 2,100 where the gradient and surface flow both noticeably decrease. The channel bed widens in Segment 4 and the streambed material consists of uniform, medium sized gravel (Photo 8). As previously noted, surface stream flow discontinued near stream station 2,800. Significant amounts of gravel-sized material was observed along the entirety of the Segment 4, but it's unclear how frequently it's exposed to mobilizing flows. Infrequent wetting was supported by observations of increasing amounts of duff material and moss-covered sediment further up in the ravine. At stream station 4,100 a stormwater tight-line and energy dissipater was observed entering the creek from the south side of the ravine.

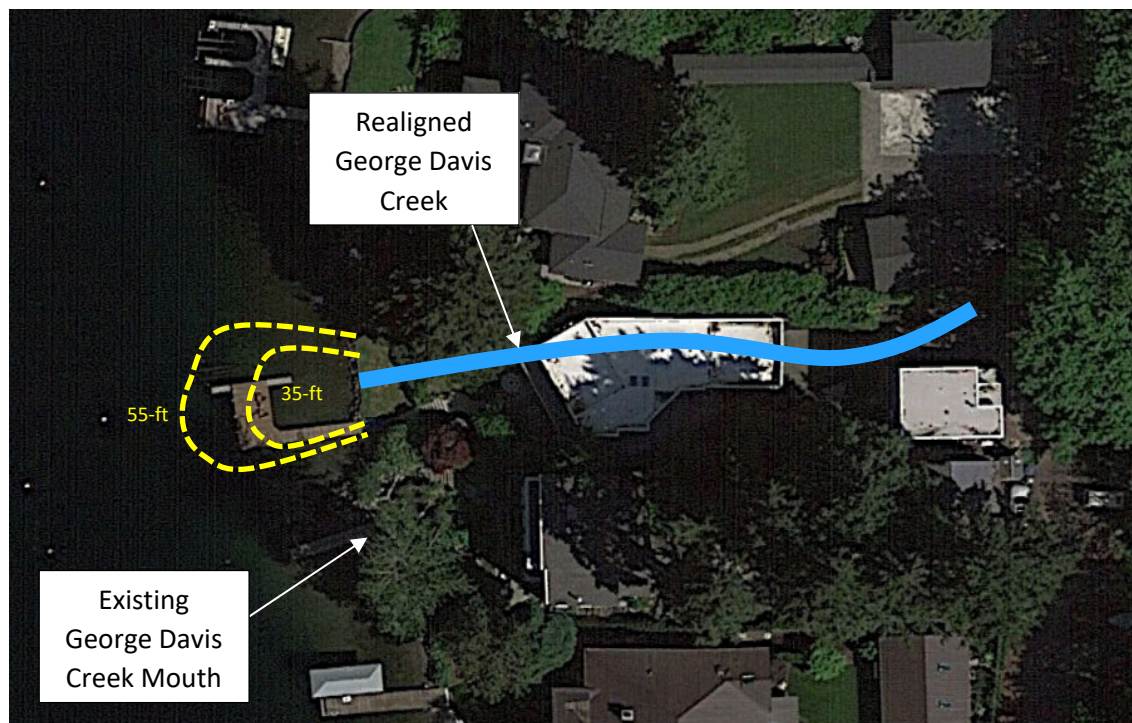
Figure 5. Aerial photo of estimated delta growth in 10 years

given uncertainty with upstream sediment loading, lake bathymetry, and longshore transport of sediments. A first-order estimate of delta planform growth, assuming sediment loads in the range 60 to 120 cubic yards per year (see Section 2.3), predicts a delta lobe could extend 35 to 55 feet into Lake Sammamish within 10 years of project construction. Given the relatively wide buffer, sediment deposition and delta formation is not expected to adversely affect access to neighboring docks or the overall quality of the waterfront in the vicinity (Figure 5).

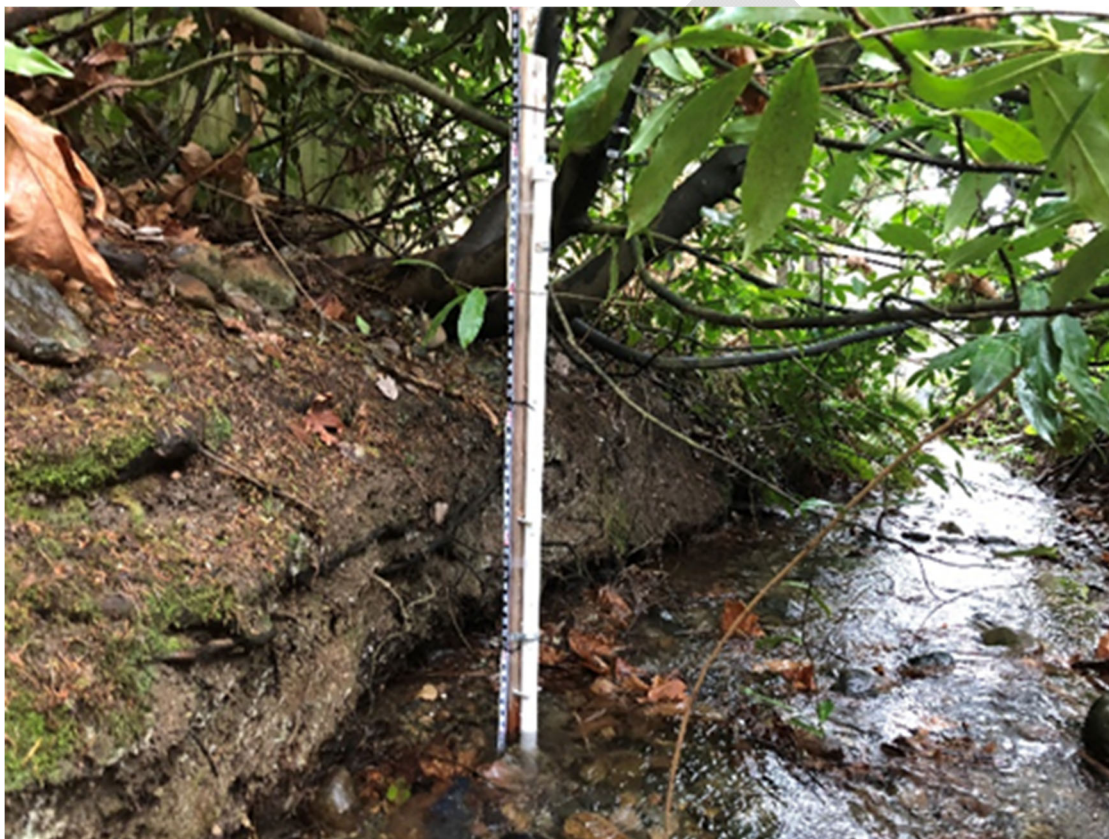
Photo 9. Stream gage installation on George Davis Creek

NHC installed a stream gage on December 13, 2018 (Photo 9) approximately 120 feet upstream of the ELSP sedimentation basin. The gage setup consists of PVC piping with a perforated bottom to allow water inside the column and a Solinst levellogger inside, sitting in the water, taking measurements at 5-minute increments. A tape measure is attached to the gage housing to act as a staff gage. Flow measurements in channel were collected approximately 50 feet downstream (Photo 10). A total of six flow measurements were taken during the fall and winter of 2019/2020 (Table 3,). Staff gage readings and data from the level logger and barometric pressure logger were also downloaded during these site visits.

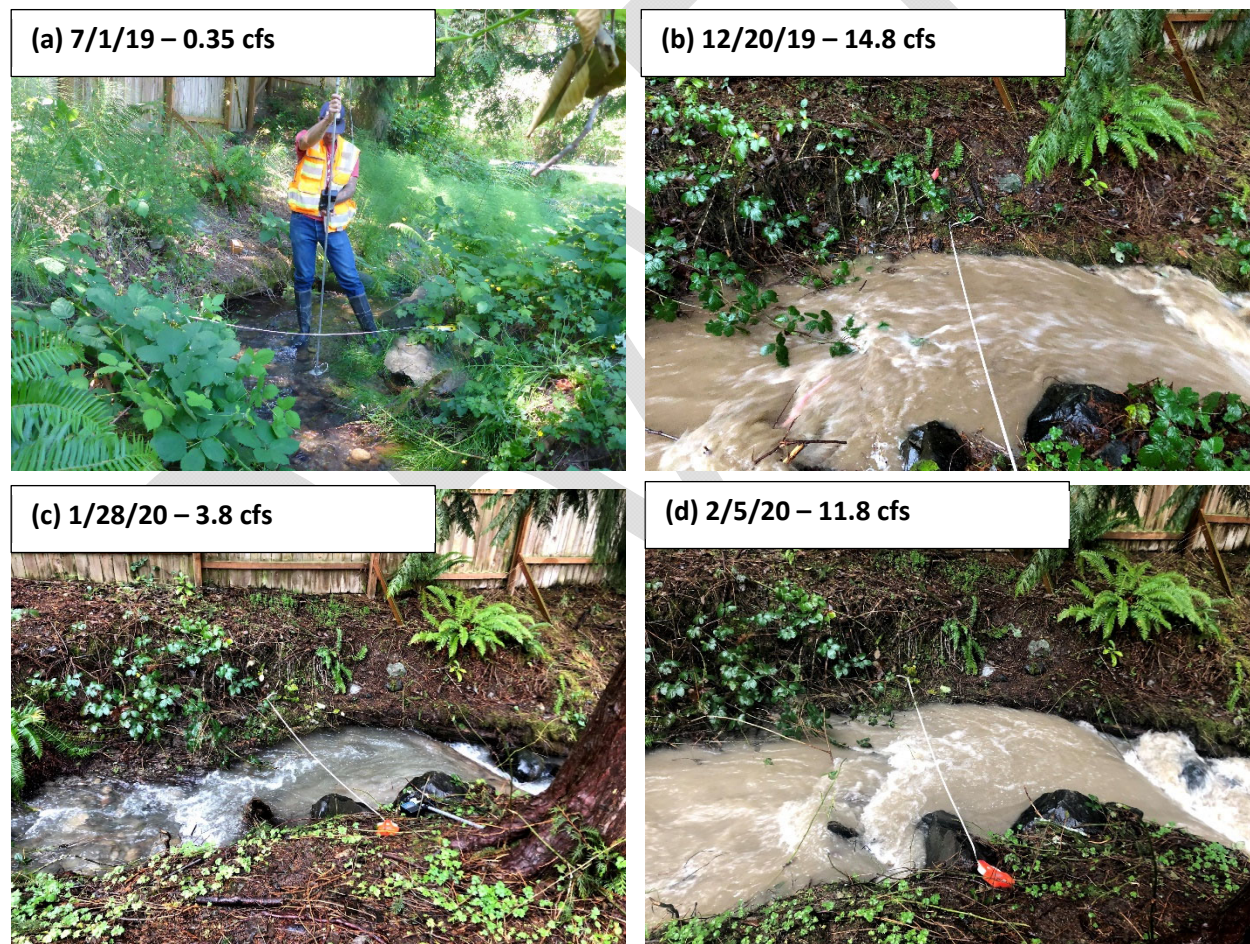
Photo 10. Flow measurements on George Davis Creek

Date	Time	Flow (cfs)
12/13/18	12:30	0.5
12/19/18	12:30	0.7
10/22/19	9:00	0.9
12/20/19	13:15	14.8
1/23/2020	16:20	2.0
1/28/2020	10:50	3.8
2/5/20	13:45	11.8

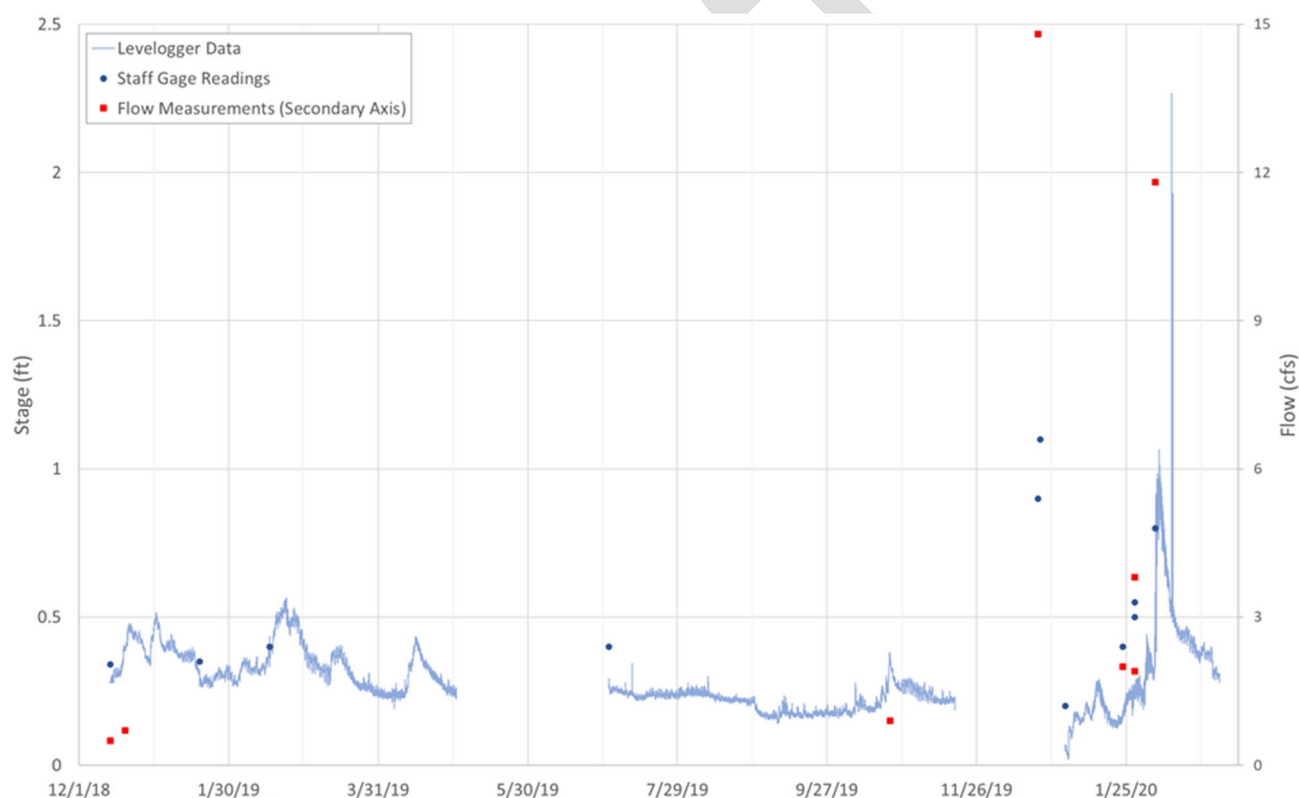
Figure 6. Recorded monitoring data on George Davis Creek

The recorded monitoring data were compiled, but NHC was not able to develop a consistent rating curve due to the changing conditions at the gage site. Two data gaps occurred because of the level logger running out of memory in May-June and late November-December 2019 (Figure 3). As a result, there was a significant event at the end of December that was not captured by the installed gage. NHC staff were able to visit the site and gather a flow measurement as well as observe conditions in the upper basin in December. From that visit it was concluded that the upper basin was not contributing any sizeable flow to the ravine. During the following February 2020 event it was confirmed that NHC's flow measurement did not occur during the peak based on data from nearby stream gages and the level logger stage hydrograph on George Davis Creek. Since the peak flows were not captured by the flow measurements, data from a nearby streamflow gage, King County's Laughing Jacobs Creek, was obtained for flow frequency analysis.

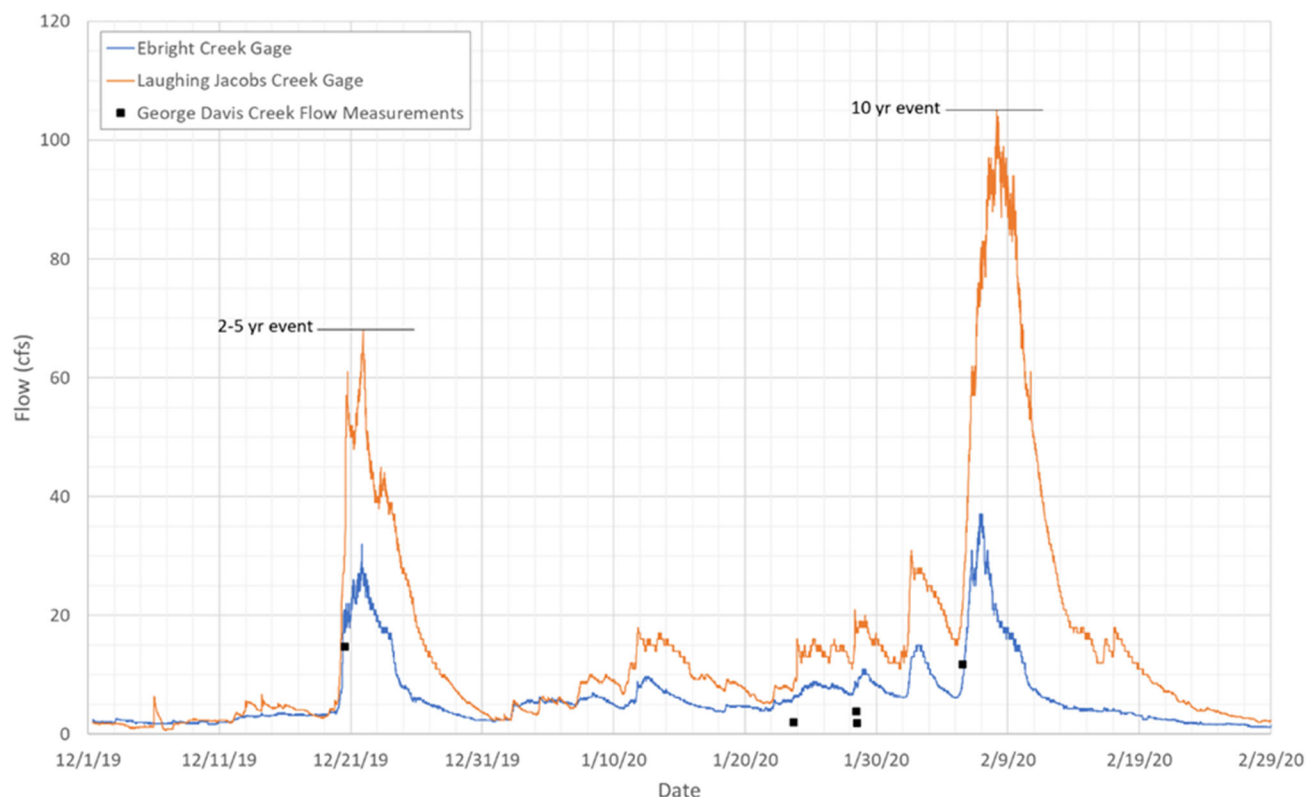
Figure 7. Flow hydrographs on Ebright and Laughing Jacobs Creek compared to flow measurements on George Davis Creek.

The Laughing Jacobs flow frequency analysis would put the December 2019 event between a 2- and 5-year return period and the February 2020 event as a 10-year return period. Flows in Laughing Jacobs Creek at the same date and time that George Davis flow measurements were collected shows that the peak flows in the December and February events for Laughing Jacobs Creek were 2 and 5 times greater than at the time of the George Davis flow measurements, respectively. Similar checks of the flow record on Ebright Creek provided very similar peak flow ratios (Figure 7). Applying the Laughing Jacobs peak multipliers for these events to the measured George Davis flows produces estimated peaks of 32 cfs for December 2019 and 56 cfs for February 2020. These correspond to 2-year and 5-year frequency events per the results in Table 4, fairly consistent with the Laughing Jacobs flow frequencies.

Based on the flow frequency analysis, the MGS flows are very low and the HSPF regional model estimates are too large. There is not enough evidence from the monitoring data or nearby flow gage comparison to support use of the low MGS flows. Utilization of the peak flow estimates from the flow frequency analysis are suggested for design since they are based on observed data as opposed to the two previously suggested uncalibrated models (Table 4).

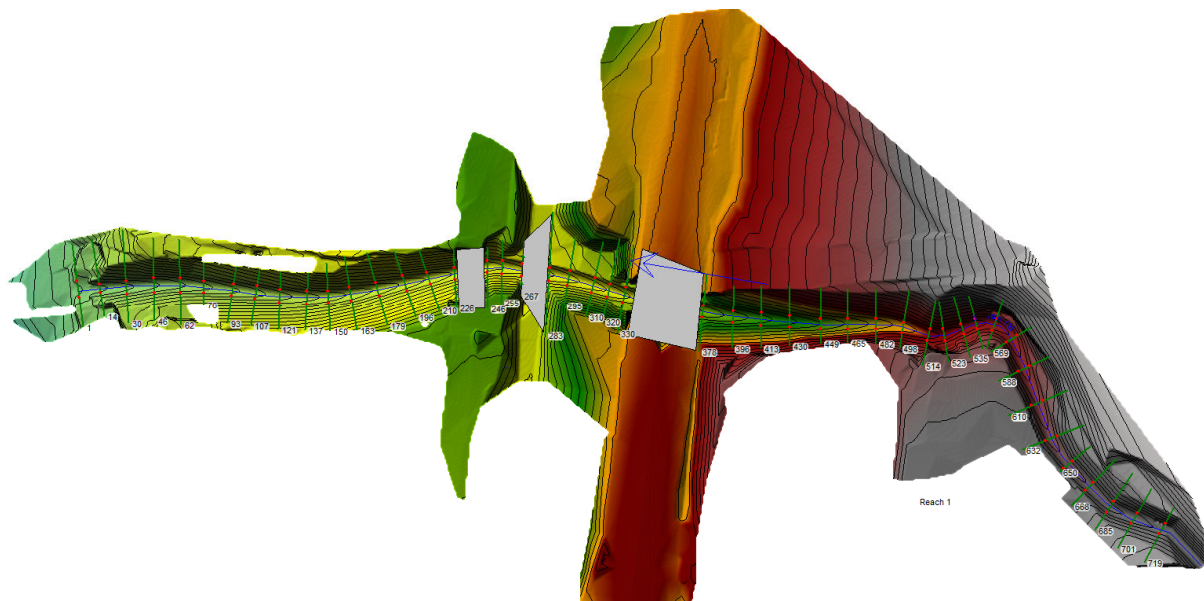
Figure 8. Proposed condition model domain and surface.

NHC developed a proposed condition 1D HEC-RAS model using a grading surface provided by PBS on May 1, 2020. The model surface extends along the lower 700 feet of George Davis Creek, to approximately the ravine outlet (Figure 8). Model grading assumed an active channel width of approximately 12-feet and side slopes graded at 2H:1V. The channel gradient from ELSP to Lake Sammamish averages approximately 6.5 percent and increases to 7 percent through ELSP upstream 300 feet to where it ties into natural grade at the ravine outlet. A high Manning roughness coefficient (n) was selected for the channel in anticipation of roughness elements to be included as part of design. The U.S. Forest Service's (USFS) Stream Channel Flow Resistance Coefficient Computation Tool (version 1.1, 2-2018) was utilized to estimate n -values (Yochum, 2018). Of the several relations provided, only those of Yochum et al (2012) and Aberle and Smart (2003) are considered applicable for steep channels with

wood. These relations yield roughness coefficients of 0.192 and 0.209, respectively. These values are consistent with photographic data provided in Yochum et al (2014). An average value of 0.20 was selected for modeling proposed conditions on lower George Davis Creek.

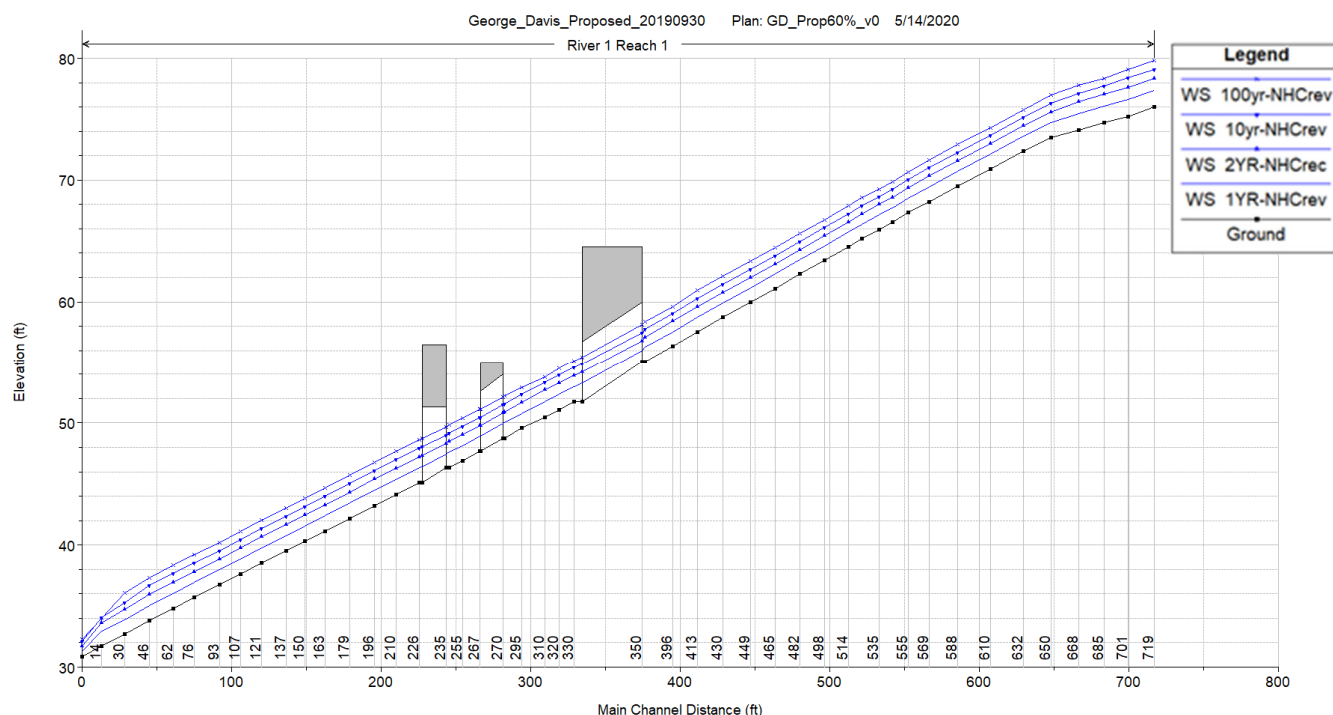
Figure 9. Computed flood profiles on George Davis Creek for proposed conditions

Figure 9 shows computed flood profiles for the 1.01-, 2-, 10-, and 100-year event under proposed conditions along George Davis Creek. Maximum flow depths during a 100-year event (128 cfs) are approximately 3.5 feet and are contained to the channel. Freeboard, i.e. the distance between the low chord of the stream crossing and water surface elevation, ranges from approximately 1.5 to 1.9 feet during the 100-year event. Computed maximum flow velocities are low, ranging from 3.5 to 5 feet per second (fps), reflecting the high roughness coefficient selected. Use of a high roughness coefficients does translate into higher energy gradients as more friction is computed between cross-sections. Energy gradients are seen to range from approximately 0.065 to 0.08, generally correlating with channel gradient. As will be discussed in the following section, energy gradient and unit discharge (q) are more useful parameters for evaluating stability in high gradient channels. It should be noted that Figure 9

shows an abrupt water surface drop at the mouth of George Davis Creek. In this vicinity rapid flow expansion into a level pool (i.e. the lake) is expected to result in significant energy dissipation and erosion potential. Detailed hydraulic model output can be found in [Appendix X](#).

As noted in Section 4.4, significant energy dissipation is anticipated at the mouth of George Davis Creek during moderate to high flows. Energy dissipation would likely be in the form of a hydraulic jump, the formation of which could result in upstream incision and potential channel destabilization through headcutting. Conversely, sediment deposition would likely occur downstream of a hydraulic jump and could result in lateral channel migration. Downstream deposition will result in delta formation into the lake (Section 2.4.4). To address headcut instability it is recommended that LWD be more densely spaced within the lower 40-feet of George Davis Creek. This stream length is intended to account for varying lake levels including the FEMA 100-year base flood elevation of 36 feet NAVD 88. Placement could mimic that alternate bank pattern, spacing, and burial depths described above, but pieces would be placed continuously for the entire 40-foot length. To address lateral migration, it is recommended additional wood be placed along the shoreline in a streamwise widening pattern. Pieces should be anchored to prevent recruitment into the lake and placed shoreward (e.g. above ordinary high water) to reduce habitat potential for predatory fish species.

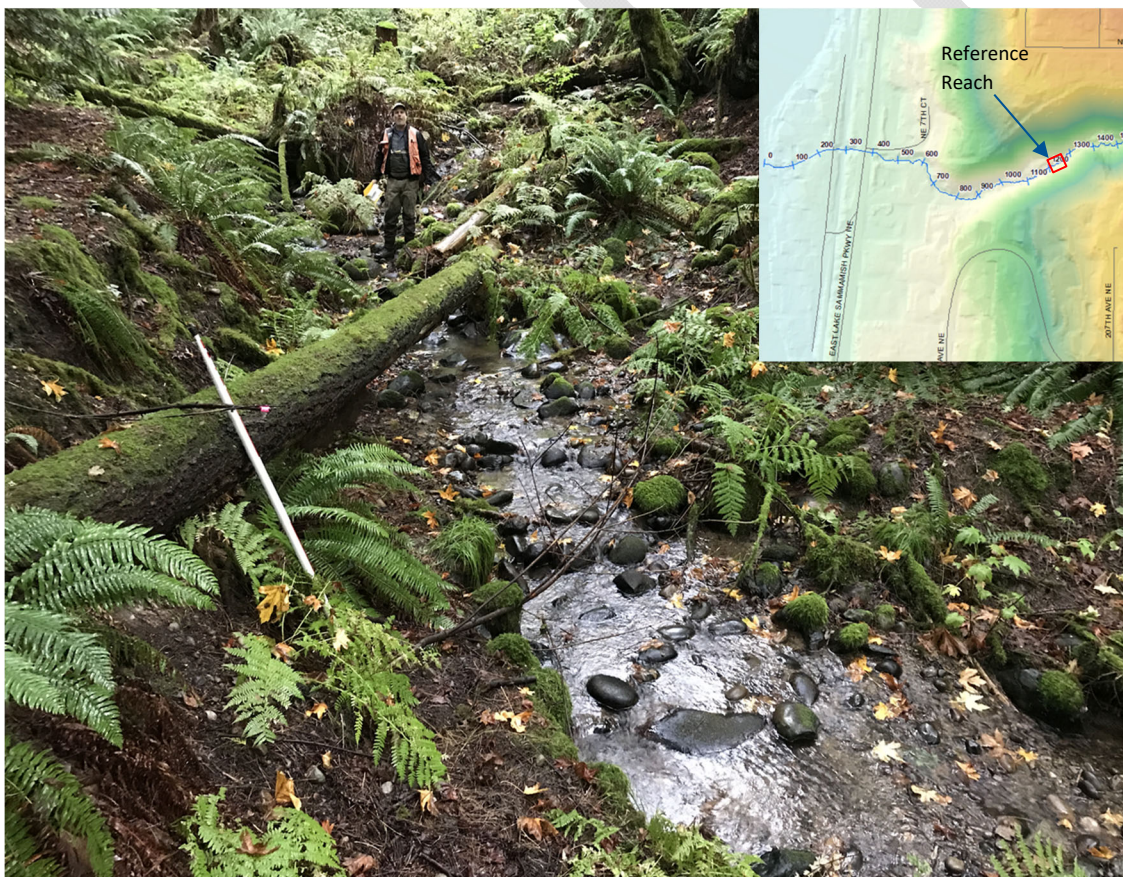
Photo 11. Reference reach on George Davis Creek (inset: reach location)

NHC identified a suitable stream simulation reference reach (Barnard et al, 2013) approximately 250-feet upstream of the existing diversion dam, in the transition between Segments 2 and 3 (see Figure 4 and Photo 11). This reach was selected because it represents a relatively undisturbed natural condition of George Davis Creek and has a similar channel gradient (7 to 8 percent) to that anticipated for the project reach. Although well-confined in the ravine, a low floodplain bench and small side has formed along the left (south) bank. The channel follows a cascade morphology, without either distinct steps or pools, and is dominated by irregularly spaced boulder clusters. Naturally fallen wood debris was observed spanning above and adjacent to the channel, but appeared to have limited influence on channel morphology at the site. A channel spanning log jam placed by the County (King County, 1994) was identified toward the upper edge of the reference reach.

Classification of natural streambed material on lower George Davis Creek is challenging because of the rapidly varying and dynamic morphologic conditions observed along the reach. In particular, the influence of either boulder deposits or woody debris functioning as grade control were observed to strongly influence localized streambed composition. Streambed texture was seen to vary from localized deposits of very uniform fine gravels to boulder dominated clusters within relatively short distances. Streambed conditions within the reference reach generally aligned with the latter (Photo 11).

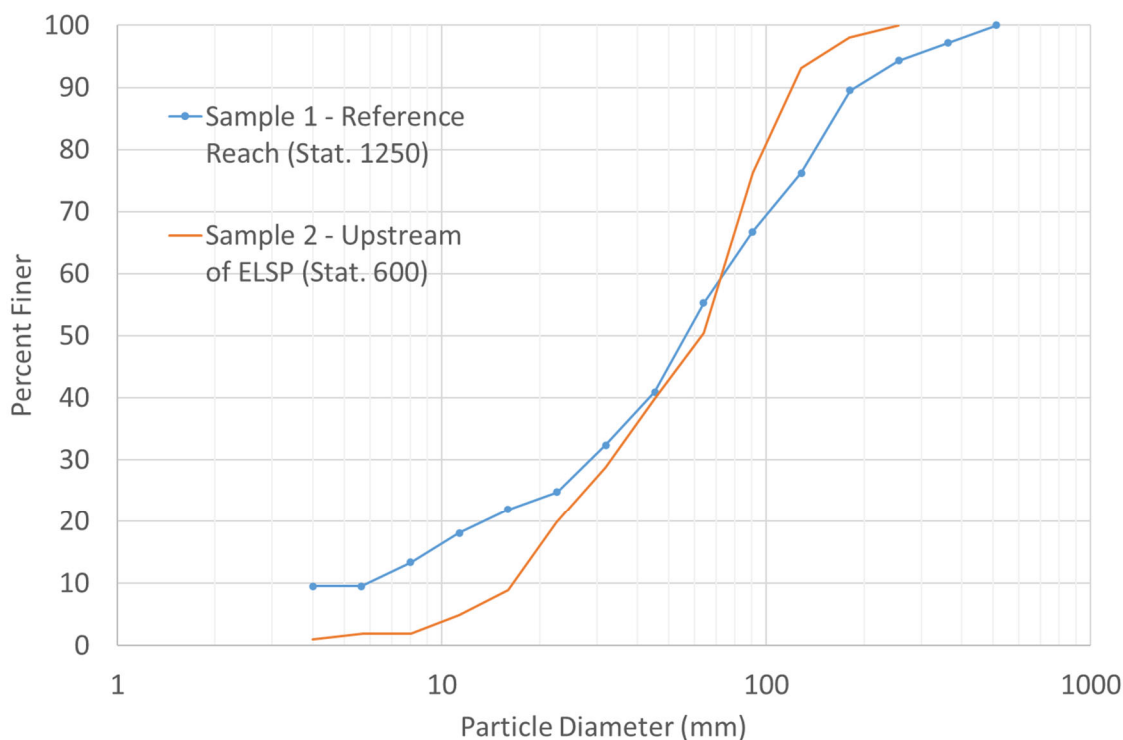
Figure 10. Grain size distributions of surface streambed material on George Davis Creek.

To quantify surface streambed composition on lower George Davis Creek, random-walk pebble counts following the methodology of Wolman (1954) were collected at two location. The first pebble count sample was taken within the central portion of the reference reach and the second approximately 150 feet upstream of ELSP in the transition between Segment 1 and 2 (Figure 4). Sample 2 was collected approximately 50 feet upstream of grade control features associated with the sedimentation basin at ELSP. As such Sample 2 is not considered representative of natural self-formed conditions, but rather, reflects armoring upstream of grade control. Grain size distributions and characteristic particle sizes of each sample are given in Figure 10 and Table 6, respectively.

The central portion of the Sample 1 and 2 grain size distributions are similar; both are composed of gravel to fine cobbles (45 mm to 72 mm). Sample 1, however, has a broader, well-graded mixture that includes significant fractions of coarse cobbles and small boulders. Approximately 25-percent of the sample falls within the cobble classification (64 mm to 256 mm) and 5-percent within the boulder classification (> 256 mm). This coarse fraction forms the framework which maintains stability along the steeper gradient observed in the reference reach. In addition to collecting a pebble count sample in the reference reach, NHC also sketched surface bed material and morphologic conditions within the reference reach (Figure 11). The sketch includes features such as natural (and man-made) woody debris, bank and floodplain conditions, and layout of boulder clusters with measurements of intermediate (b-axis) diameters, in inches. Key boulders in the reach included sizes ranging from 12 to 36 inches, which aligns with WSDOT one- and two-man boulders.

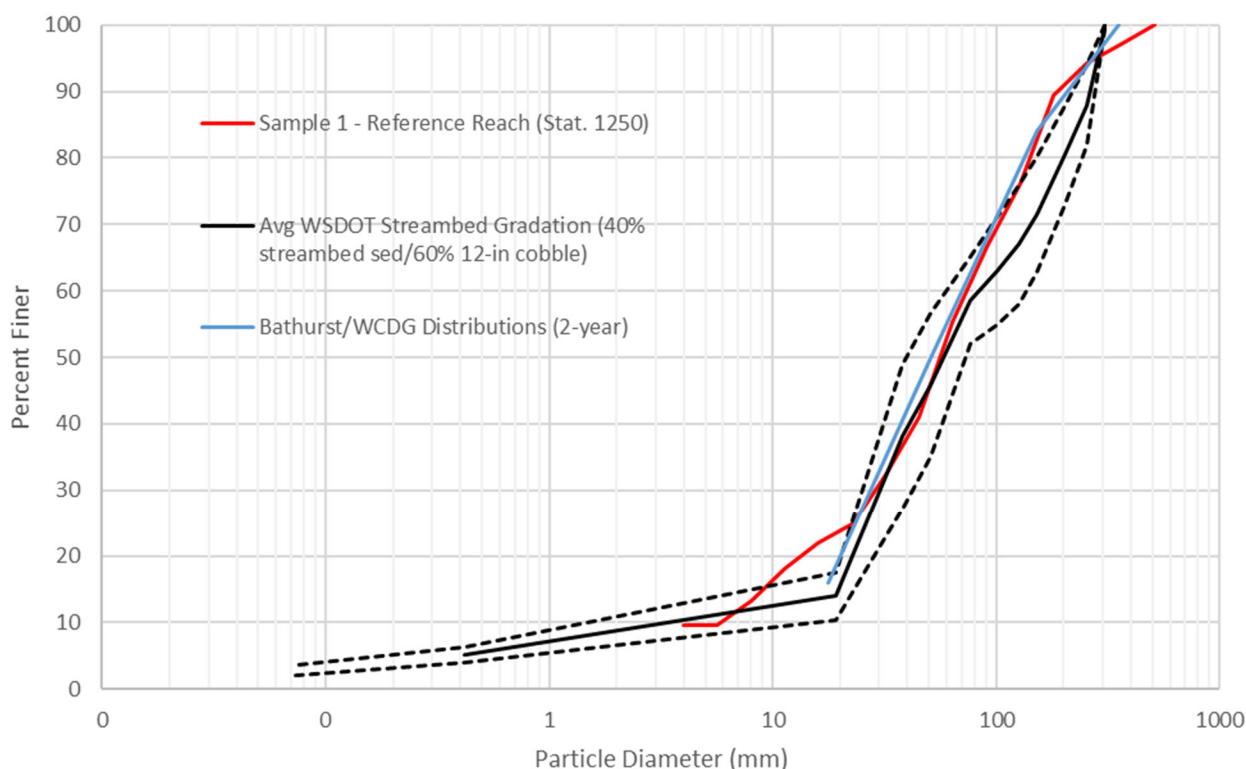
Figure 12. Recommended surface mix grain size distribution compared to Bathurst (1987) and surface grain size distribution measured in reference reach.

The surface mix was sized using the relation of Bathurst (1987), discussed above, and the recommended ratios for natural grain size distributions presented in Barnard et al (2013). A target flow threshold for motion was set to the 2-year event (39 cfs). Results yield a recommended mixture of 40 percent WSDOT streambed sediment mix (9-03.11(1)) and 60 percent WSDOT 12-inch cobbles ((9-03.11(2))). Figure 12 compares the recommended average WSDOT mixture with that computed using Bathurst (1987) and bed gradation (Sample 1) measured in the reference reach (Section 0). Dashed lines indicate uncertainty within the WSDOT specifications.

Figure 12 shows the proposed surface mix closely follows the gradation of the reference reach and Bathurst (1987) for D_{50} and finer fractions, but tends to be coarser at the higher end of the distribution. This is considered ideal in that it provides sufficient fines ($< D_{50}$) to seal the bed and allow for minor channel adjustment, but also provides a reasonable coarser matrix to give some stability. Given the high sediment loads on George Davis Creek, it would be expected that finer materials eroded during a competent event would be replaced by incoming materials. As previously noted, the surface mix is intended to be somewhat dynamic, allowing for sediment exchange and formation of pools and bars. The recommended thickness for the surface mix is 24 inches.
