LIVINGSTON BAY RESTORATION

Feasibility Study

Prepared for
Whidbey-Camano Land Trust

December 2022

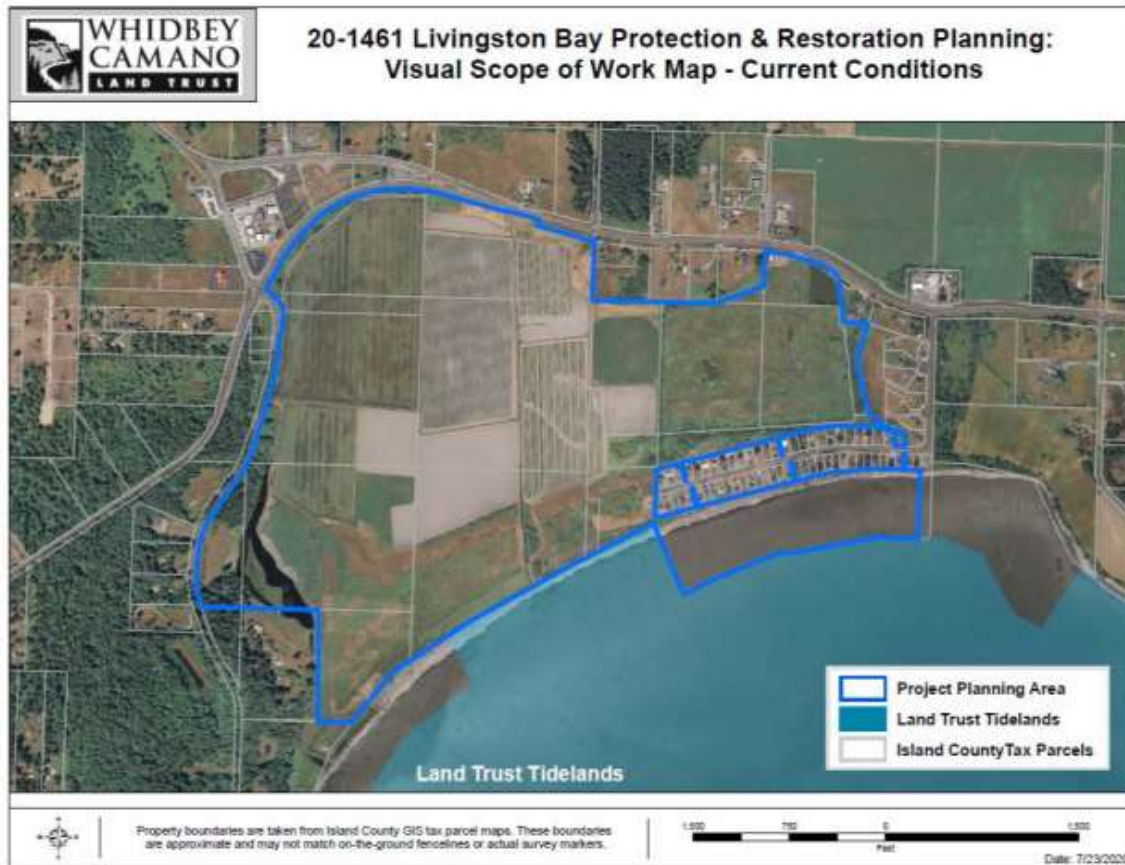
Figure 3. Study Boundary Map (Project Study Area Boundary in Blue)

Figure 3 shows the boundaries of the feasibility study area. The feasibility study area includes the Livingston Bay Community which is a shoreline community with approximately 59 houses. The community development is not considered for conducting restoration, rather it is included for the evaluation of potential changes related to the restoration actions being evaluated. Similarly, the large tideflat parcel waterward of the community is not considered for restoration, but is include in the project evaluation.

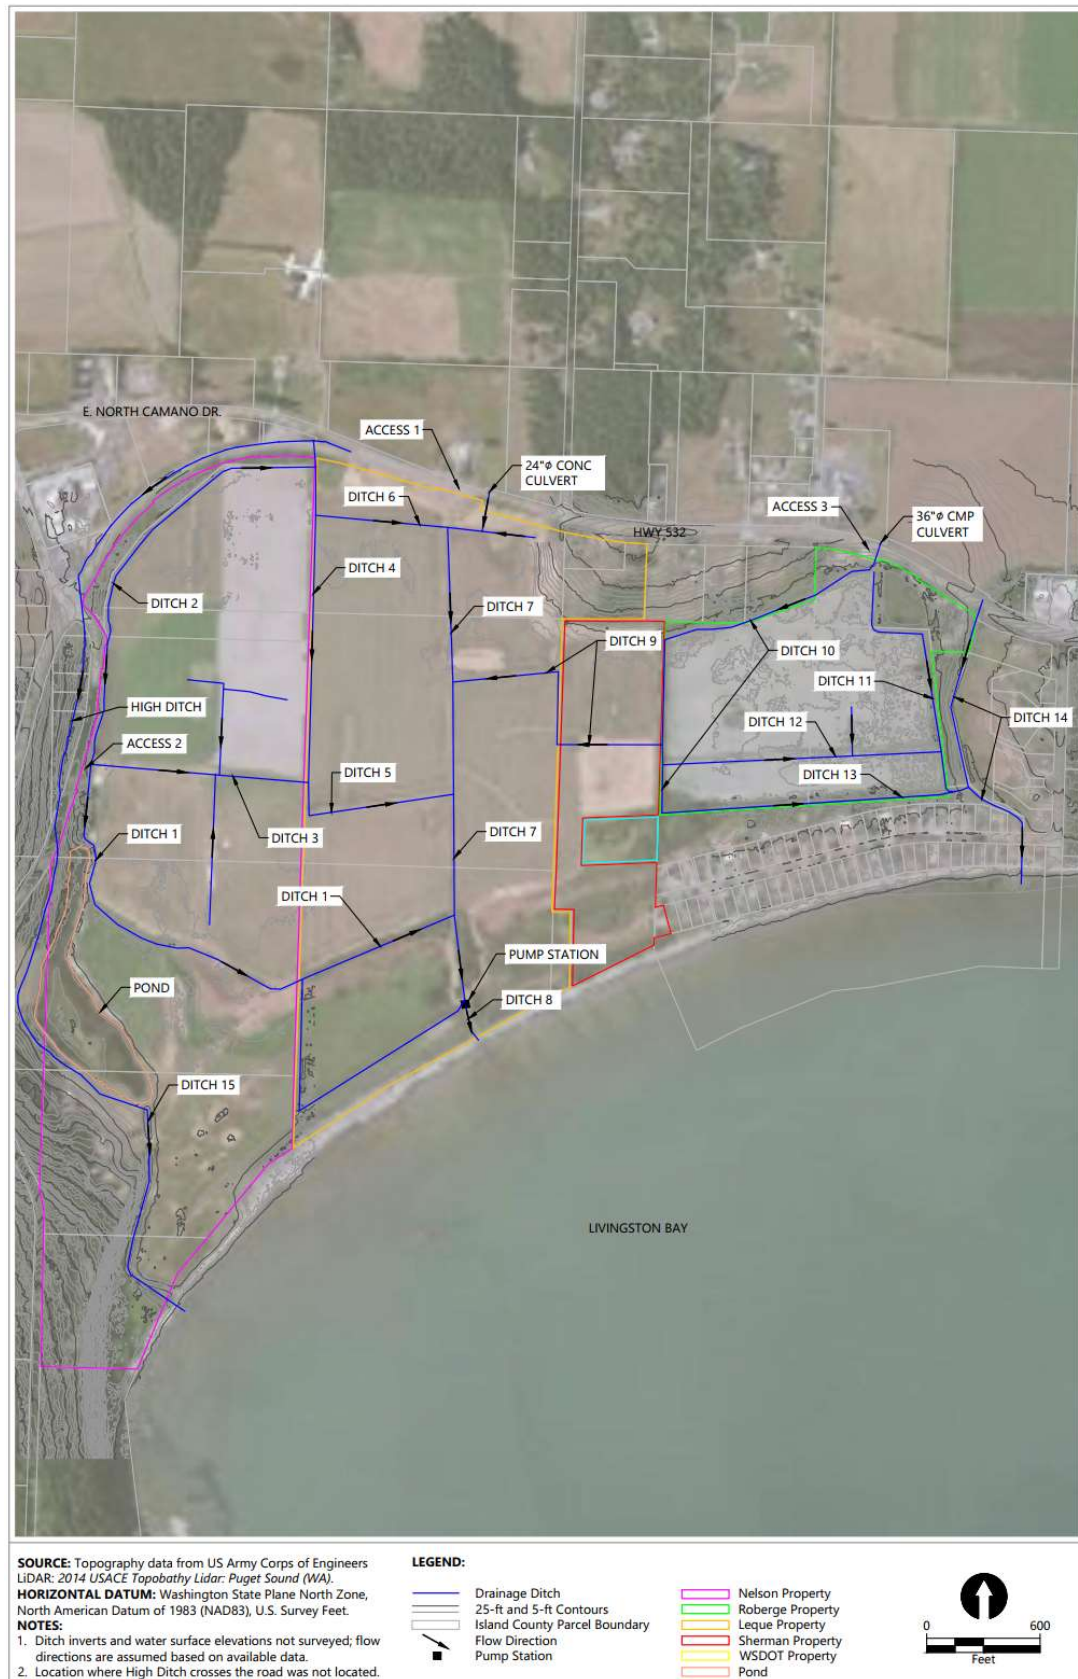
Figure 7. Drainage Infrastructure

This section outlines the existing drainage ditch network and the conditions of the pumps and pump stations at the project site. See Appendix A, “Drainage Infrastructure Memorandum,” for a detailed description of the drainage infrastructure.

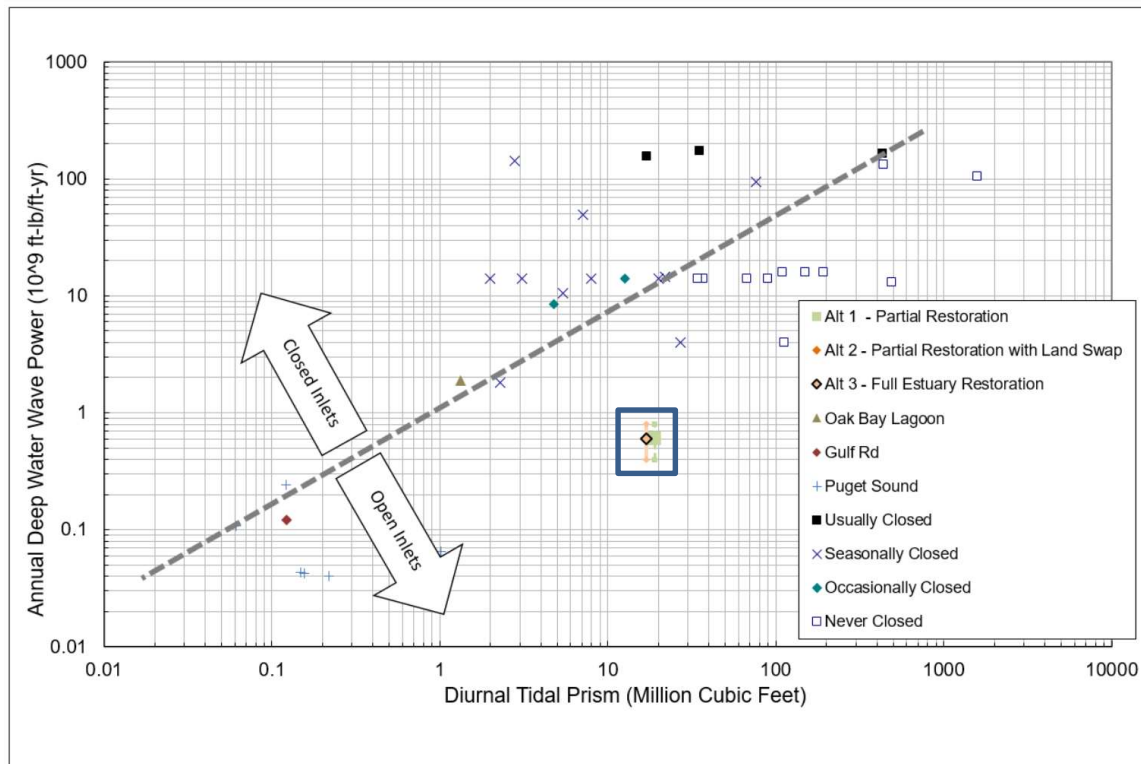
Source: Original methodology developed by Johnson (1973). Reference data compiled by ESA PWA (2013) and. Tidal prism of Livingston Bay inlet alternatives. Wave power estimate by ESA.

Figure 11. Modified Johnson Inlet Stability Diagram (blue box highlights project alternatives)

the wave power estimated in the section above. Results show that for all the scenarios evaluated, the inlet will likely remain open.

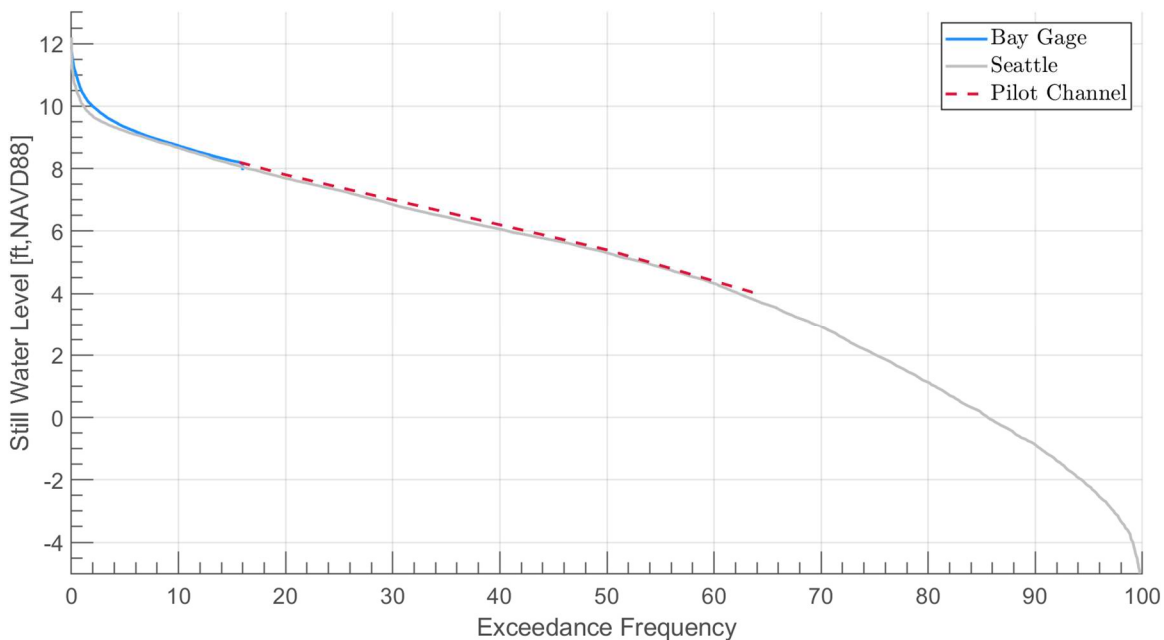
NOTE: This graph shows the likely water level exceedance with a pilot channel excavated on the mudflat.

Figure 13. Still-Water-Level Exceedance for the Bay Gage (Present Conditions), Seattle Gage, and the predicted curve with a Pilot Channel

Dredging of a mudflat pilot channel through the outboard mudflat is proposed to help accelerate this process. This will allow the project site to increase regular tidal inundation and “washing” of the imported soil, which is needed to alter the soil’s physical and chemical components that support wetland vegetation. This higher variation in elevation on the project site will allow different types of vegetation to establish and provides an allowance for vertical uncertainties in tidal hydraulics effects and vegetation establishment elevations. The proposed pilot channel will be approximately 1,500 feet long through the mudflat and will reach an elevation of 4 feet NAVD88 at the mudflat. Over time, the pilot channel will scour to hydraulically appropriate geometry, but providing even an undersized starter channels will considerably improve tidal exchange within the site. **Figure 13** shows that with this pilot channel, the estuary will be subject to tidal influence about 64 percent of the time instead of only 16 percent of the time if no pilot channel is included in the restoration.

5. ESA recommends a pilot channel on the mudflat for any of the 3 scenarios presented. The channel sizing analysis showed that the outlet channel should go to -4 FT NAVD. This is not feasible since it would require too much length of pilot channel excavation. Design of the pilot mudflat channel needs more refinement to avoid salmon entrapment and to avoid excessively large impacts to the mudflat.

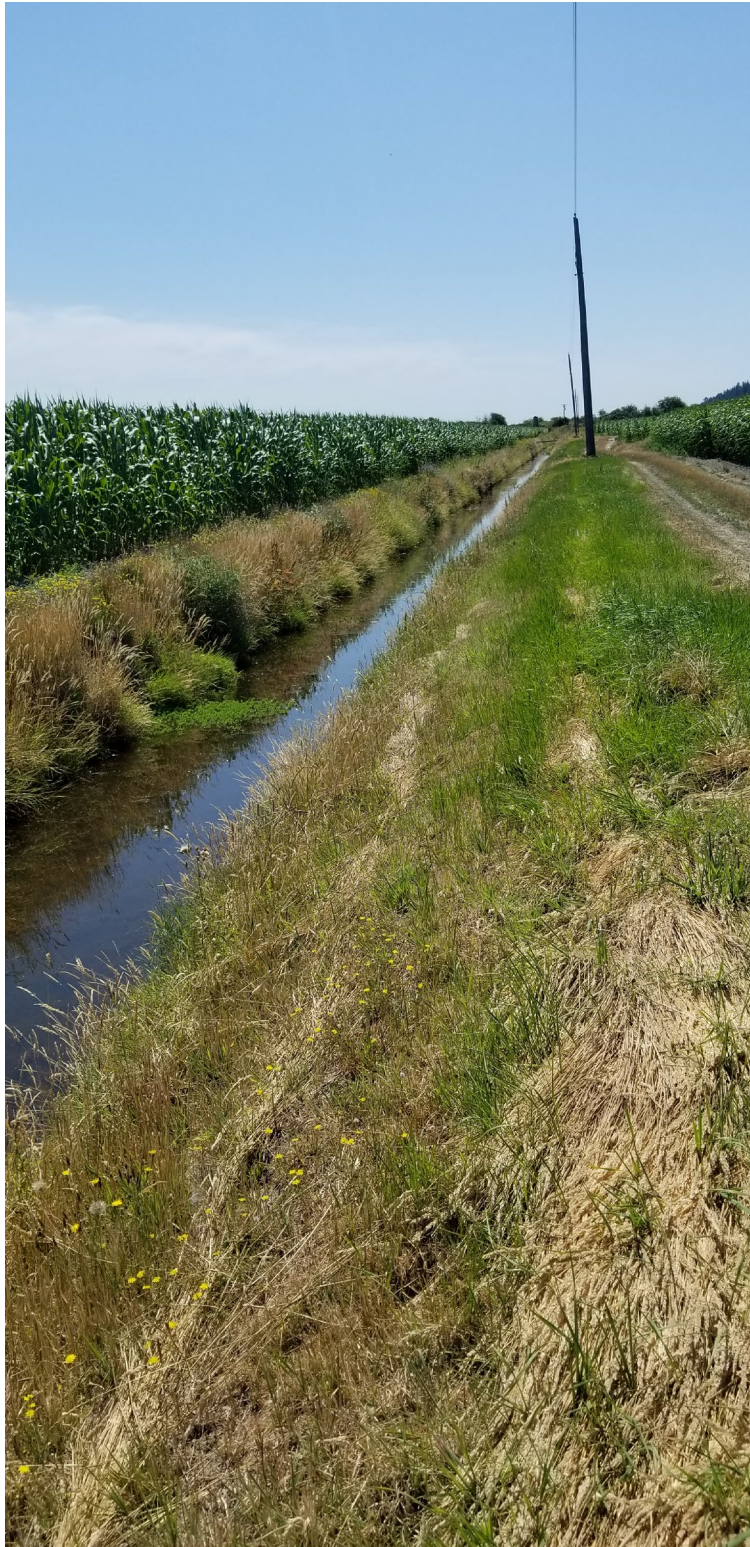
Photograph 1
Ditch 7: Typical of Less Vegetated Ditches

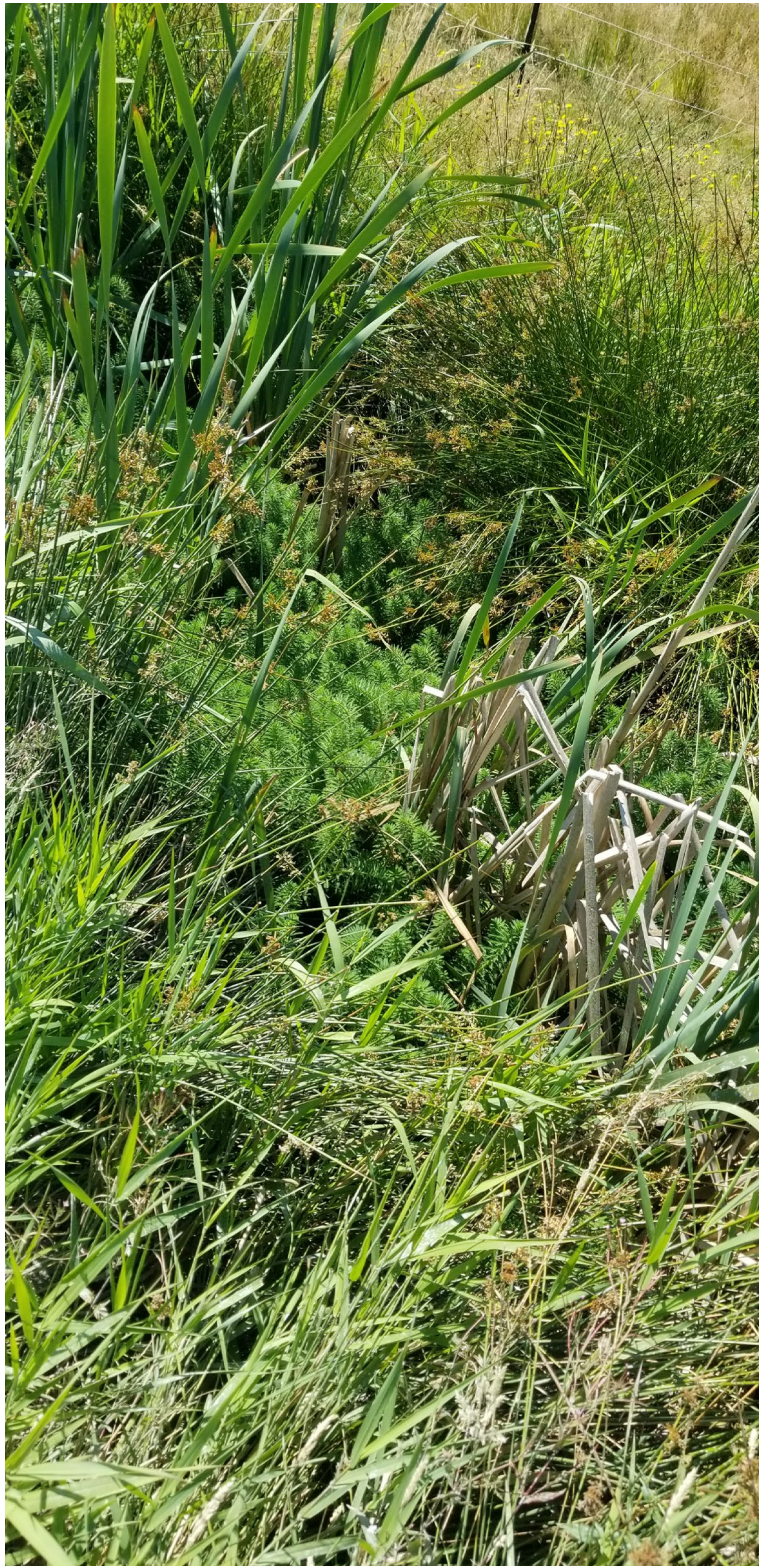
Photograph 2

Ditch 1: Typical Heavily Vegetated Ditch

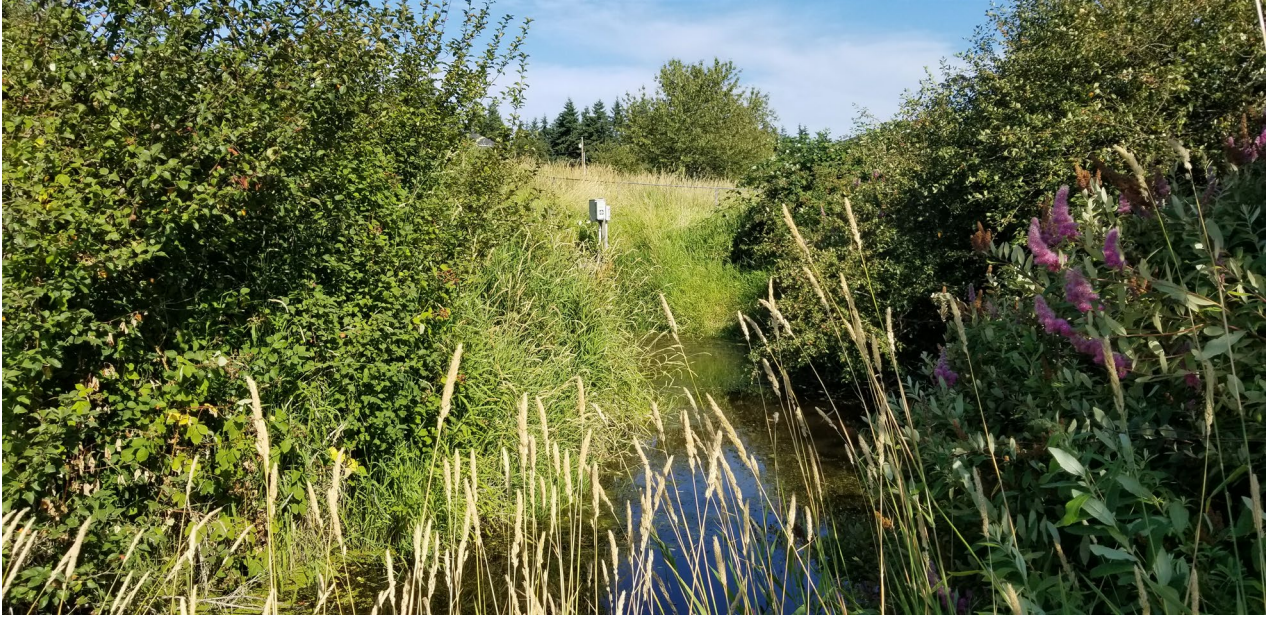
Photograph 4
Confluence of Ditches 12, 13, and 14

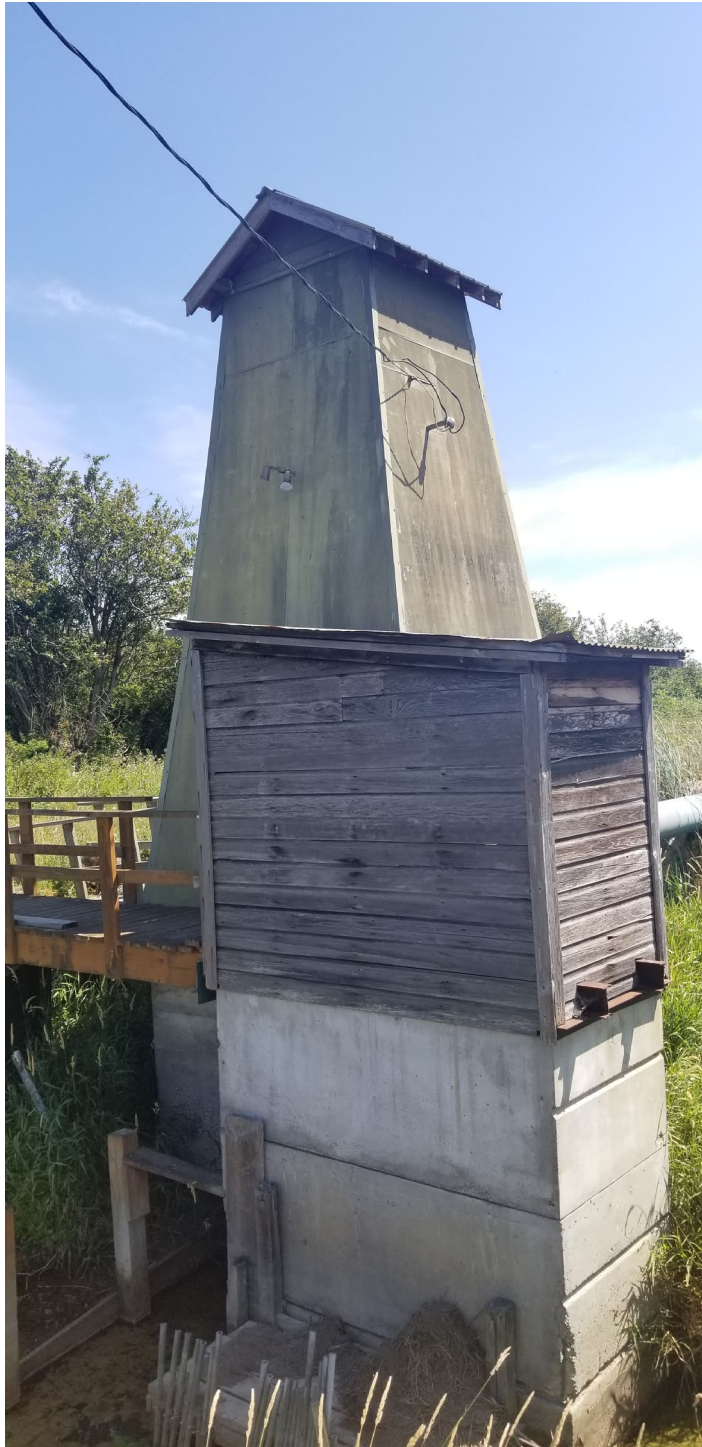
Photograph 5
Pump Station Structures

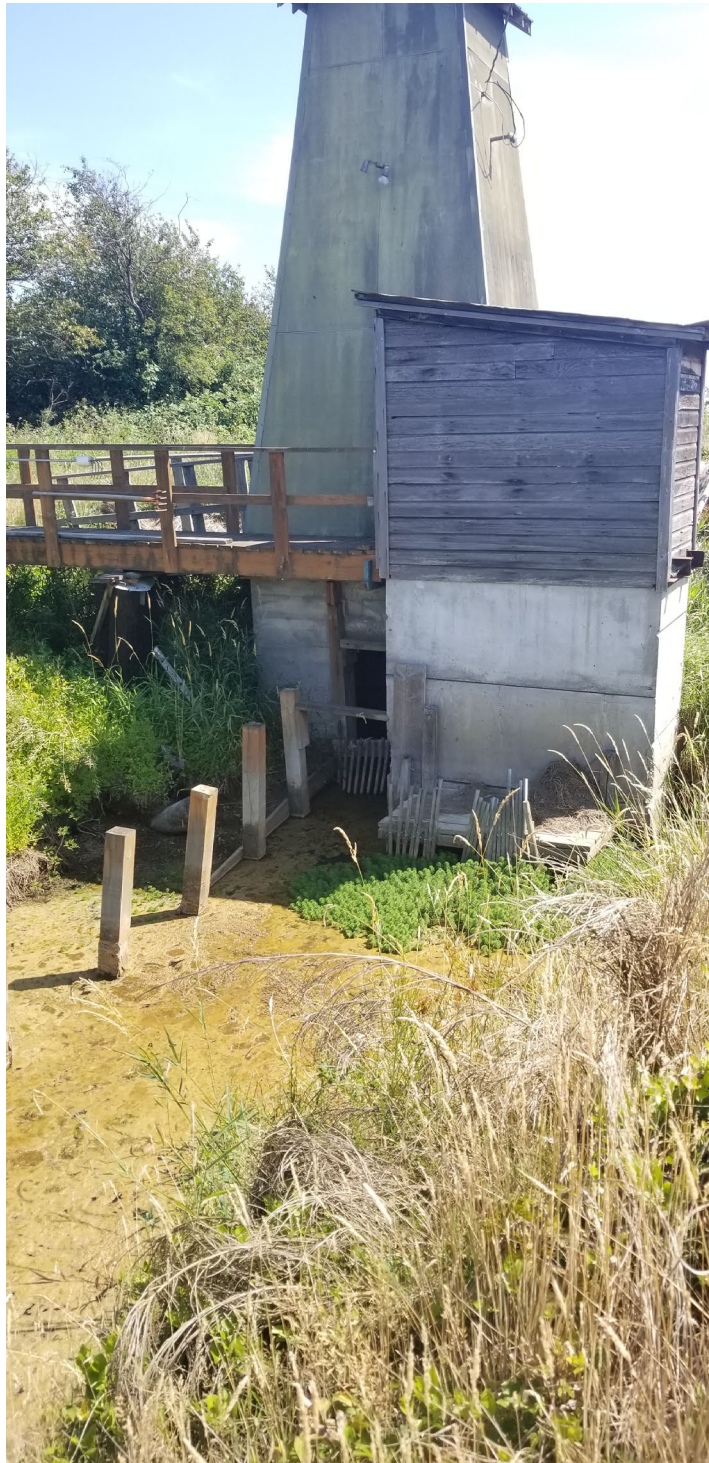
Photograph 6
Pump Station Forebay

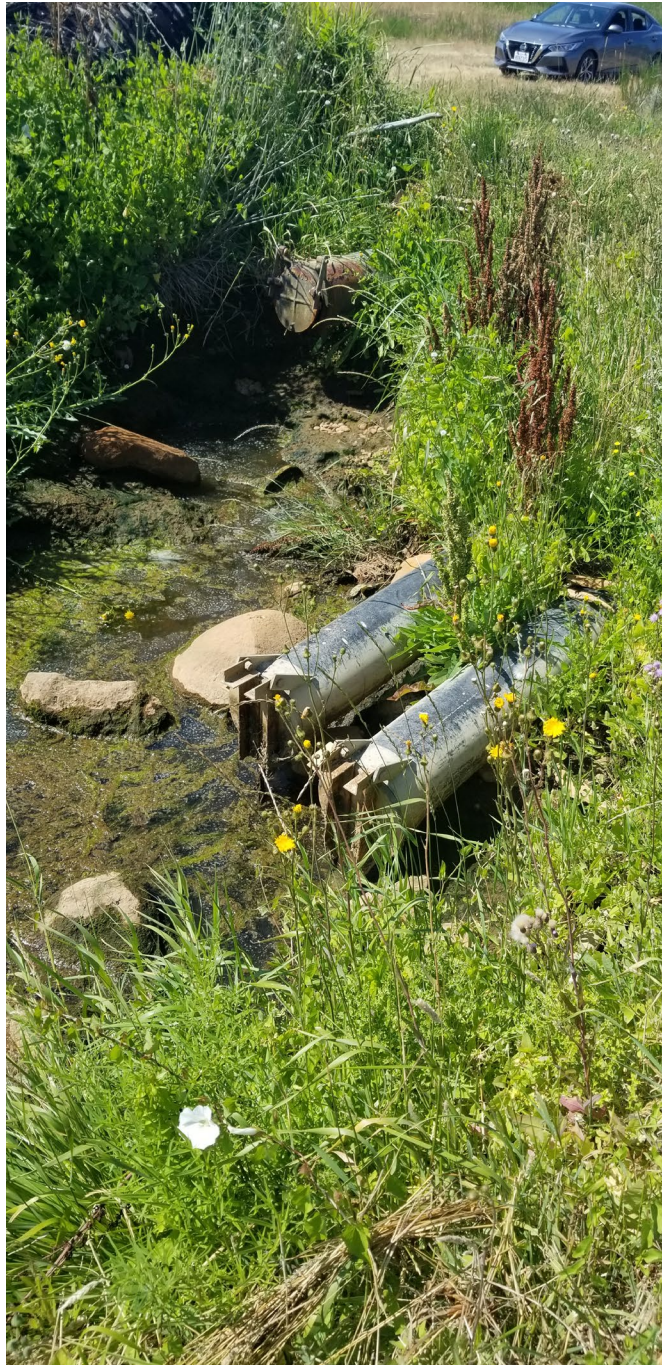
Photograph 7
Pump Station Discharge Pipes
