Assessment and Recommendations For Habitat Protection

Strawberry Point, Whidbey Island

Island County
Planning and Community Development Department

January 30, 2009

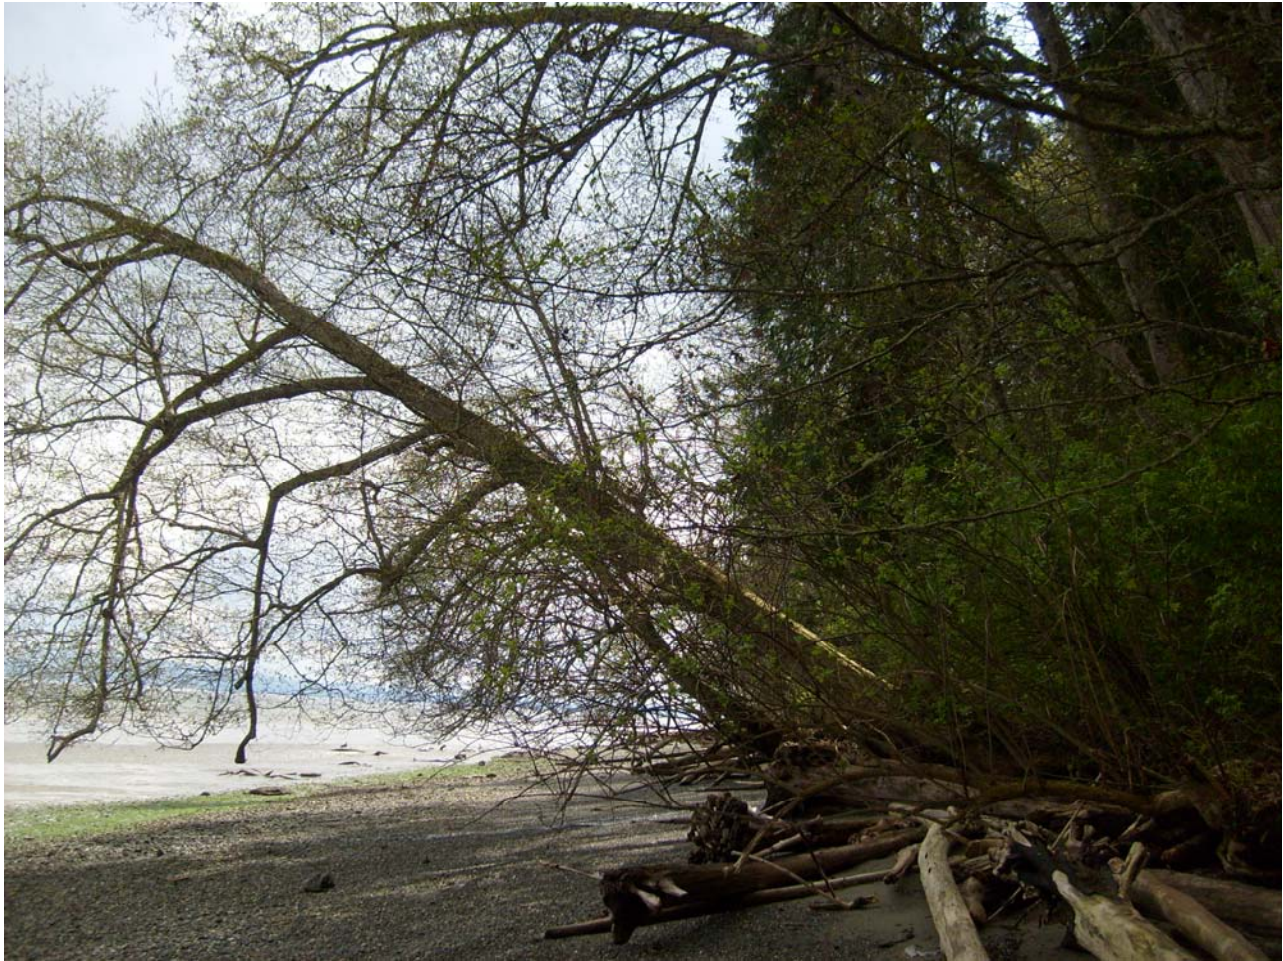
Figure 3. Photograph of the shoreline in Deception Pass State Park, which was likely typical of predevelopment conditions at Strawberry Point.

The undisturbed reach of shoreline in Deception Pass State Park provides an excellent example of geomorphic conditions found prior to European settlement. Figure 3 illustrates many of the features common to the nearshore prior to development. Here, large trees extend down to the beach foreshore. In many instances, these trees, both deciduous and conifer, shade the beach and accumulate woody debris. Large woody debris is also extensive along the shore, often suspended in overhanging trees. Near the larger stream mouths (e.g., Stream 18) in the project area, marshes could have potentially existed. Freshwater input to these marshes was likely substantially less than under existing conditions; most of the existing streamflow is associated with runoff from roads and other developed (deforested) areas. Aside from Stream 18, it is likely that concentrated (channelized) surface water flow is an artifact of development.

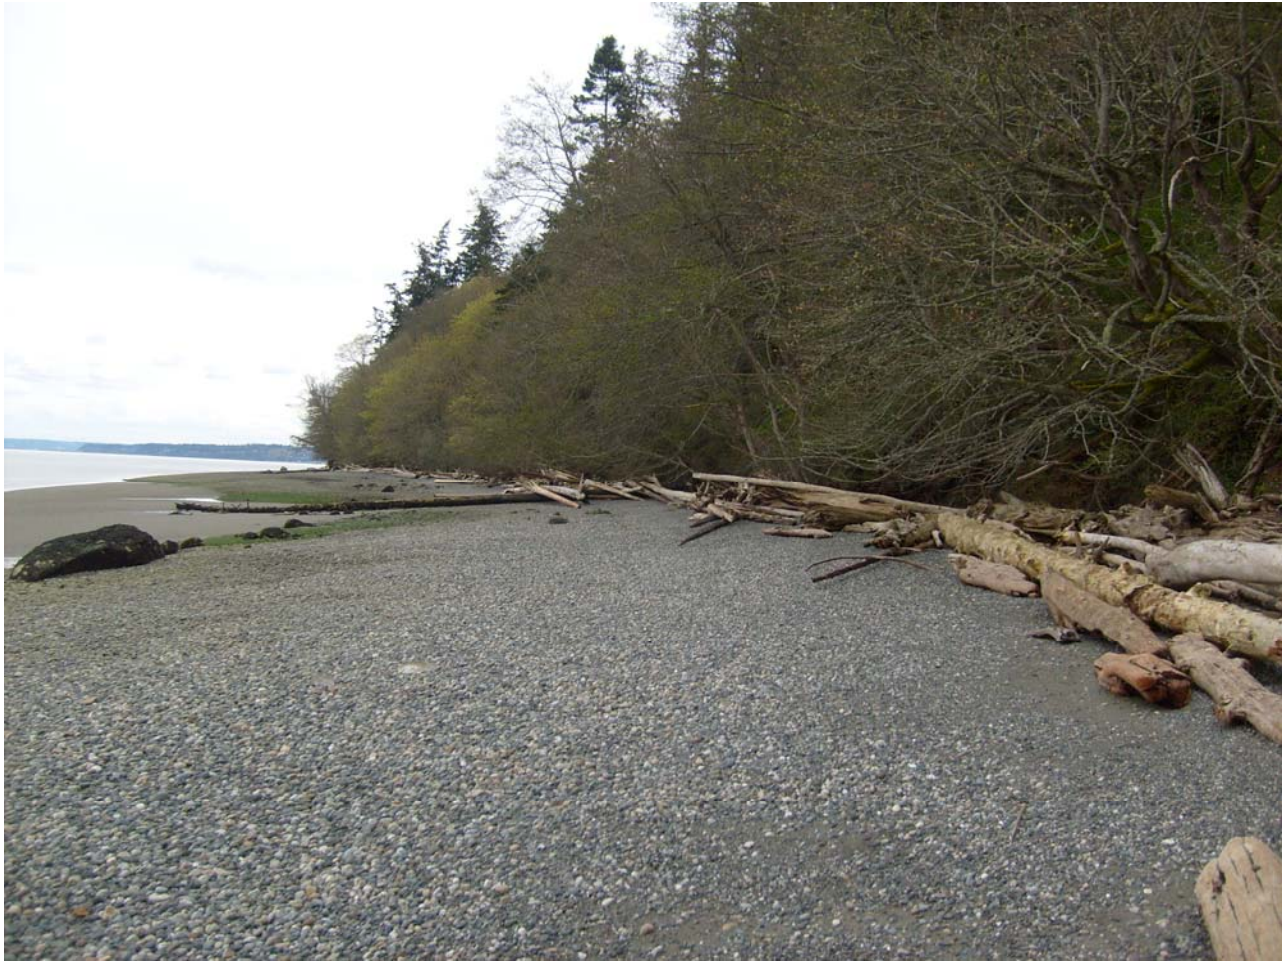
Figure 5. Photograph of a typical shoreline in Coastal Drainage Area 1.

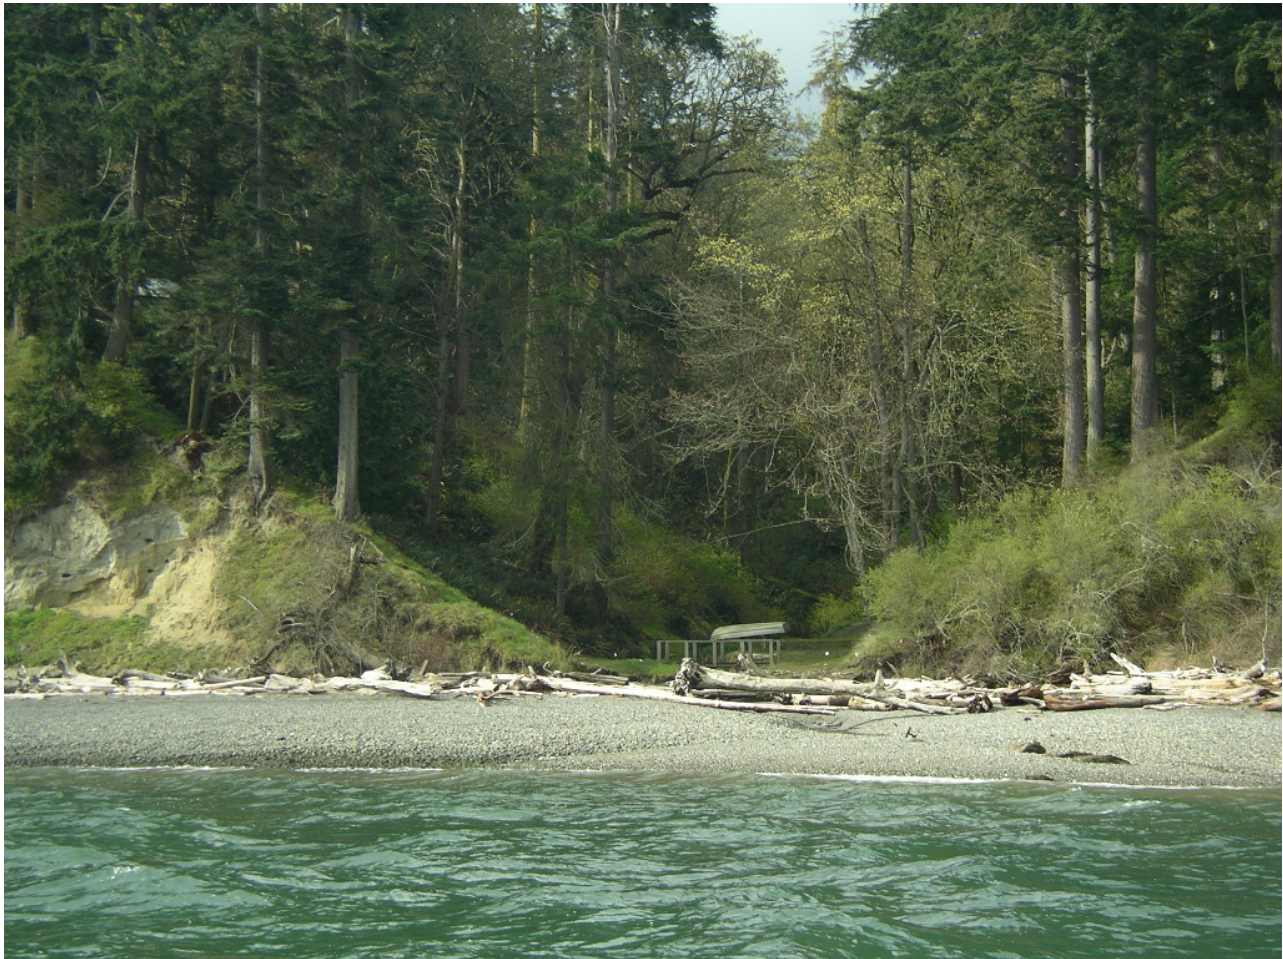
Figure 7. Small delta formed on the beach foreshore at the outlet of the stream associated with Watershed 18.

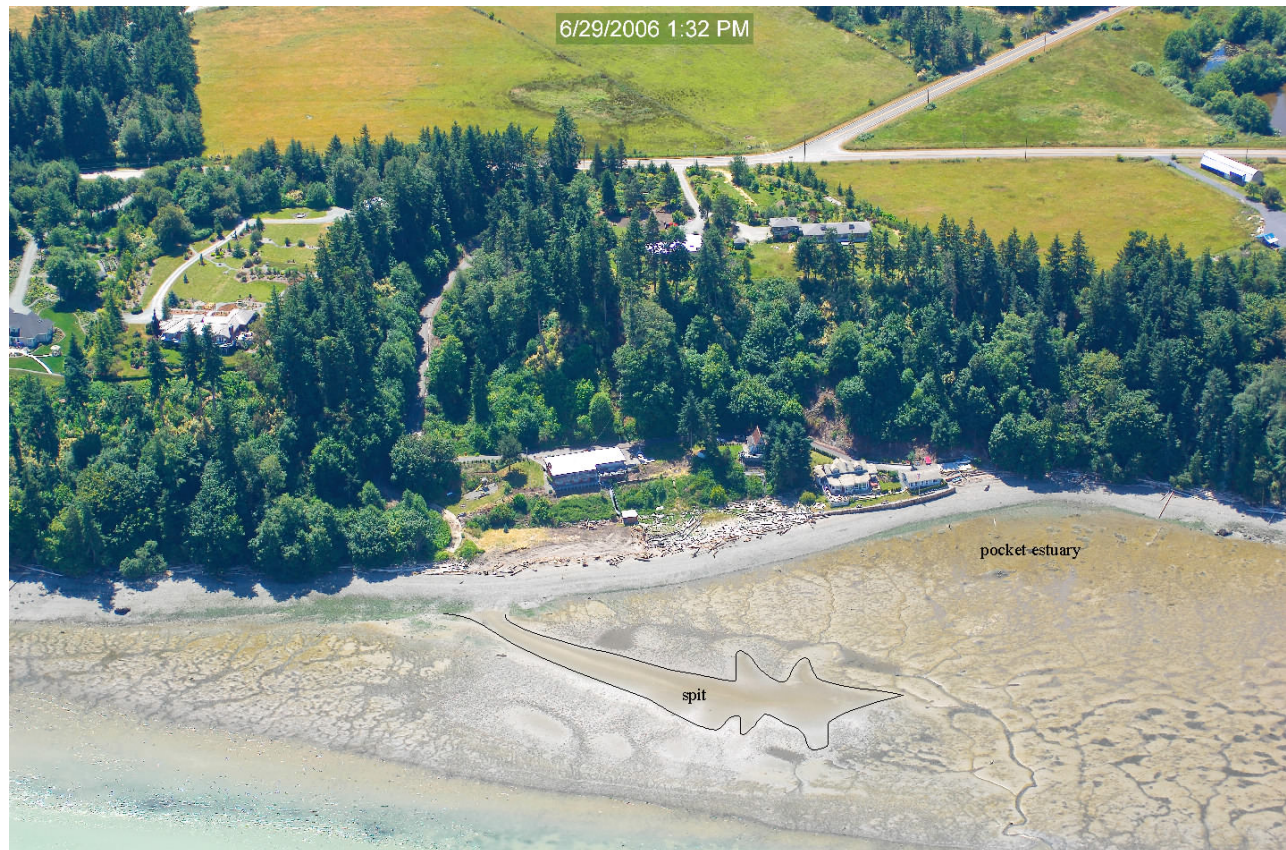
Figure 11. Developing spit at Coastal Drainage Area 2, viewed in the most recent oblique aerial (taken in 2006) available from the Washington Coastal Atlas (Ecology 2008).

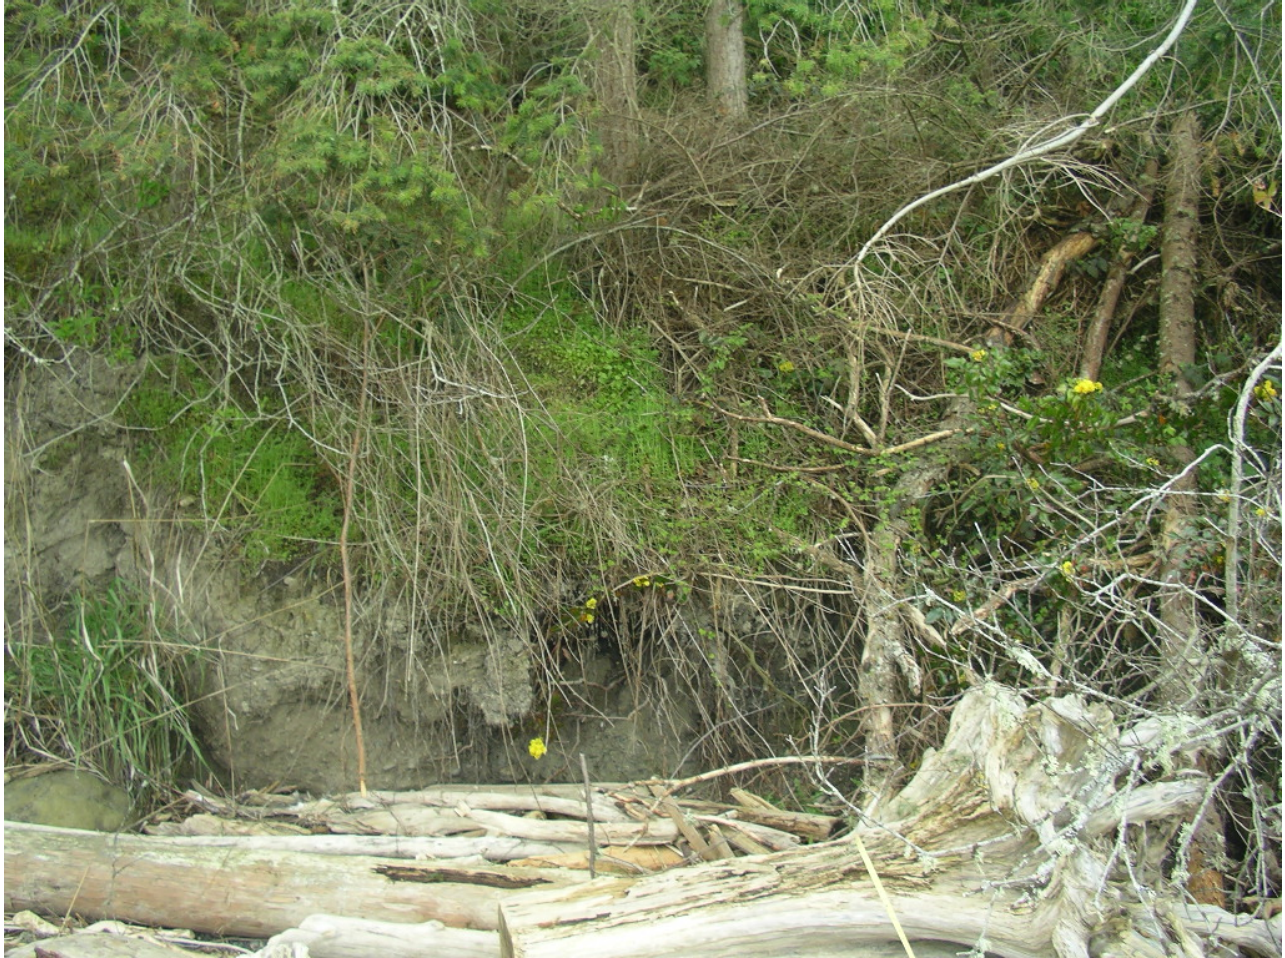
Figure 14. An example of raveling at the toe of the bluff in Coastal Drainage Area 2.

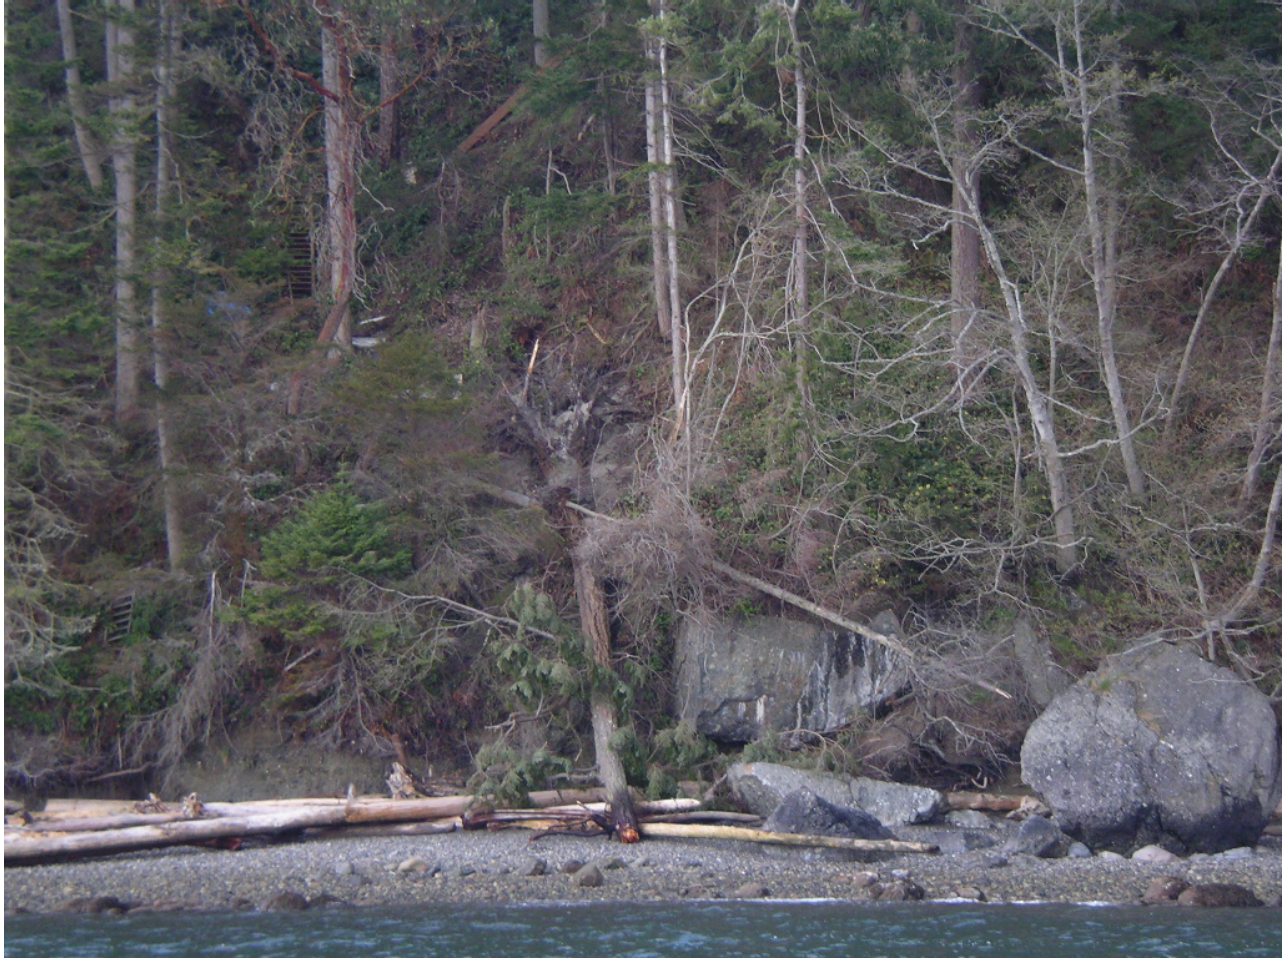
Figure 15. Landslide on privately owned bluff segment in Coastal Drainage Area 1. Note that the downed tree is still green, indicating that the landslide occurred within the past few months (photograph taken on April 9, 2008).

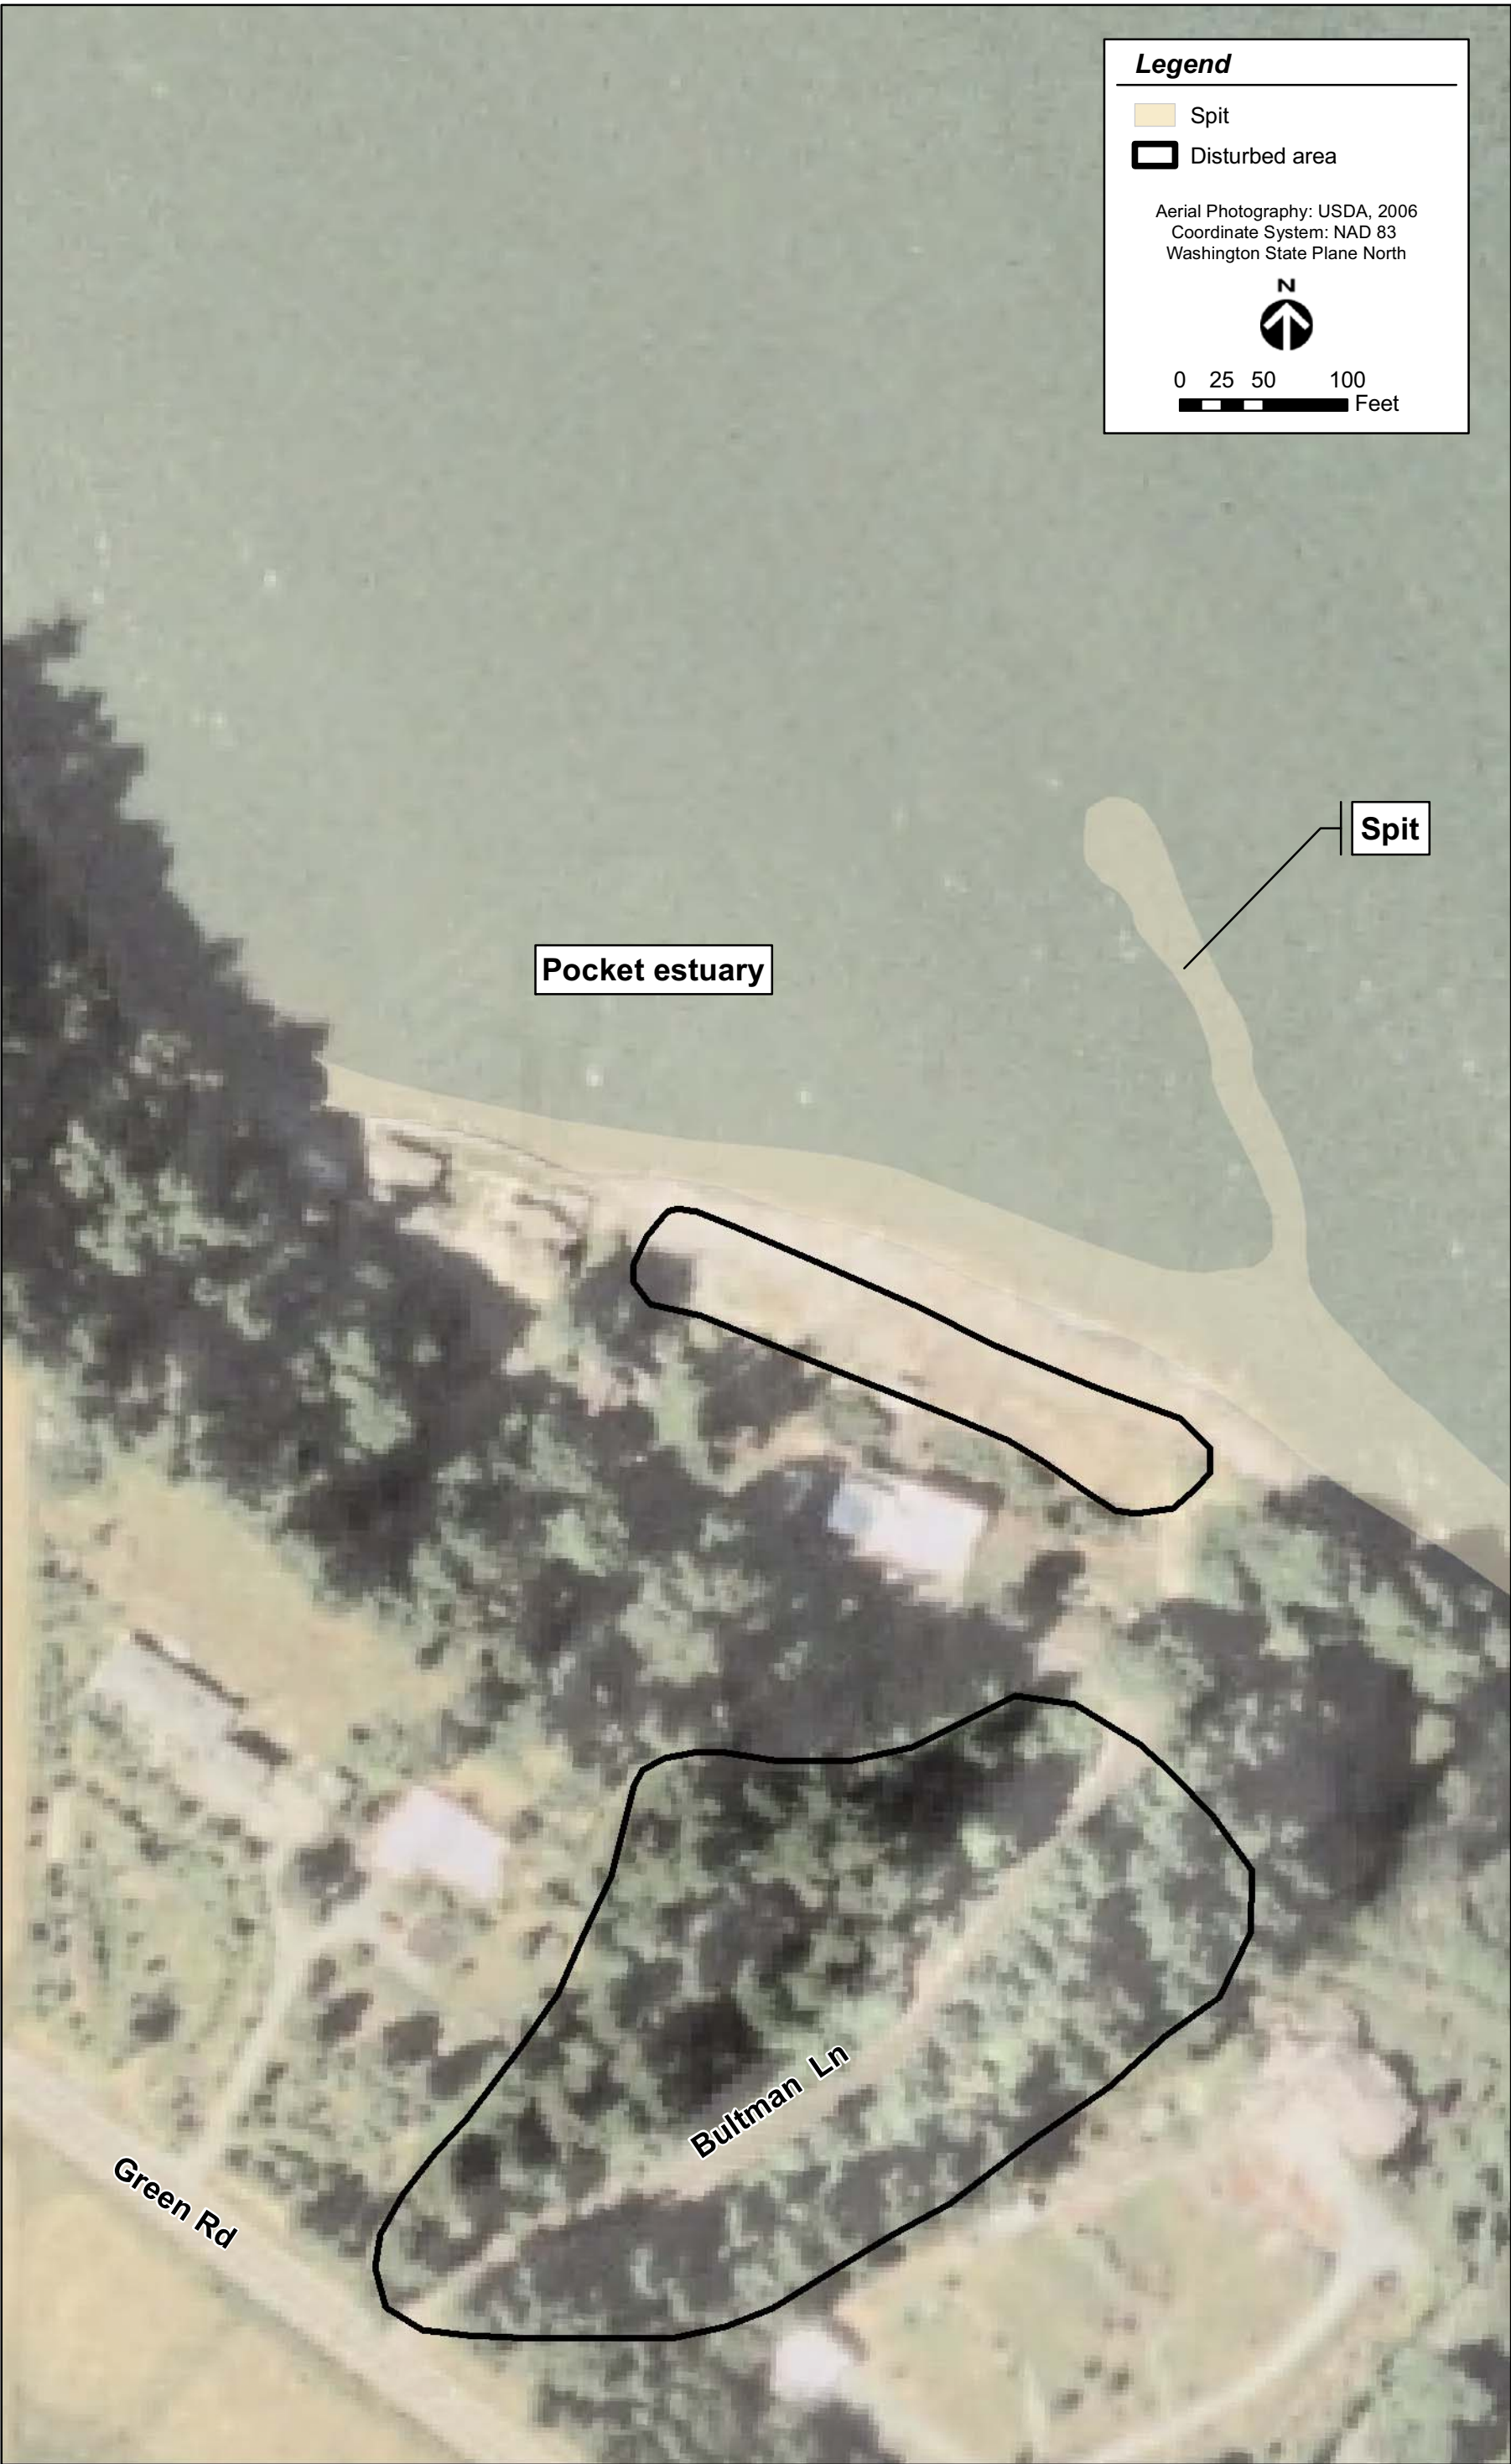
Figure 16. Close-up view of a recent aerial photograph overlain on a lidar hillshade in the area of the nascent spit in Coastal Drainage Area 2.

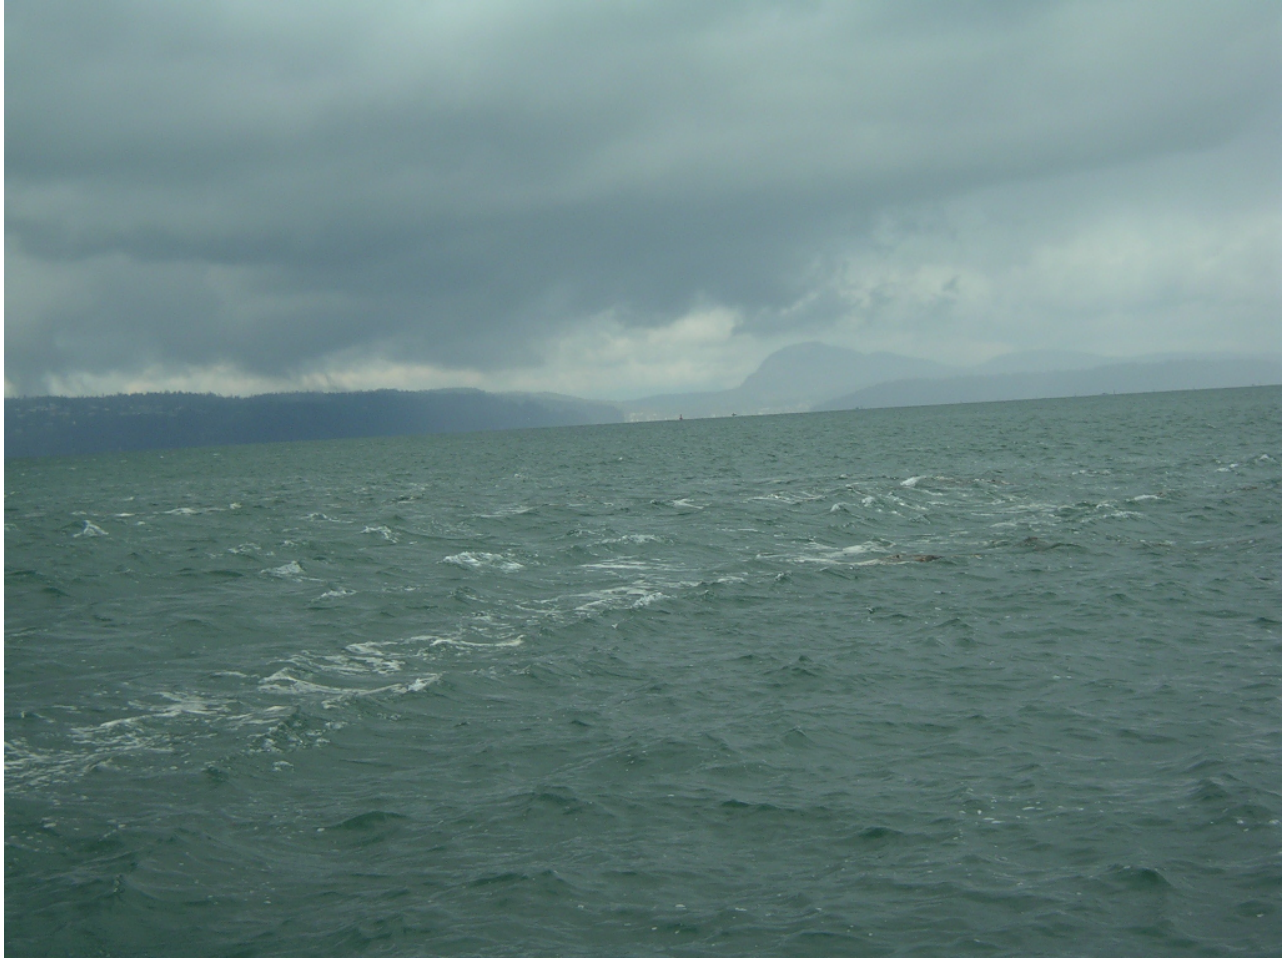
Figure 17. Oceanographic fronts observed at the eastern end of the fine sediment, muddy low-tide terrace along the shoreline of Watershed 16.

Several oceanographic fronts were observed in this area during the site visit (Figure 17). This is somewhat surprising; because of the cold weather (which minimized snowmelt) preceding the site visit on April 9, 2008, flow in the Skagit River was reduced from a historical average of approximately 15,000 cfs to 8,000 cfs (~8,000 cubic feet per second [cfs]; USGS 2008). Fronts were observed concurrently with the presence of an extensive (>200 feet wide) muddy low-tide terrace near the boundary between Watersheds 18 and 16 (see the *Existing Geomorphic Conditions* section for details). The mud-rich low-tide terrace is identified as a distinct feature on all recent nautical charts. The combination of fine sediment supply and protection from waves likely causes fine sediment from the Skagit River to accumulate on the low-tide terrace in areas north and west of the presence of the fronts, while shorelines farther south and east (e.g., Coastal Drainage Area 1) are energetic enough to prevent such accumulations of sediment.

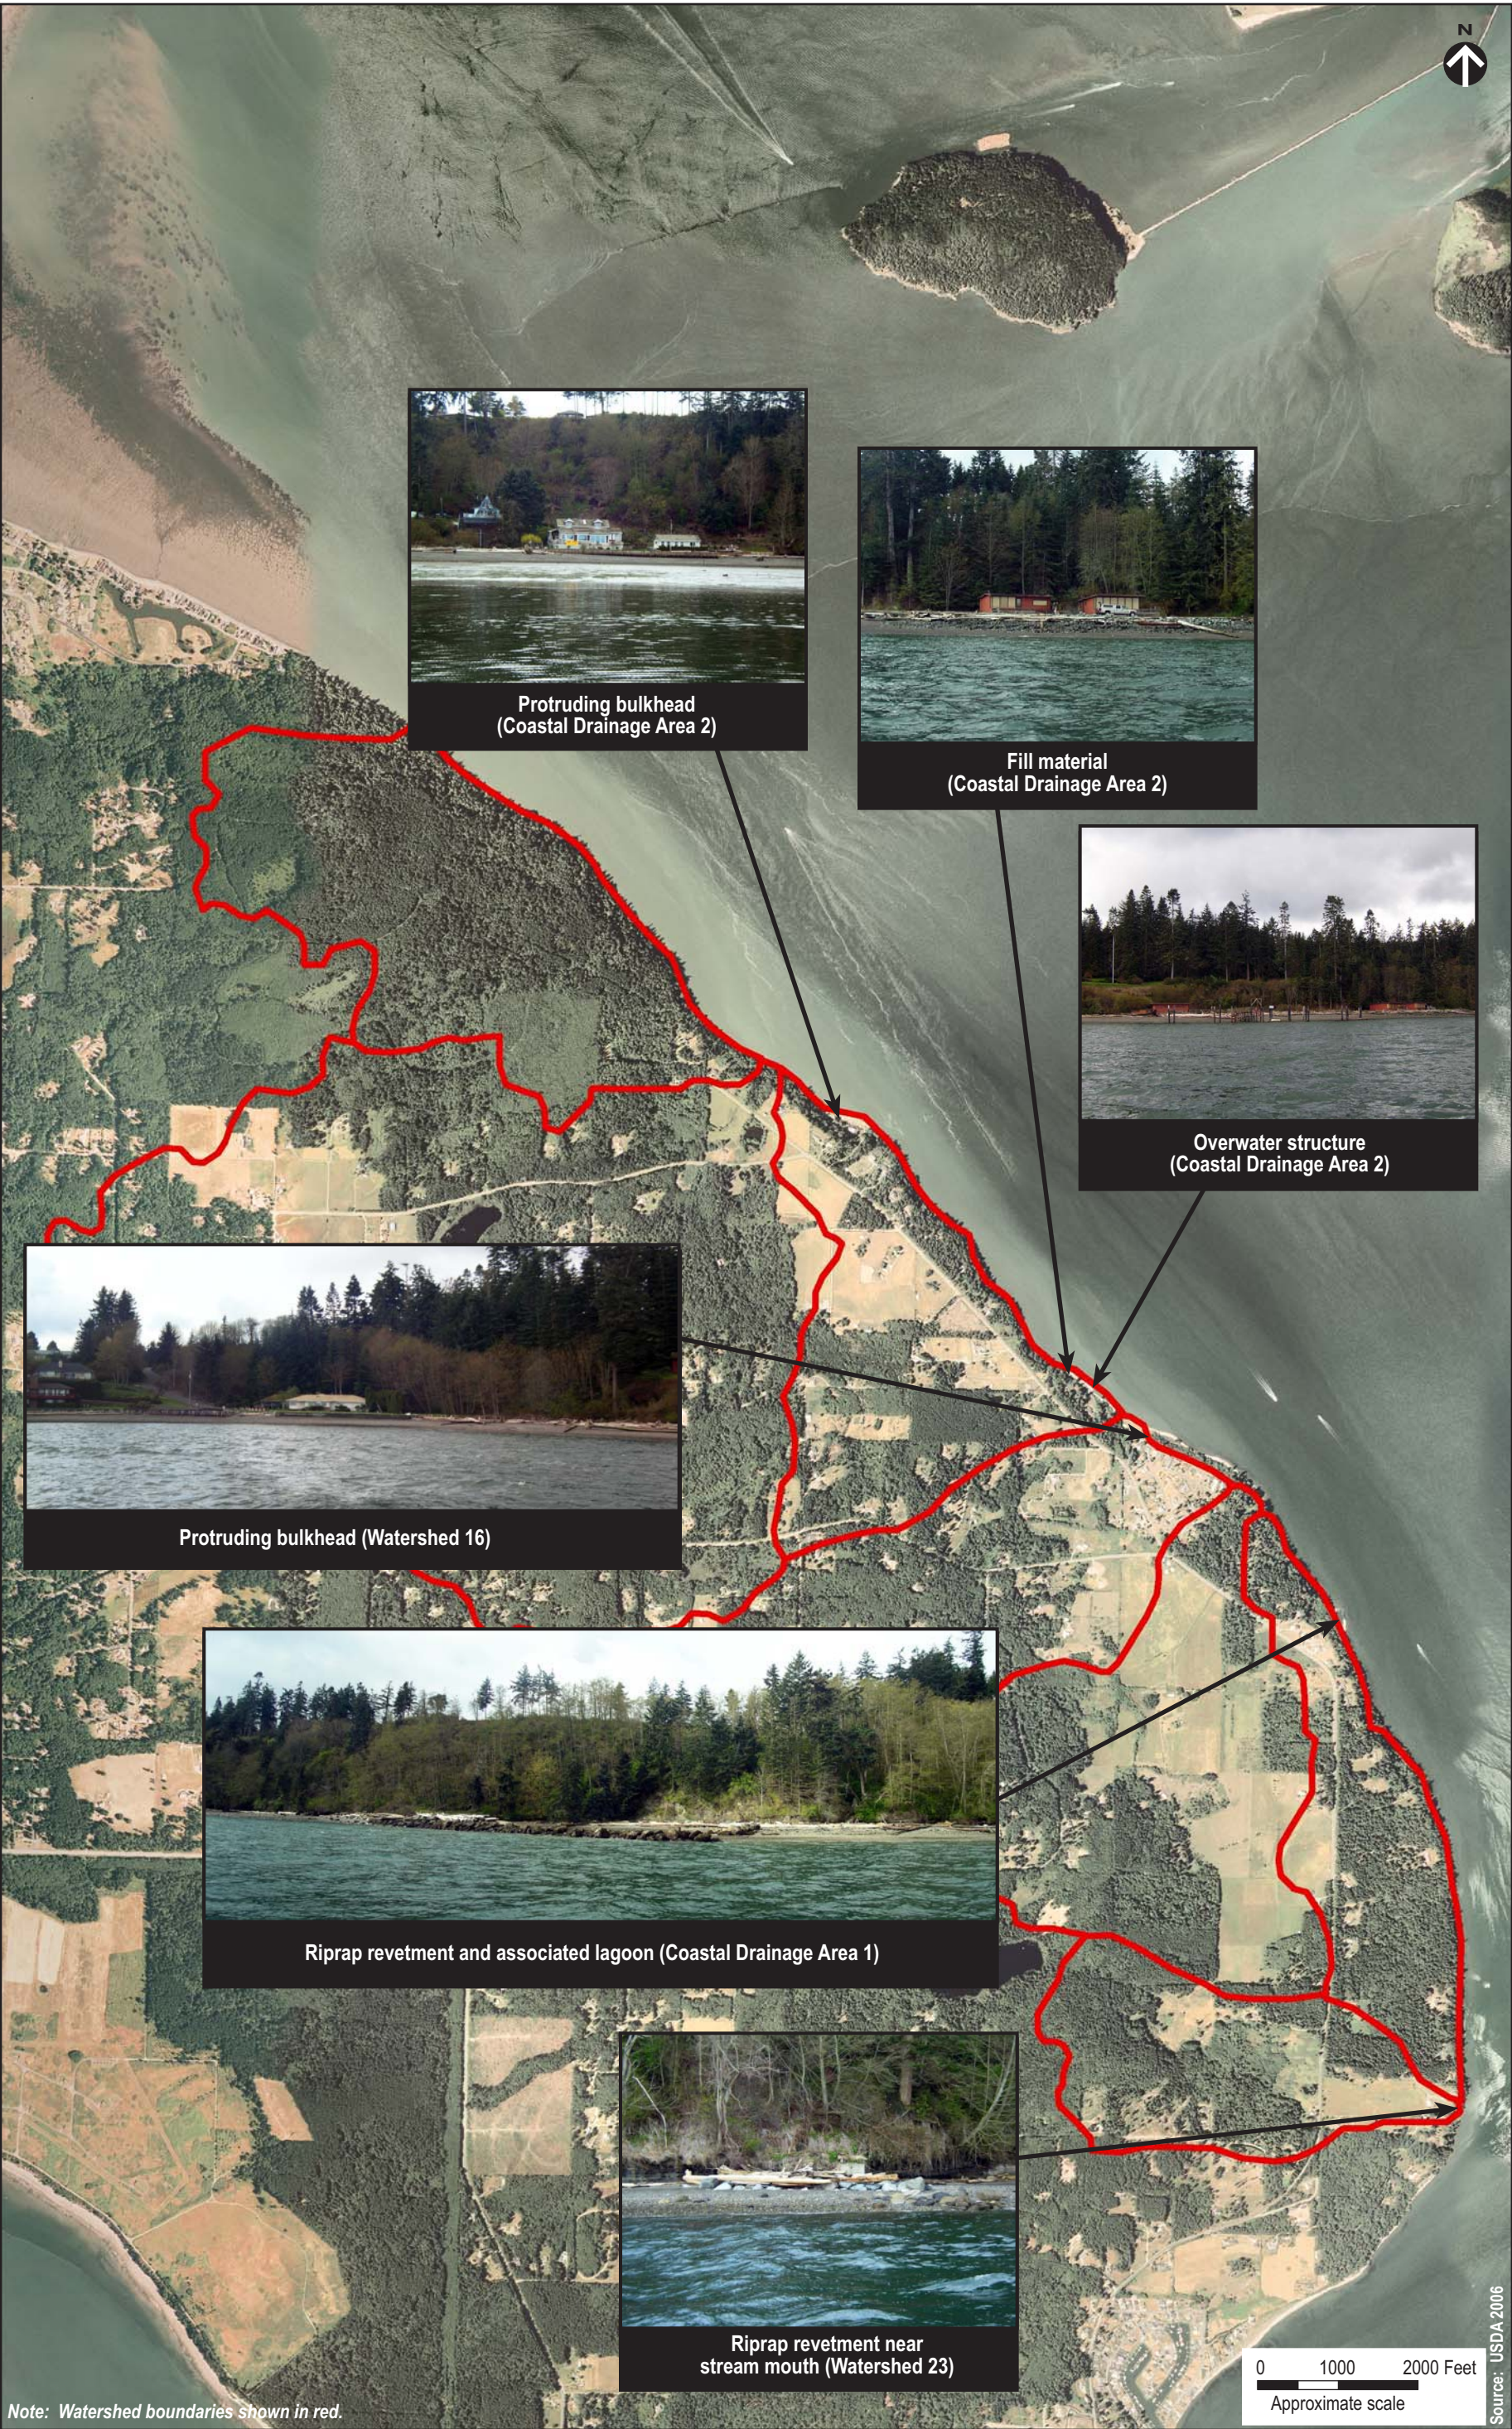
2. Riprap revetment and associated “lagoon” in Coastal Drainage Area 1 – This modification has produced the largest geomorphic impact of any human modification along the Strawberry Point shoreline. Although the rationale for placing the riprap revetment is unknown, it protects a small lagoon and the adjacent bluff which was subject to mass wasting in the

Figure 18. Shoreline human modifications along the Strawberry Point project area.

geologically recent past (see the *Coastal Bluffs and Landslides* subsection). The structure protrudes approximately 160 feet into the nearshore. Its presence is sufficient to rob the foreshore on the downdrift (west) side of the revetment, which has resulted in denuding and armoring of the beach substrate. It has also deepened and almost eliminated the low-tide terrace on the downdrift (west) side of the structure. Based on an analysis of the aerial photographs, this modification was likely constructed sometime between 1944 and 1965.

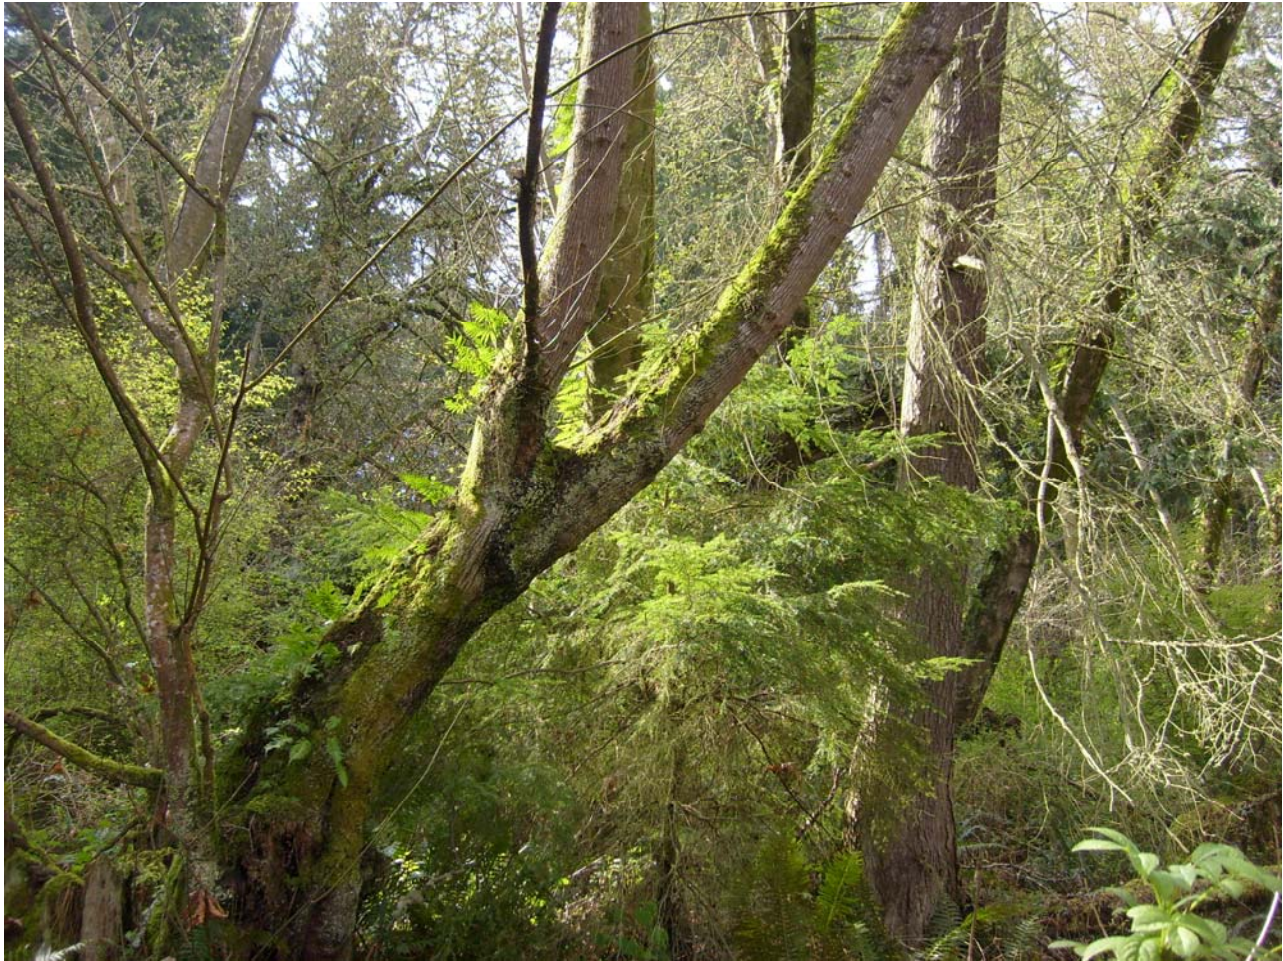
This land cover type is common in all seven watersheds (approximately 24 percent of the total study area; 24.51 acres), and it often occupies bluff faces and toes and also gaps in coniferous or mixed forests or landslide tracts. Common dominant species include red alder and big leaf maple. Their presence likely indicates disturbance intervals short enough to preclude the establishment of mature coniferous vegetation, and resident trees are most often very young (<50 years). Some historically active erosion areas that have not experienced landslide activity or other major disturbance in the recent past (e.g., along the shoreline in Coastal Drainage Area 3) are characterized by overhanging, old big leaf maple trees that provide an excellent substrate for the abundant growth of epiphytic plants such as mosses, ferns, and lichens (Figure 20).

Figure 20. Photograph of mature big leaf maples characterized by abundant epiphyte (mosses, licorice ferns, and lichens) growth in Coastal Drainage Area 3. April 9, 2008.

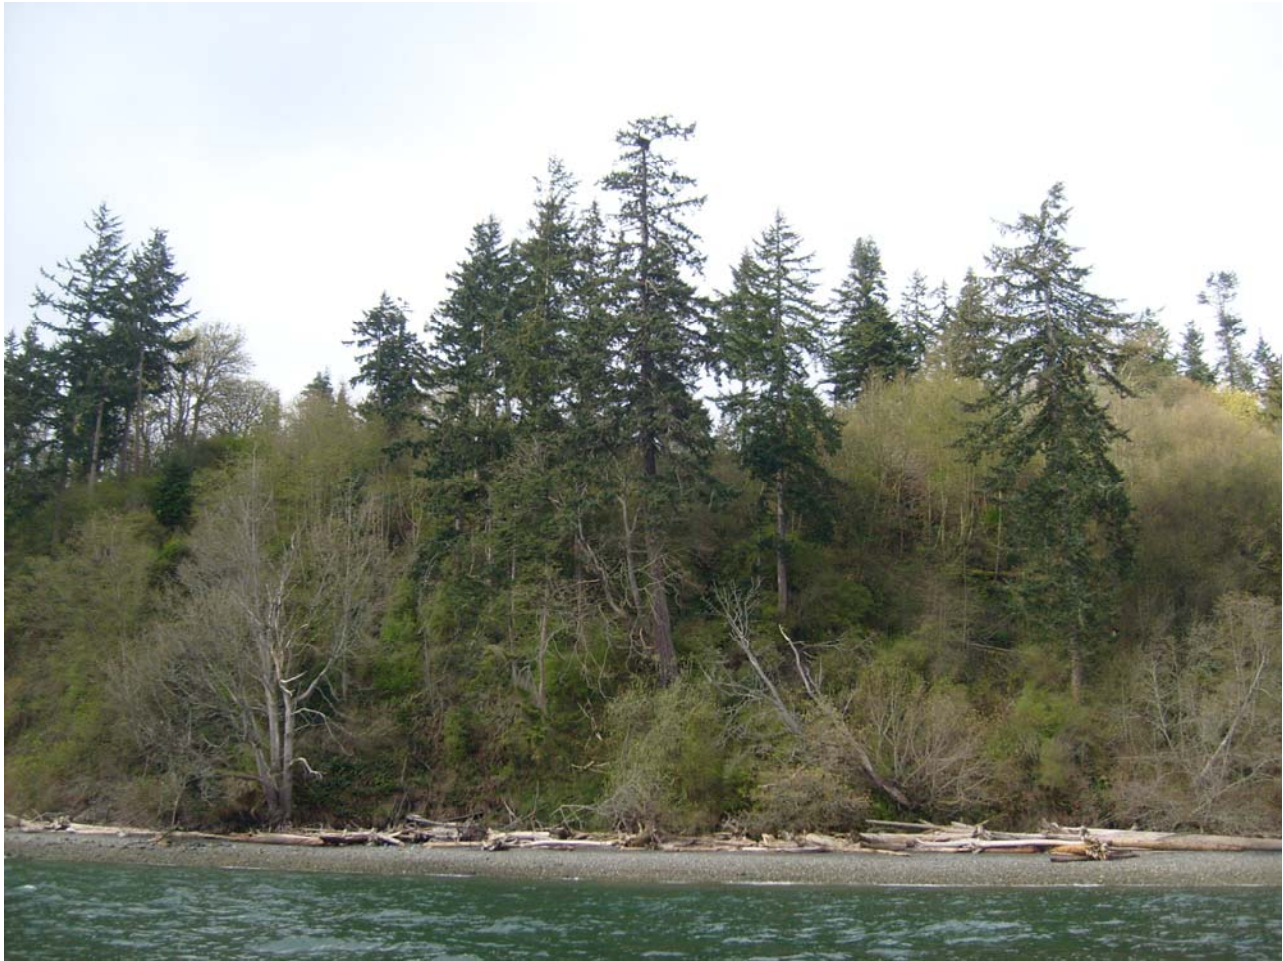
Figure 21. Photograph of large relict conifer on bluff face providing bald eagle nesting site in Coastal Drainage Area 1. April 9, 2008.

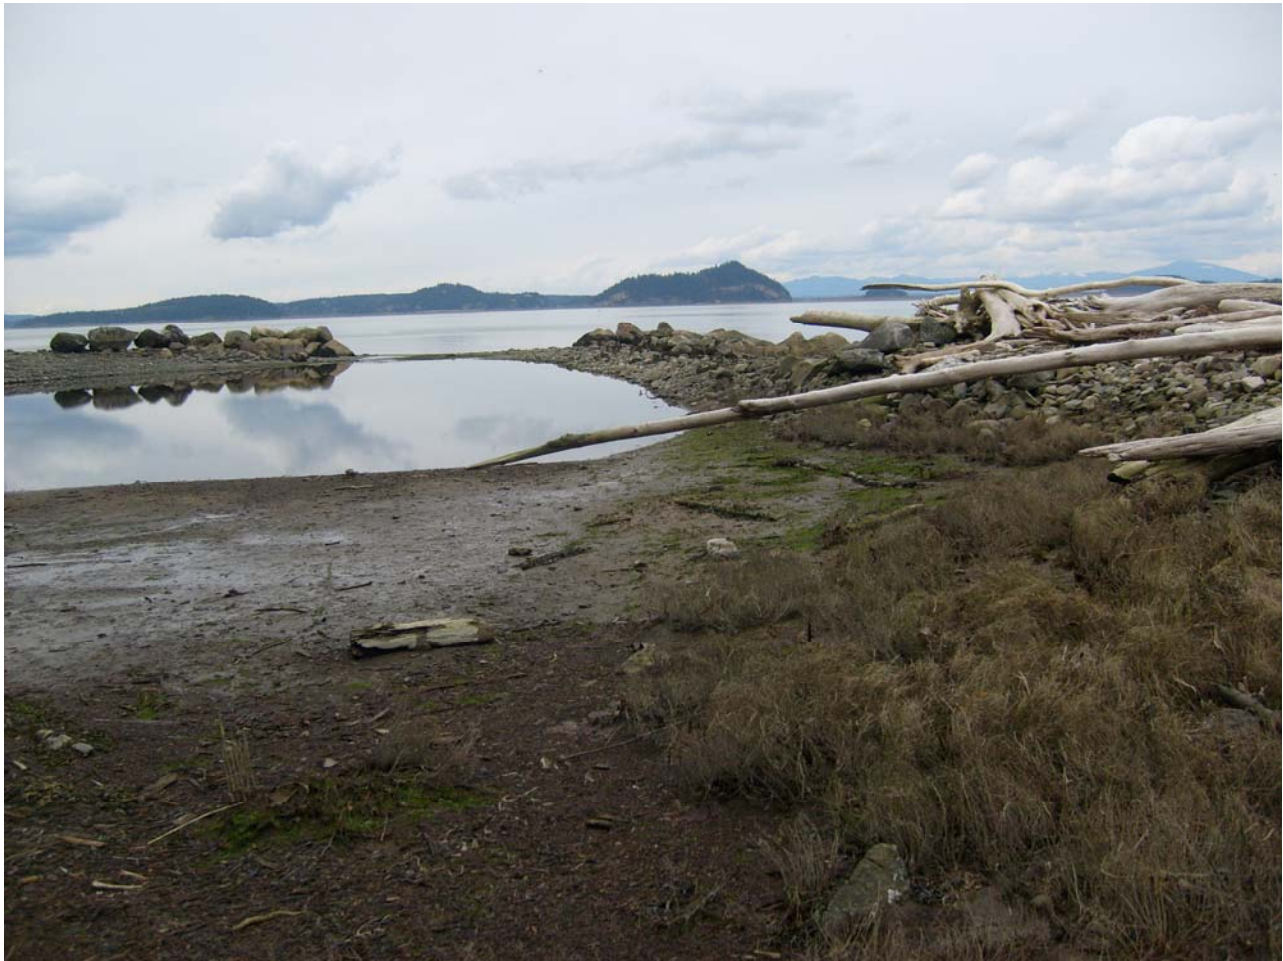
Figure 22. Photograph of pickleweed patch on the edge of the artificial coastal lagoon created as a result of the manmade spit feature in Coastal Drainage Area 1. April 9, 2008.

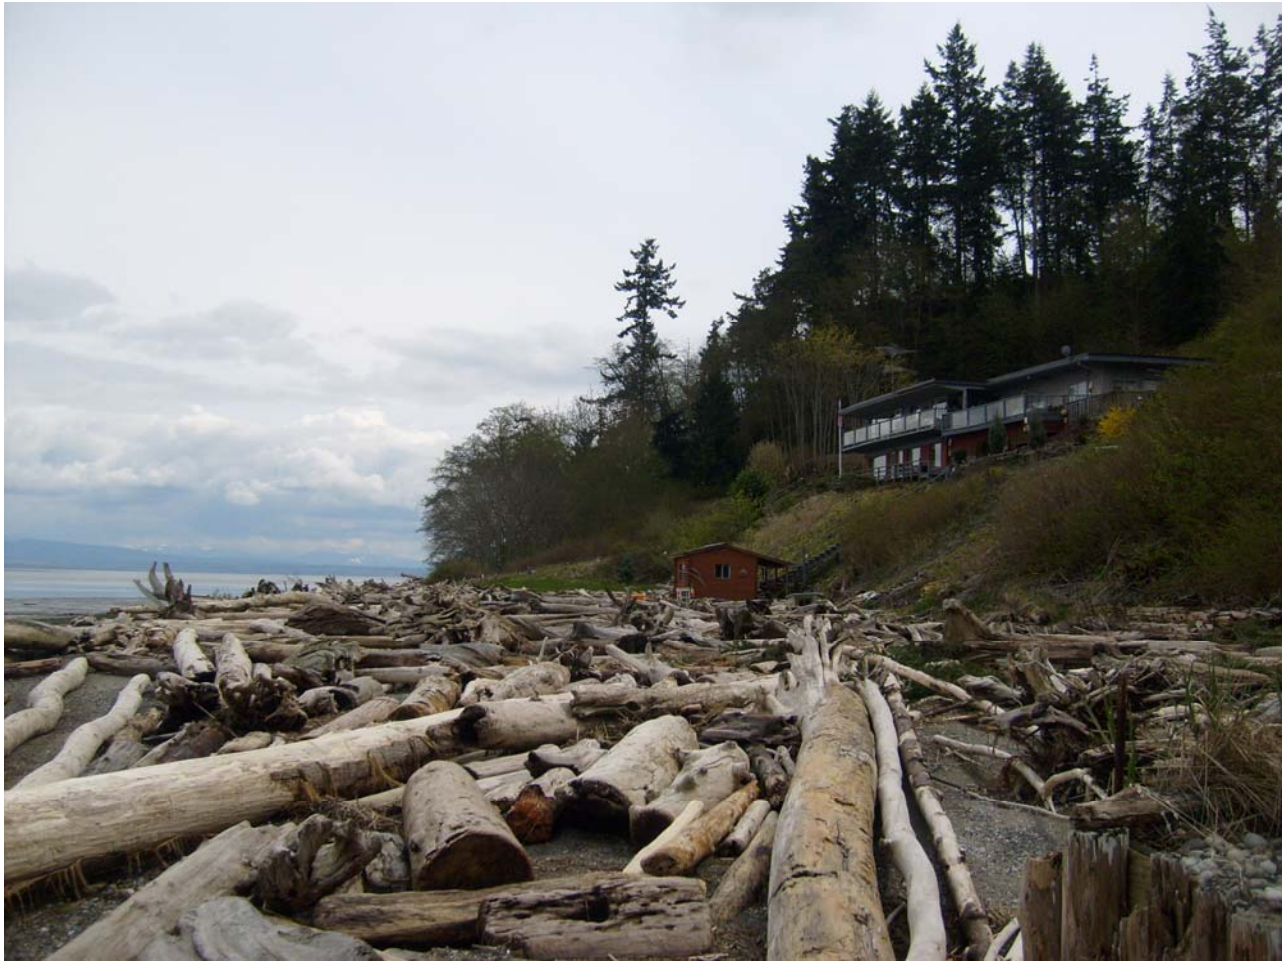
Figure 23. Photograph of sparse dune vegetation amidst accumulated large woody debris in Coastal Drainage Area 2. April 9, 2008.
