Assessment and Recommendations For Habitat Protection

Strawberry Point, Whidbey Island

Island County
Planning and Community Development Department

January 30, 2009

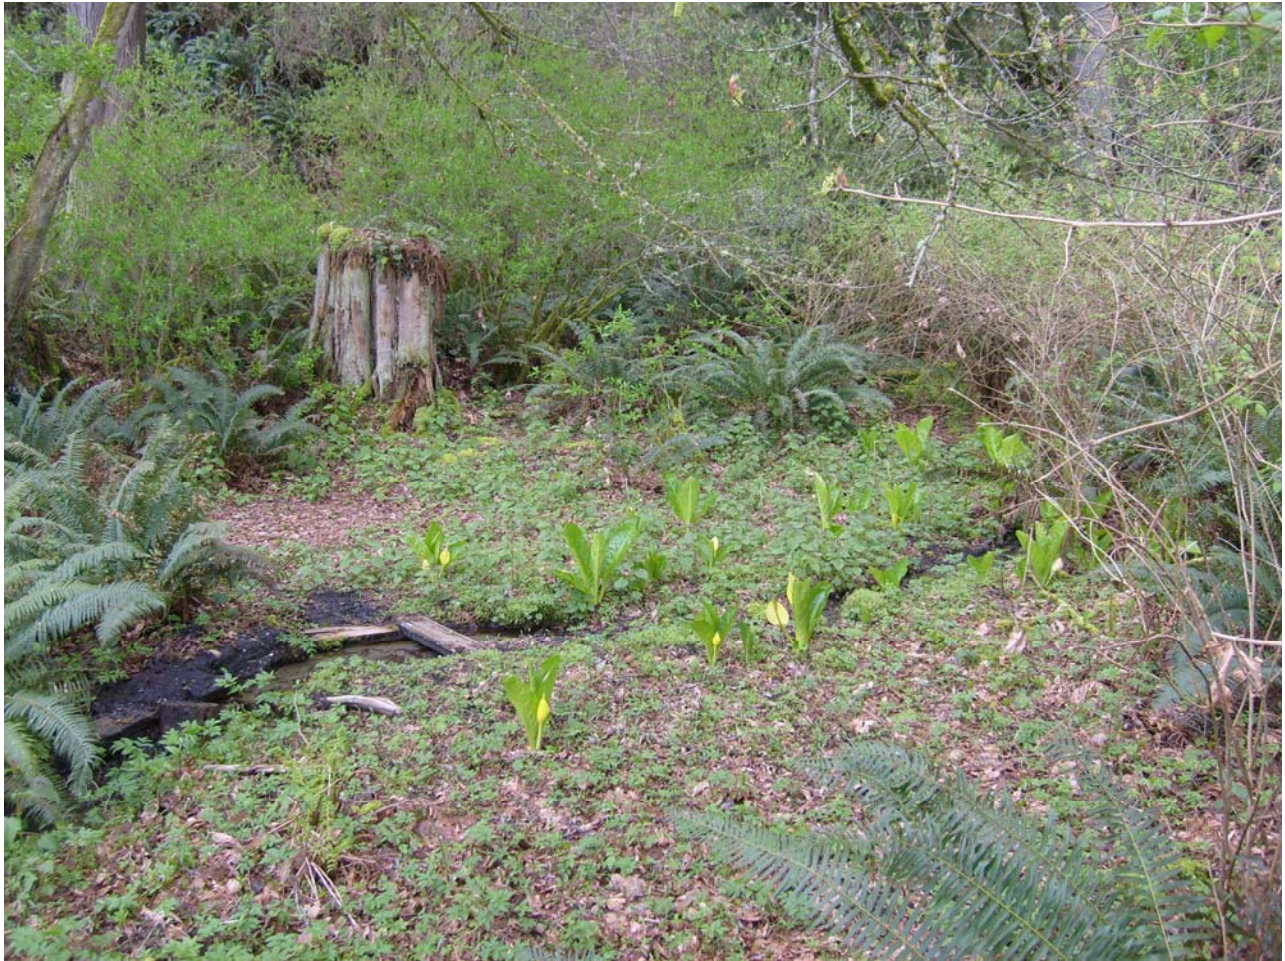
Figure 24. Photograph of freshwater wetland on bluff toe terrace in Coastal Drainage Area 3. April 9, 2008.

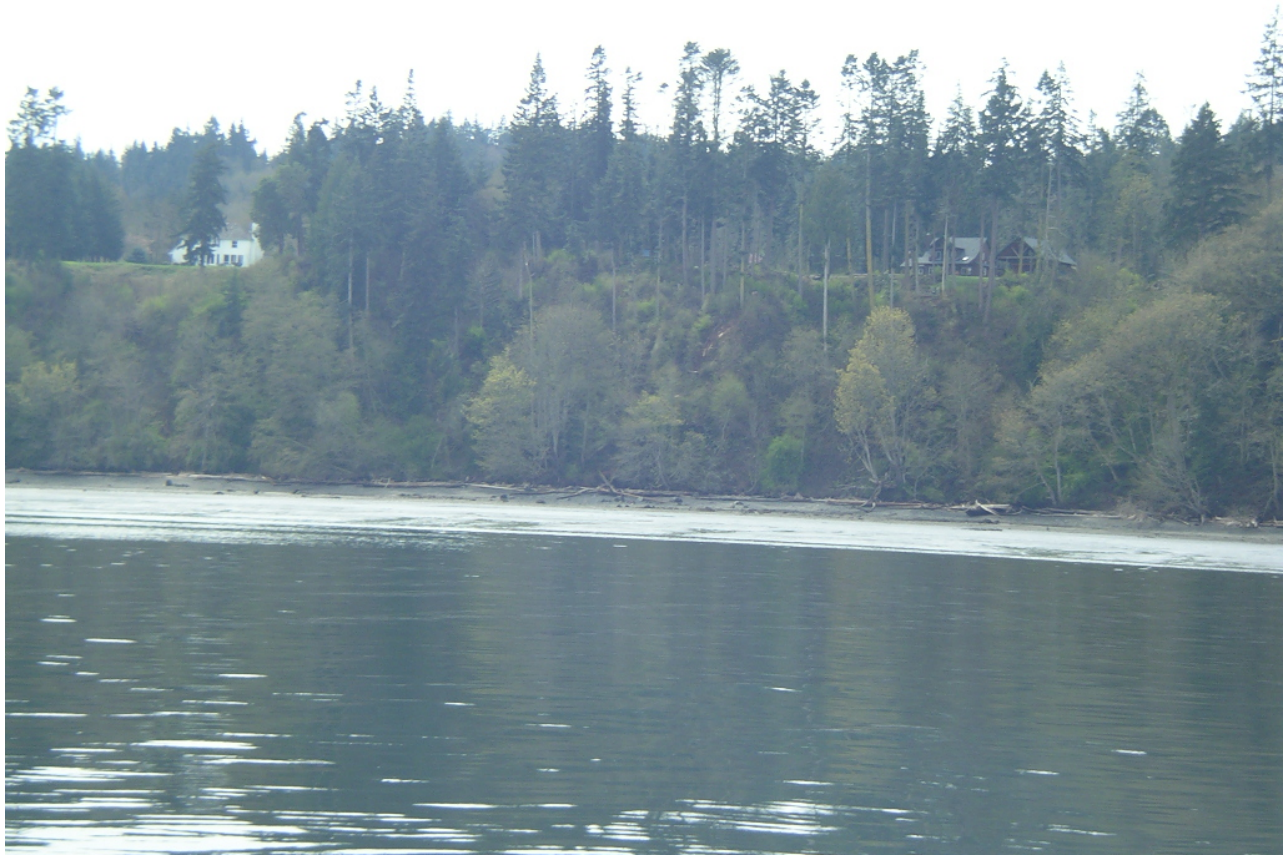
Figure 25. Photograph of two adjacent properties illustrating two different approaches to view preservation. The residence on the right uses a “windowed” approach that is both sustainable and not significantly detrimental to nearshore habitat, while the residence on the left potentially increases shoreline erosion and compromises nearshore habitat by eliminating nearly all vegetation at the top of the bluff.

Discourage the installation of new shoreline structures – While little of the shoreline in the project area is currently armored (in comparison to the general shoreline conditions of Puget Sound), future development could include the placement of new revetment structures. However, with the exception of Coastal Drainage Area 1, there is little shoreline erosion in the project area, and protection of property can be accomplished successfully with “softer” means (e.g., addition of stable wood and maintenance or protection of an intact, native bluff and shoreline vegetation). Where possible, these alternative methods should be strongly encouraged over the placement of new structures.

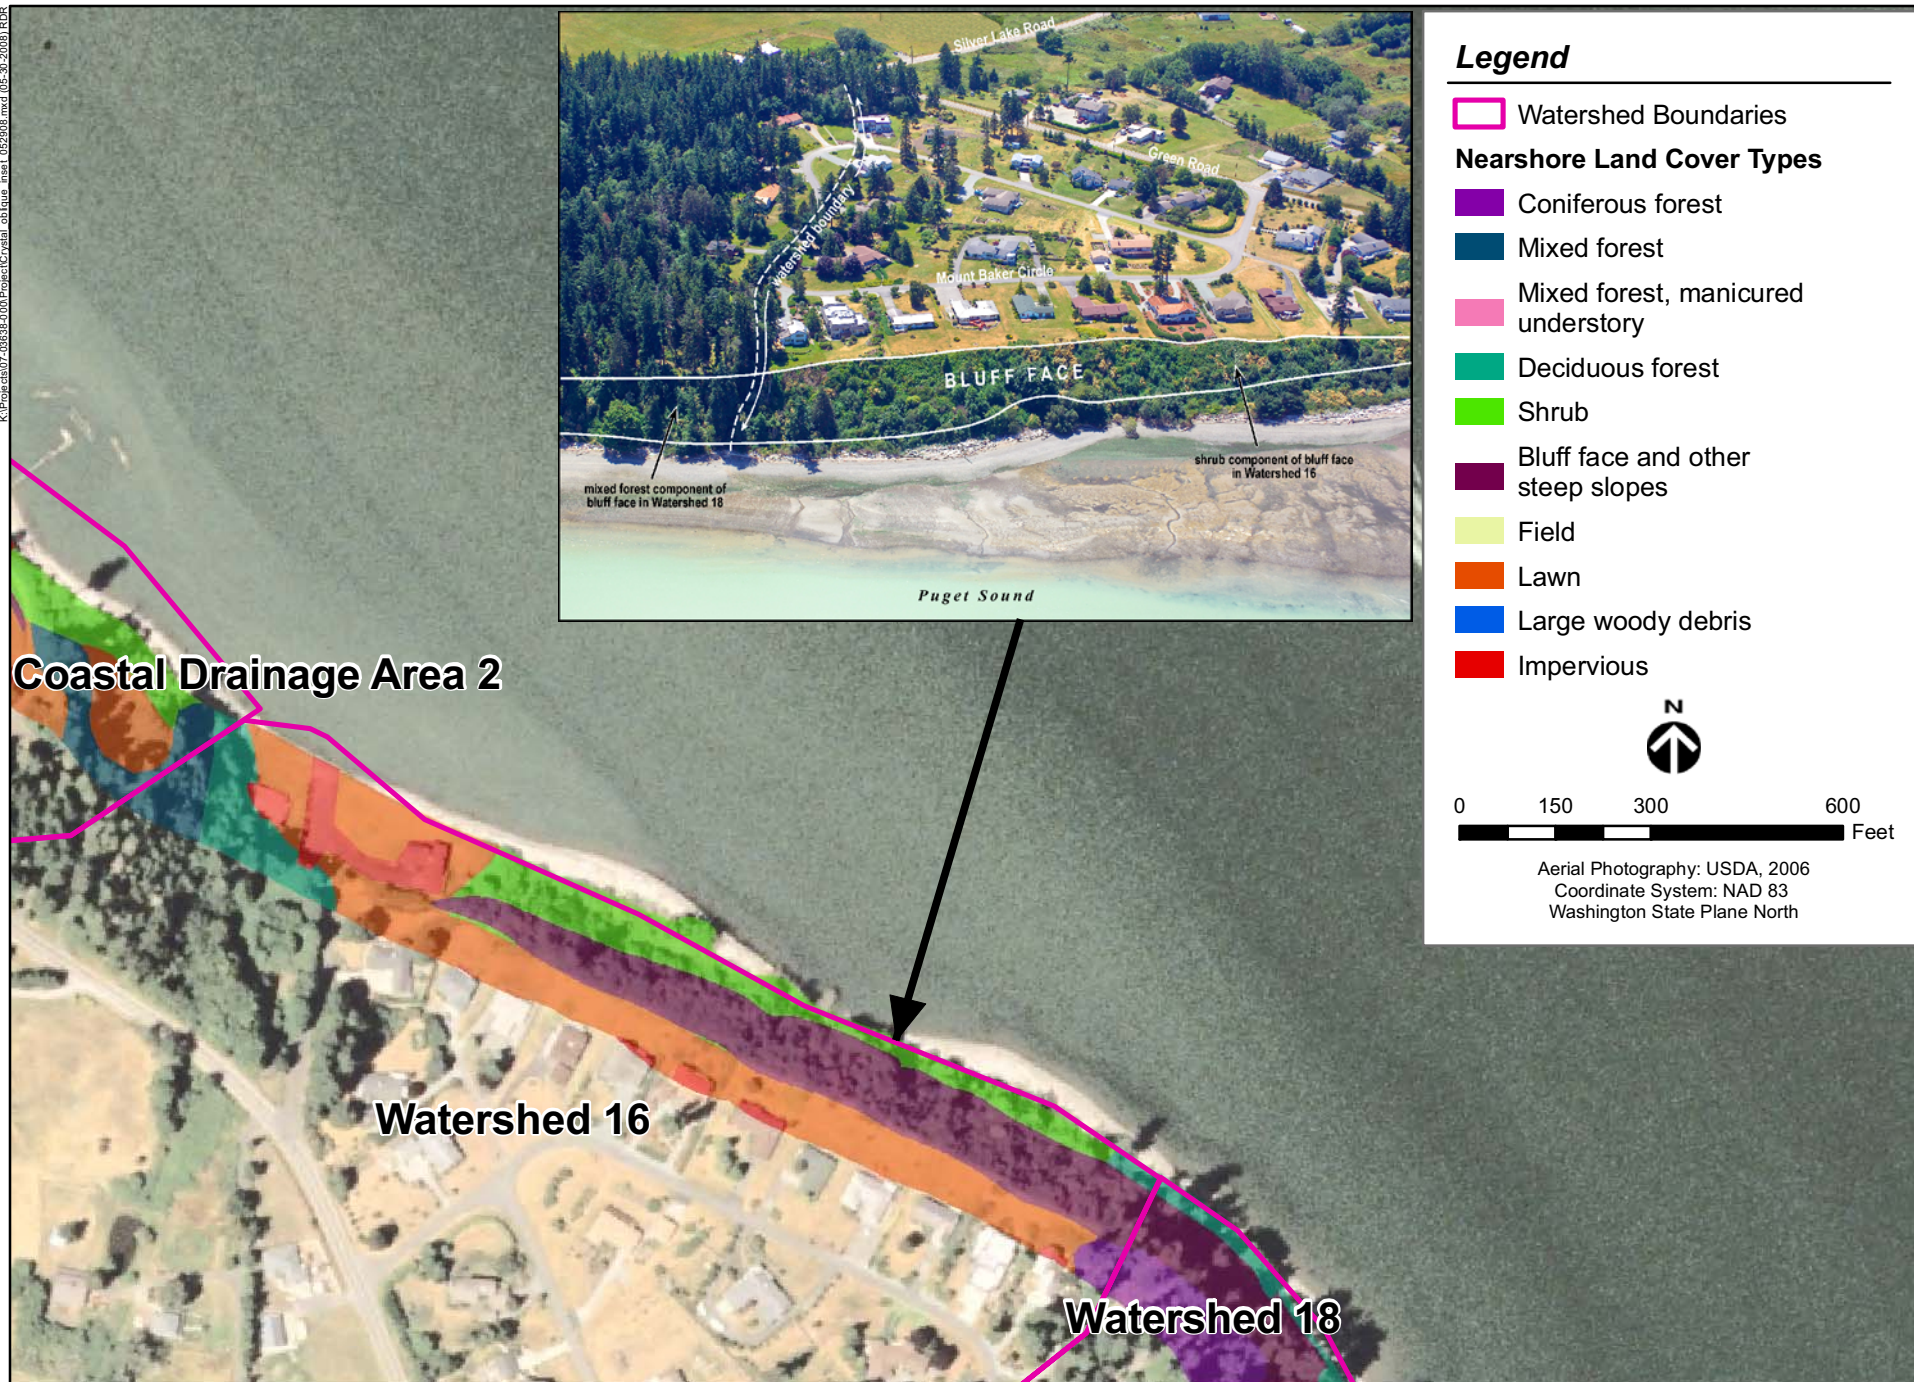
Appendix C. Excerpt from Strawberry Point land cover type map and corresponding oblique photograph (Ecology 2006) illustrating bluff face extent and land cover components adjacent to the residential development in Watershed 16.
