## 15. Appendix B – Snyder Watershed Sediment Assessment 2012

### Snyder Creek Watershed Sediment Assessment 2012

Prepared by Dan Richardson,  
UCD Watershed Resource Technician

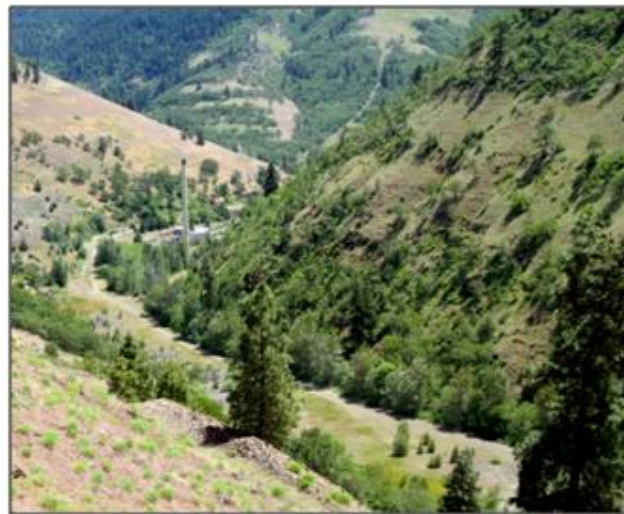
**Figure 3: Snyder Canyon saw mill.** This view is just upstream of the Snyder Stream confluence with the Klickitat River, a few hundred feet around the bend from the abandoned sawmill's smokestack, at photo center-left.

Unscored. (See Figure 3 for photo.) The former sawmill property, upstream of the recent fish-passage work at the Snyder-Klickitat confluence, is not necessarily an erosion site (it was not measured due to access restrictions) – it should be considered more of a restoration opportunity than an erosion risk. The stream empties out of its long canyon here into a narrow floodplain, which was reworked as the site of a long-running sawmill. In 2003-04, several agencies undertook a reconstruction of the stream mouth from the confluence up into the mill site proper; above the mill buildings, however, the stream remains channelized in a deep, straight cobble bed against one side of the canyon. It's likely that the change from high- to moderate-gradient here resulted historically in a more meandering or braided stream and floodplain. Restoring that function would be enormously expensive, given likely mill-cleanup costs, but could recreate a sediment-trapping stream reach and backwater areas for salmon spawning and rearing. Ownership: Confluence proper – Klickitat County. Upstream of mill buildings – Private individual.

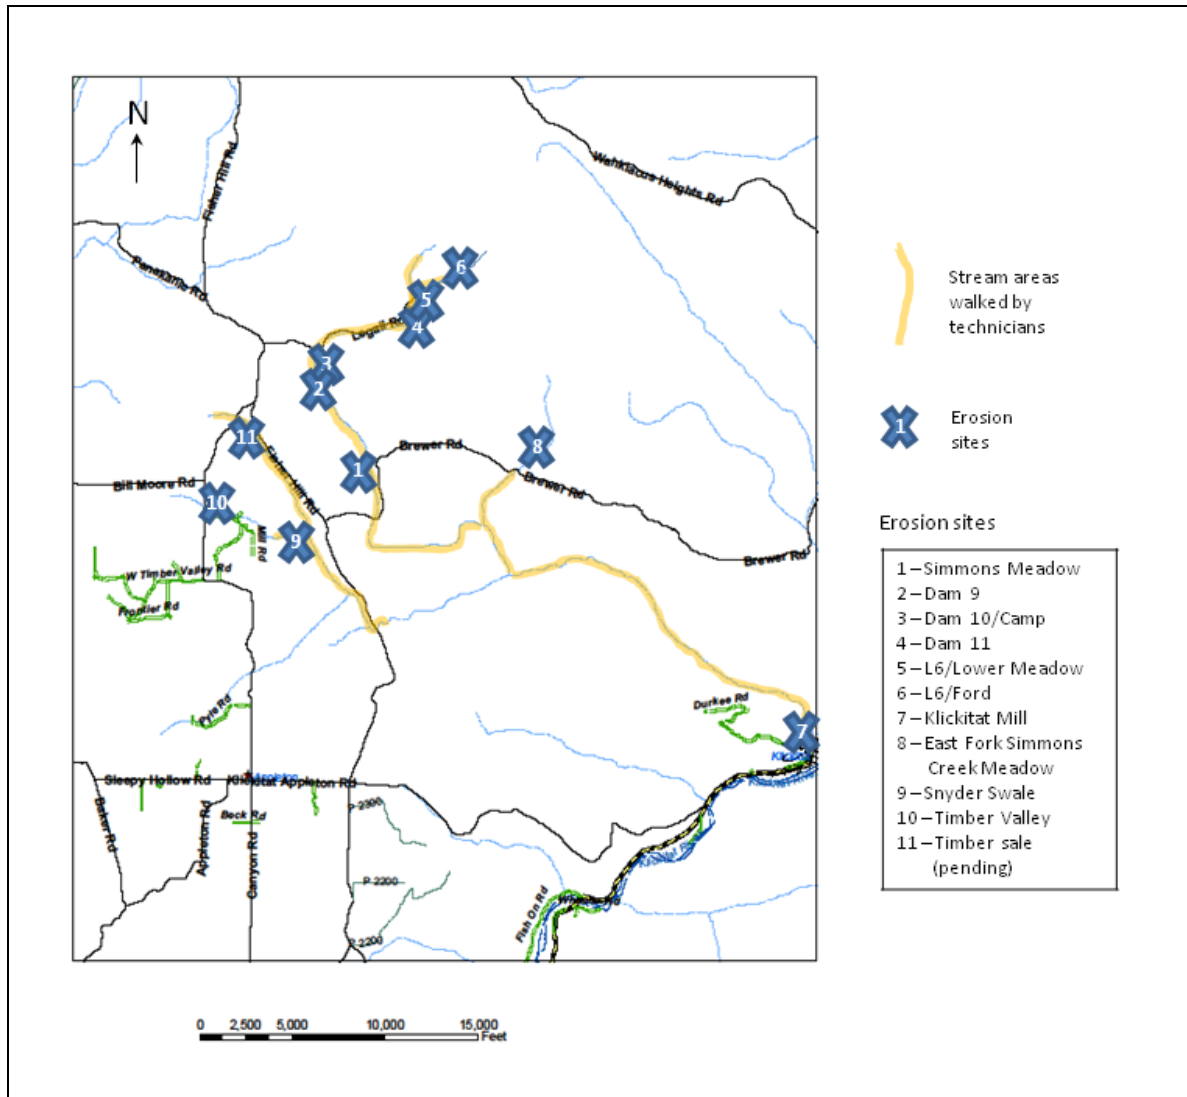
**Figure 5: Snyder Watershed sites of concern.** This map identifies the major reaches of the watershed, the areas walked by UCD technicians in spring 2012, and identified erosion sites. Some of these were measured as actively eroding riparian areas; others are unmeasured areas of concern. See notes for each, below.

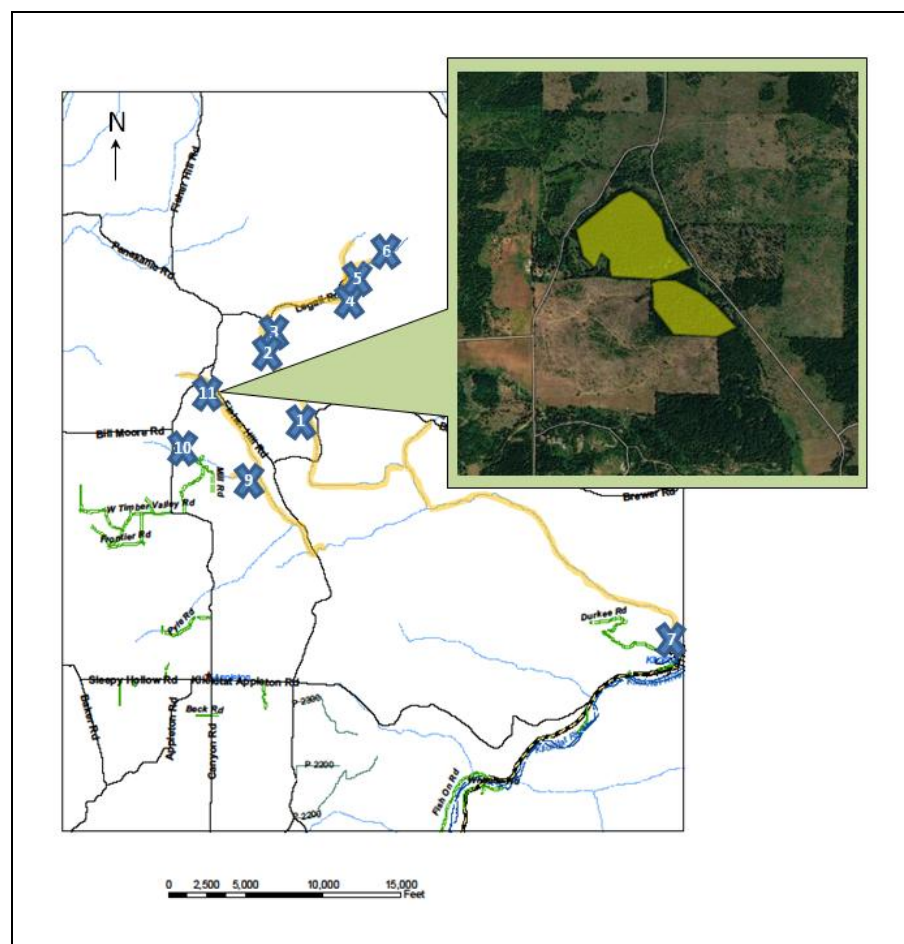
**Figure 13: Timber sale planned area.** A superimposed aerial photo and approximate areas of a DNR-planned timber sale at erosion site 11. This is south of the Fisher Hill Road and Canyon Road intersection, and represents 100 acres to be logged at the head of Snyder Swale.
