**Technical Memorandum:
Ala Spit Restoration Feasibility,
Island County, WA - Draft**

Prepared for: Island County Public Health

Prepared by: Coastal Geologic Services Inc.

August 15, 2013

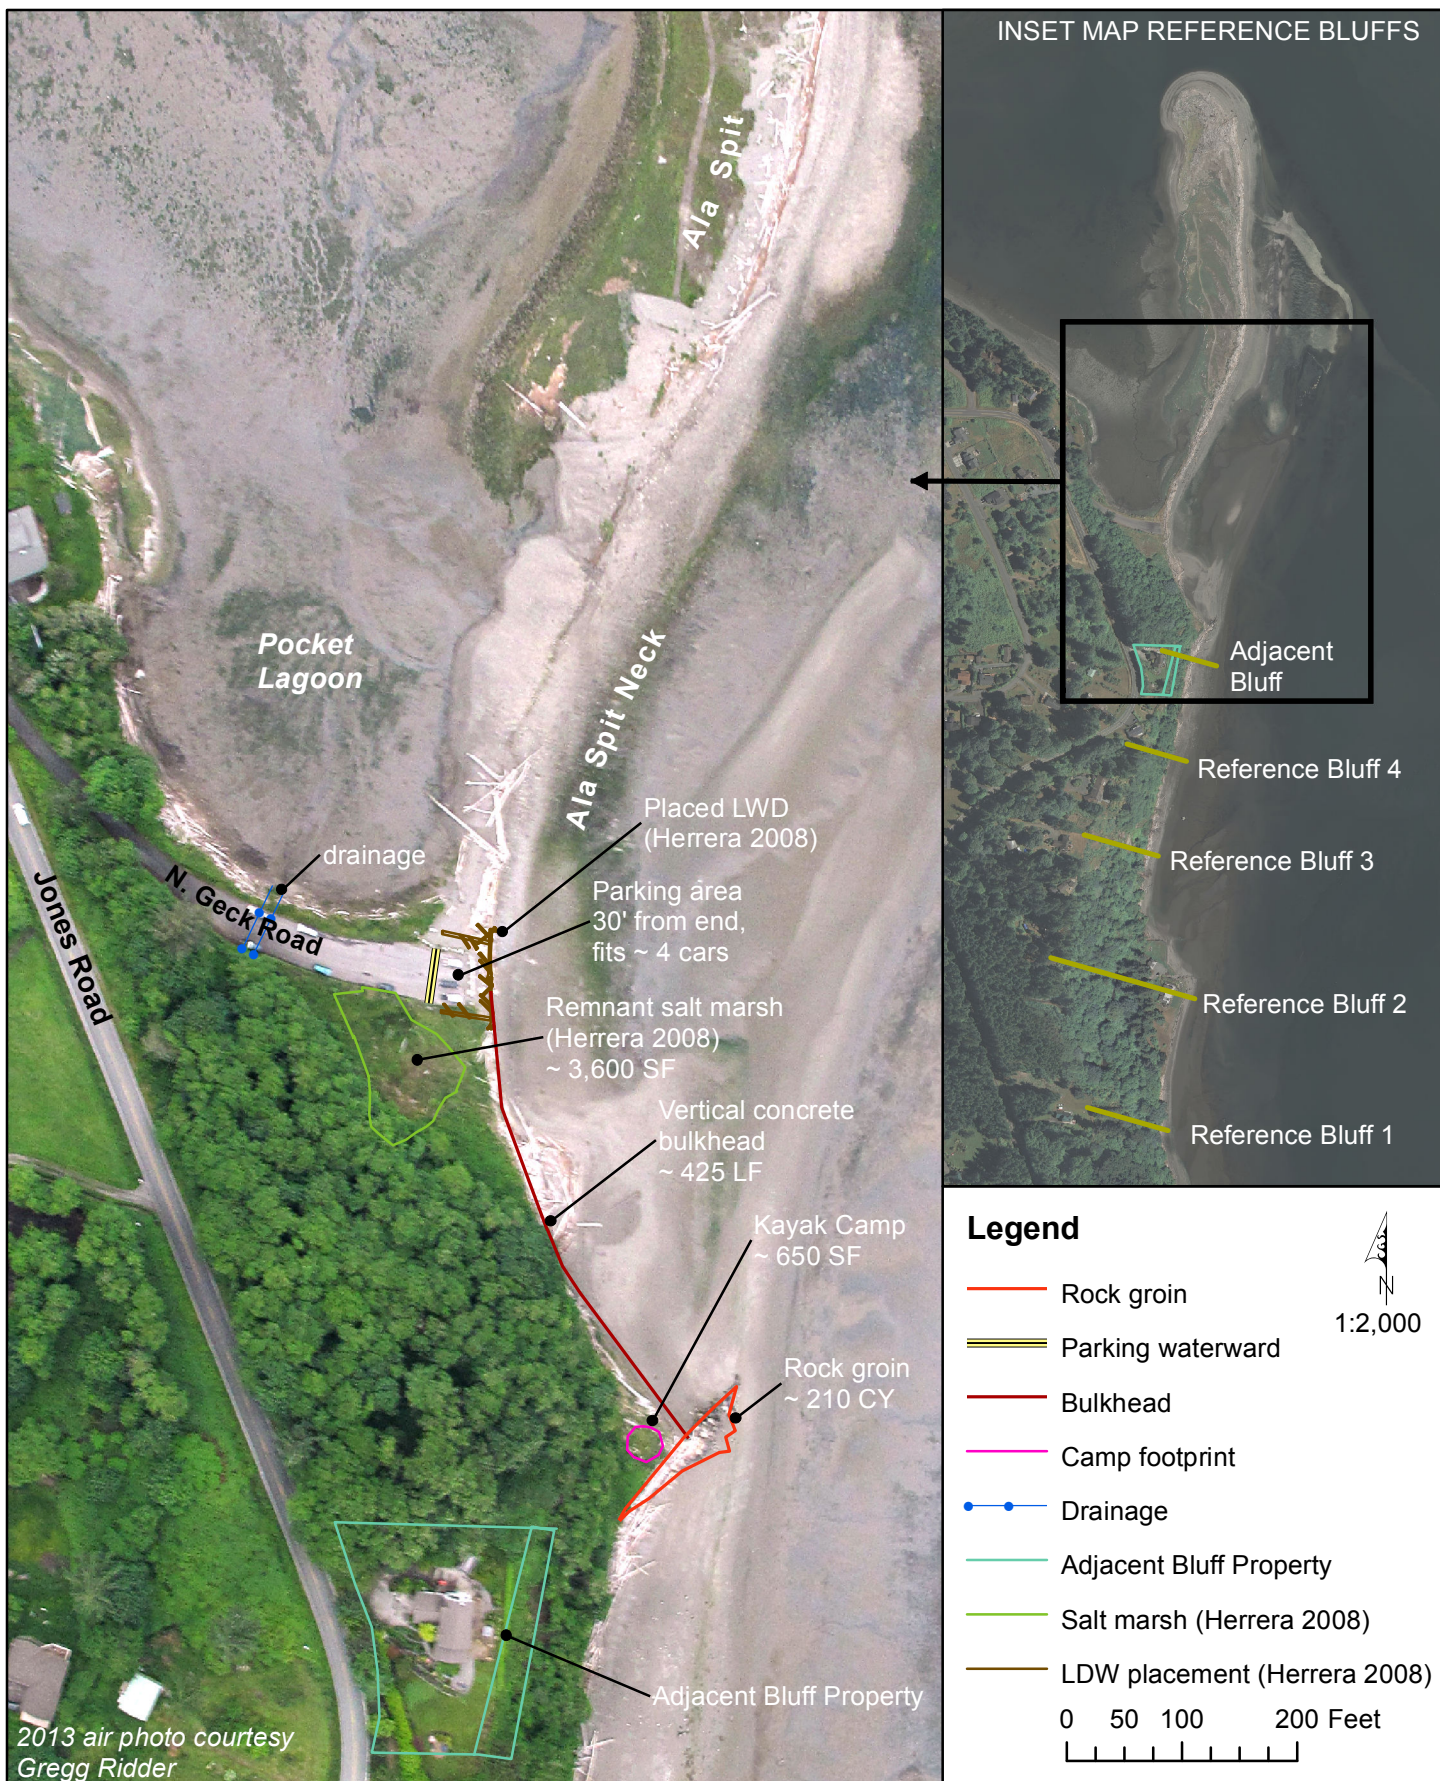
Figure 2. Ala Spit site features map and inset map of reference bluffs.

This groin was surveyed by CGS during the July 20th site visit. The quantity of rock in the groin based on the preliminary survey data and CADD work is approximately 210 cubic yards (CY), not accounting for the buried portion (Figure 2). This groin has a maximum elevation of +10.4 ft MLLW and a minimum elevation of +5.1 ft MLLW and is oriented across-shore obliquely toward down-drift or north. No subsurface investigations were conducted as part of these estimates, so the volumes above surface should be considered preliminary.

Geck Road transitions into the parking area for Ala Spit where the grade of the road is reduced in the vicinity of the pocket lagoon. Cars park at the road end (most waterward extent of road) and along both sides of the road, which is clearly displayed in the 2013 aerial photo (Figure 2). This includes approximately 220 ft along the south side of the road, 175 ft along the north side of the road and enough room for approximately 4 cars at the road end in a space approximately 30 by 45 ft. It appears that this parking arrangement allows for a maximum of 11 cars along the south side, 9 cars along the north side, and 4 cars at the road end, for a maximum of 24 cars in this area of the park. However, because there are no designated parking areas and parking is irregular, the current maximum capacity is approximately 20 cars.

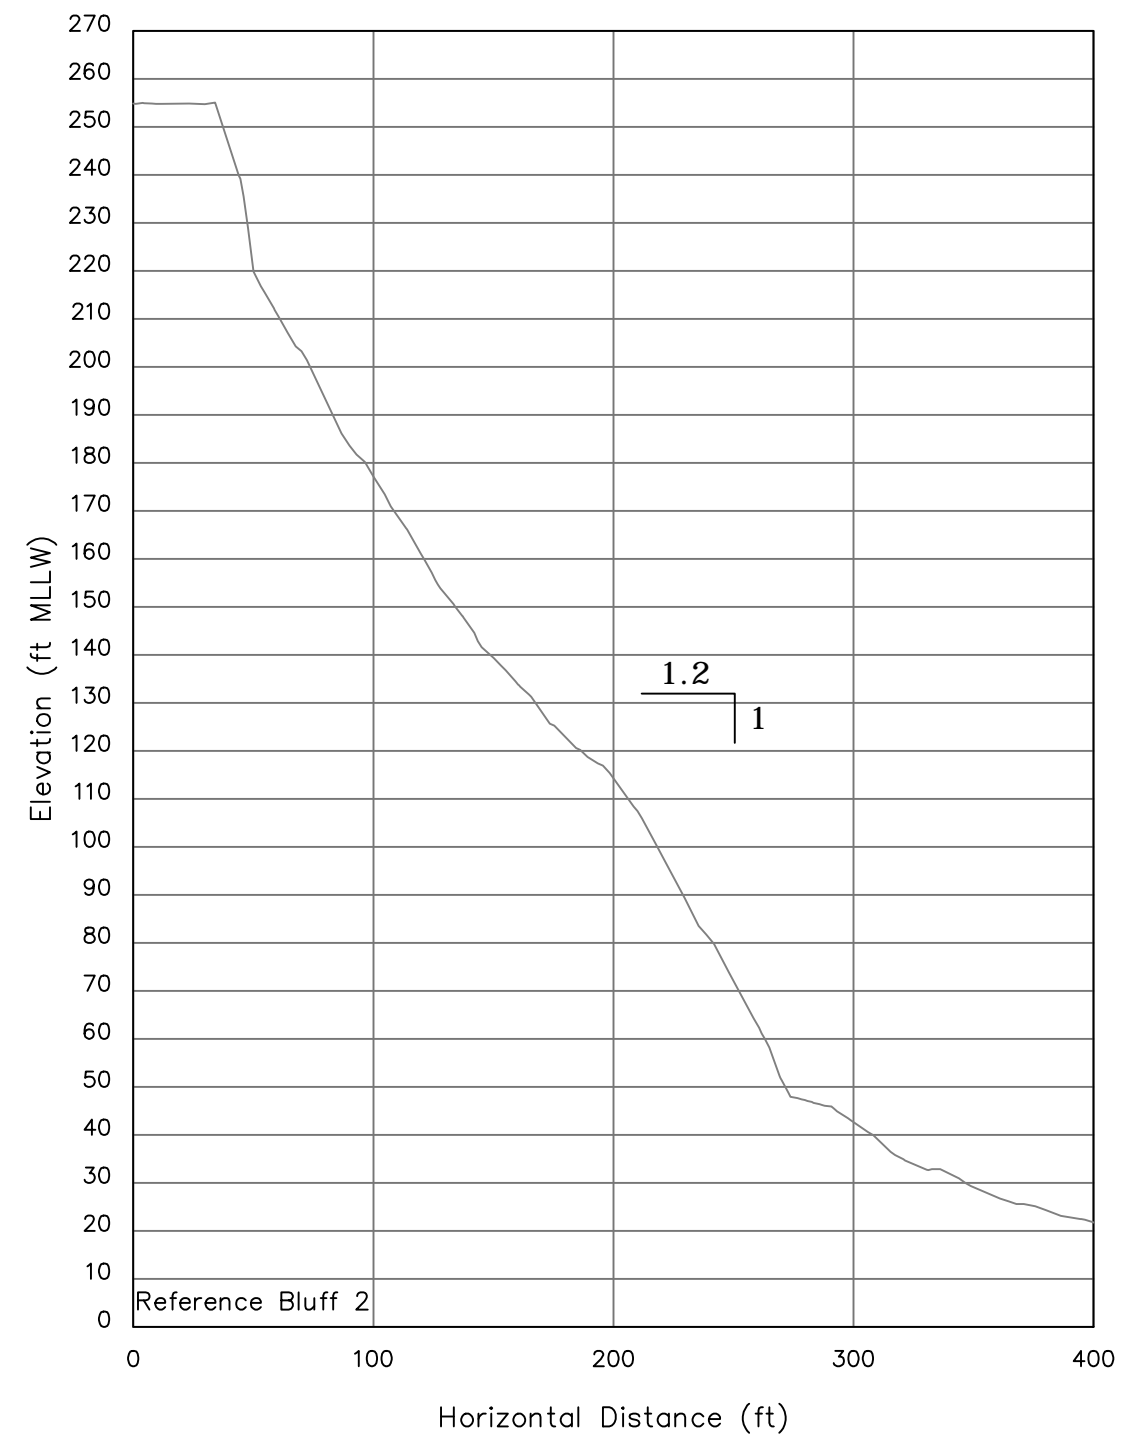
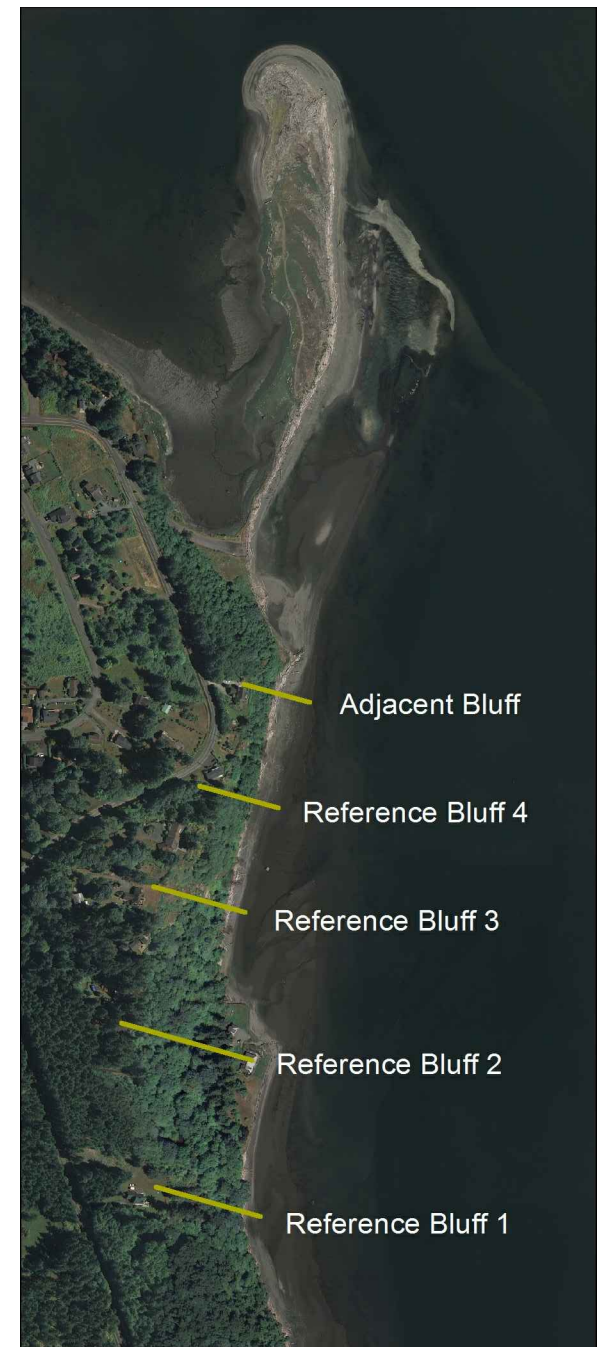
Figure 5a. Bluff cross sections (profiles) from LiDAR data south of Ala Spit. Sections shown at 2x vertical exaggeration. Slopes shown are average for entire bluff face.
 LiDAR data acquired from Puget Sound LiDAR Consortium

Bluff crest recession was measured from historical aerial photos along reference bluff cross sections (Figure 2, 5a, and 5b) among the years 1956, 1969, 1985, and 2007. Analysis indicated the following observations and measurements (Table 3):

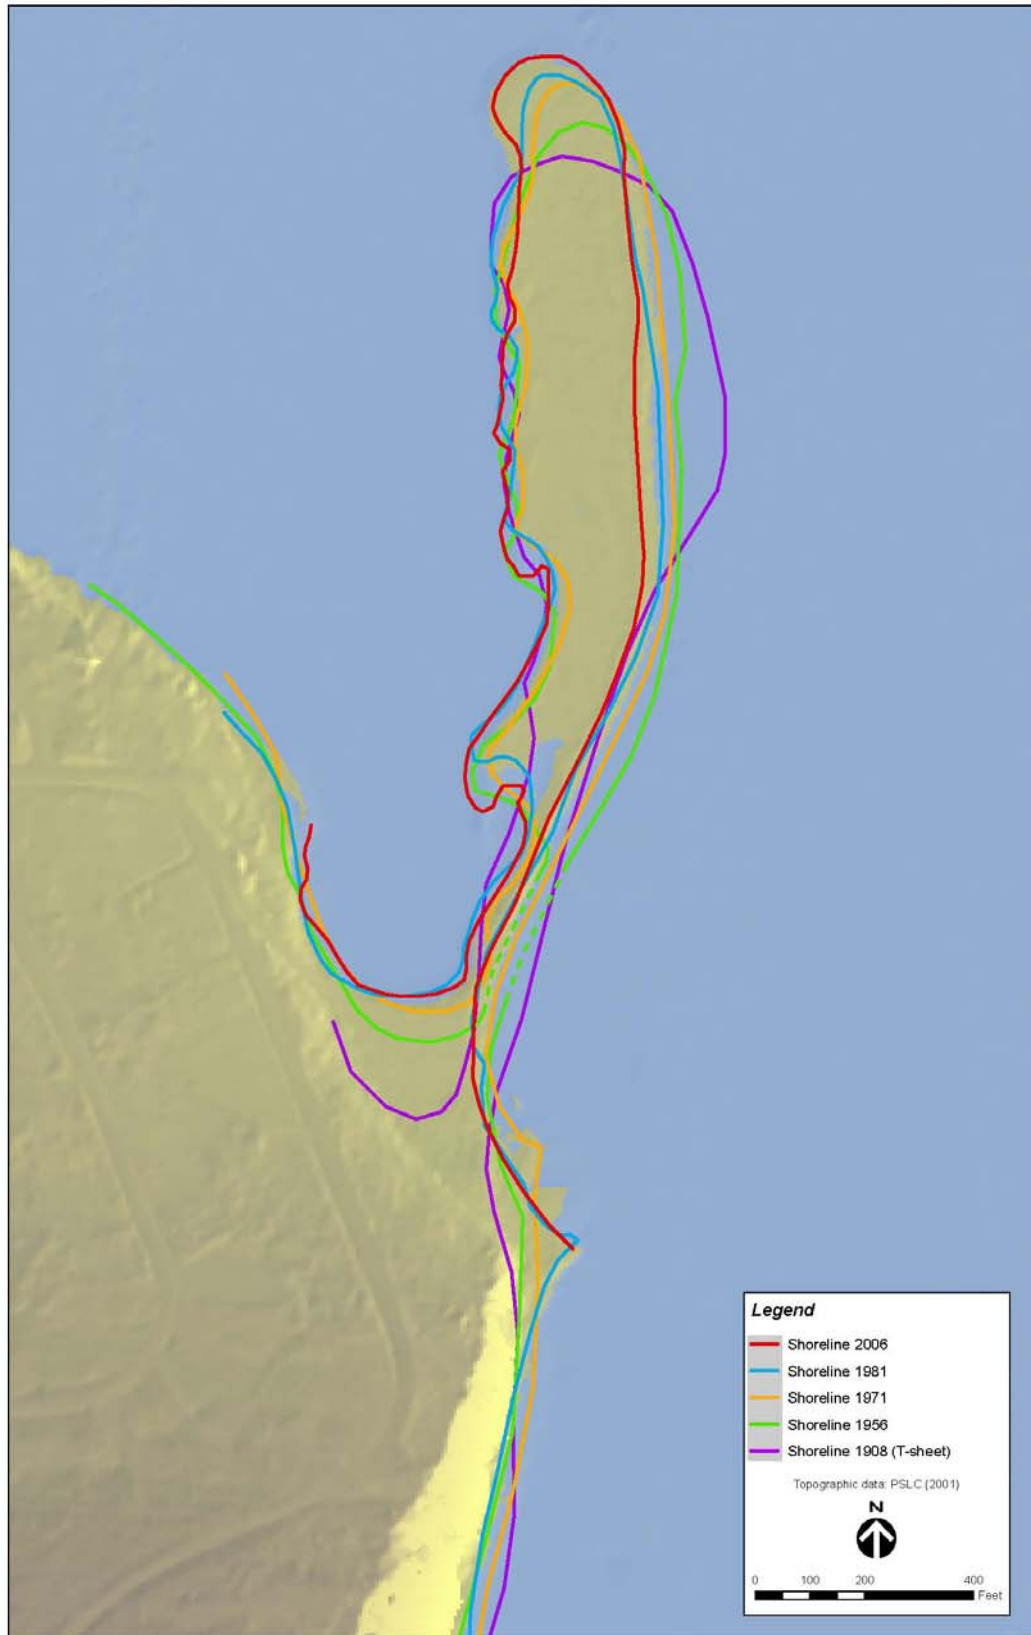
Figure 6. Shore change mapping of Ala Spit (Herrera 2008).

Herrera Environmental Consultants (2008) conducted a shore change assessment of Ala Spit (Figure 6) that showed a narrowing and elongating migration of Ala Spit over the course of nearly a century. The shorelines mapped include the 1908 T-sheet shoreline, and the Ordinary High Water (OHW) as indicated by riparian vegetation, wrack, and other indicators from 1956, 1971, 1981, and 2006 (Herrera 2008).
