**Technical Memorandum:
Ala Spit Restoration Feasibility,
Island County, WA - FINAL**

Prepared for: Island County Public Health

Prepared by: Coastal Geologic Services, Inc.

October 18, 2013

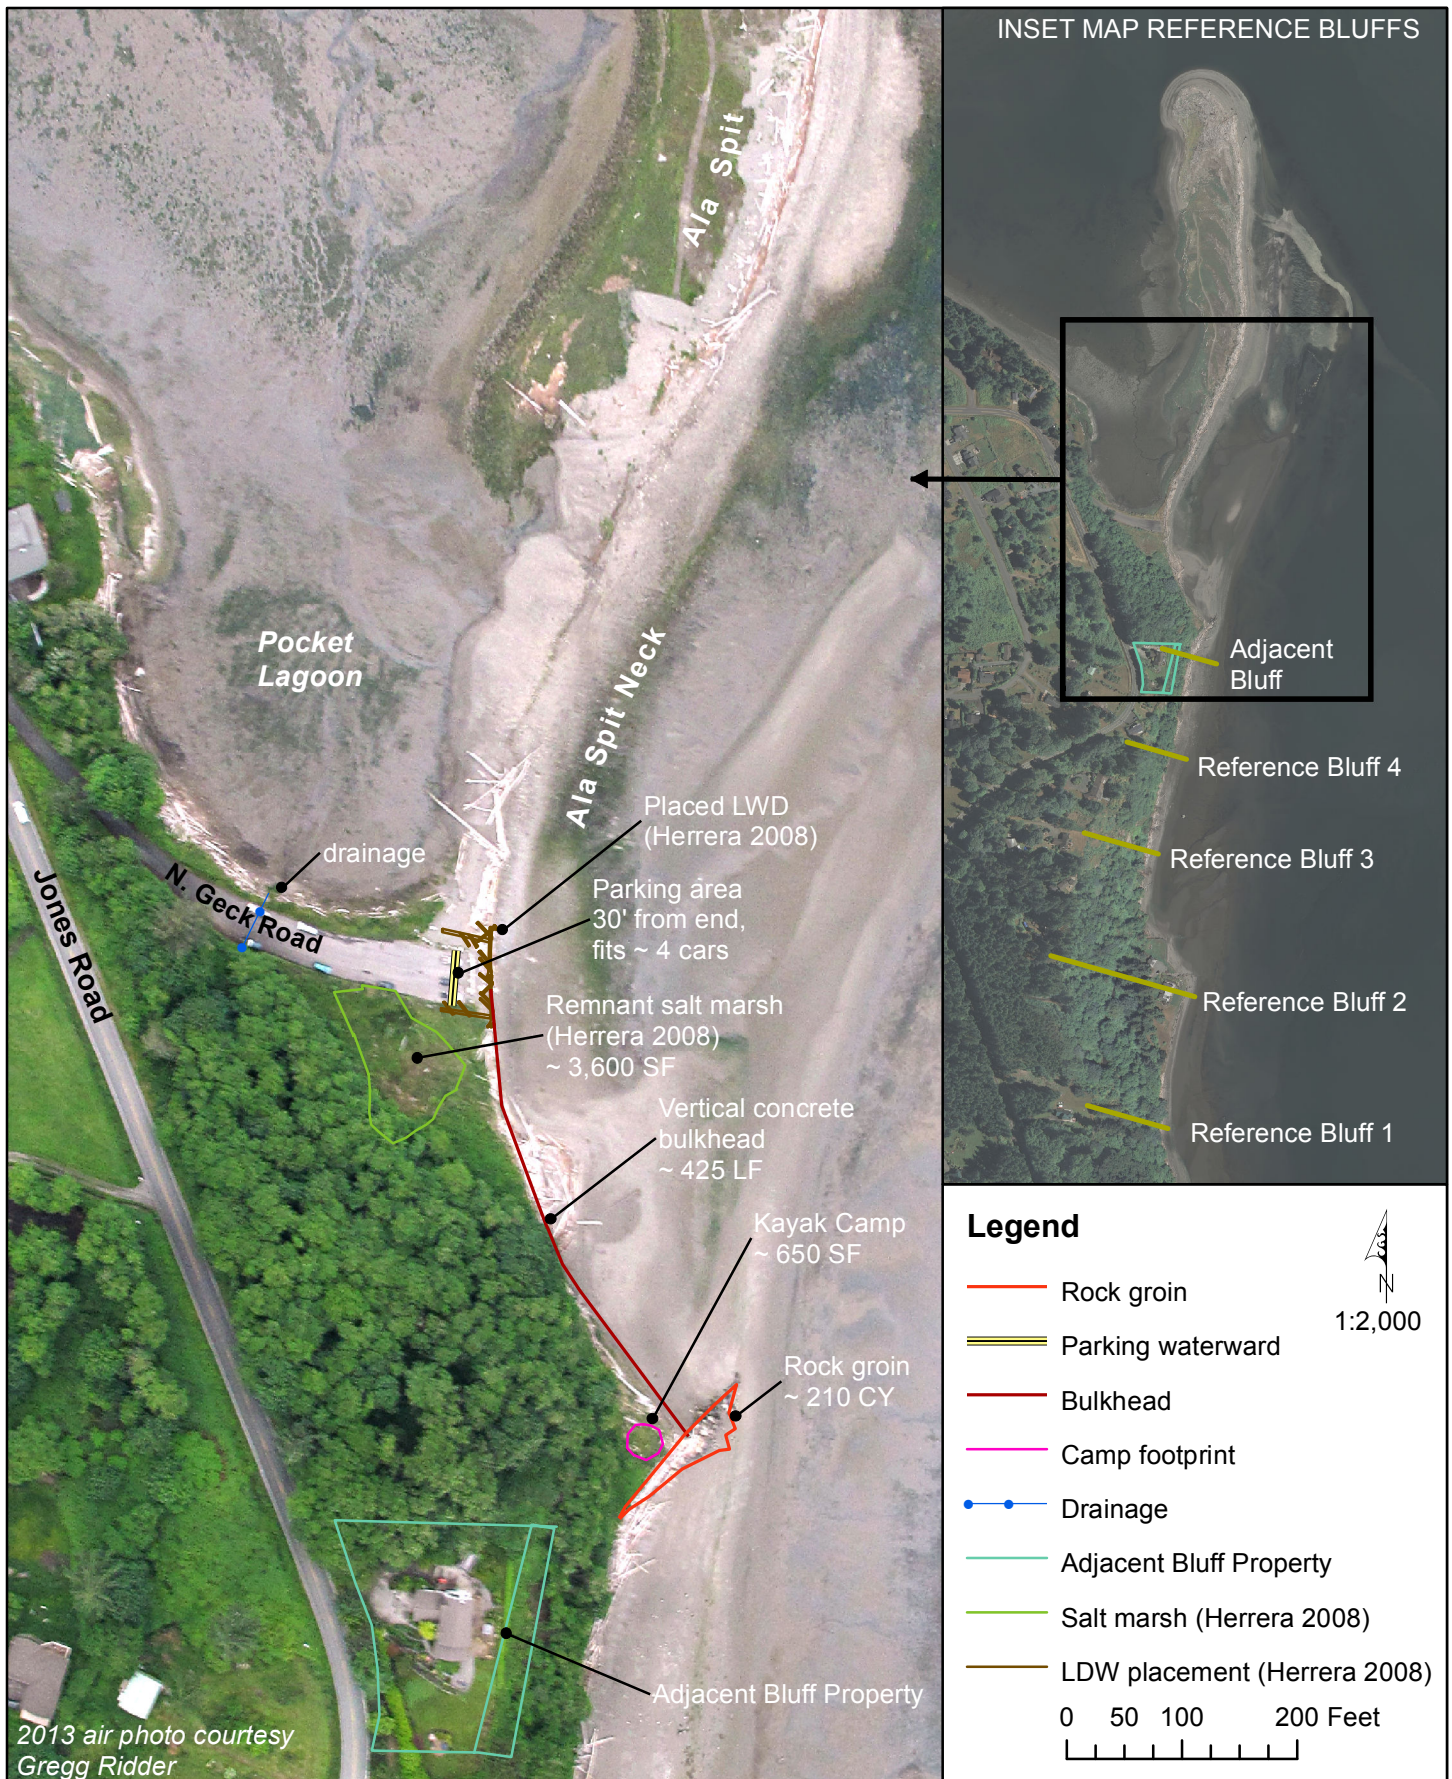
Figure 2. Ala Spit site features map and inset map of reference bluffs.

This groin was surveyed by CGS during the July 20th site visit. The quantity of rock in the groin based on the preliminary survey data and CADD work is approximately 210 cubic yards (CY), not accounting for the buried portion (Figure 2). This groin has a maximum elevation of +10.4 ft MLLW and a minimum elevation of +5.1 ft MLLW and is oriented across-shore obliquely toward down-drift or north. No subsurface investigations were conducted as part of these estimates, so the volumes above surface should be considered preliminary.

Geck Road transitions into the parking area for Ala Spit where the grade of the road is reduced in the vicinity of the pocket lagoon. Cars park at the road end (most waterward extent of road) and along both sides of the road, which is clearly displayed in the 2013 aerial photo (Figure 2). This includes approximately 220 ft along the south side of the road, 175 ft along the north side of the road and enough room for approximately 4 cars at the road end in a space approximately 30 by 45 ft. It appears that this parking arrangement allows for a maximum of 11 cars along the south side, 9 cars along the

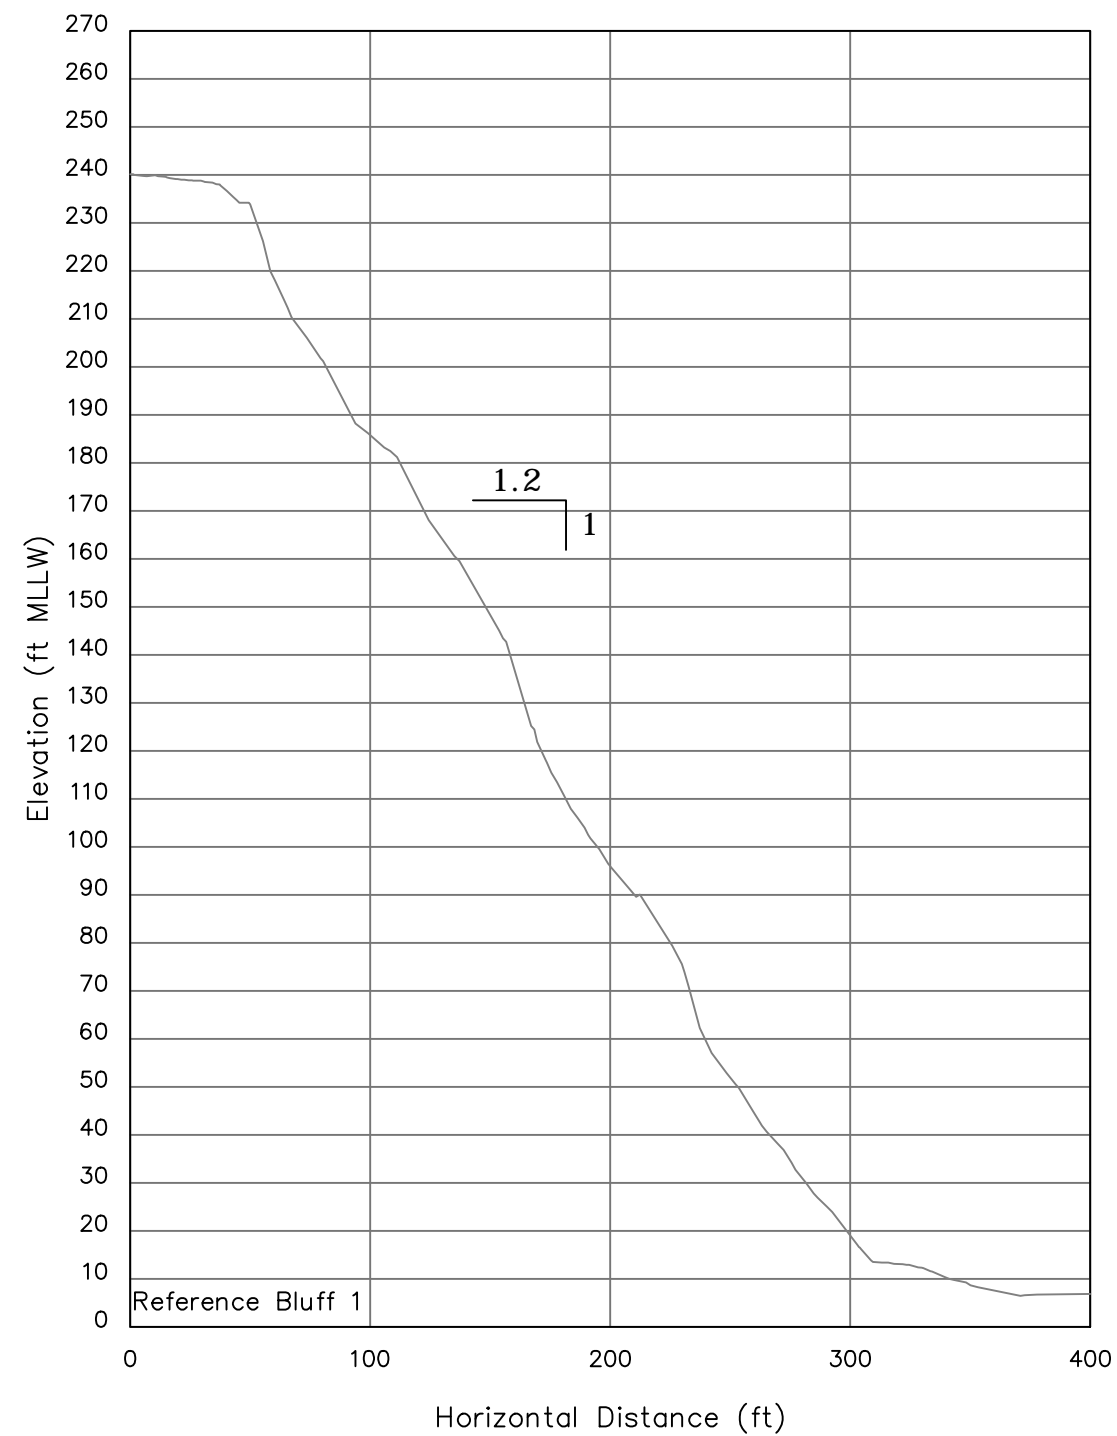
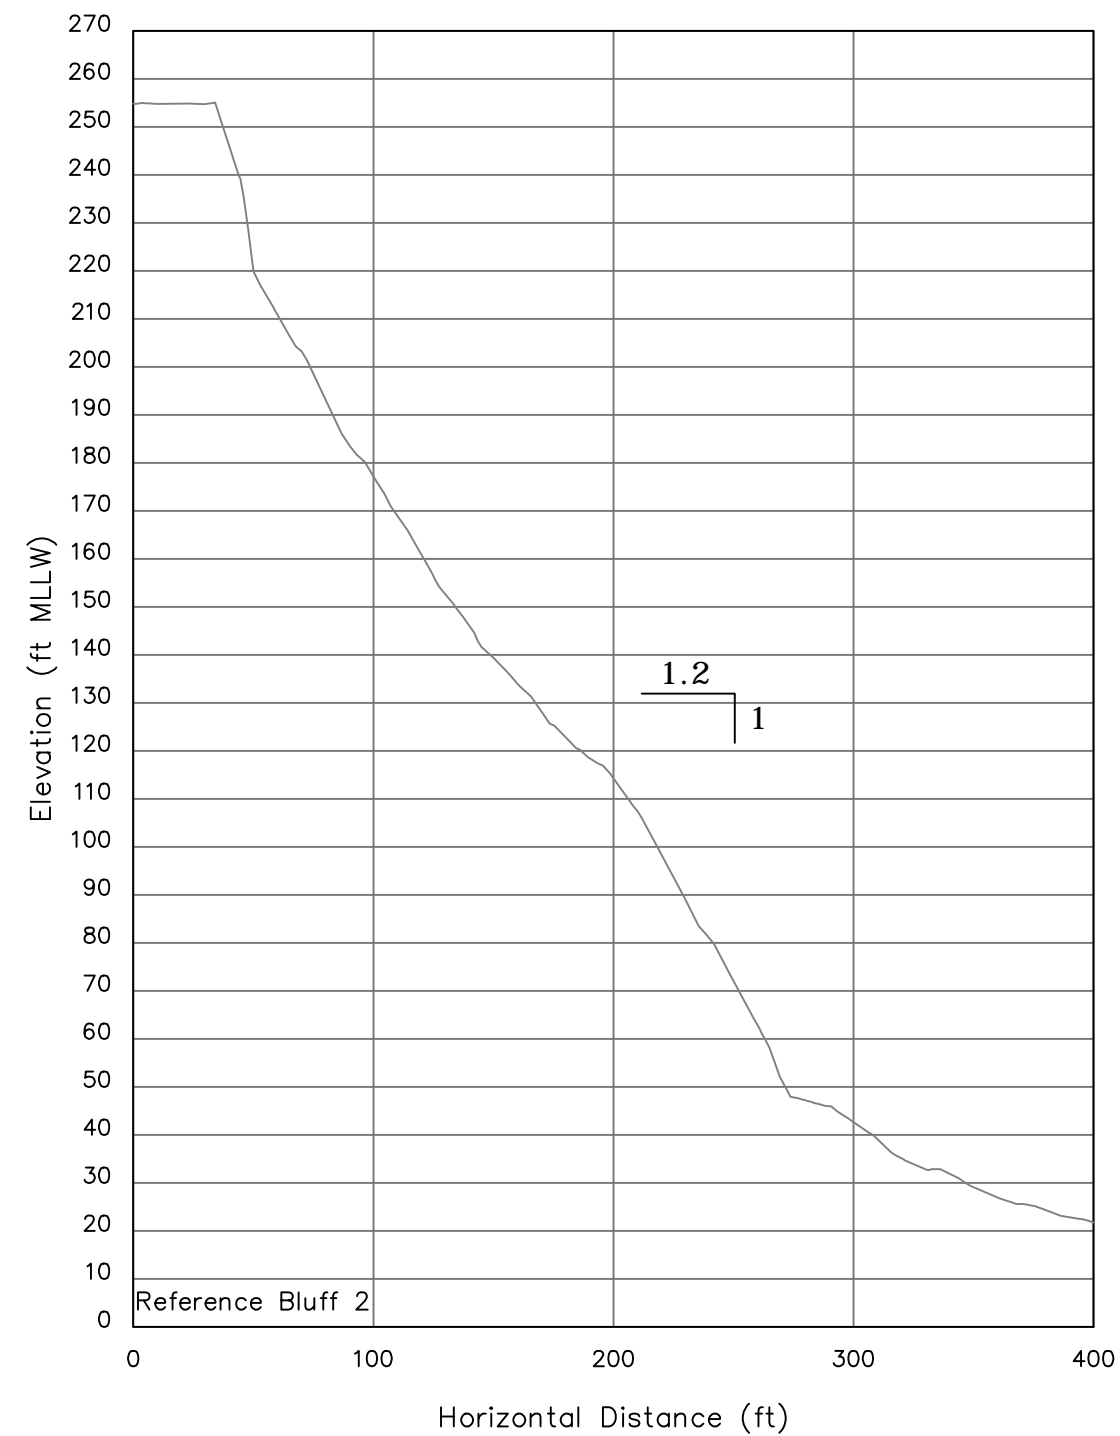
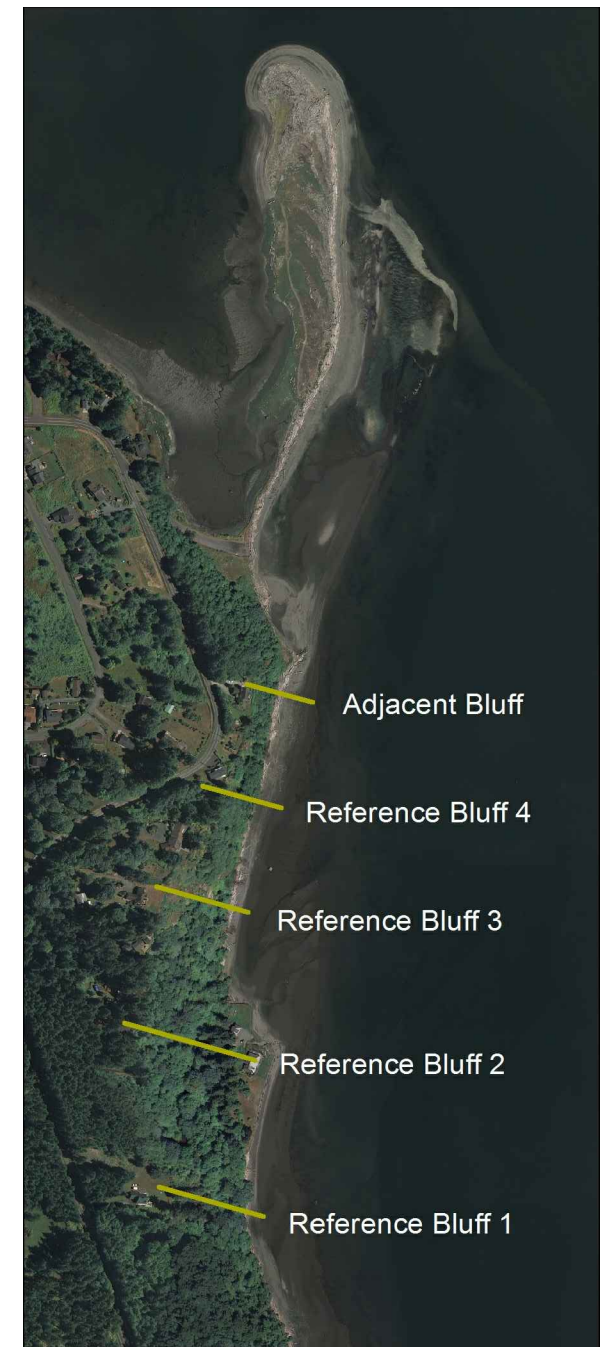
Figure 5a. Bluff cross sections (profiles) from LiDAR data south of Ala Spit. Sections shown at 2x vertical exaggeration. Slopes shown are average for entire bluff face.
 LiDAR data acquired from Puget Sound LiDAR Consortium

Bluff crest recession was measured from historical aerial photos along reference bluff cross sections (Figure 2, 5a, and 5b) among the years 1956, 1969, 1985, and 2007. Analysis indicated the following observations and measurements (also see Table 3):

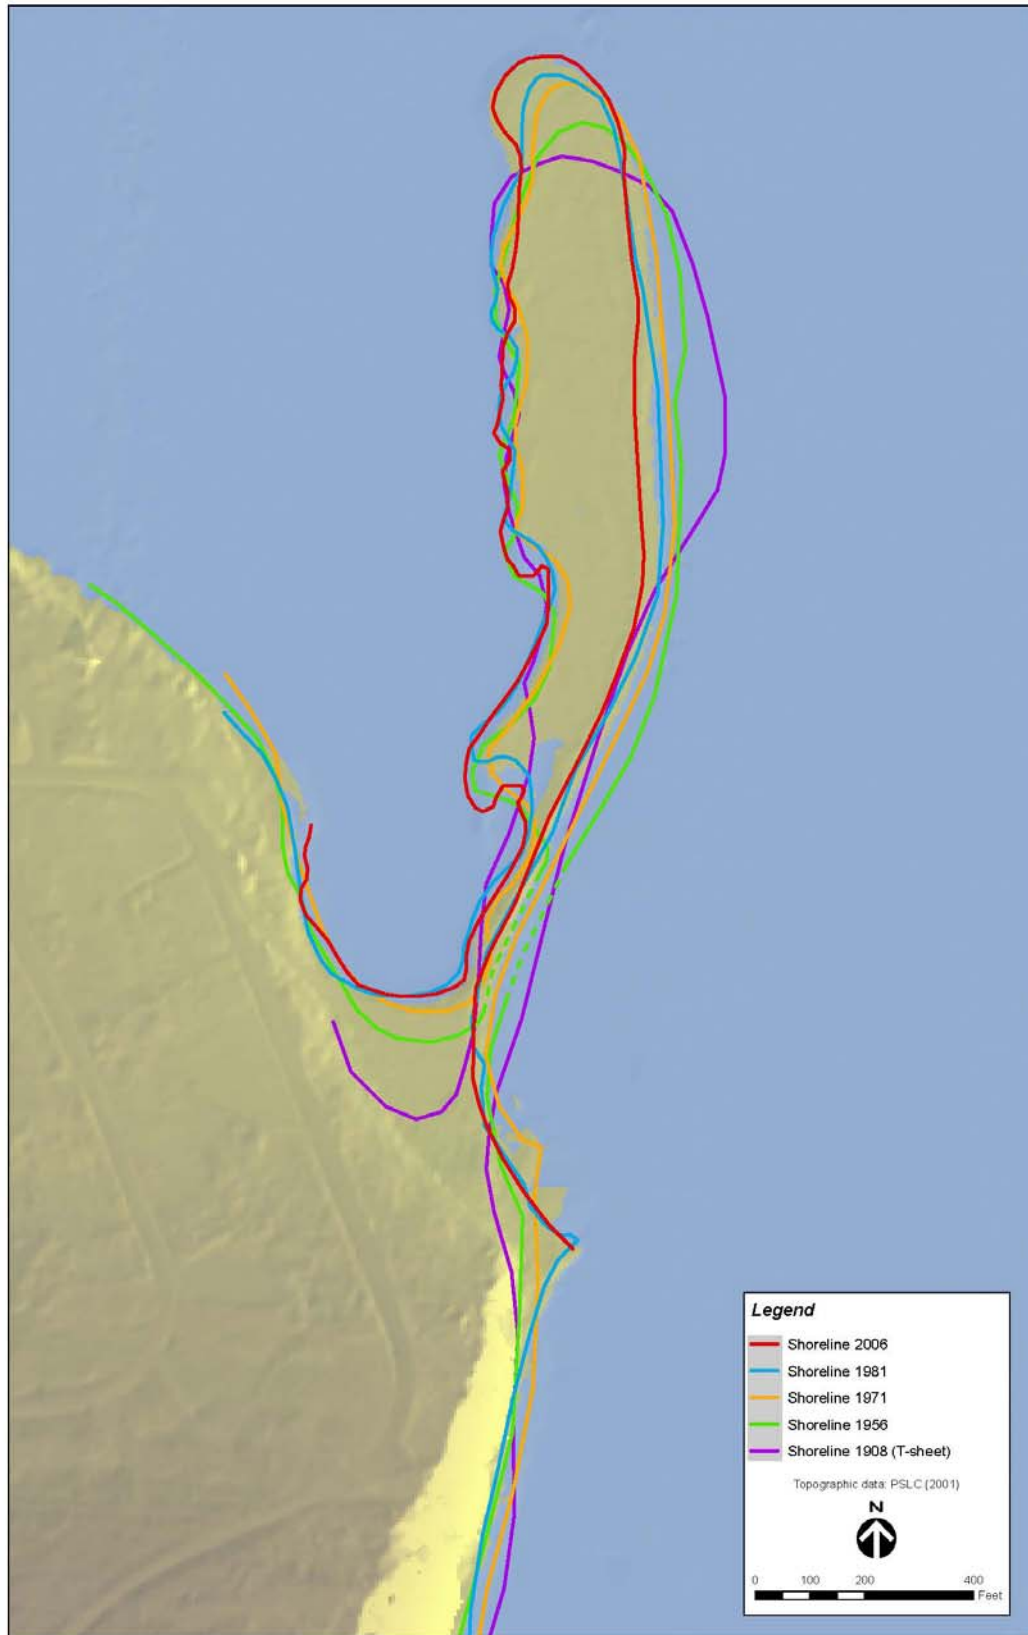
Figure 6. Shore change mapping of Ala Spit (Herrera 2008).

Herrera Environmental Consultants (2008) conducted a shore change assessment of Ala Spit (Figure 6) that showed a narrowing and elongating migration of Ala Spit over the course of nearly a century. The

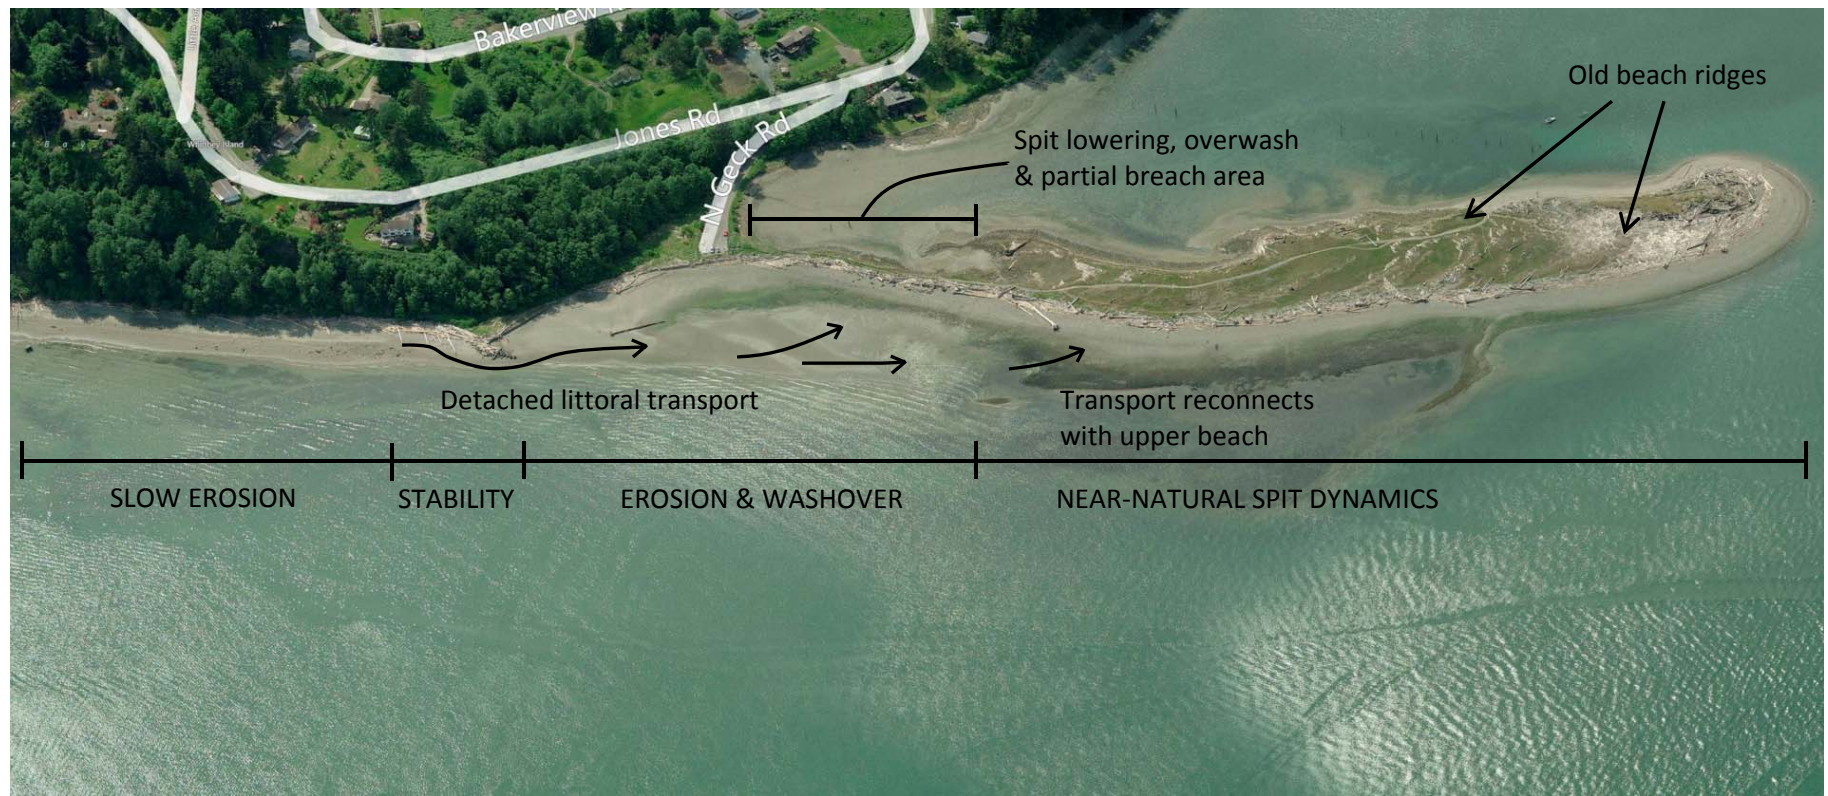
Figure 8. Ala Spit coastal geomorphic model annotated oblique aerial photograph (Bing aeriels website accessed 2013).

Another potential factor is the effect of the groin on the plan form of the spit. Since installation in 1960 the groin has caused an offshore "shunting," i.e., sediment bypassing the upper beach at the spit neck to the lower beach or sand flat (see annotated "model" in Figure 8). This is a simple process evident in most aerial photos since the 1970s which show sand and gravel extending north from the tip of the groin, and not reattaching to the upper beach until 900–1,000 ft north of the groin (Figures 7 and 8). The sediment supply from up-drift feeder bluffs has only been slightly reduced due to development within this drift cell (Johannessen and Chase 2005), with the major impediments being the Ala Spit groin and the private bulkhead area approximately 1,500 ft south of the groin.

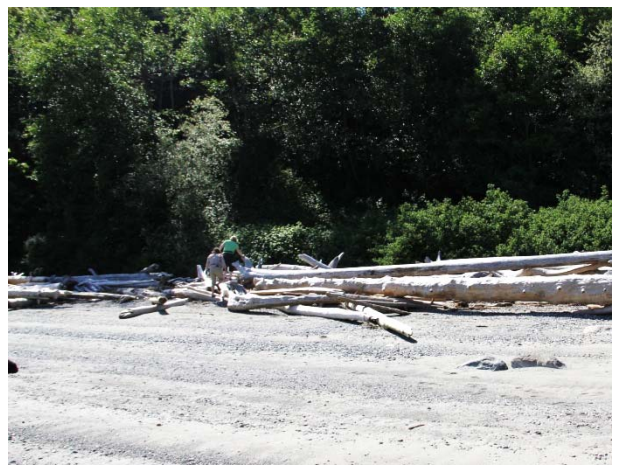
Photo Page 3. Reference bluffs for slope stability assessment of bluffs from the July 25th, 2013 site visit.

Broad, accreted beach immediately south of the groin at the “Adjacent Bluff Property”
