# The Nason Creek Fill Removal and Oxbow Enhancement Project (N1)

## 2015 Monitoring Report

Prepared by: Chelan County Natural Resources Department

Adrienne Roumasset, May 2015

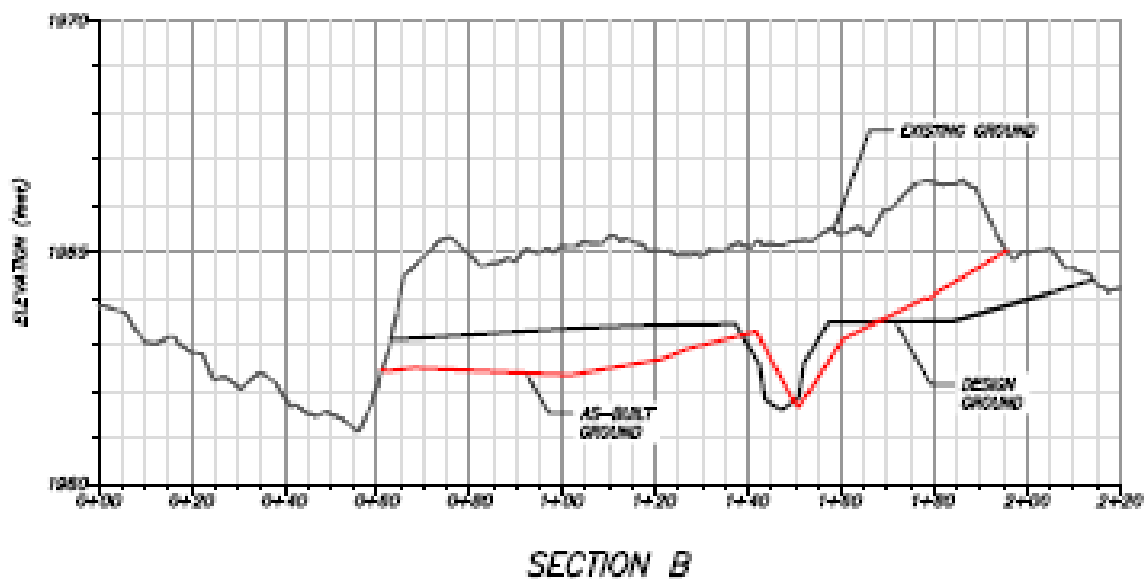
Figure 16. Cross section of parking lot fill removal area (see Figure 17 for cross section location).

The as-built topographic survey of the river right parking lot fill removal area indicates the floodplain was lowered by 2-3 feet due to the project (Figure 16 and 17), giving Nason Creek increased access to its floodplain. The difference in post construction grading as compared to the plan set from Station 1+90 to 2+00 was a field staking change made to avoid removing mature existing forested vegetation.

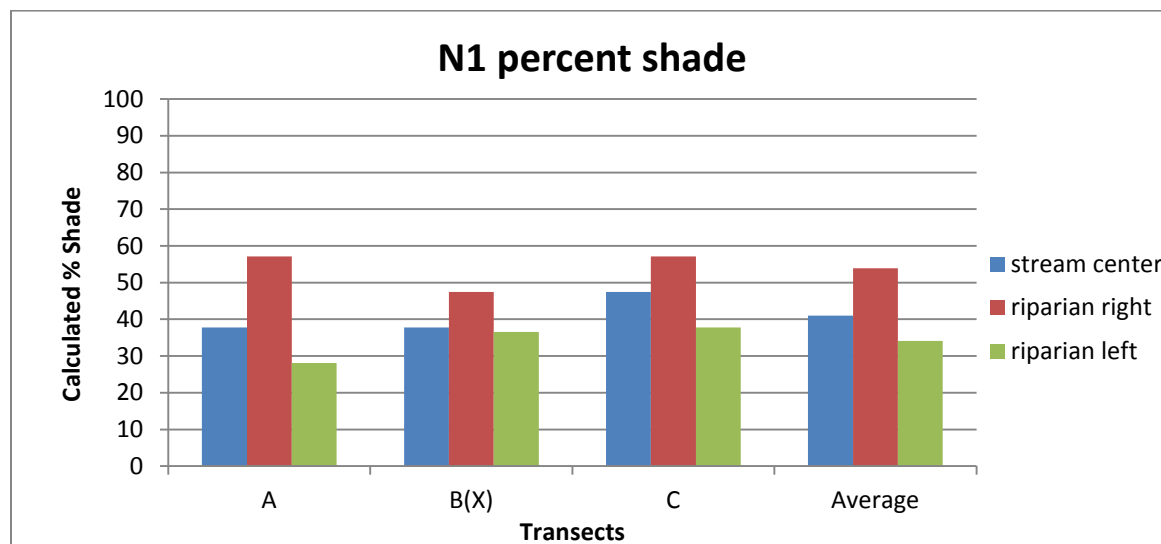
Figure 22. Transect and transect average percent shade around constructed channel.

Shade values were higher on the right side (southeast) side of the constructed channel, due to existing shade from the surrounding forest. Shade values ranged from 28 – 57 % (Figure )

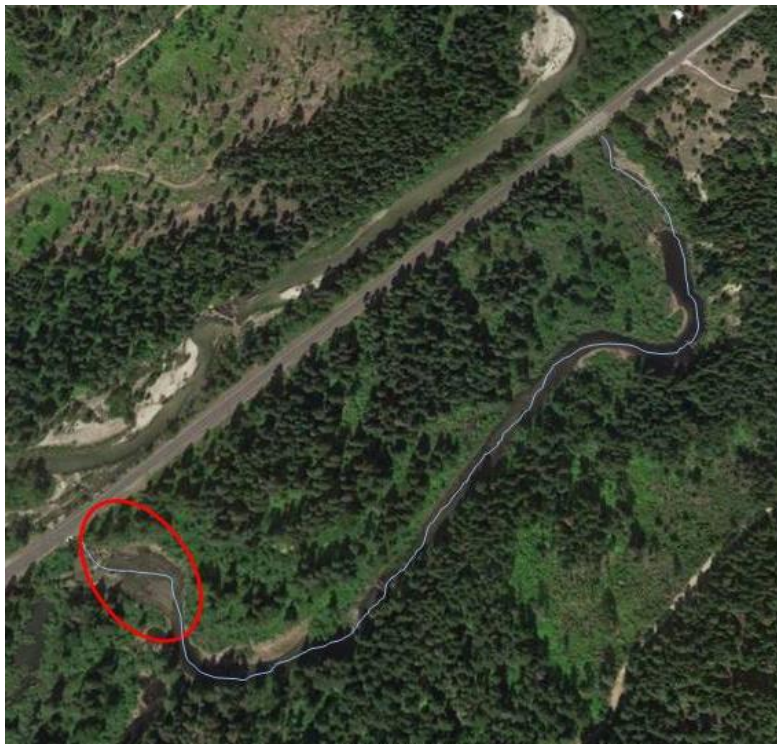
Figure 24. Nason Oxbow. Red circle indicates the area wood was added in 2014. Blue line is the extent of the YN's snorkel survey.

Yakama Nation conducted snorkel surveys of the entire 2007 oxbow, including the area where wood was added in 2014, pre construction and post construction in March and August of 2014 and 2015 (Figure 24, Table 6). Results indicate ESA-listed salmonids are using the oxbow – however, how added large wood effects fish-use of the site cannot be inferred from these fish counts. Nason Creek had just half the discharge during the 2015 low flow survey compared to the 2014 low flow survey (table 6) – which likely contributed to the lower numbers of salmonid observations and higher numbers of Shiner and Sucker species observed in 2015.
