The Nason Creek Fill Removal and Oxbow Enhancement Project (N1)

2016 Monitoring Report

Prepared by: Chelan County Natural Resources Department

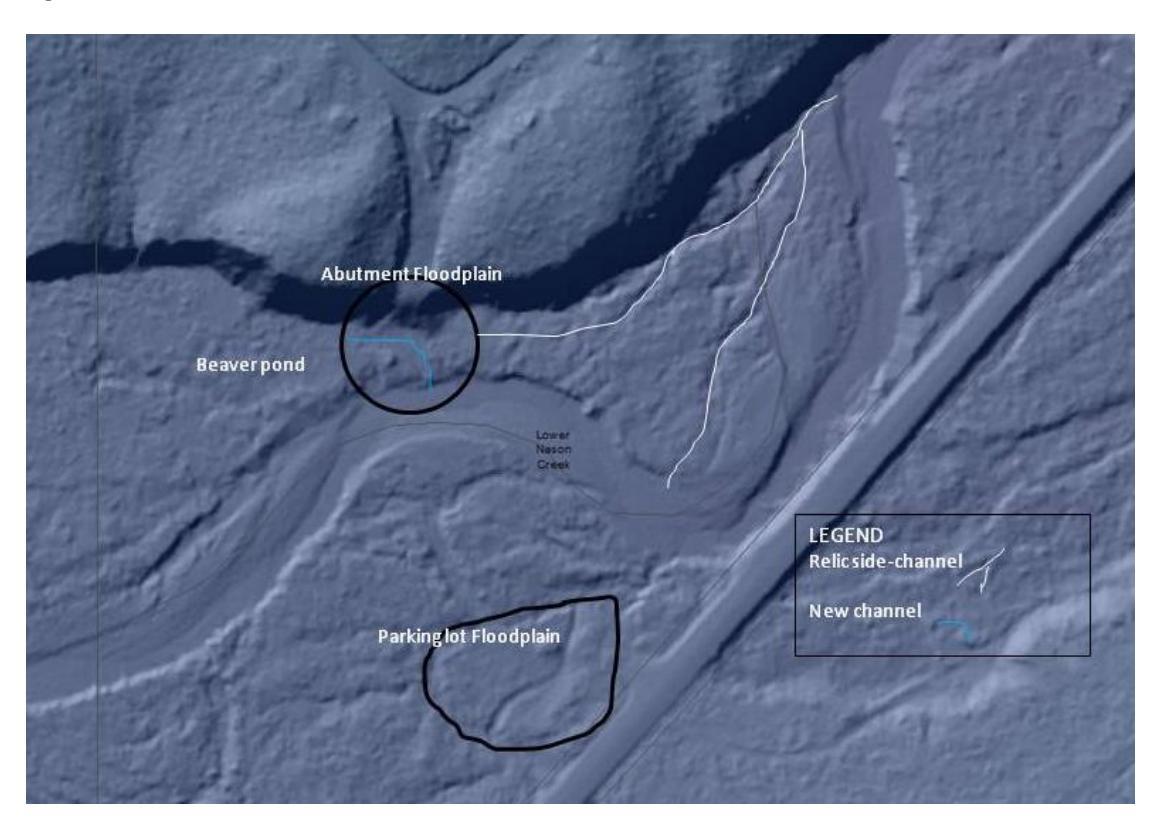
Figure 4. Post-construction FEMA lidar flown with locations of relic and new side-channels.

The abutment removal area is active and flooded at high flow and has undergone natural process, including channel formation and relic side channel activation, following fill removal. Initial post-construction floods in November 2014 formed a "new channel" that extends across the floodplain from the upstream beaver pond to a breach in the brush mattress that formed during this same flood. The floodplain was under water and both the relic side channel and the new floodplain channel were activated on April 21, 2016 when the Nason Creek gage recorded 1750 cfs (Figure 5). Flood waters were from both Nason Creek and the beaver pond (Figure 2). The brush mattress was inundated, partially out of the water and along with the activated floodplain provided high flow refuge habitat to juvenile salmonids.

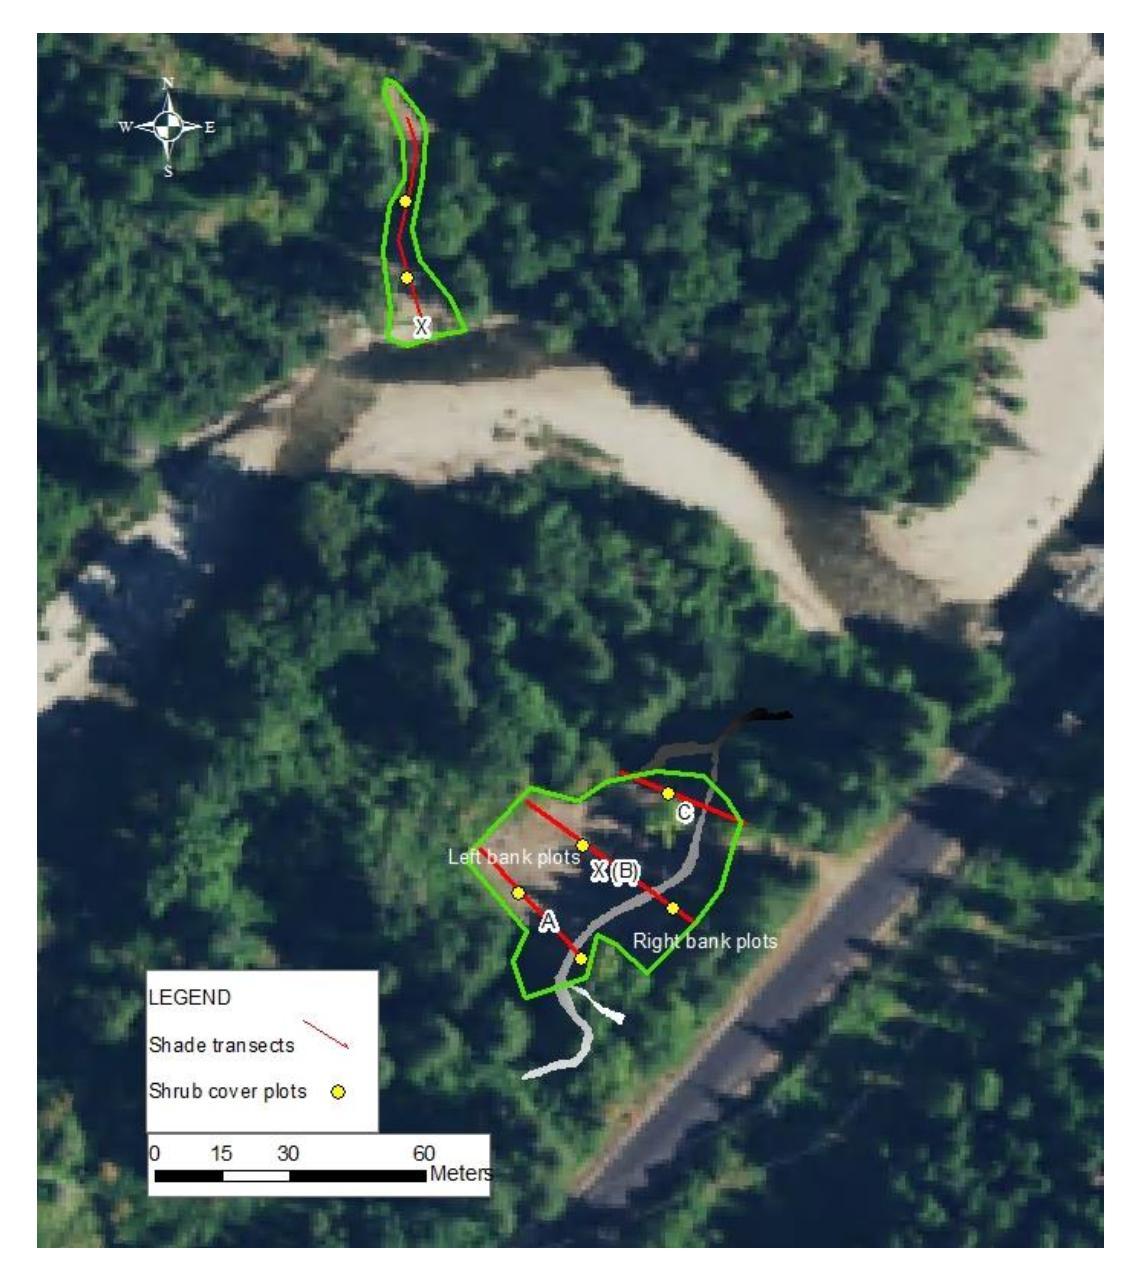
Data collected along shade transects and in shrub cover plots (Ecology mandated Wenatchee Basin Shade Study) suggest no increase in shrub or shade cover from 2015 to 2016 in the parking lot removal area (Table 3). As noted photo points indicate ground cover has increased and was recorded in plots in 2016 (Table 3). In general, right bank plots had more shrub, ground, and shade cover, as well as more soil and less cobble substrate, than left bank plots. Scour in plot LBX is apparent in the decrease in willow cover. Figure 15. N1 shade Transects and vegetation plots established as part of the Wenatchee Basin Shade Study.

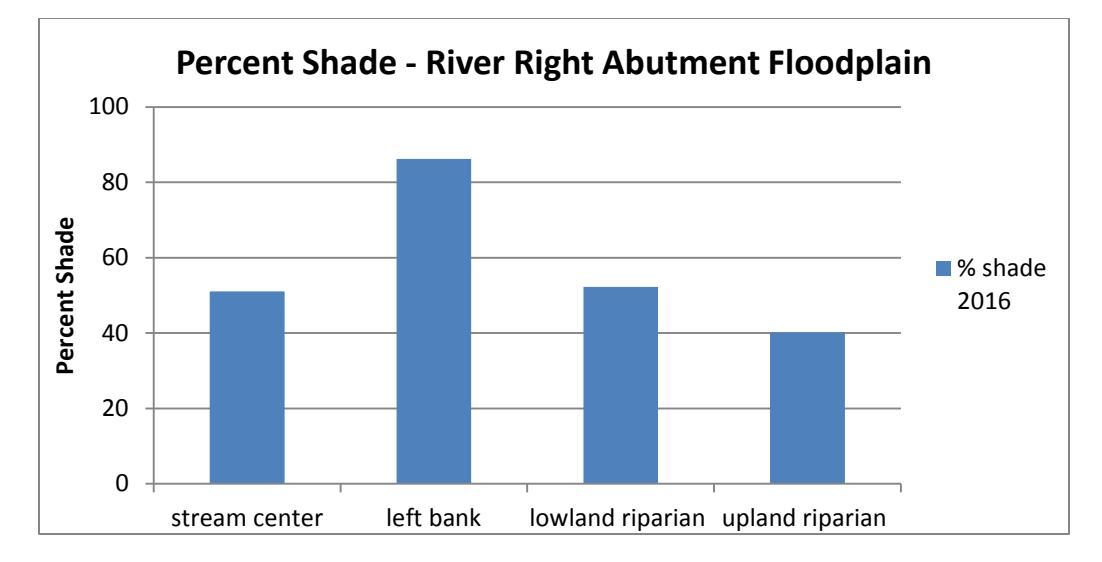
Figure 18. Abutment fill removal floodplain shade.

The 2015 stem count on abutment removal site indicated 92 percent survival of installed plants and was not repeated in 2016. Brush mattress cover, composed primarily of willow, was 80 - 90 percent (Table 4, Figure 16). One shade transect and two vegetation plots were established (Figure 15). Shrub cover estimates in plots indicate shrub cover ranges from 5 - 10 percent on both the upland and lowland areas, and is composed primarily of willow and cottonwood in the lowland and rose and cottonwood on the upland. 30 percent of the lowland plot was wetted at the time of the survey (Figure 17). No noxious weeds were noted in the lowland plot. However, a substantial amount of knapweed was recorded in the upland plot, and several clumps of bullthistle observed north of the plot. Shade in the lowland, upland, and stream center plots ranged from 40 - 50 %, whereas shade on the bank was 85%, due to the influence of the brush mattress (Figure 18).

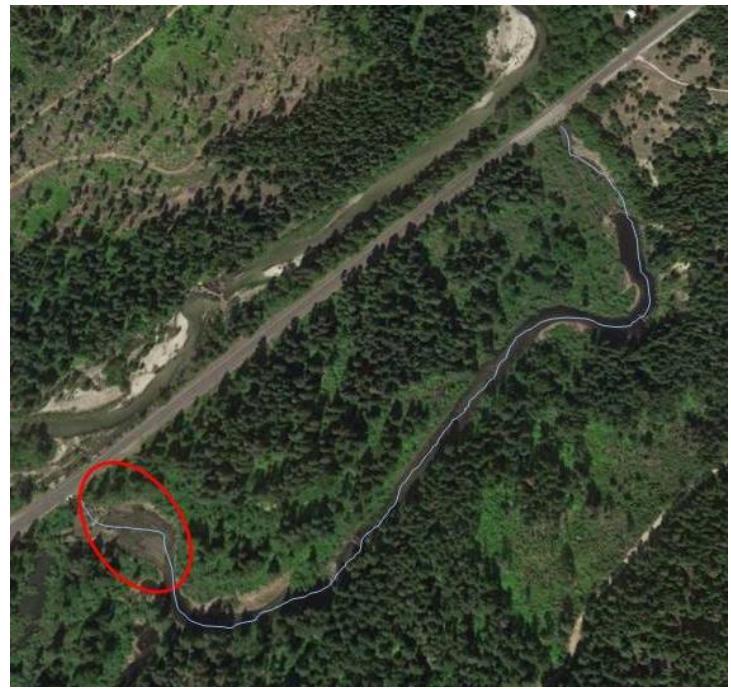
Figure 24. 2007 Oxbow. Red circle = area wood was added in 2014. Blue line = extent of the YN's snorkel survey.

Yakama Nation snorkel counts indicate ESA-listed salmonids are using the oxbow – however, how added large wood effects fish-use of the site cannot be inferred from these fish counts since counts represent fish use in the entire oxbow (Figure 24). Like the constructed channel, ESA listed-species counts in the 2007 oxbow were markedly lower in 2016 than 2015 (Table 8). Yakama Nation noted in the snorkel survey memo that ESA listed-species concentrations were also low at the Nason Creek smolt trap during the survey. YN hypothesized low counts were due to downstream displacement during the high water event in November 2015.
