# Final Design and As-built Report

## Increasing Wood Densities in Asotin Creek Intensively Monitored Watershed

### **Grant 19-1499**

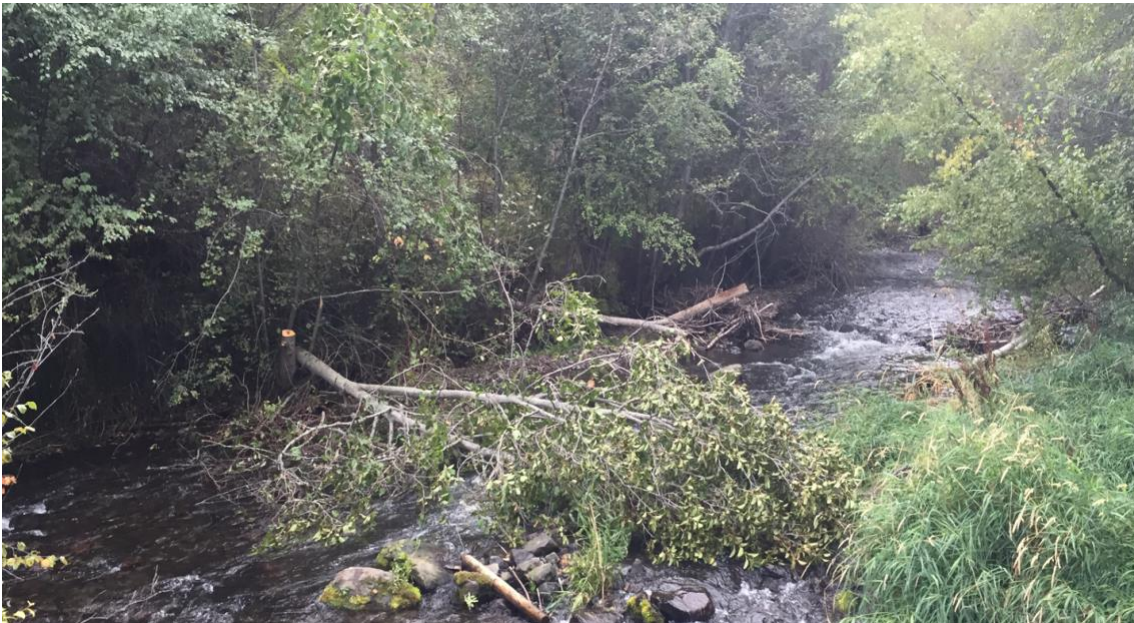
Figure 5. Example of a falling alders along North Fork Asotin Creek to increase wood density.

**Cutting subdominant trees:** The most efficient way to increase wood densities is to harvest wood on site along the riparian area (Figure 5). We have permission from the WDFW manager and forestry to cut subdominant conifers and alder in areas where the densities of trees are high. We have observed that alder in particular are locking the stream in a single channel and harvesting some trees may help to allow the stream to begin to meander and interact with the floodplain more frequently.

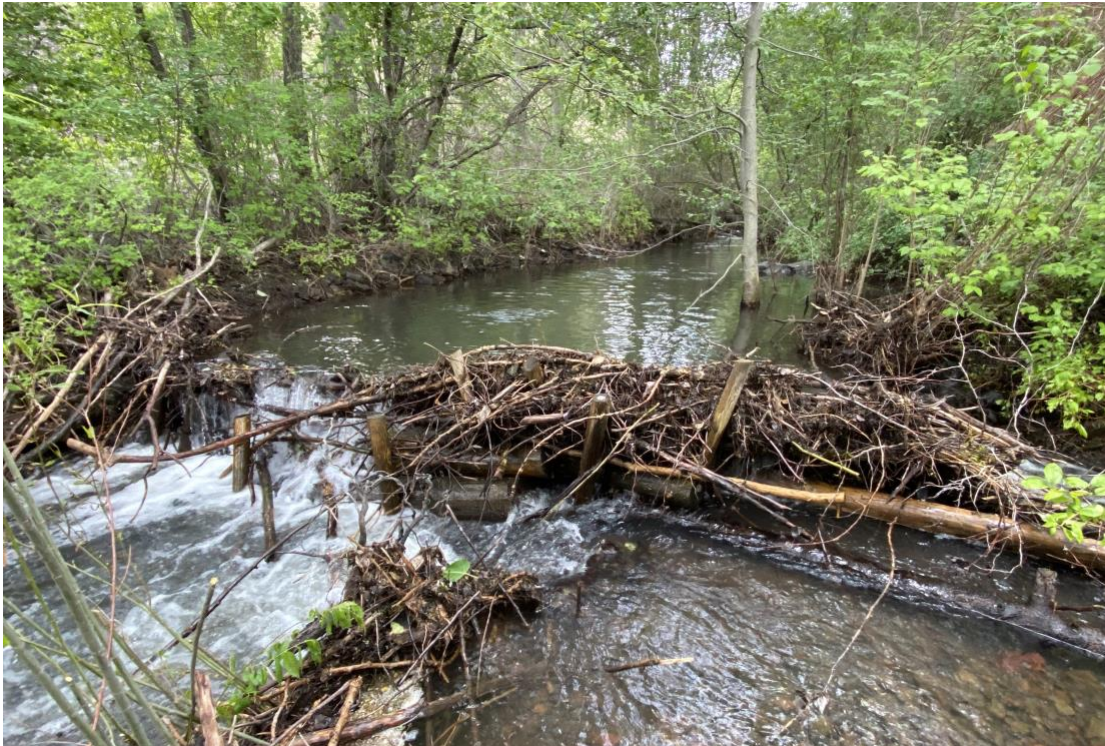
*Figure 6. Example of hydraulic and geomorphic diversity created by a channel spanning PALS on South Fork Asotin Creek. A large dam pool was created upstream, a plunge pool and gravel bar formed downstream, and overbank flow is being forced, connecting a portion of floodplain.*

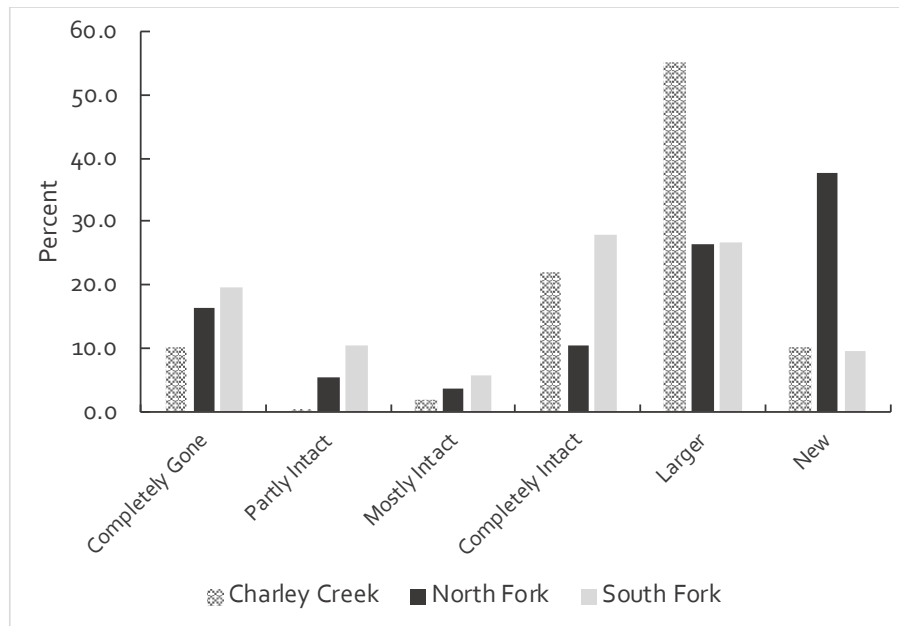
Figure 7. Percent of structures by category describing their integrity based on 2019 survey. Larger refers to structures that have increased 25% in volume due to wood accumulation and New refers to wood accumulations that have developed since the original restoration treatment from IMW wood, natural recruitment or both (Total number of wood accumulations now = 750 in 14 km treatment area).

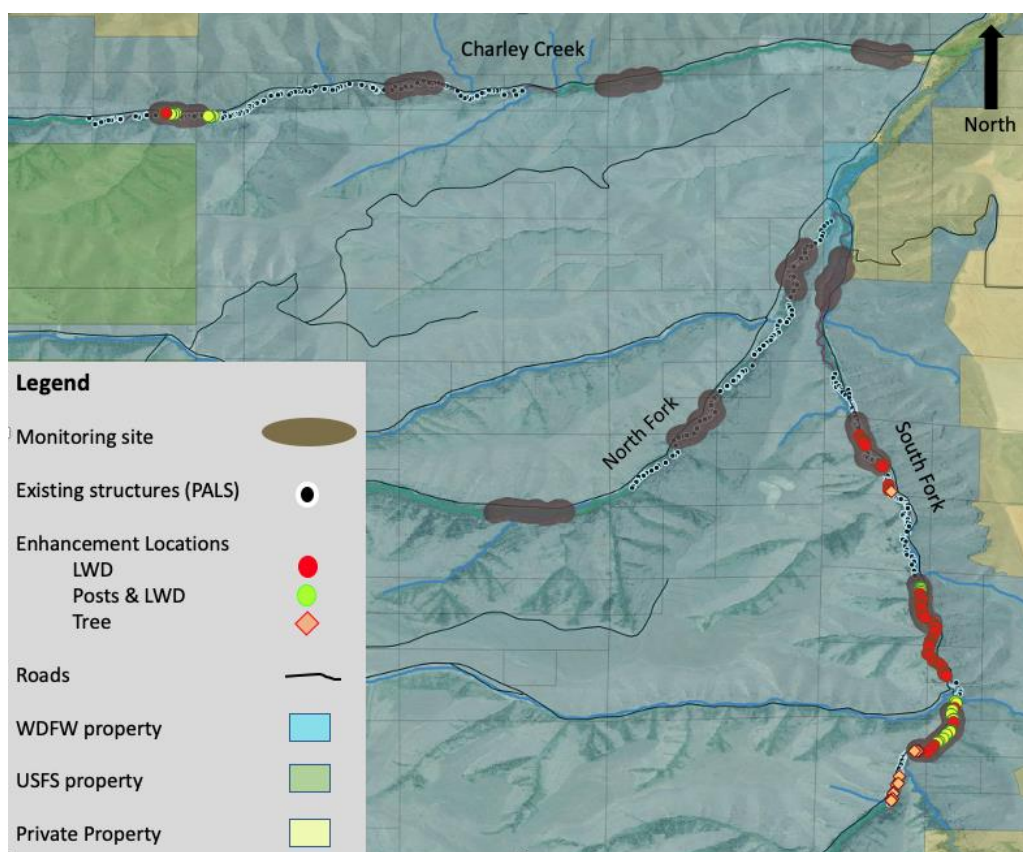
Figure 8. Final design plan for increasing wood density showing existing fish and habitat monitoring sites, existing post-assisted log structures (PALS), 116 structures enhanced with additional wood, roads, and property boundaries. The type of enhancement included large wood added to existing structures (LWD), existing structures being rebuilt (post & wood), and live trees felled into the stream (Tree). See Appendix C for list of all structures enhanced with wood and their GPS location.

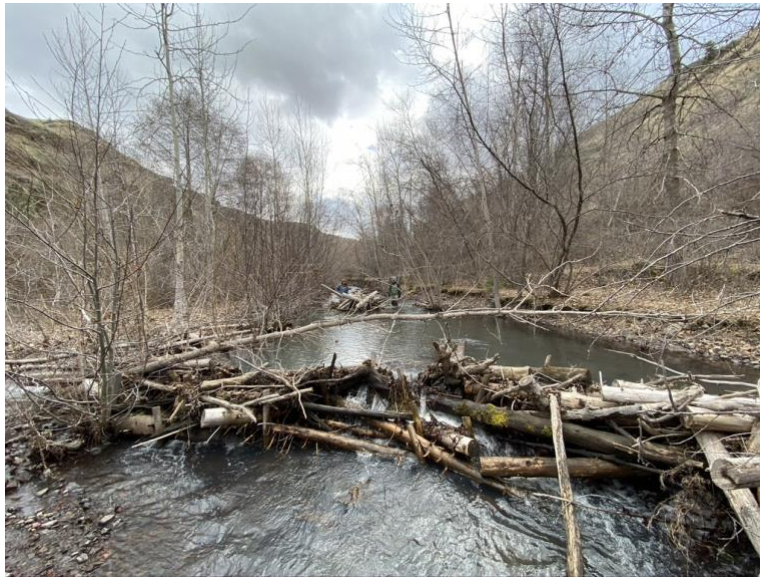
*Figure 12. Post-restoration conditions in South Fork Asotin Creek – channel spanning post-assisted log structure forcing overbank flow (during receding high flow) and ponding water upstream of the structure.*

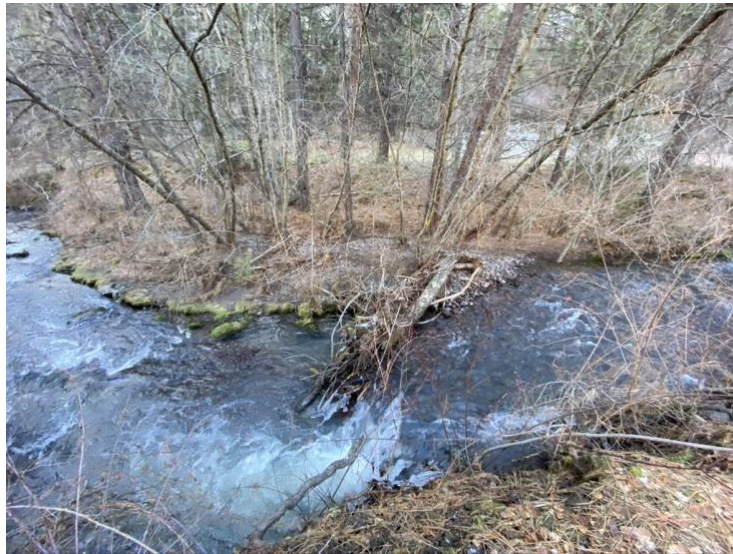
*Figure 13. Post -restoration conditions in Charley Creek – bank attached post-assisted log structure forcing flow against river left bank, creating eddy pool downstream, and forcing overbank flow and forming upstream and downstream bars on river right.*

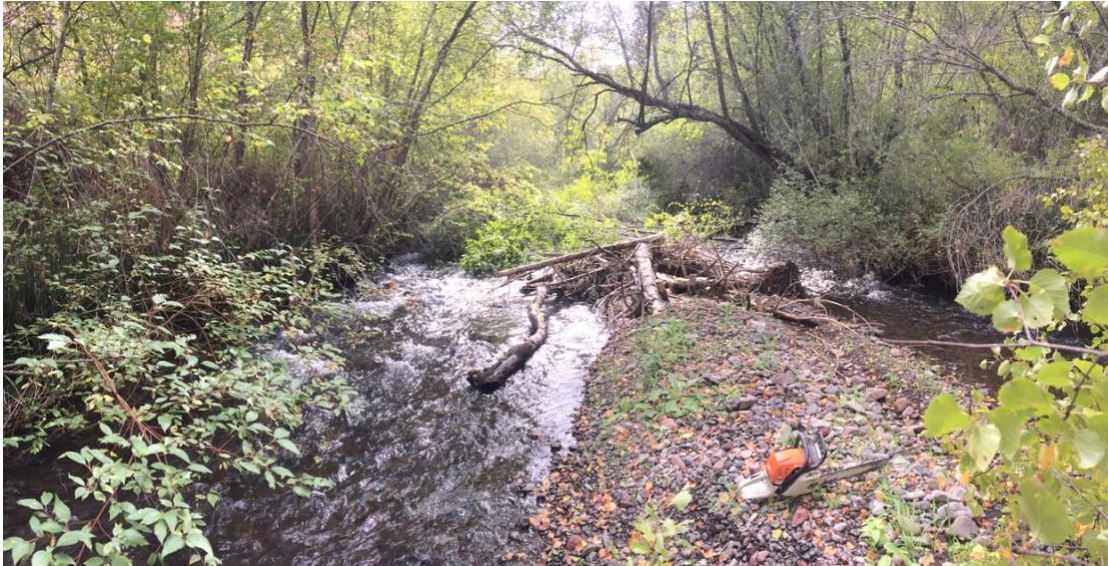
*Figure 14. Post -restoration conditions in North Fork Asotin Creek – mid-channel post assisted log structure splitting flow and creating downstream mid-channel bar.*
