# Preliminary Design Report

## Increasing Wood Densities in Asotin Creek Intensively Monitored Watershed

### **Grant 19-1499**

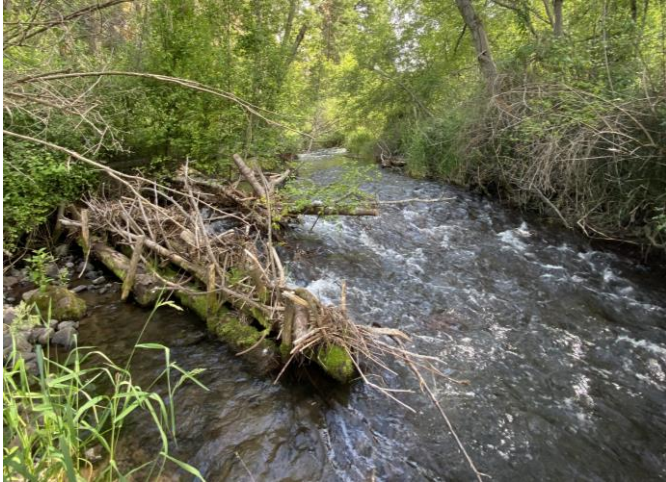
*North Fork Asotin Creek Partly Intact PALS*

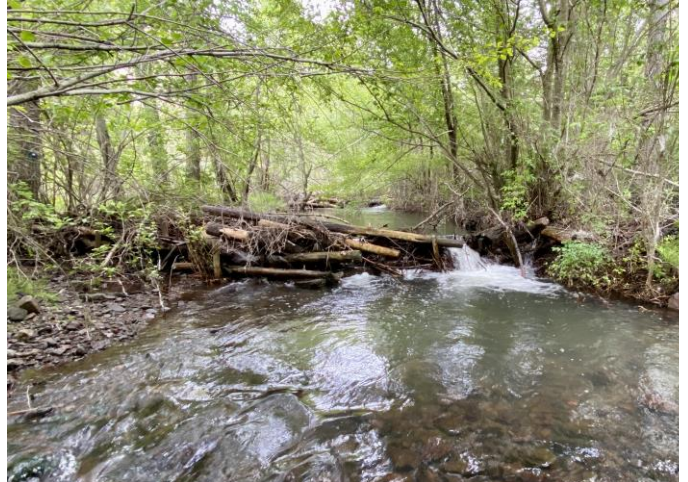
*South Fork Asotin Creek Fully Intact PALS*

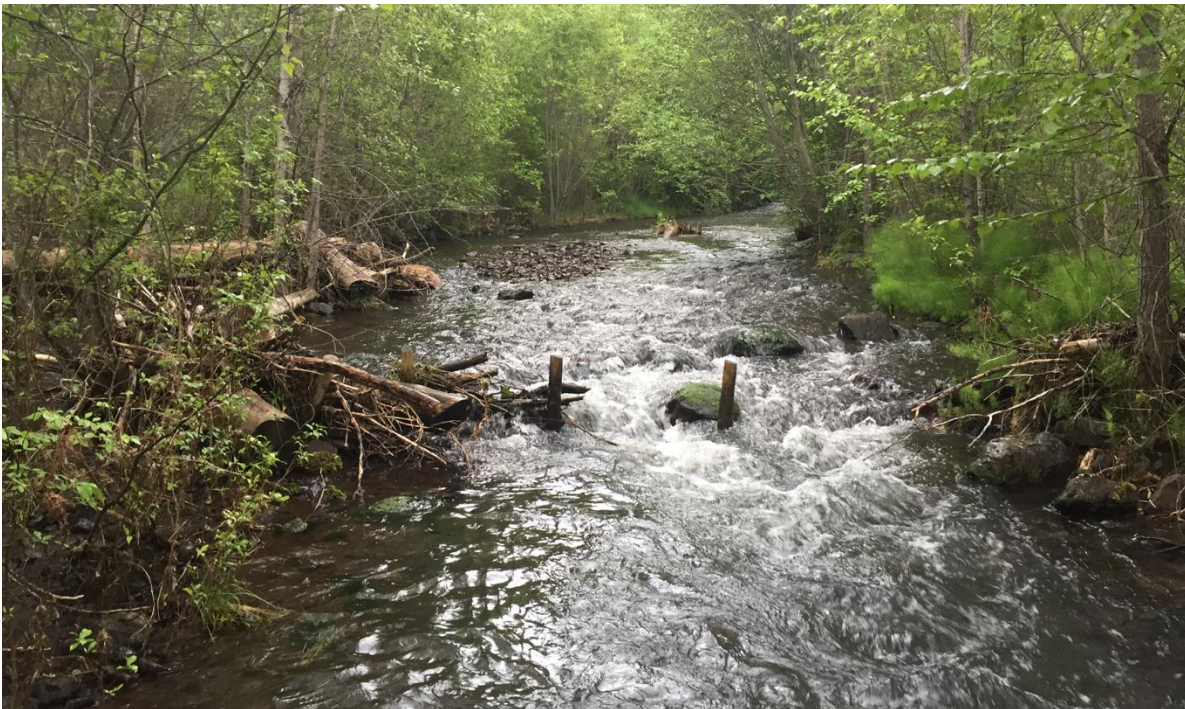
*Figure 3. Example of a partly intact post-assisted log structure that could be enhanced with the addition of more large woody debris.*

**Adding wood to existing PALS:** Some PALS are still present but have lost wood. This happens when wood floats off the structure or when part of the structure is washed away (Figure 3). We will add LWD to increase the size of the PALS, interlocking the wood into remaining posts or live trees. Wood will be harvested from the USFS and transported to the treatment sites or collected on site when available.

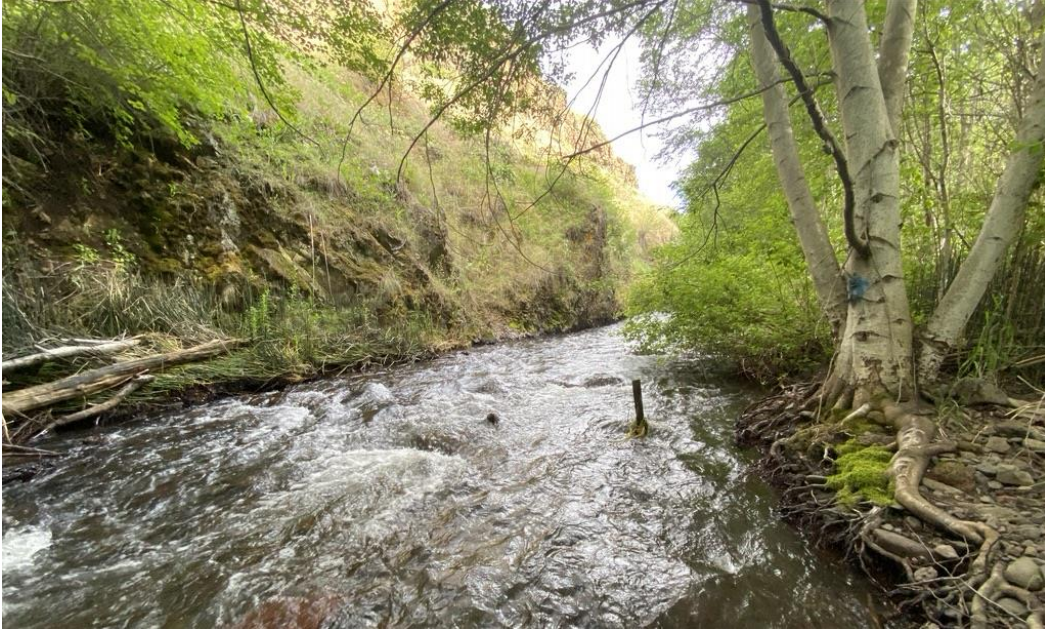
Figure 4. Example of a post-assisted log structure that has washed downstream that could be rebuilt.

**Rebuilding PALS:** Some PALS have completely moved leaving areas within the treatment where there is limited wood. Where it is logistically feasible to move the hydraulic post-driver to these locations, we will rebuild the PALS (Figure 4). Wood will be harvested from the USFS and transported to the treatment sites.

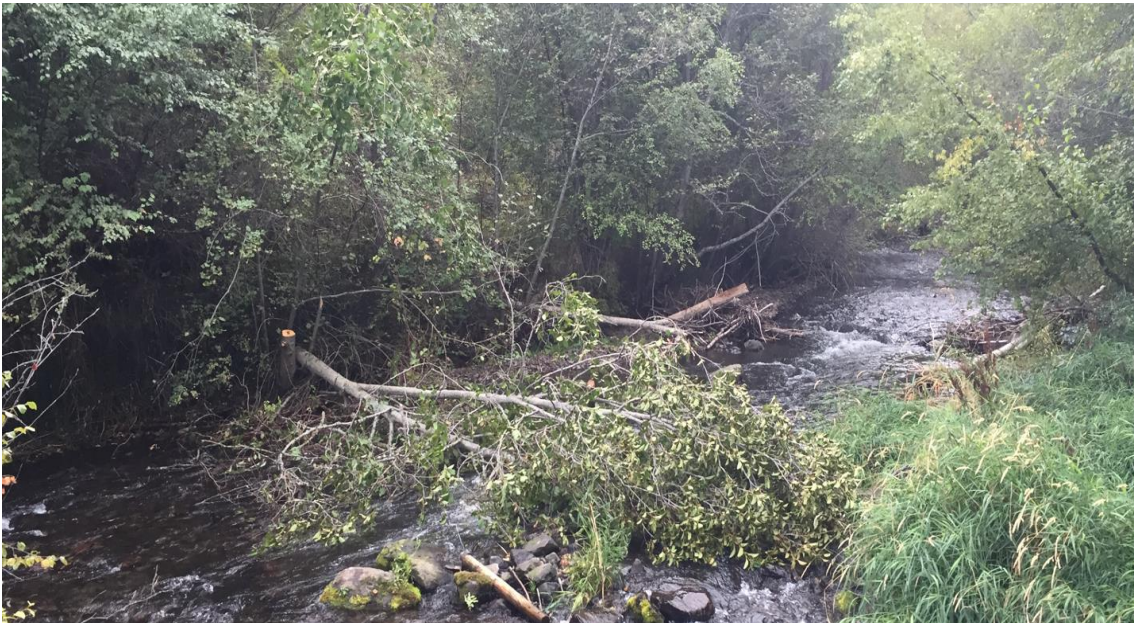
Figure 5. Example of a falling alders along North Fork Asotin Creek to increase wood density.

**Cutting subdominant trees:** The most efficient way to increase wood densities is to harvest wood on site along the riparian area (Figure 5). We have permission from the WDFW manager and forestry to cut subdominant conifers and alder in areas where the densities of trees are high. We have observed that alder in particular are locking the stream in a single channel and harvesting some trees may help to allow the stream to begin to meander and interact with the floodplain more frequently.

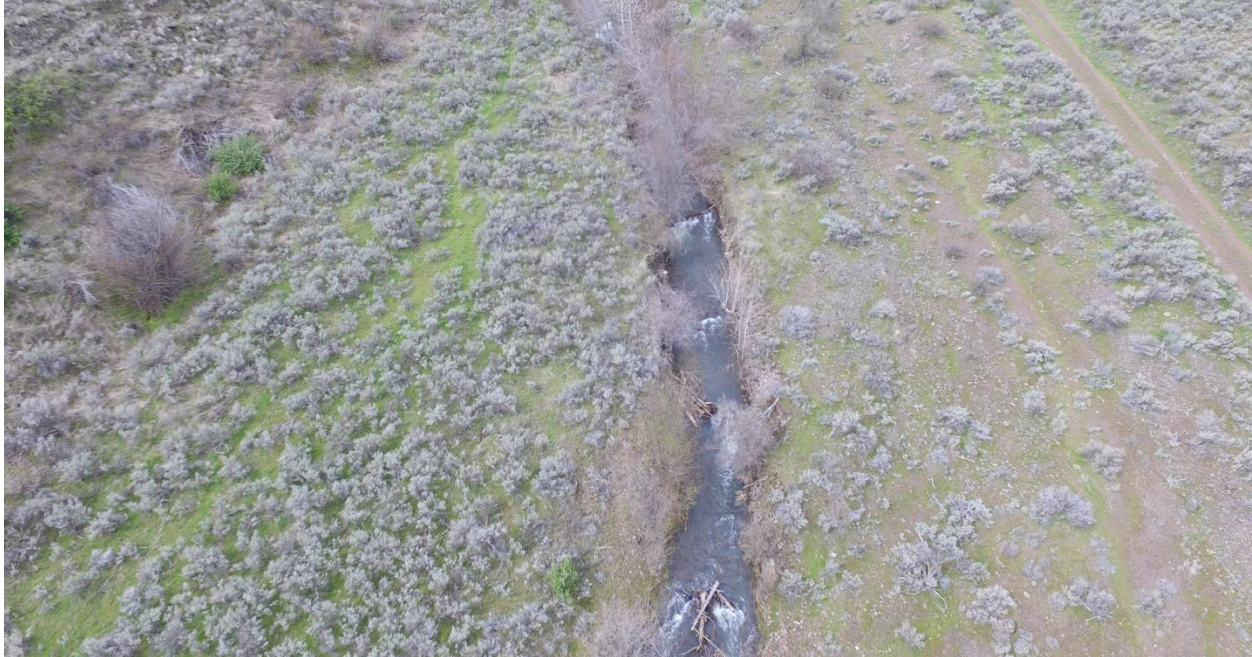
*Figure 6. Example of treatment section along Charley Creek where beaver-dam analogs may be used to force floodplain connection during low flows. Post-assisted log structures are increasing hydraulic and geomorphic diversity in Charley Creek but have not forced floodplain connection.*

**Beaver dam analogs:** BDAs will be used in the two smaller study streams (Charley and South Fork) to promote overbank flow during base flow conditions. PALS are increasing complexity within the existing channel but do not force overbank flows at base flow (Figure 6). We wish to test if BDAs can help reconnect the floodplain at low flows in combination with the existing PALS.

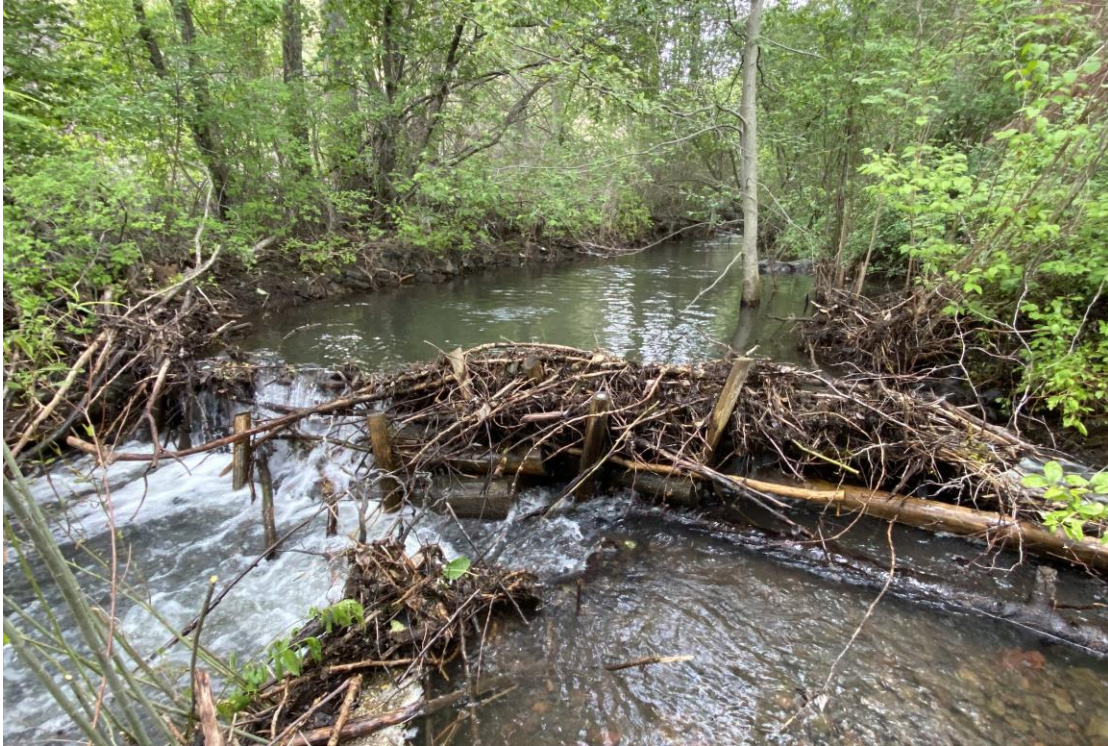
Figure 7. Example of hydraulic and geomorphic diversity created by a channel spanning PALS on South Fork Asotin Creek. A large dam pool was created upstream, a plunge pool and gravel bar formed downstream, and overbank flow is being forced, connecting a portion of floodplain.

The original post-assisted log structures were designed in four basic configurations: bank-attached, mid-channel, channel spanning, and seeding. Each of these designs were developed to promote specific hydraulic and geomorphic responses. We have observed these responses during our annual IMW monitoring (Figure 7; Wheaton et al. 2012, Camp 2015, Wheaton et al. 2019, Bennett et al. 2020). Therefore, we plan to generally add wood or rebuild structures to their original configuration although we have noted larger responses from channel spanning structures and may alter some bank-attached or mid-channel PALS to create channel spanning PALS. If adding wood, the wood will be placed to interlock with remaining posts or live trees at the site to secure the wood. If cutting trees, the trees will also be interlocked and where possible felled on existing structures to provide stability. We have noted from our extensive surveys of PALS that the high density of PALS tends to trap mobile wood causing other PALS to get large and, in some cases, create new log jams (Figure 8).

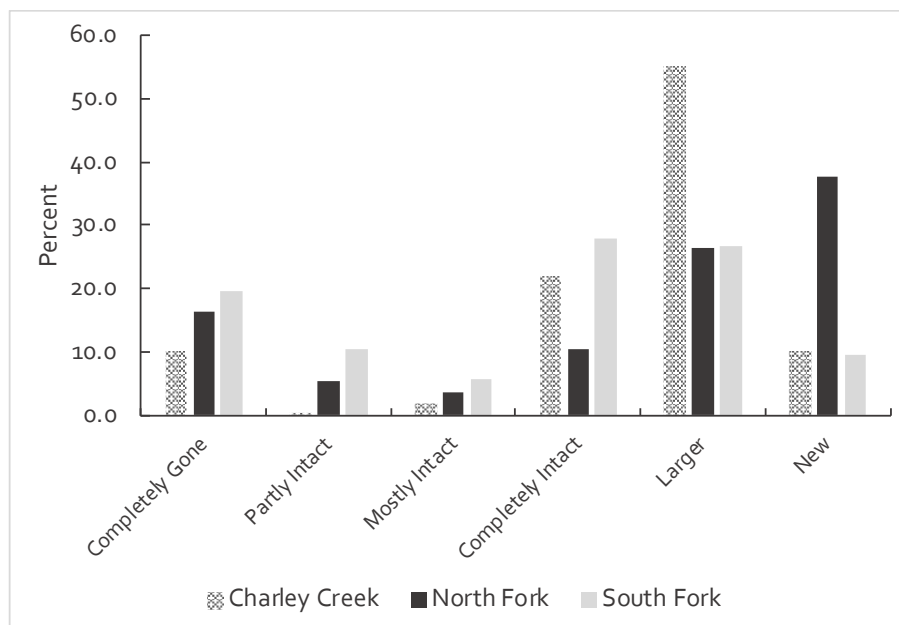
Figure 8. Percent of structures by category describing their integrity based on 2019 survey. Larger refers to structures that have increased 25% in volume due to wood accumulation and New refers to wood accumulations that have developed since the original restoration treatment from IMW wood, natural recruitment or both (Total number of wood accumulations now = 750 in 14 km treatment area).

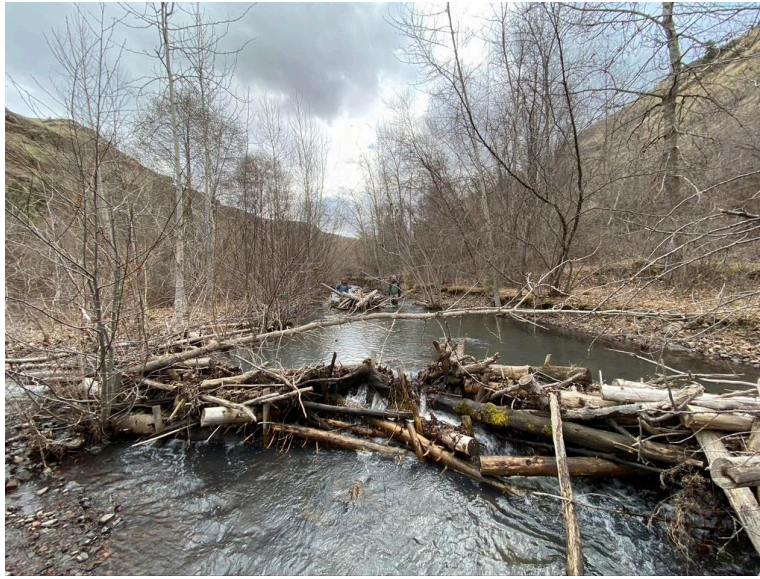
*Figure 10. Post-restoration conditions in South Fork Asotin Creek – channel spanning post-assisted log structure forcing overbank flow (during receding high flow) and ponding water upstream of the structure.*

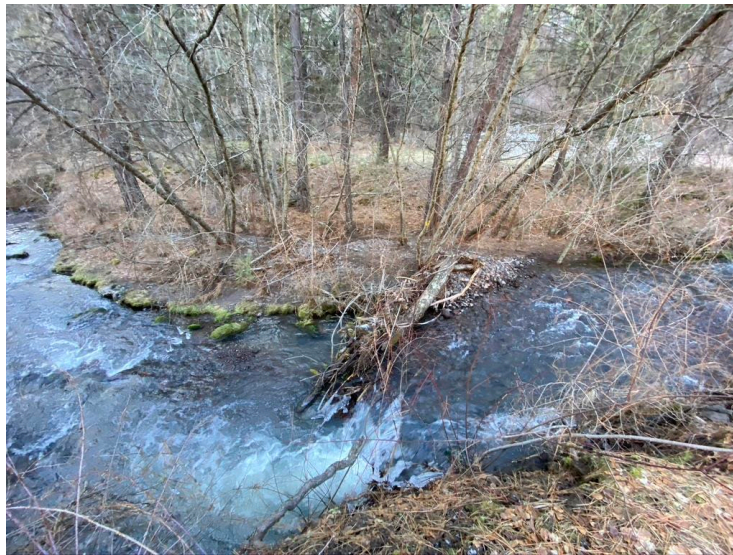
*Figure 11. Post -restoration conditions in Charley Creek – bank attached post-assisted log structure forcing flow against river left bank, creating eddy pool downstream, and forcing overbank flow and forming upstream and downstream bars on river right.*

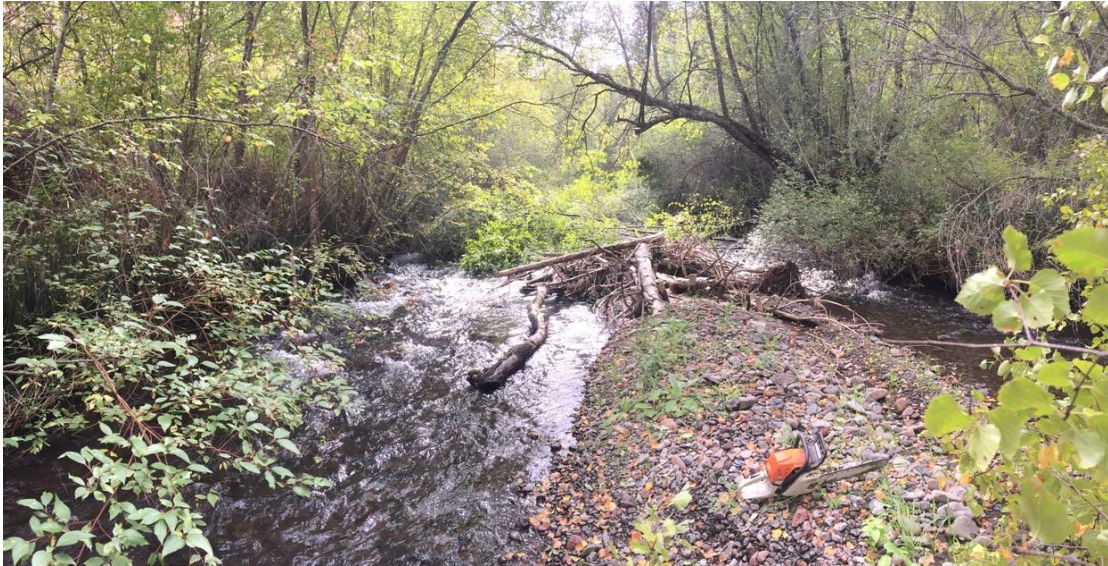
*Figure 12. Post -restoration conditions in North Fork Asotin Creek – mid-channel post assisted log structure splitting flow and creating downstream mid-channel bar.*

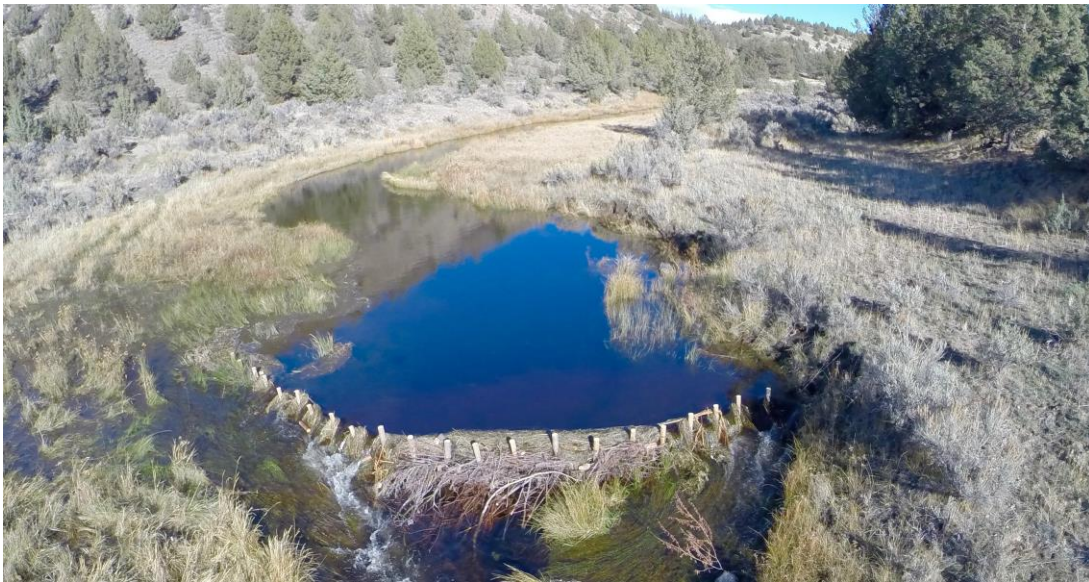
*Figure 13. Beaver dam analog on South Fork Crooked River, Oregon forcing overbank flow during low flow.*
