CRESCENT HARBOR CREEK RESTORATION

Eric Mickelson, Project Manager Skagit River System Cooperative 11426 Moorage Way (P. D. Box 368) La Conner, WA 98257

PROJECT LOCATION & DRAWING LIST DRAWING 1

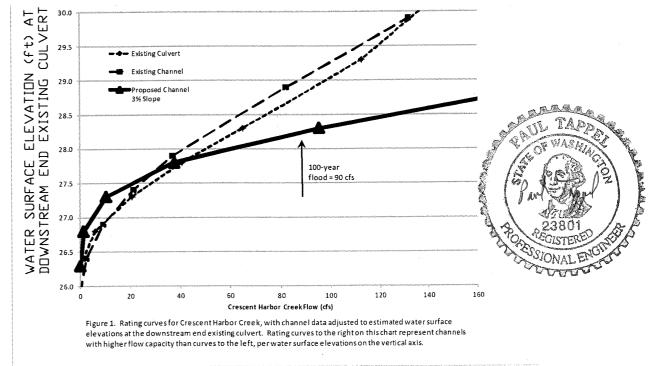
Notes for Potential Backwater Upstream of Existing Culvert

The project engineer completed a detailed survey near the existing culvert and prepared rating curves to quantitatively show the relationship between creek flow in cubic feet per second (cfs) and estimated water surface elevations at the downstream end existing culvert. The specific interest was whether or not the proposed channel would result in additional backwater of the existing culvert. Flow rating curves are shown in Figure 1, with all rating curves adjusted per creek alignment to hydraulically coincide with the downstream end of the existing culvert. Conclusions from the analysis of rating curves:

- > On the chart (Figure 1), rating curves to the right represent channels that have higher flow capacity than curves to the left.
- For flows zero to 40 cfs, the existing culvert and downstream channel would both have slightly more flow capacity than a roughened channel at 3% slope; see the thick solid line (proposed channel) to the left of dashed lines (existing conditions) in Figure 1. Within this flow range, the proposed roughened channel would create a minor backwater within the existing culvert, up to about 0.3' deep. Slightly higher water elevations (up to 0.3' higher) upstream within this flow range were not considered any concern.

- Above 40 cfs flow in Crescent Harbor Creek to the estimated 100-year flood flow and above, the proposed roughened channel would have increasingly high flow conveyance capacity compared with existing conditions. On-site, beginning at about 60 cfs flow, there would be a small water level drop from the existing culvert into the roughened channel. This water level drop would be about 0.5'-high at the estimated 100-year flood flow; there would not be any upstream backwaters at high creek levels, or during floods.

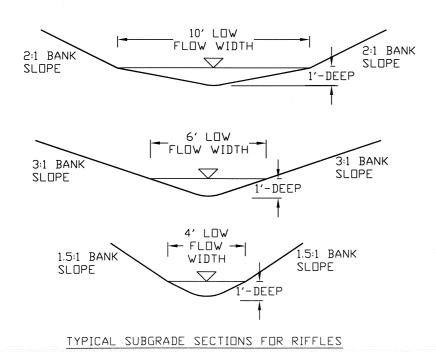
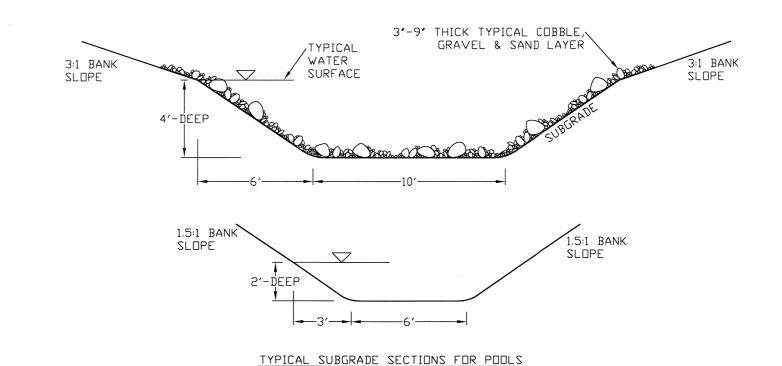
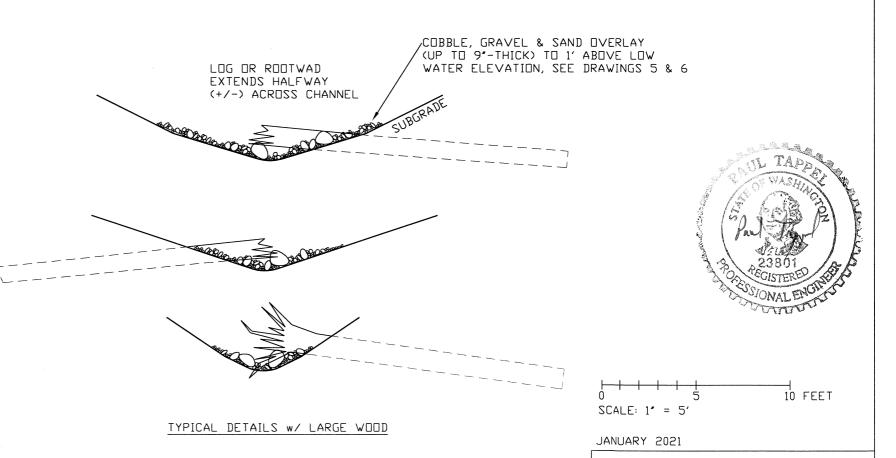
SUBGRADE SECTIONS & TYPICAL CHANNELS

TYPICAL SUBGRADE w/ SCISSOR LOG WEIR AT UPSTREAM END POOL

TYPICAL SUBGRADE w/ LOG CONSTRICTION AT UPSTREAM END POOL

Channel Subgrade, Large Wood & Cobble/Gravel/Sand Mix Notes:

- Typical channel dimensions shown this drawing. Actual dimensions will vary along the restored channel length, within the limits shown.
- 2. Low flow riffle widths 4' to 10'-wide w/ variable bank slopes.
- 3. Pools 2' to 4'-deep by 10' to 20'-wide w/ variable bank slopes.
- All logs and logs w/ rootwads to be salvaged from Crescent Harbor Creek estuary at low tide. Select logs 12"-24" trunk diameter (+/-) approx. 15'-25' long.
- 5. All logs extending into channel shall have broken ends (no sawn ends). Buried log ends may by sawn or broken.
- Cobble/Gravel/Sand to contain the four materials listed below, each at ¼ of the mix by volume:

Rounded cobbles 6" to 18"-size. Gravel 2" to 6"-size Gravel 1" to 2"-size. Washed sand. (these size ranges may vary slightly)

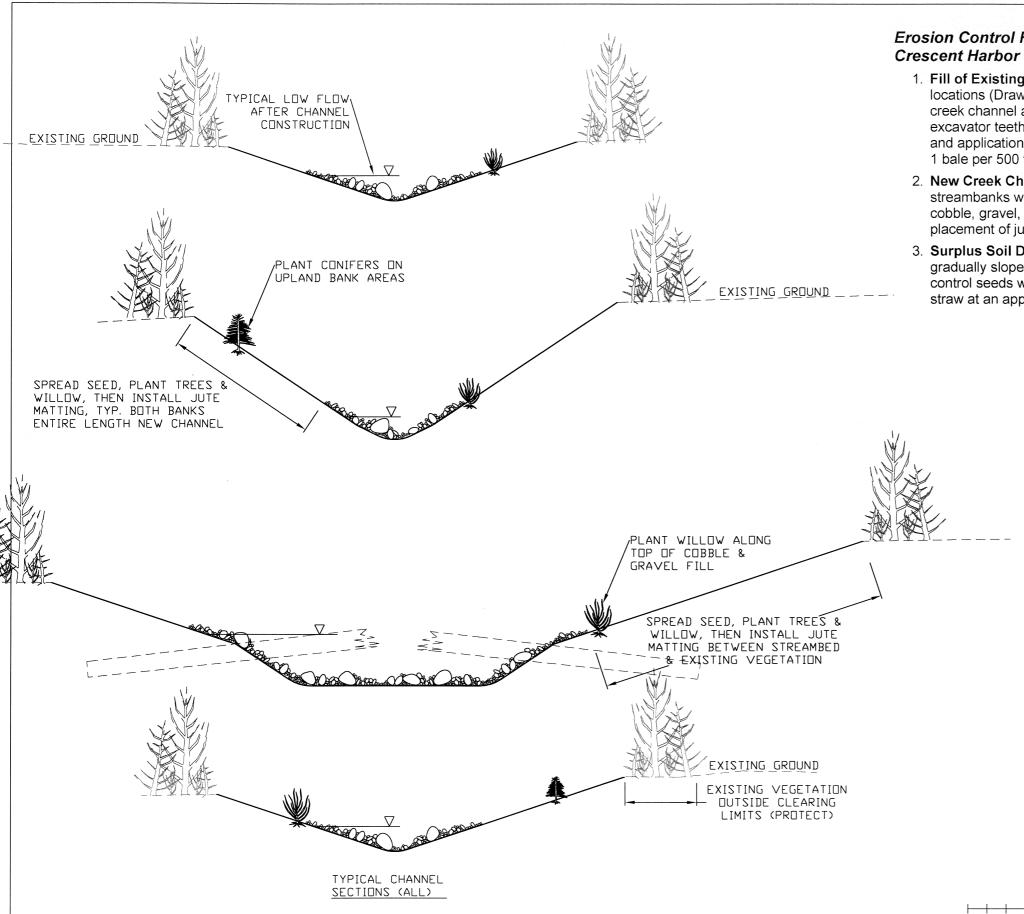
EROSION CONTROL FOR NEW CHANNEL BANKS

Erosion Control Requirements for Crescent Harbor Creek Restoration:

- 1. Fill of Existing Creek Channel (ditch) and Abandoned Agricultural Ditches All specified locations (Drawing 9) to be filled to surrounding ground levels, using native soils excavated for new creek channel alignment. Lightly tamp fill into ditches, but do not compact, rake surface with excavator teeth for rough ground surface. Then, spread erosion-control seeds with seed variety and application rate determined by SRSC, and spread weed-free straw at an application rate of 1 bale per 500 ft² area.

- 2. New Creek Channel Banks (all including roughened channel) Erosion control for streambanks will be erosion-control seeds spread over all areas between undisturbed ground and cobble, gravel, or rock (streambed materials), planting native shrubs and trees, and then placement of jute matting over all channel bank areas.

- 3. **Surplus Soil Disposal Area** The upland area covered with surplus excavated materials shall be gradually sloped to match adjacent terrain, with the soil surfaces raked. Then, spread erosion-control seeds with seed variety and application rate determined by SRSC, and spread weed-free straw at an application rate of 1 bale per 500 ft² area.

Notes for Native Plants:

Native trees shall be 18" to 4'-high; willows shall be 1' to 2'-high. Space trees 15' apart along both channel banks, stagger up-and-down banks, and alternate tree species. Place trees about 20' apart for fill over existing creek channel (ditch); stagger spacing and species. Plant 20 trees at disposal site for surplus soil. Place all willows near water edge in new creek channel, with random pattern averaging one willow per 10' channel length.

\triangleright	Shore Pine	90 each
Þ	Sitka Spruce	80
Þ	Grand Fir	80
Þ	Pacific Willow	130
