Mill Creek/Mountain Home Ranch Road Fish Passage

SRFB Comments

Peshastin Tributary Monitoring

(Larson, Mill, and Ruby Creeks)

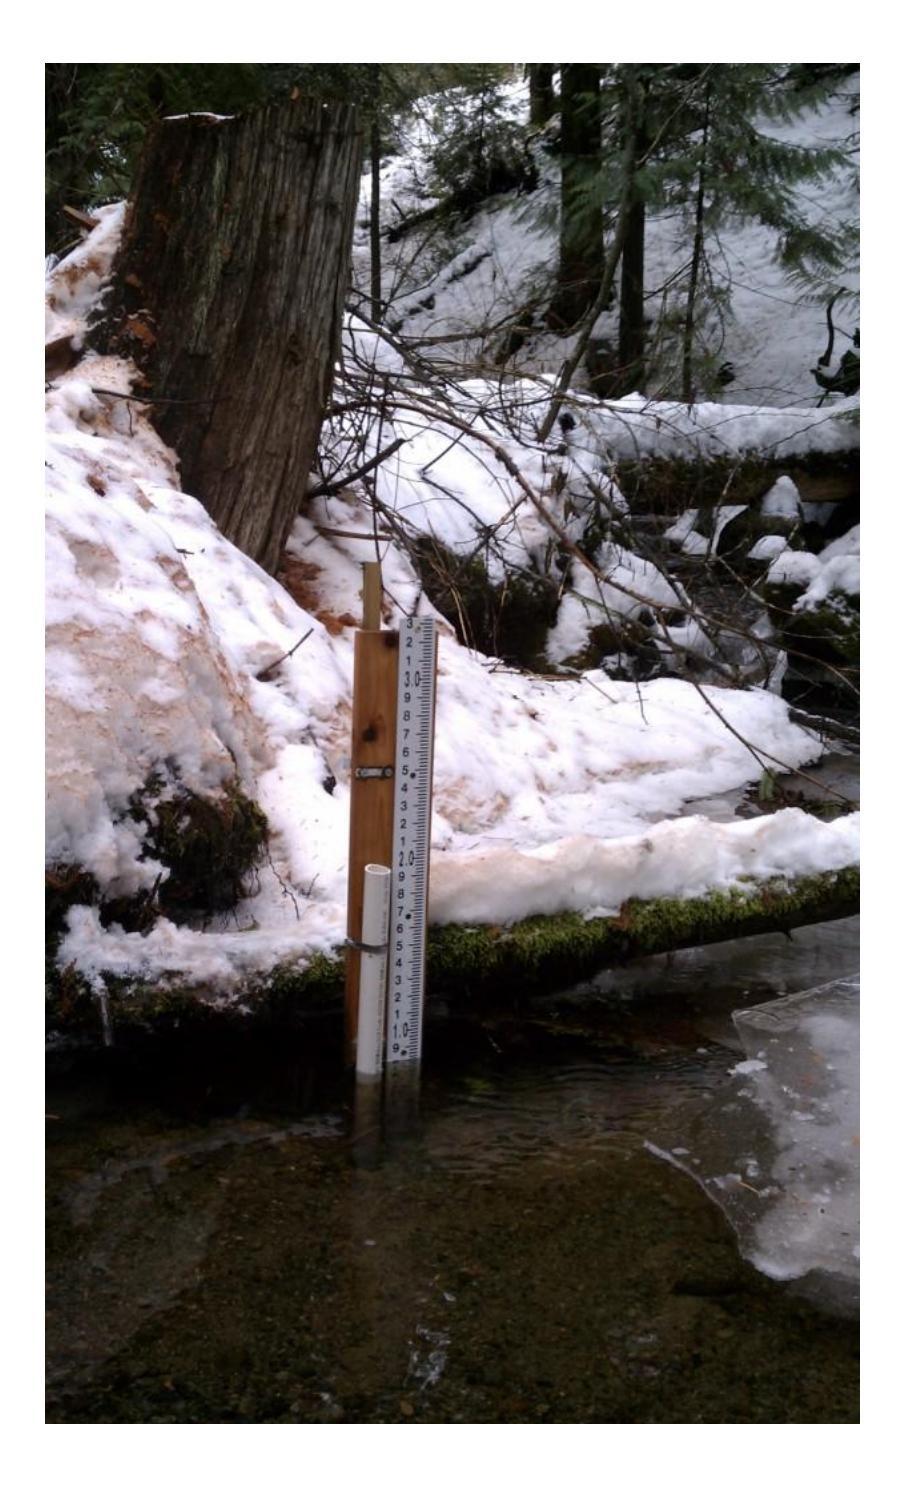
Each tributary has one monitoring site equipped with a staff plate, water level logger (Onset, HOBO) and barometric pressure logger (Onset, HOBO). A rating curve will be developed so that water level logger data may be corrected and represent a continuous recording of discharge throughout the study period (July – October 2011). Monitoring locations were chosen based on close proximity to Peshastin Creek, site accessibility, and channel conditions. Ideally the site is as close to the confluence with Peshastin Creek without receiving influence from, during high flows. This is important when capturing low flow conditions. All sites were established in favorable locations with willing landowners.

Once the general location had been determined on each tributary, a site for the staff gauge and crosssection were chosen using the "Standard Operating Procedure for Estimating Streamflow "(WSDOE). Each tributary's staff plate was fastened to a 4 foot 2x6 using 2" screws. Next to the staff plate on the 2x6 a PVC housing for the water level logger was fastened to the board by two hose clamps. The PVC housing is complete with an elevation screw to ensure the zero point on the logger matches up with the zero on the staff. A T-post was hammered into the streambed until sturdy, with special care being taken to keep it upright. The "staff board" could then be attached using two U-bolts and secured at bed elevation. The loggers were launched on July 15th with a 0.5hr logging interval and installed. In addition to water level, temperature is recorded at the same interval.

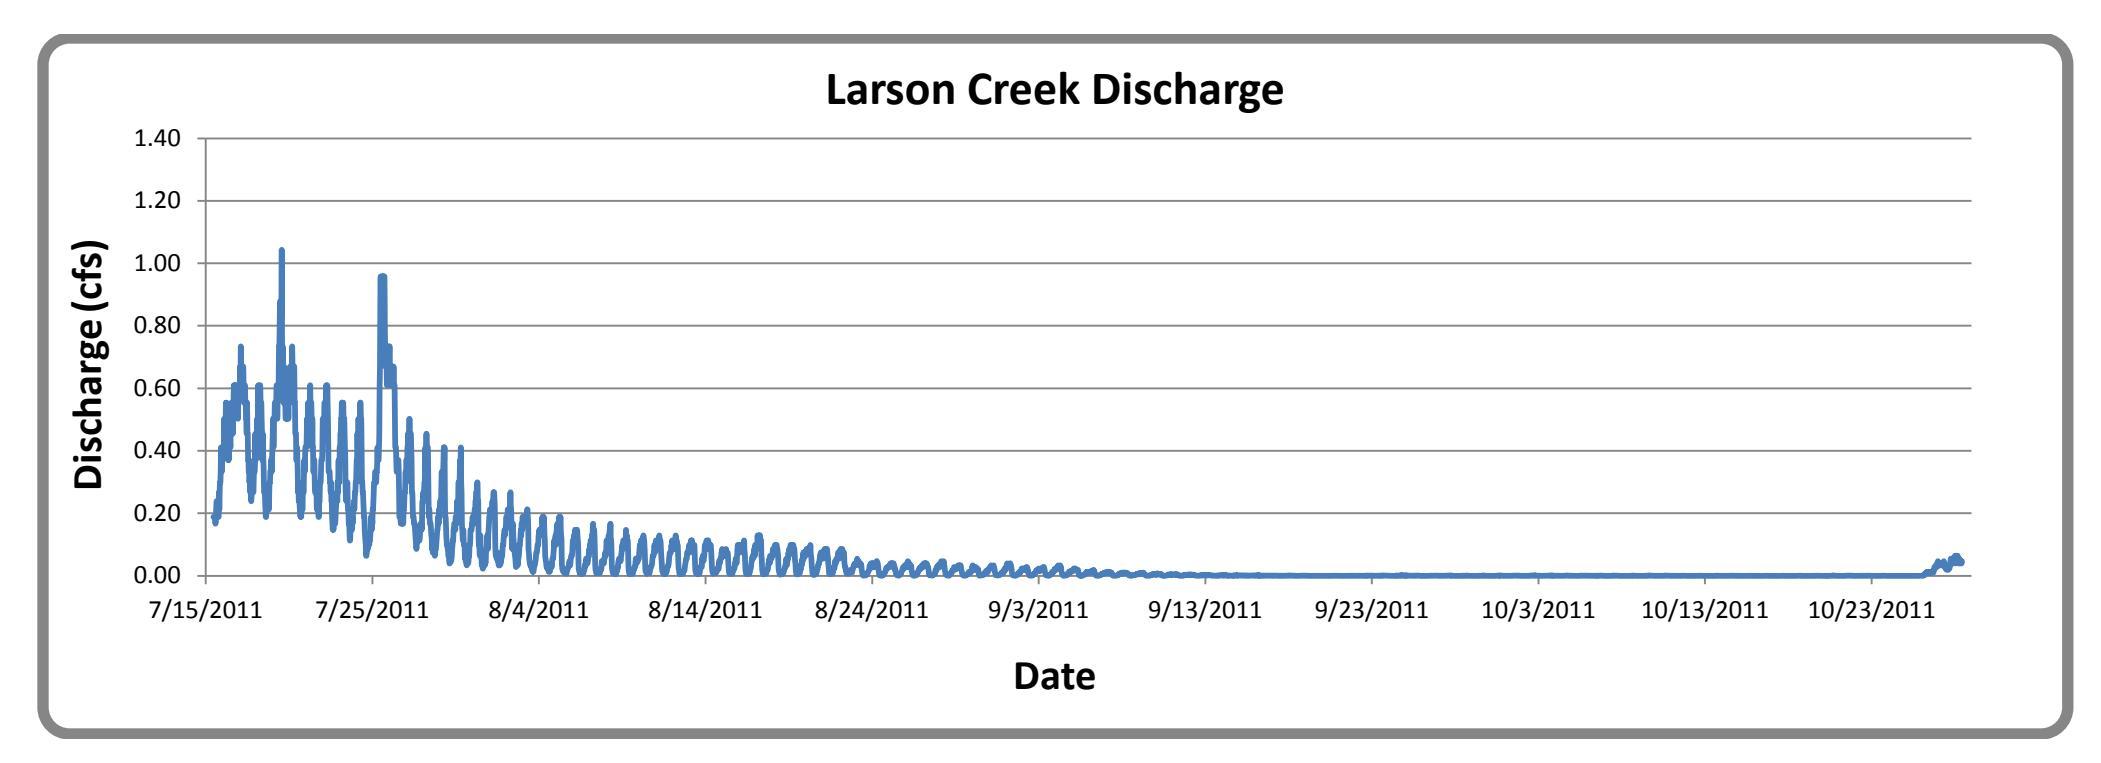
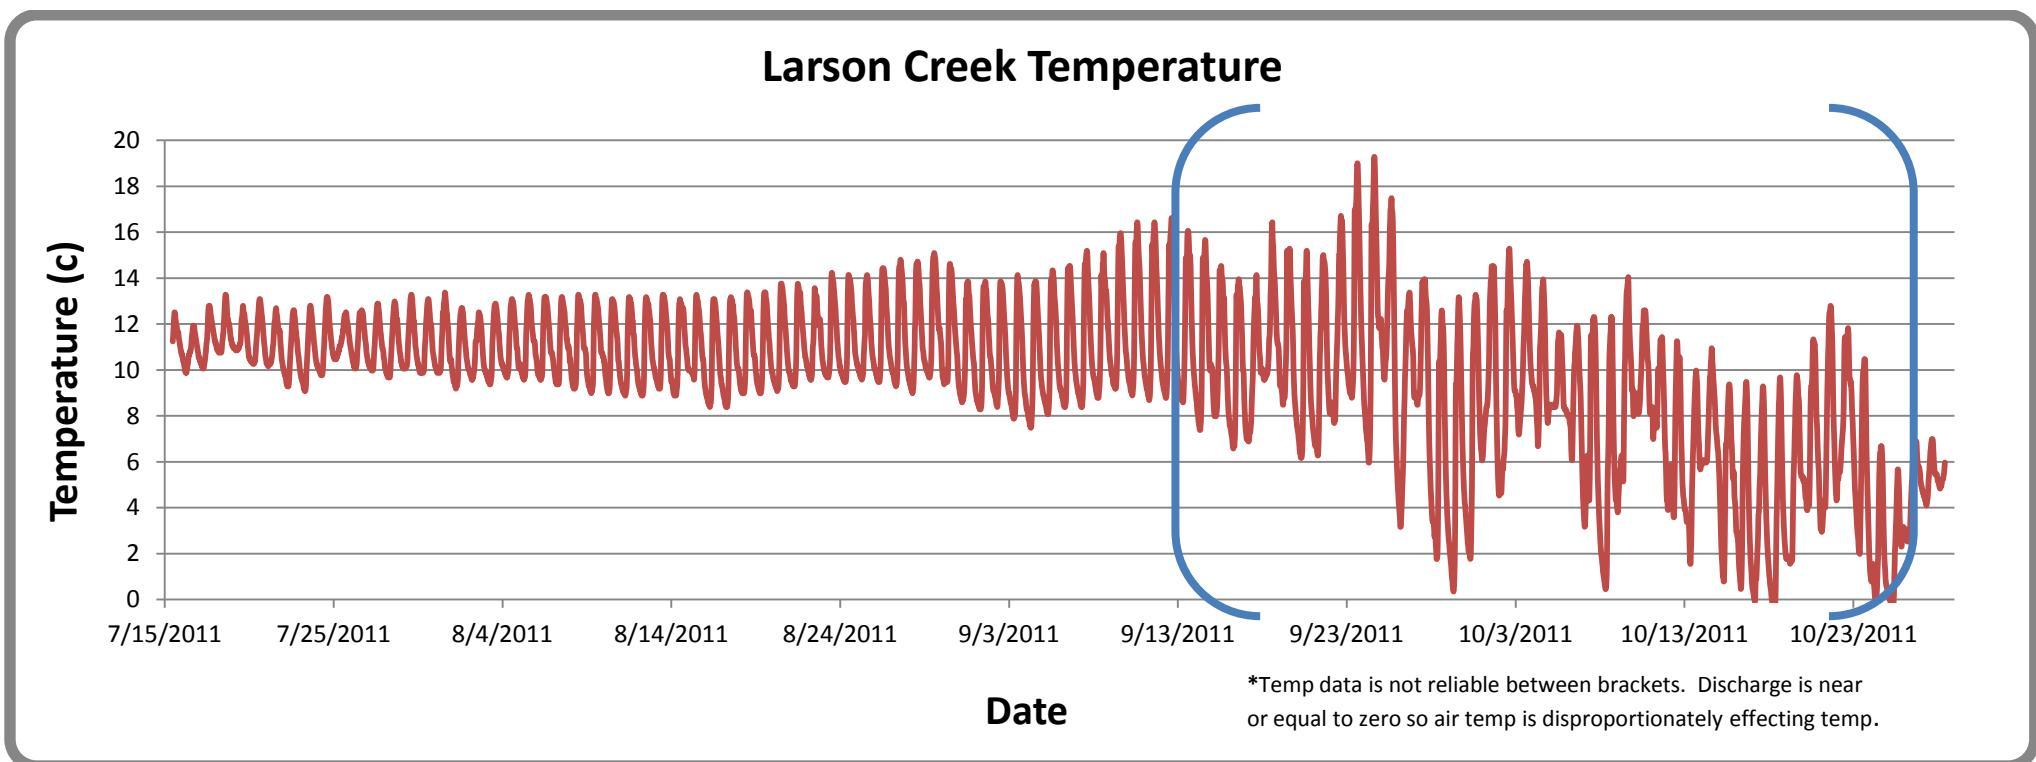
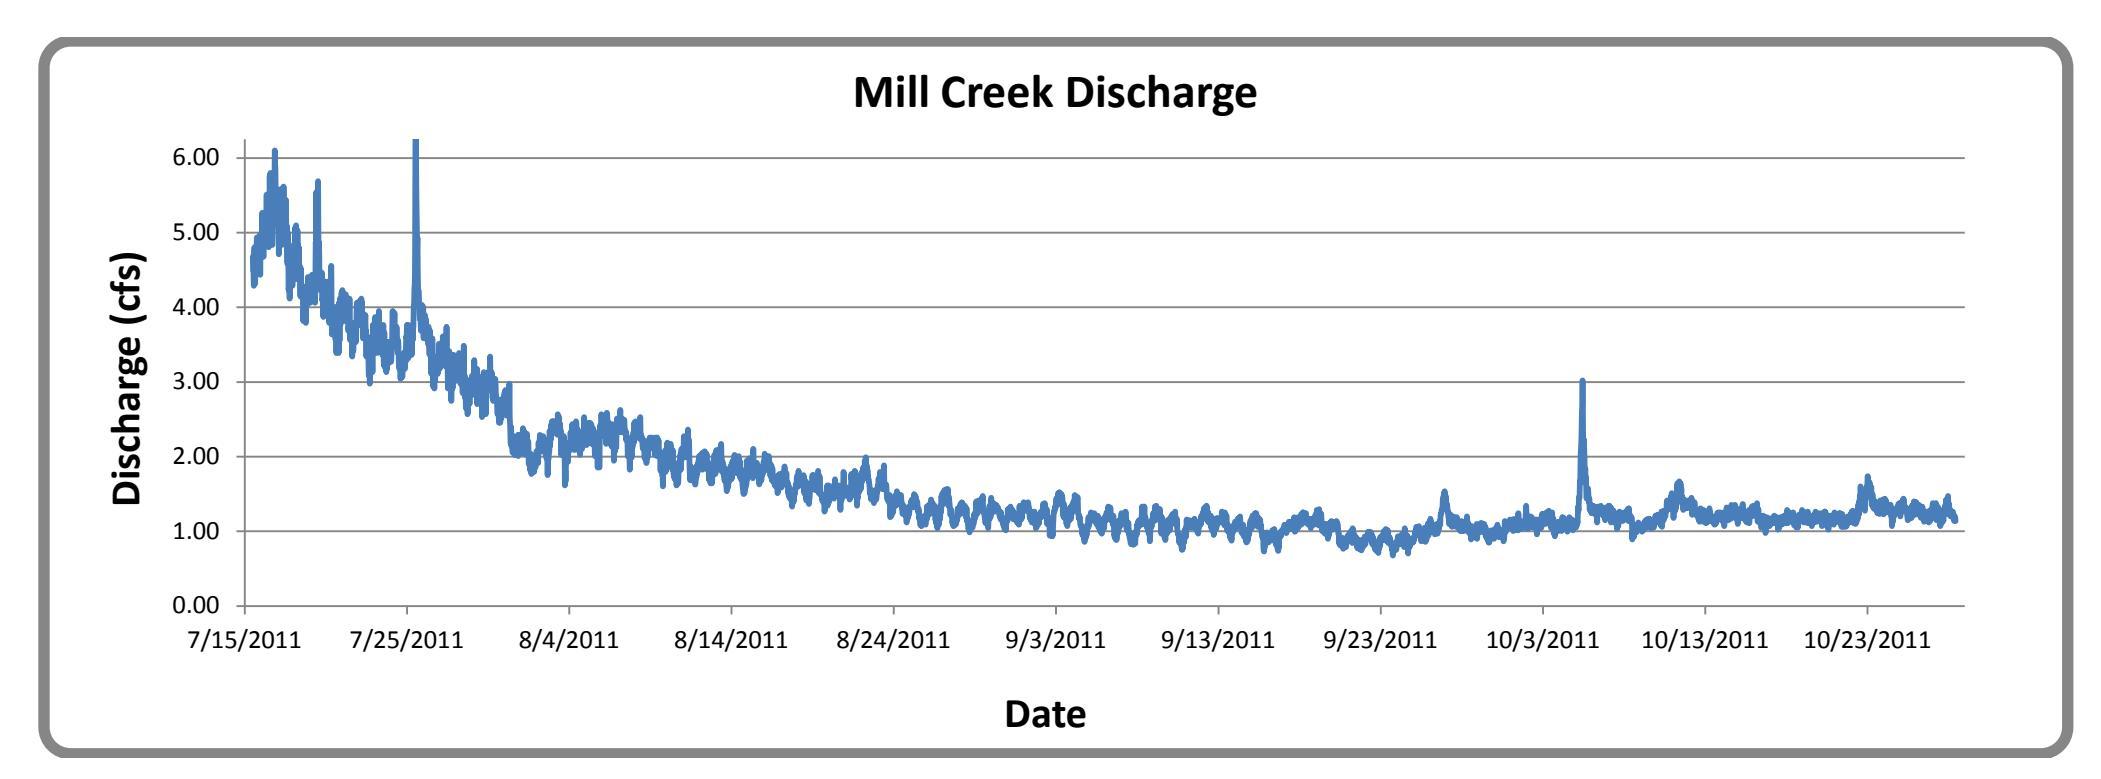
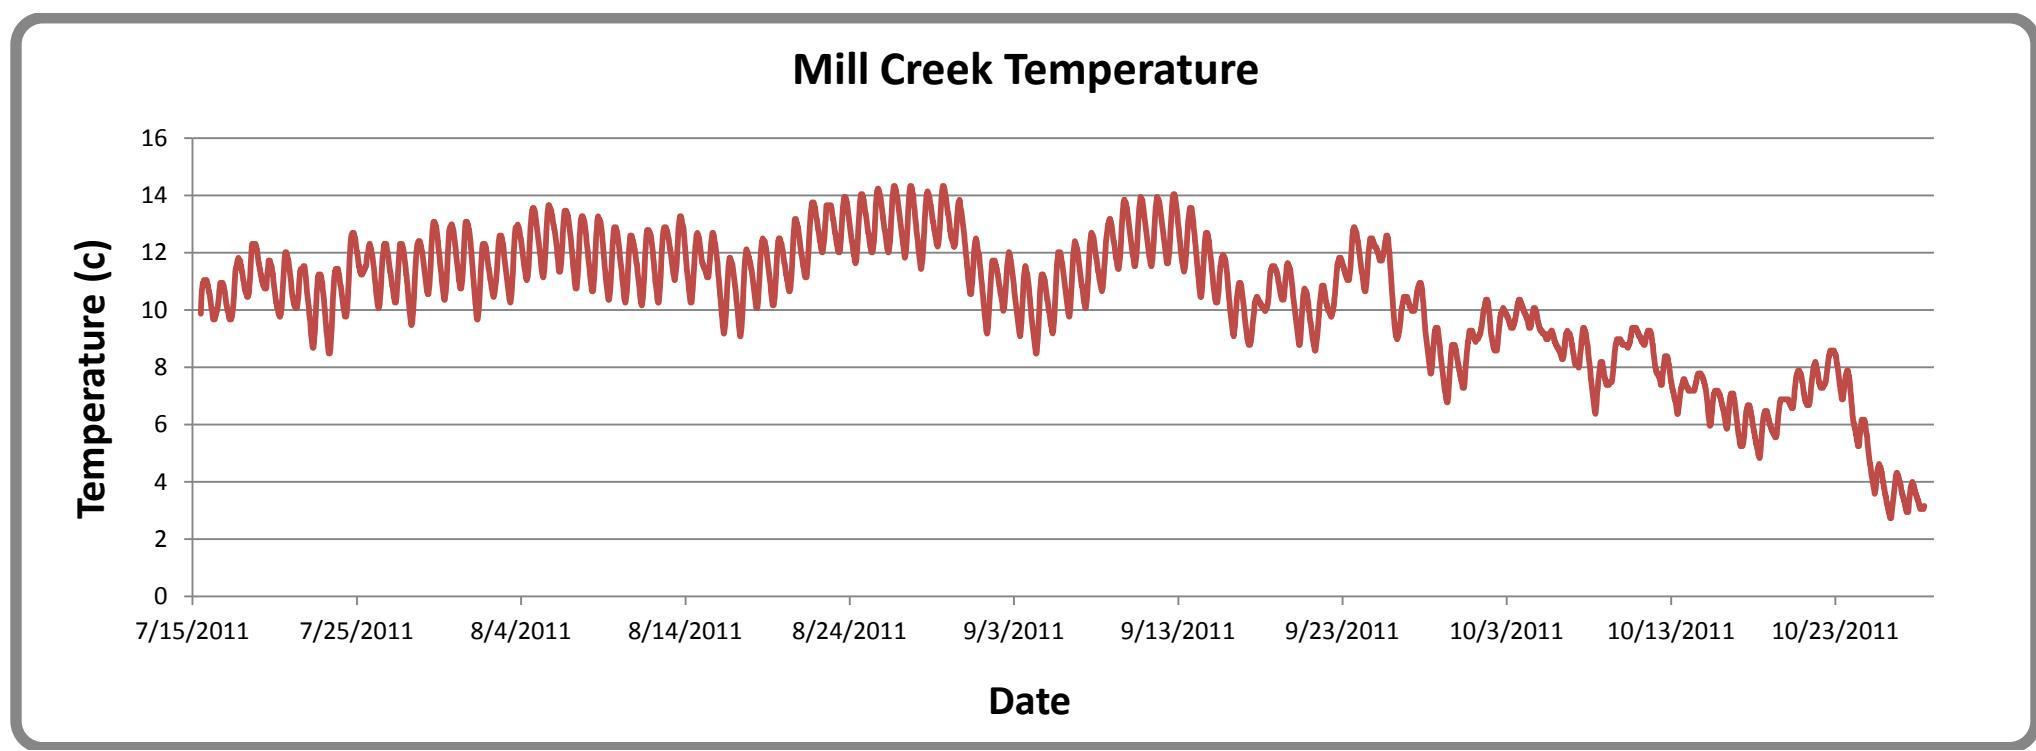
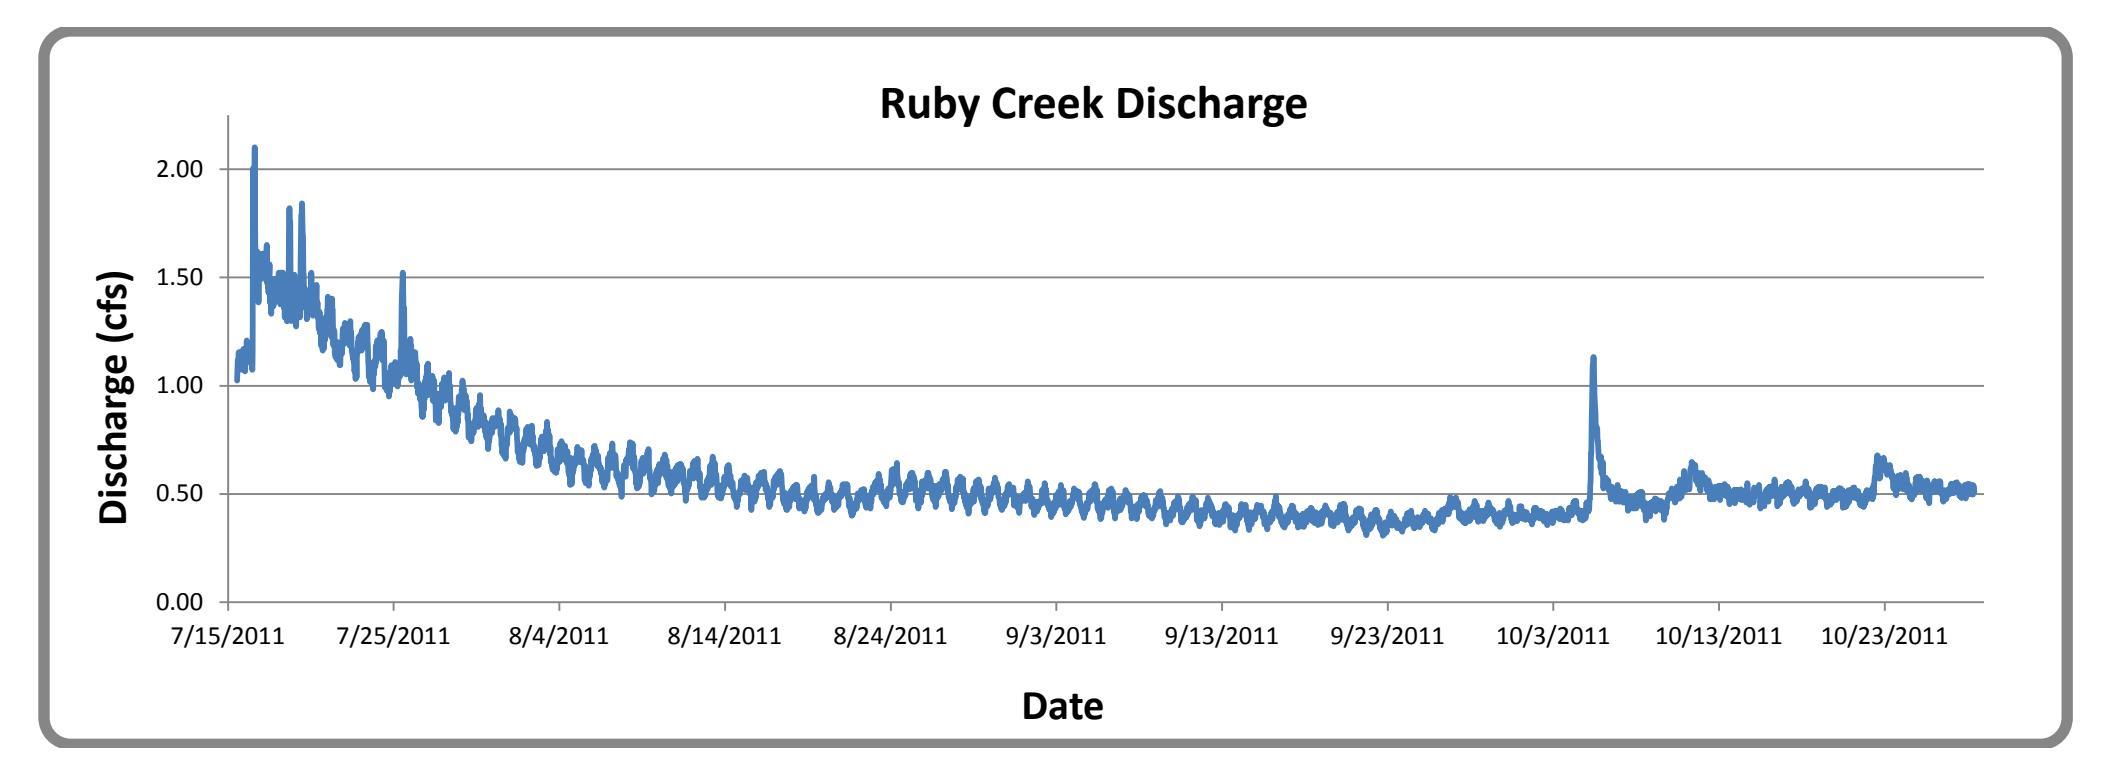
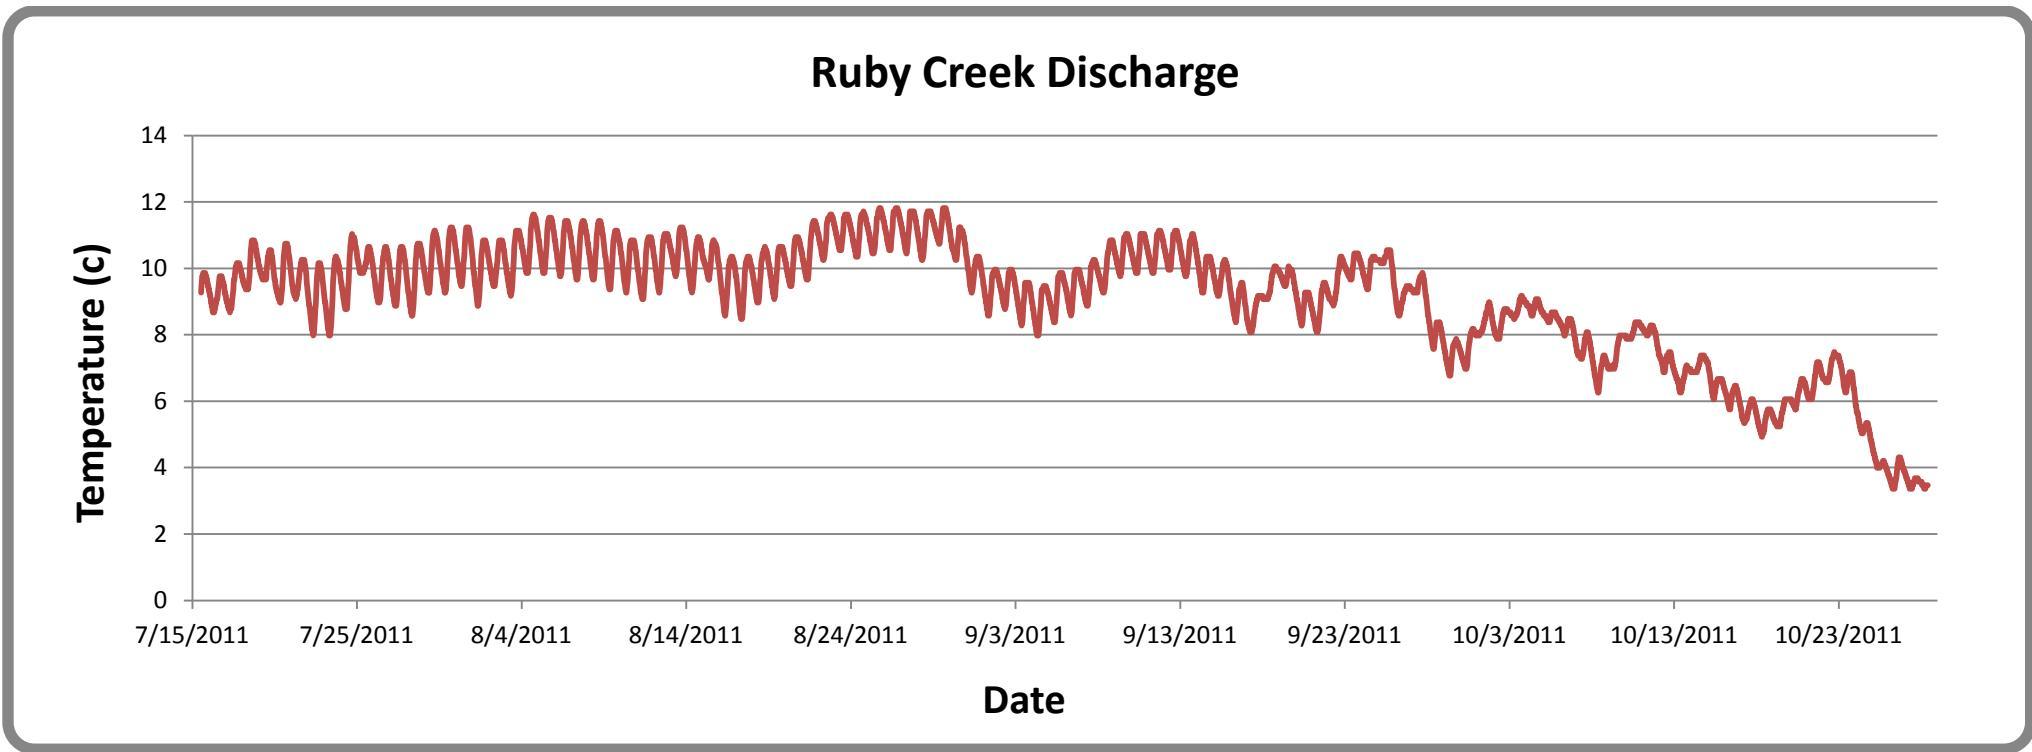
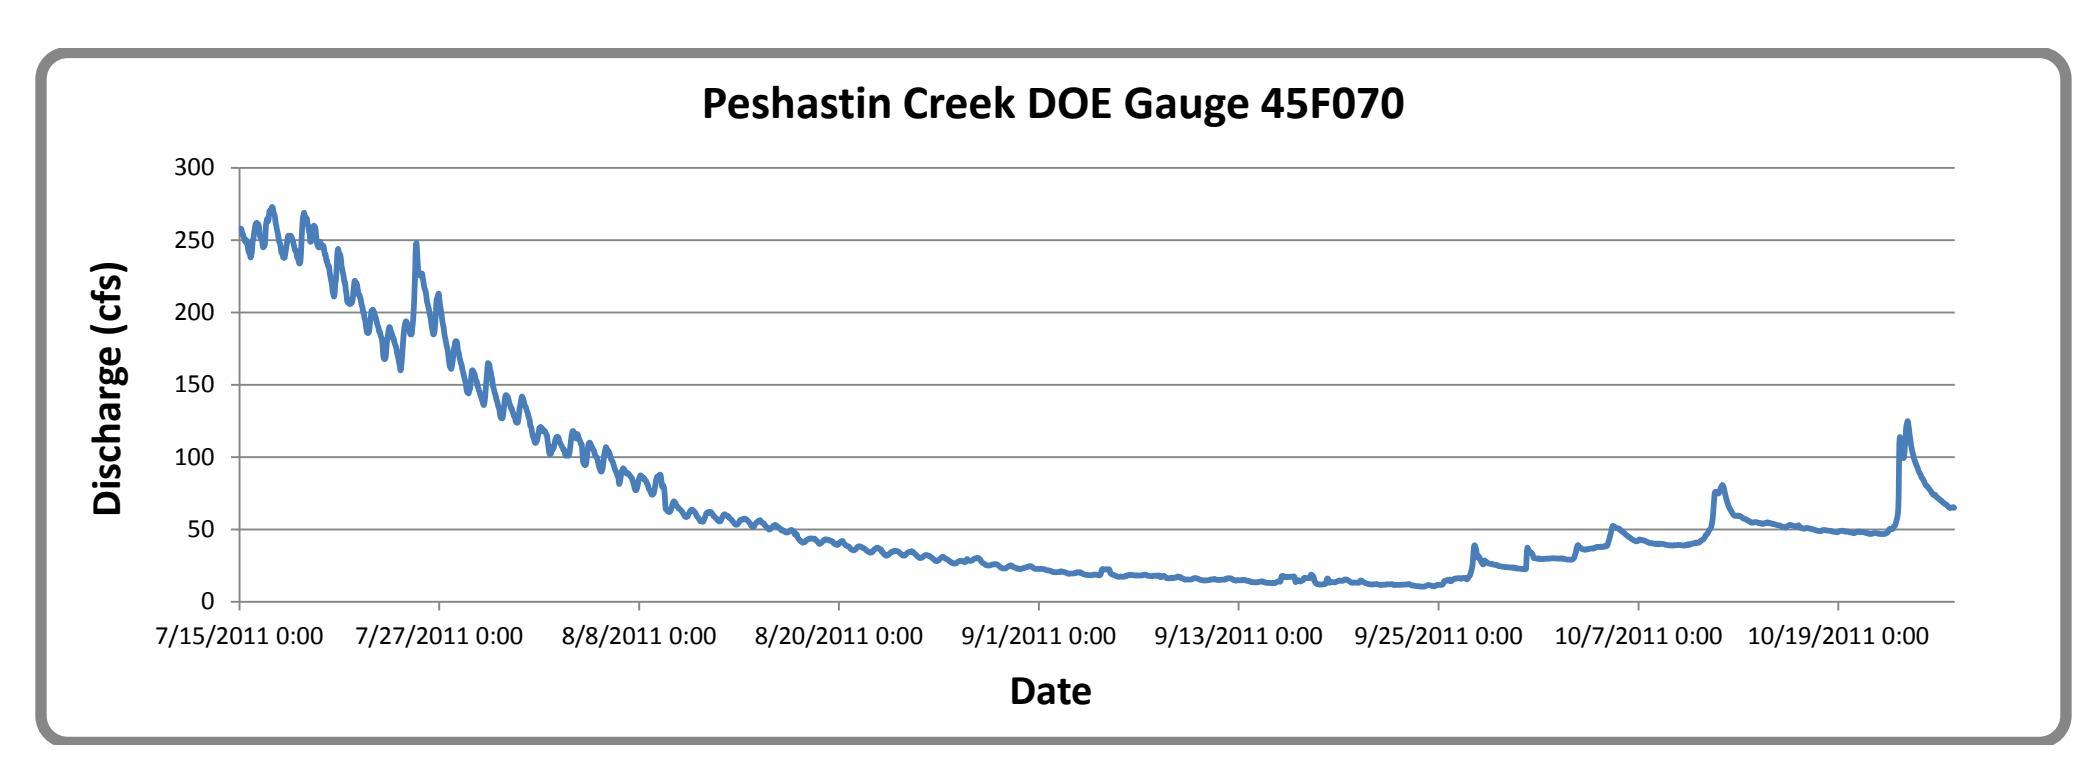
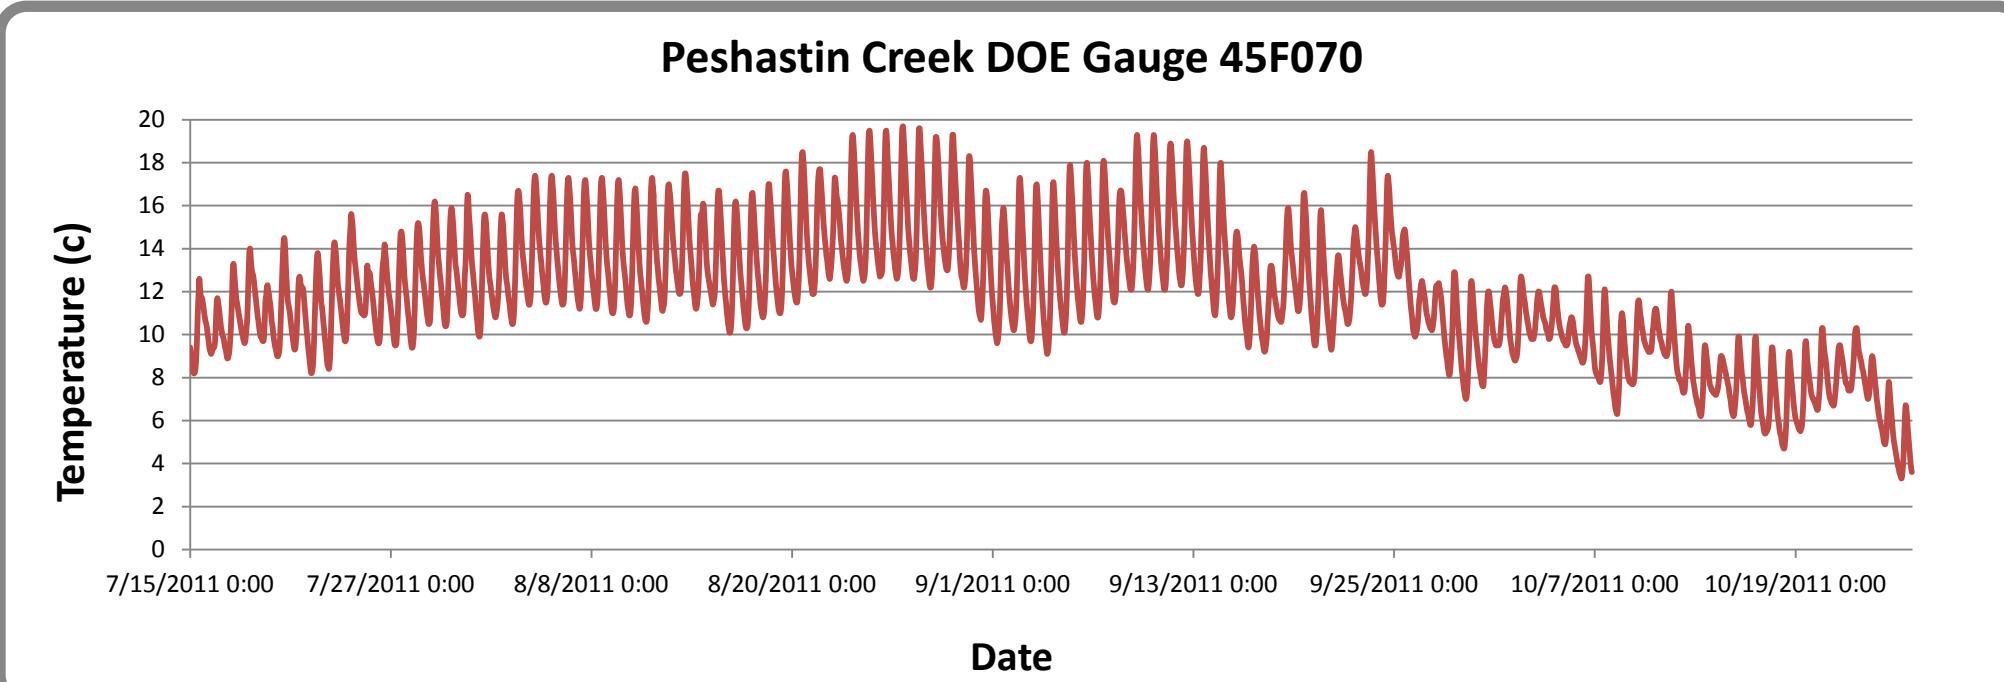
After all data management is complete a continuous record of discharge and temperature data is available from July 15th thru October 28th in 0.5hr increments for each tributary. A rating curve has been developed and will be extended to include high flows during spring 2012. Below are hydrographs and temperature graphs for each tributary and the WADOE gauge on Peshastin Creek. Tabular data is also available.

The discharge rating curve equation was then applied to logger data and thus produced a continuous recording of each tributaries discharge. One last QA/QC exercise was performed to ensure data reliability. Discharge measurements were compared to logger data discharge values to locate any discrepancies and adjust if necessary.
