# Project Status Report – Final Construction Report

Project Name: Lower Nason RM 3.7-4.7 Restoration RCO project # 14-1238							
Project Action: Floodplain fill removal and oxbow enhancement							
Project Sponsor: Chelan County I	Natural Resour	ces De	epartment				
Project Design: ICF							
Landowner(s): US Forest Service	and Weyerhau	ser					
Funding Source(s): USBR and RCO Implementation Cost: Roughly \$175,000							
	State: WA	County: Cl		elan	Strea	am: Nason	
Project Location:	Latitude: 47.782	2556 N		Longitude:	120.7	725919	
	Township: 26N	Range: 17E		Section: 9		<sup>1</sup> ⁄ <sub>4</sub> Section:	
Project Status: Construction com	pleted 2014						
Project Phase: Monitoring and Ad	aptive Manage	ment					
	Funding: Secu	ured					
	Design: Completed						
Milestones	Permitting: Completed						
	Construction	Start	Date: July	14, 2014			
	Construction	Comp	letion Date	: October	31, 20	014	
Distantia di Demetit	Species: steelhead and spring Chinook

Nason Creek
RM 4.7 - RM 3.3
<b>Restoration Project</b>

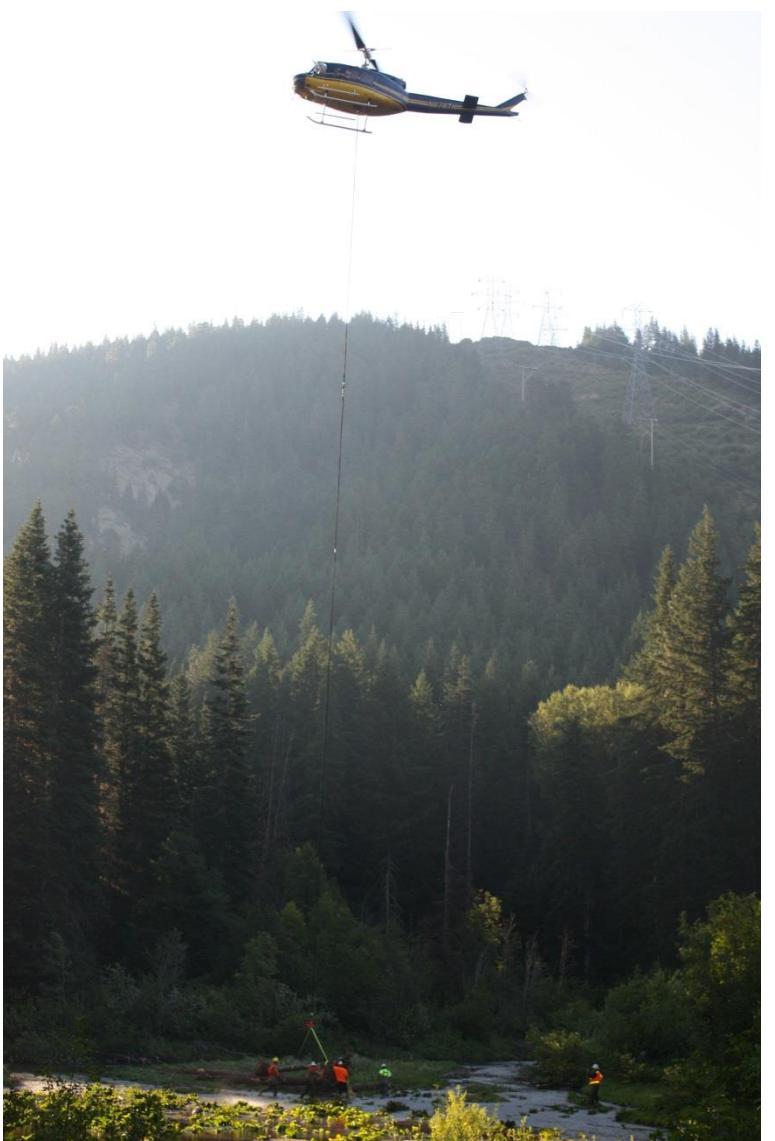
# 7-28-14 Flying logs into the oxbow

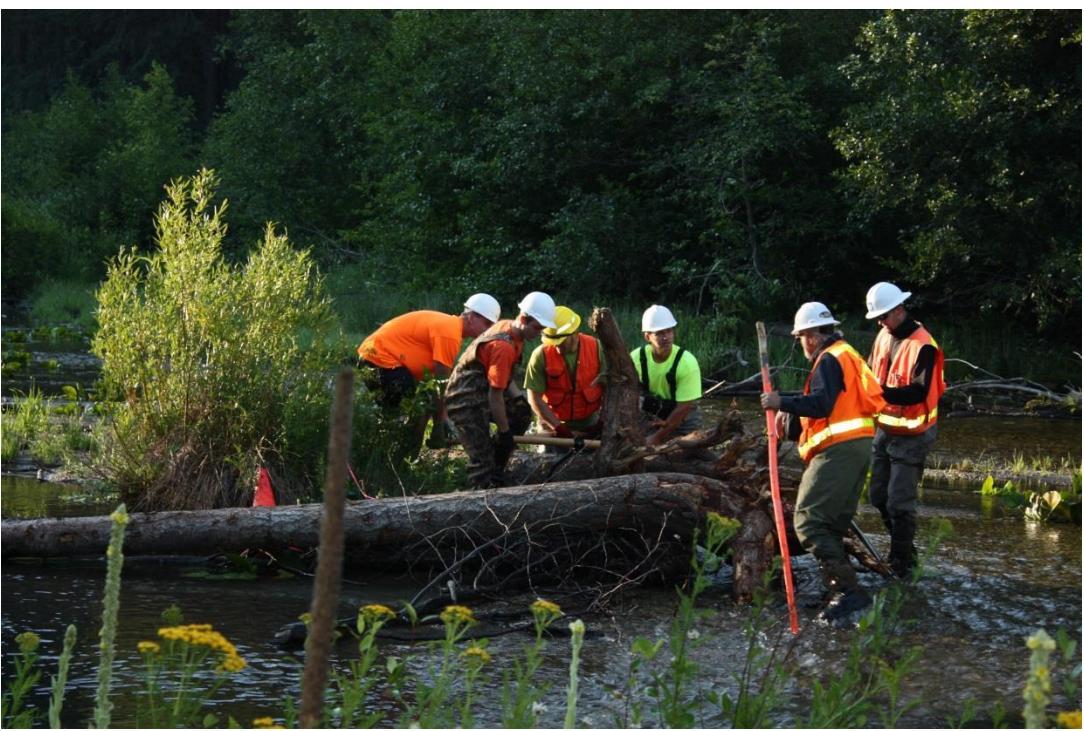
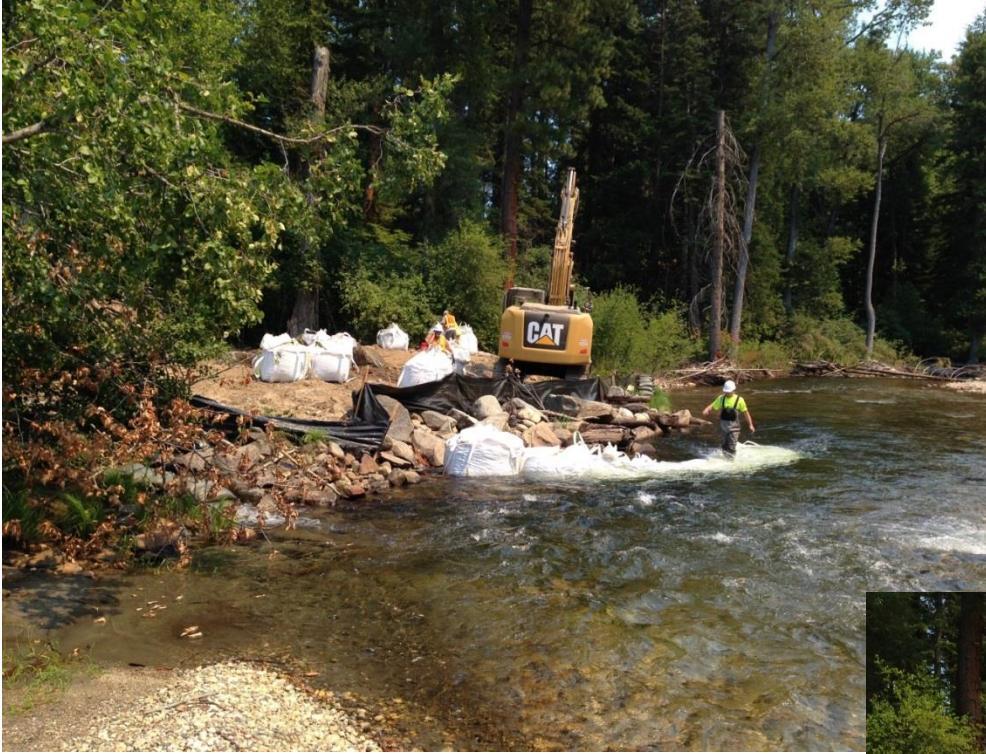
7-31-14 Building the cofferdam for in-water work to remove an historic bridge abutment consisting of rip-rap, cable, and embedded pressure treated logs

<u>Permitting</u> – there was discussion about whether or not to cofferdam for the bridge abutment removal. Without the cofferdam, there would not have been a Corps permit for the project (since the project was all fill removal and placement of organic material). Without a Corps permit, there was no Section 401 coverage for the project. So the NWP 33 for placement of a cofferdam provided the DOE statewide programmatic coverage for the Section 401 water quality certification. WDFW supported the need for a cofferdam because we requested a later in-water work window and the project is near spring Chinook spawning. In the end, I was super glad we had a cofferdam because we would have made a muddy mess without it. There was minimal sediment release with the cofferdam in place. Construction –

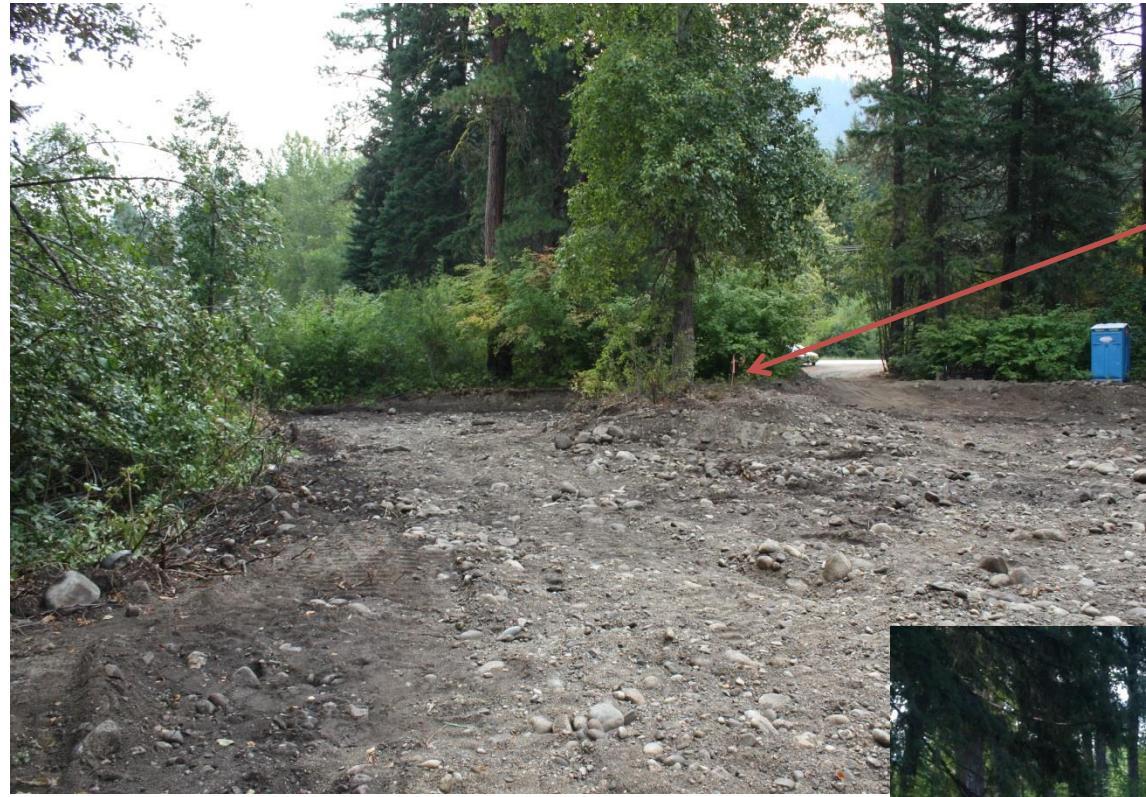
8-21-14 Floodplain fill removal area. At this date, the brush had been lopped and scattered and hay placed for temporary erosion control, but plants had not been installed yet. This photo looks upstream at a little swale that was installed through the floodplain fill removal area.

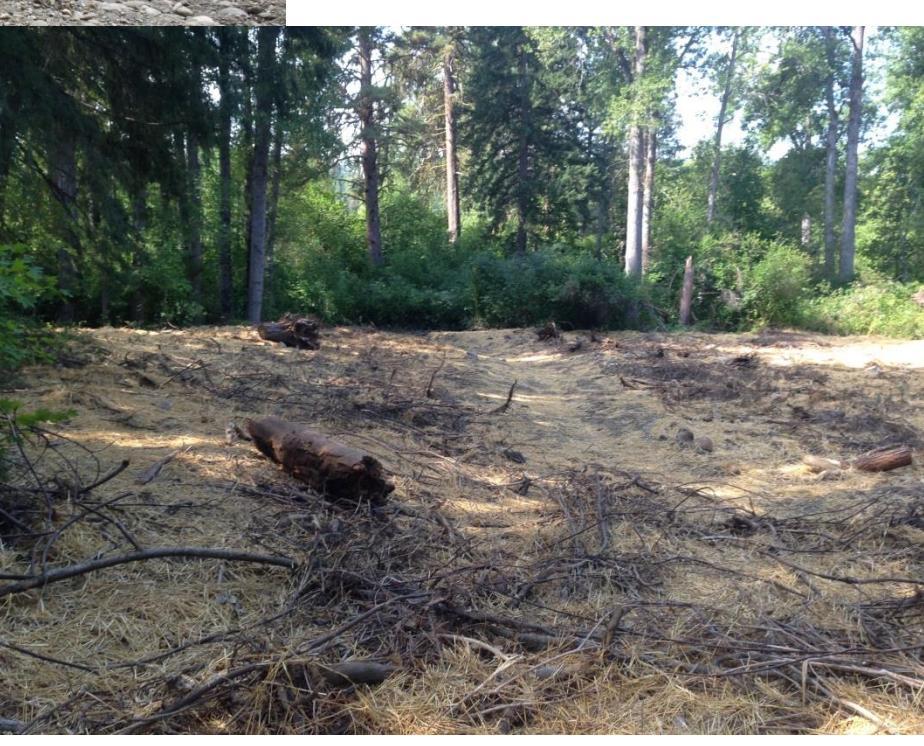
October 15, 2014 Plants are hard to see but they have been installed amongst the scattered brush

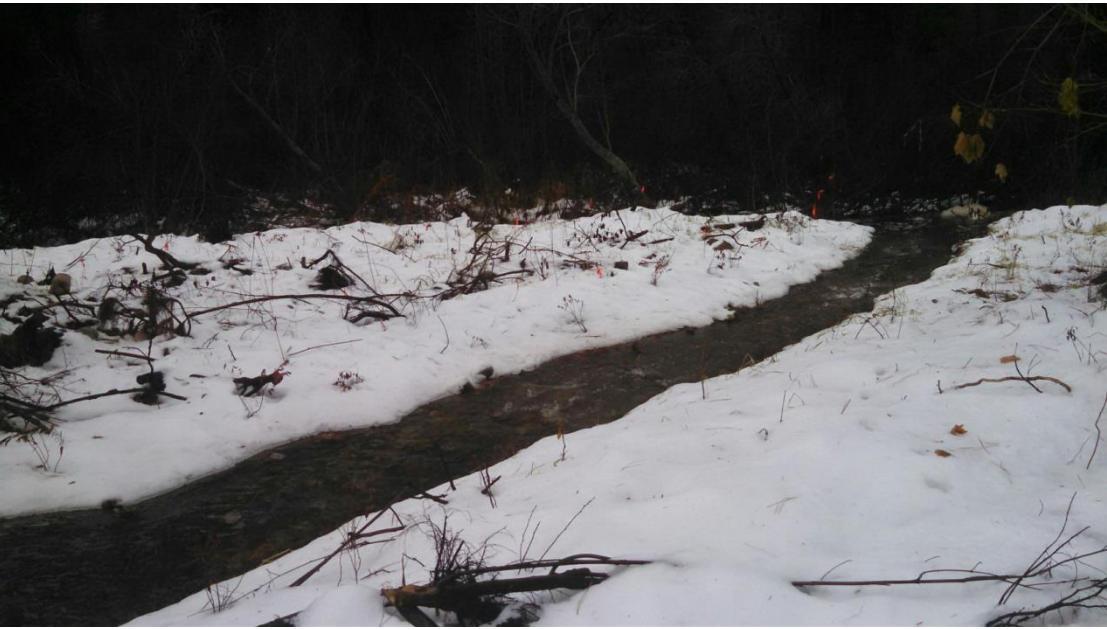
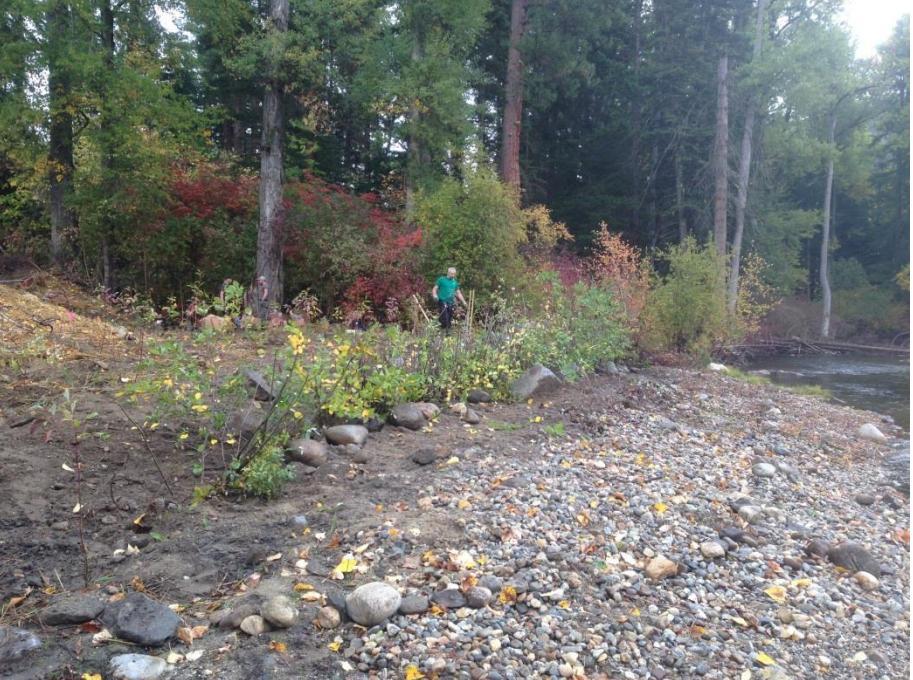
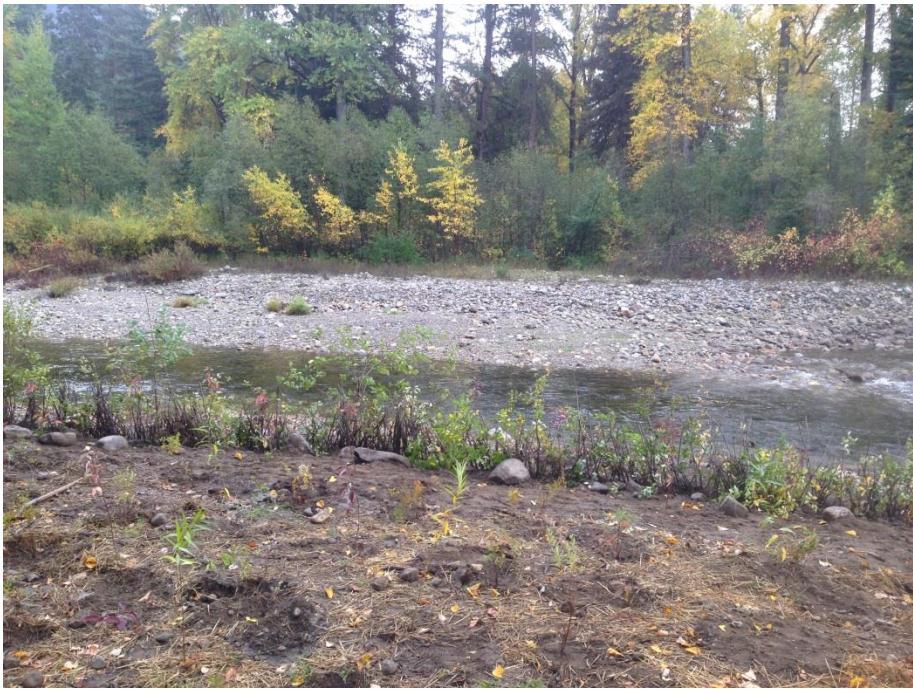
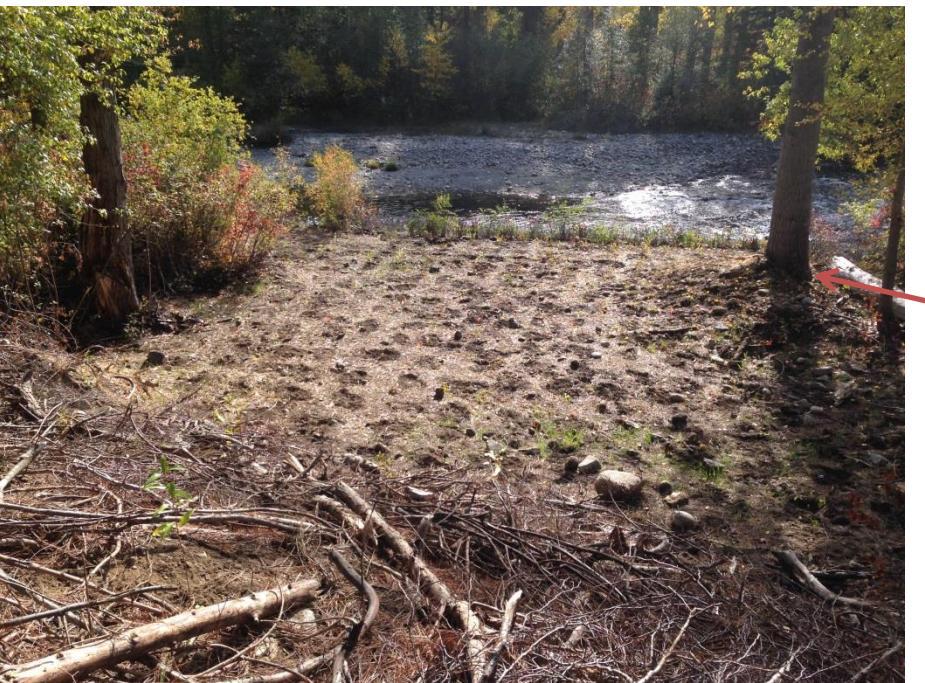
## October 15, 2014

Top photos = Brush Trench with buried wattles Bottom left photo taken from the hillside above the bridge abutment removal area during plant installation. Plants were installed on a grid to facilitate maintenance. Note the ground elevation at the base of the cottonwood for a reference elevation for the floodplain fill removal.

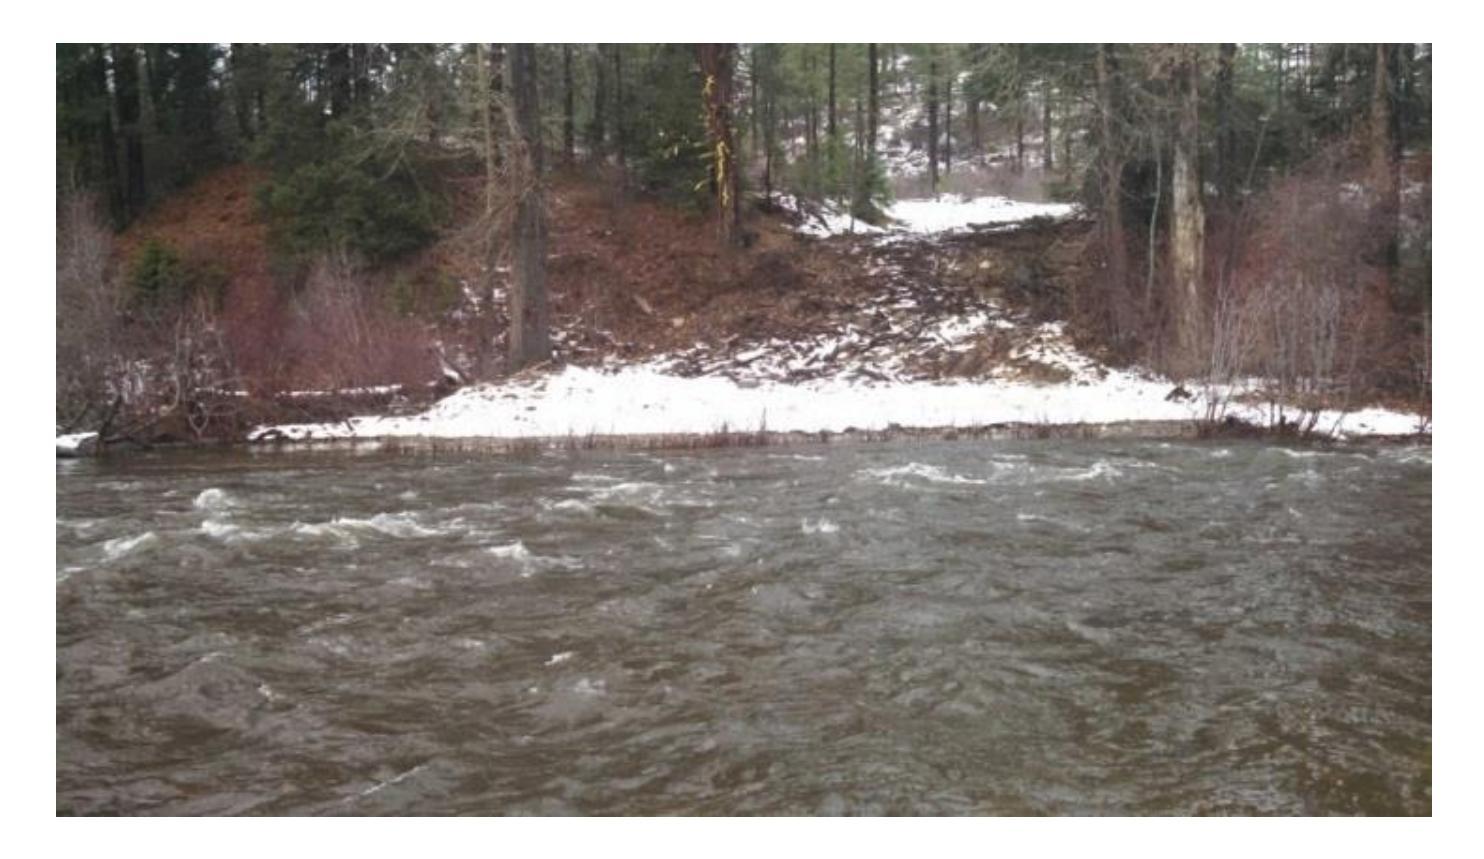
November 2014 The first watering of the bridge abutment removal area during a ~ 2 year event in Nason Creek. So far it looks like the brush trench is still in place!

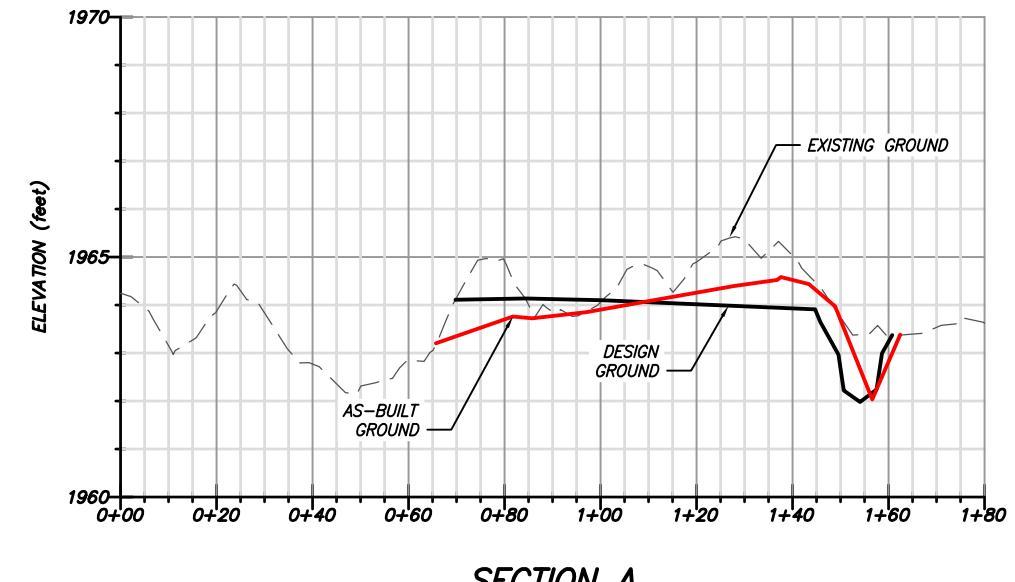
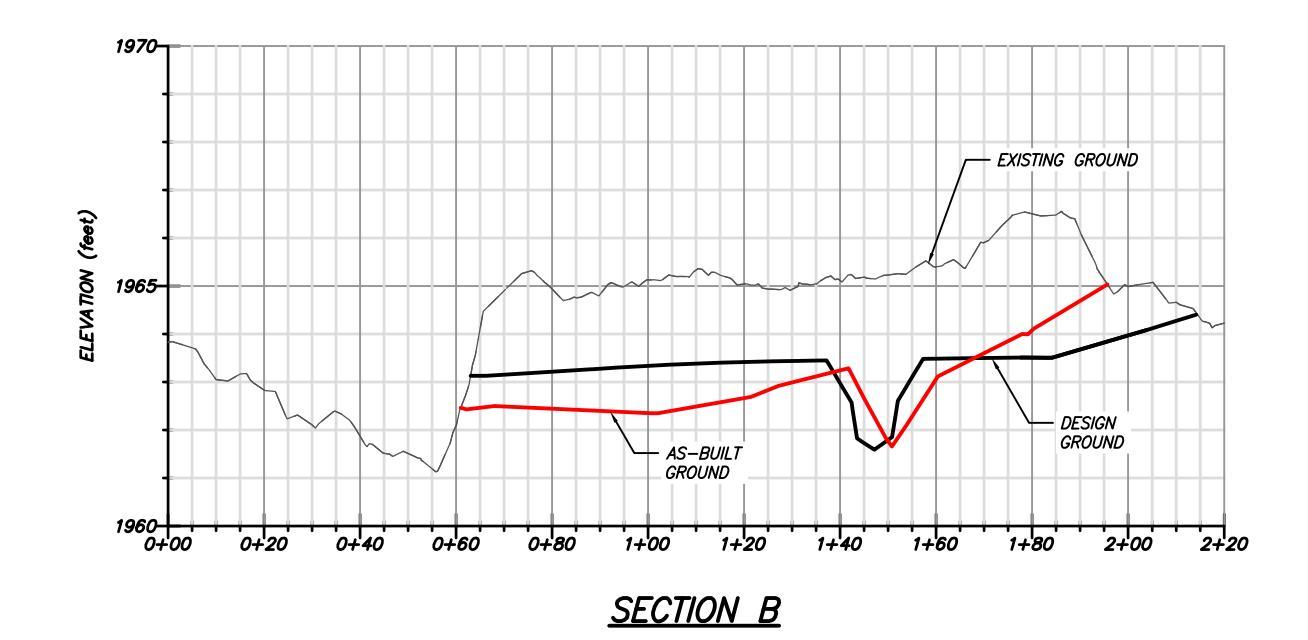
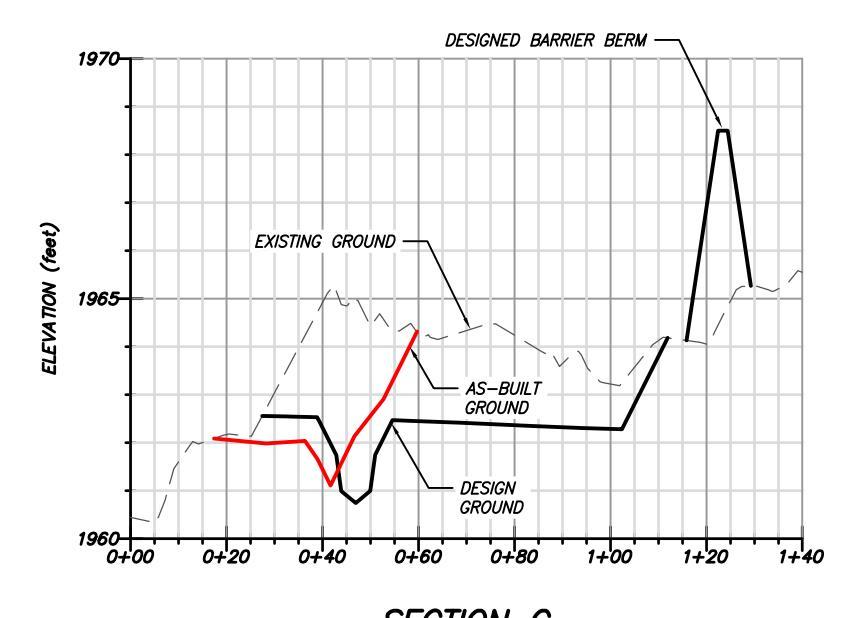
PARKING LOT
REMOVAL SECTIONS

<u>SECTION</u>	<u>C</u>

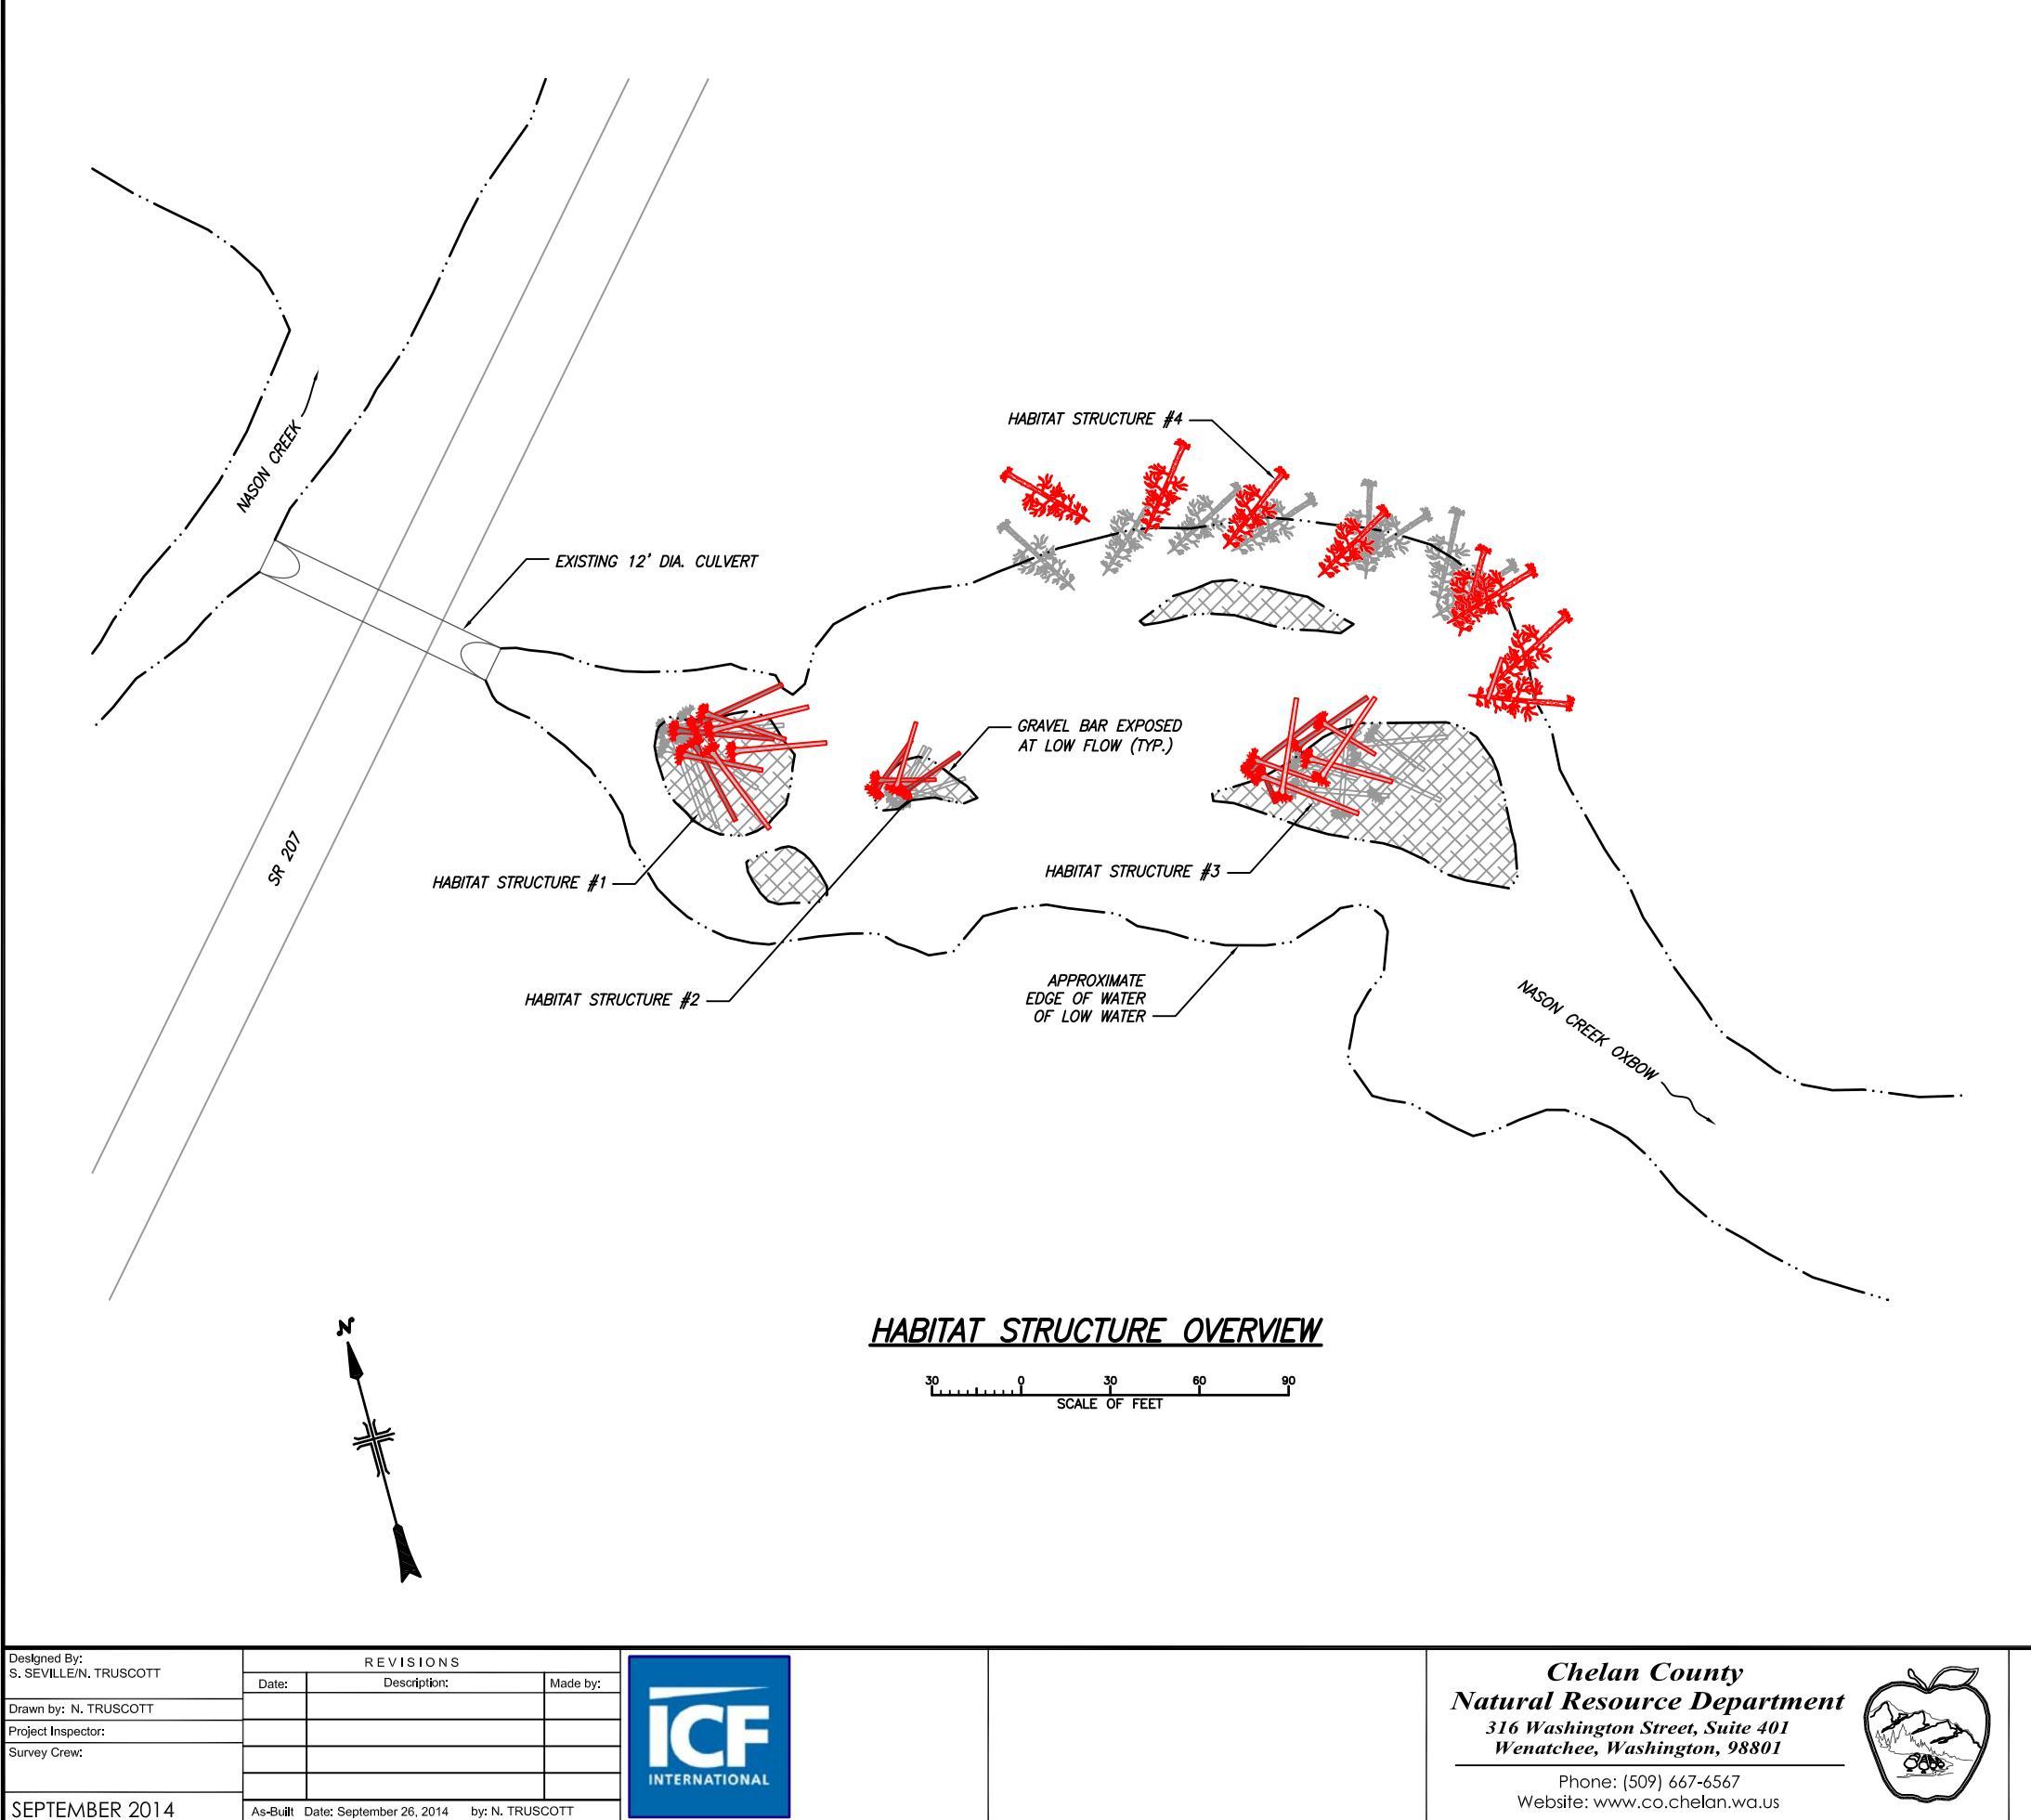
## HABITAT STRUCTURE AS-BUILT OVERVIEW

AS-BUILT LOG LOCATIONS ARE BASED ON A TOTAL STATION SURVEY CONDUCTED BY ICF ON SEPTEMBER 17, 2014.
THE LOCATIONS OF EXPOSED GRAVEL BARS HAVE BEEN APPROXIMATED BASED ON AERIAL PHOTOGRAPHS; THEY WERE NOT SURVEYED.
