WASHINGTON WATER PROJECT

Lower Wenatchee Instream Flow Enhancement Project

Final Narrative Report

July 31, 2013

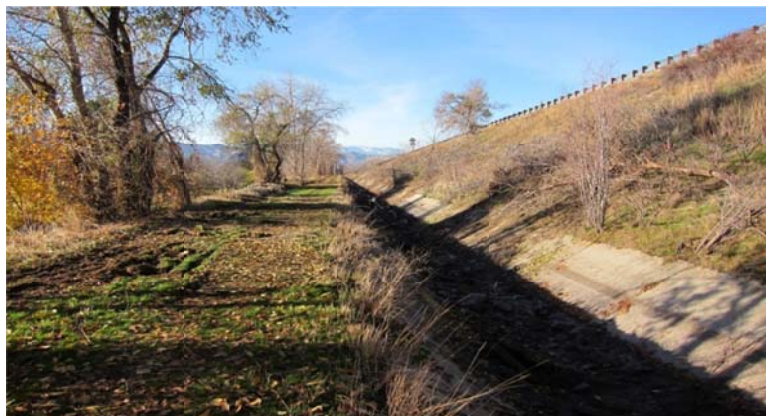
Concurrent with the mass excavation, POW had a crew working on grading and backfilling the existing earthen channel along the entire six miles of ditch on the North River. This included removing some concrete sections of the ditch and a few sections of pipe.

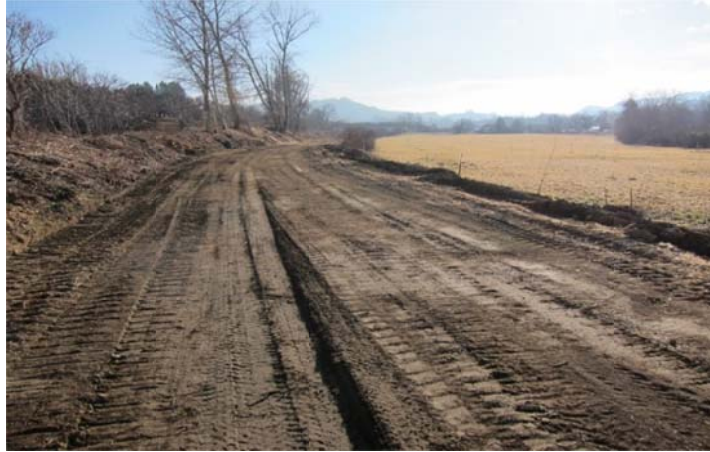
POW graded the ditch first to create room to work. This work included being able to stage HDPE pipe and the extra room was valuable for running the HDPE welder and other equipment on PWUA right of way.

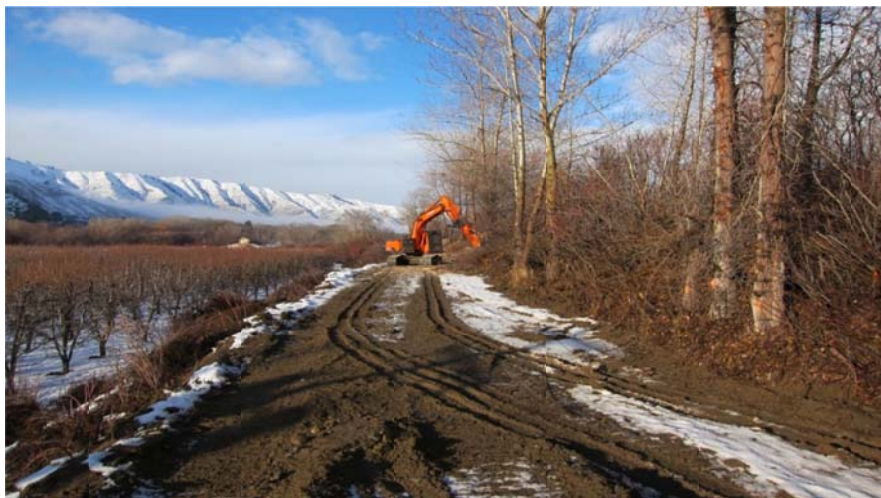
At the same time as the prep work was being done to the existing ditch, POW had two sub-contractors removing all of the trees and brush along the right of way. A total of 1,050 trees were removed during this process, most of which were cottonwood, alder, and elm. One of POW sub-contractors used an excavator with a brush blade. They used this implement like an enormous weed whacker and it was capable of clearing small brush and small trees, with a maximum DBH of 2". Another sub-contractor was strictly a tree removal crew; they took care of all the larger trees and also chipped and mulched all of the trees. The larger trees that could not be chipped were hauled off site.

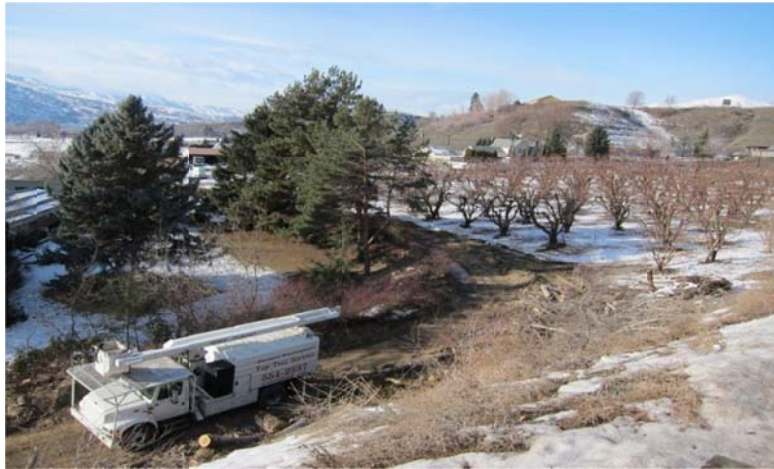
HDPE pipe was the preferred product for this application and was used on the entire Project. With the ditch graded and the trees removed, POW was able to start welding the HDPE pipe. The first 2,500 feet of pipe would be pulled through the existing 3-foot by 4-foot concrete box culvert. The box culvert was utilized on the first section of the new mainline because of issues with bank stability and steepness of the adjacent slope. The recommendation was made by the hydrogeological consultant on the Project, who ultimately determined that disturbing the slope would cause unnecessary harm. This made more sense when the pipe could be sleeved through the culvert instead. In preparation, POW had a crew go through the entire length of box culvert and clean out all rocks, debris and any other sharp objects. This was a precautionary measure to insure that while sleeving, the pipe there would not be damage; HDPE is heavy-duty stuff but it was better to be certain no damage would occur during the long sleeving run.

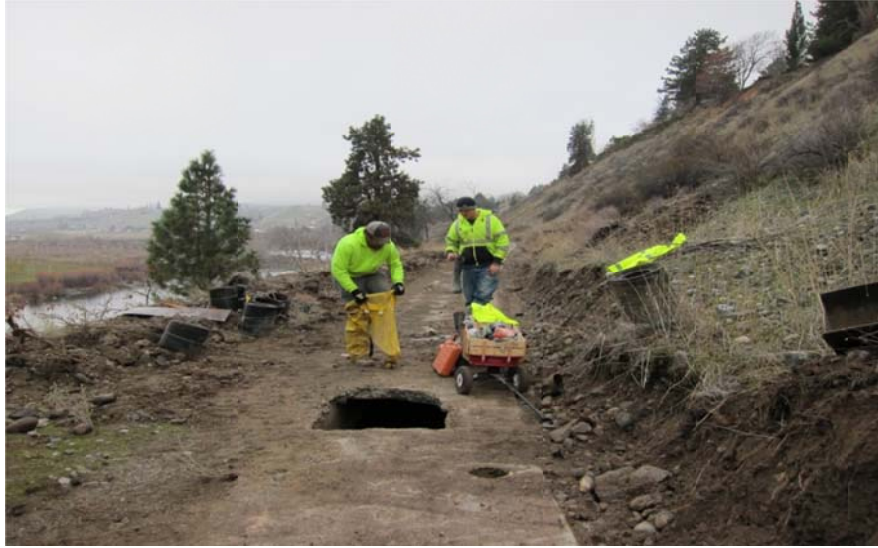
After this was complete, the crew would push 700 feet of pipe through the culvert at a time, using an excavator with a large strap around the pipe. Incrementally, they would push the pipe 15 feet at a time then readjust the strap and push again until they were completely through.

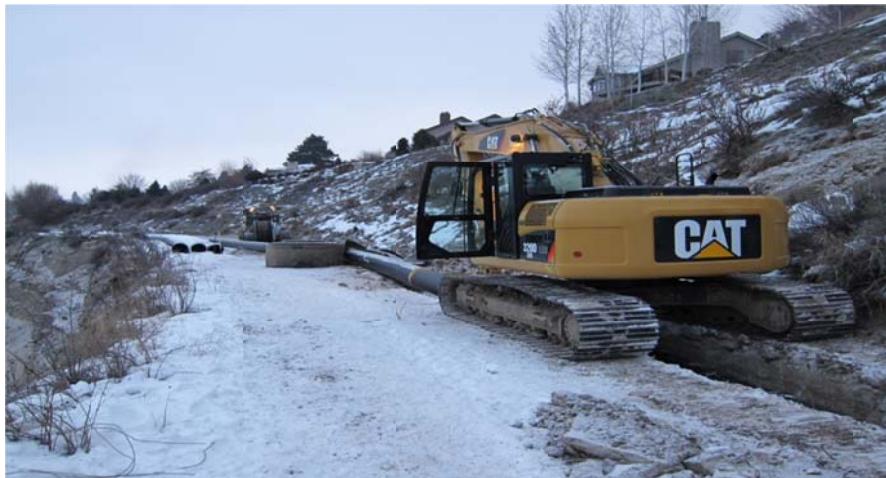
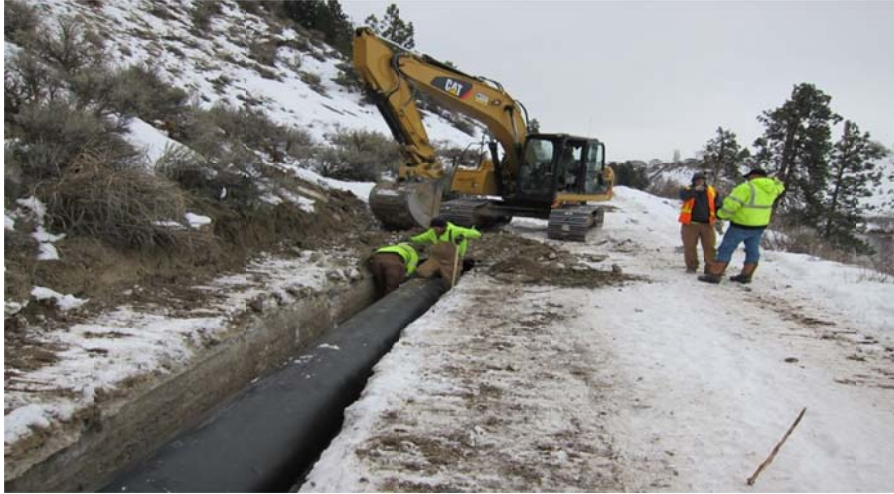
The five miles of pipe beyond the box culvert was installed in a similar fashion; the crew welded 700 feet at a time and then, moved and dragged the pipe into place with a track-hoe. The bulk of the welding started in January and with this amount of pipe to weld together POW had two welding machines going at the same time. The pipe sizes ranged from 24 inch at the pump station and scaled down to 8 inches toward the end of the system, near Monitor. After it was all complete and welded together it was one continuous piece of pipe from start to finish.

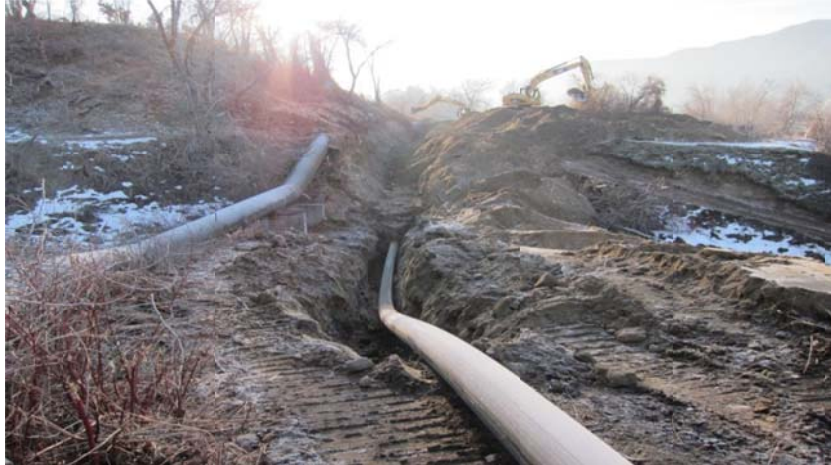
On the left- 3 foot steel pipe from the old gravity canal system, on the right is the new 14 inch HDPE pipe being installed.

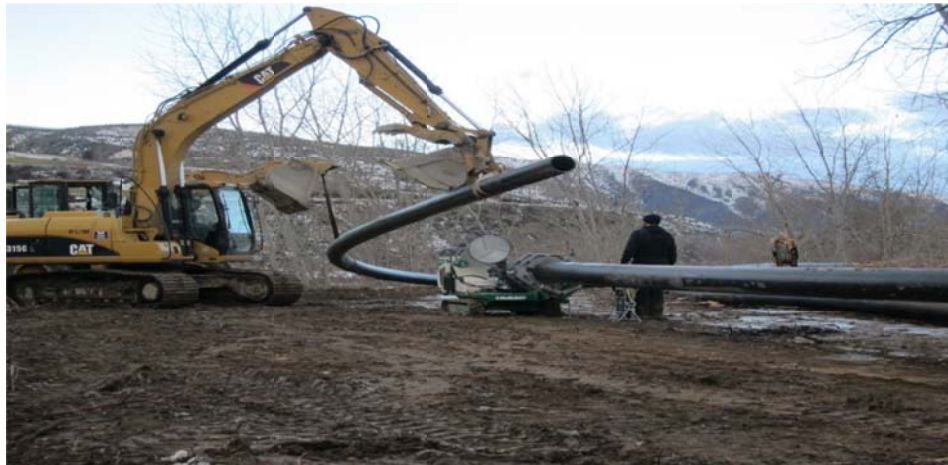
With the mass excavation done and the temporary road down to the river, it was time to start the construction of the coffer dam. The coffer dam was needed to install the fish screen, the suction line and suction header.

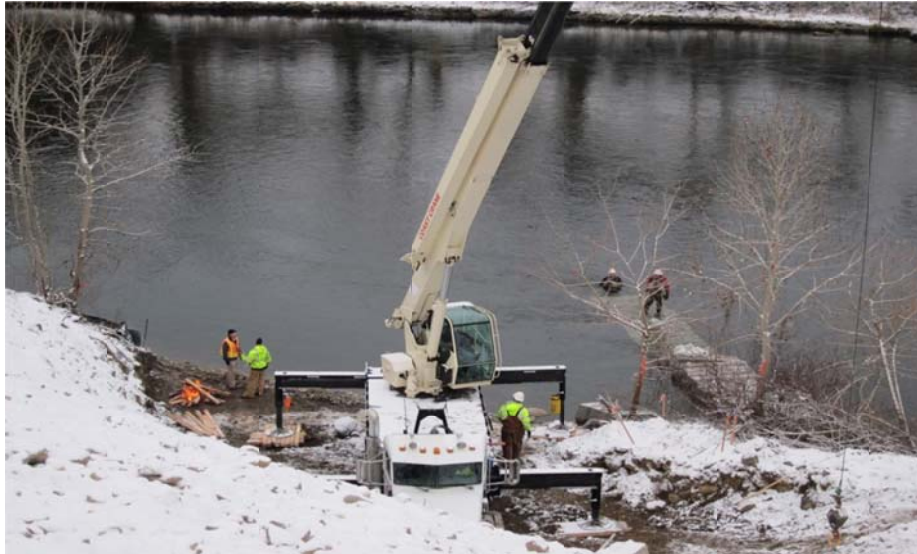
Initially, POW was going to use a product called Porta Dam. Porta Dam uses plastic sheeting and steel bracing to construct coffer dams. For multiple reasons, POW decided to go with ecology blocks to build the coffer dam. To accomplish this they brought in a 30-ton crane to set the ecology blocks, 275 of them in all. After the ecology blocks were set, they used landscape fabric as the inner shell to protect the 12 millimeter plastic sheeting that was placed as the outer shell. This proved to be effective in keeping “most” of the water out of the work area.

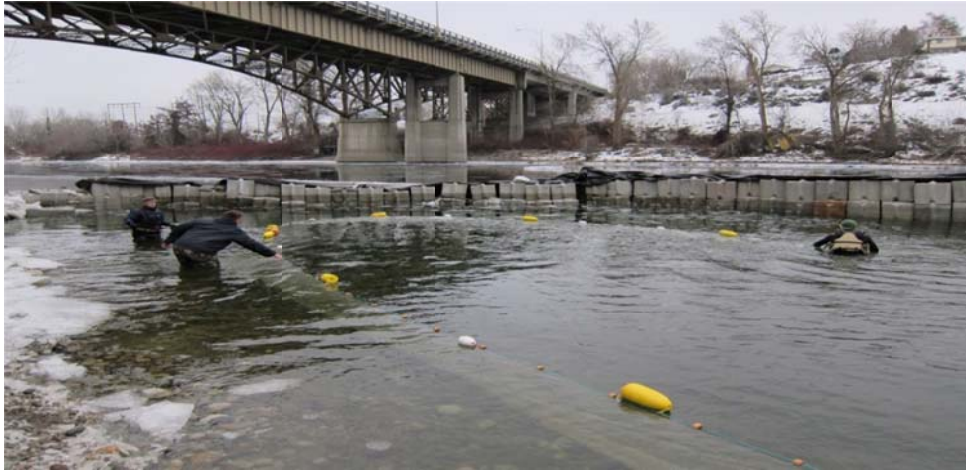
As you can see in the above photo, the crew was working in some pretty challenging conditions; the temperature was in the low to mid 20's. Three biologists were onsite and conducted the fish removal with assistance from divers working on the coffer dam. Fish capture gear onsite included beach seines, various sized fish nets (long handled and small mesh minnow nets), and buckets.

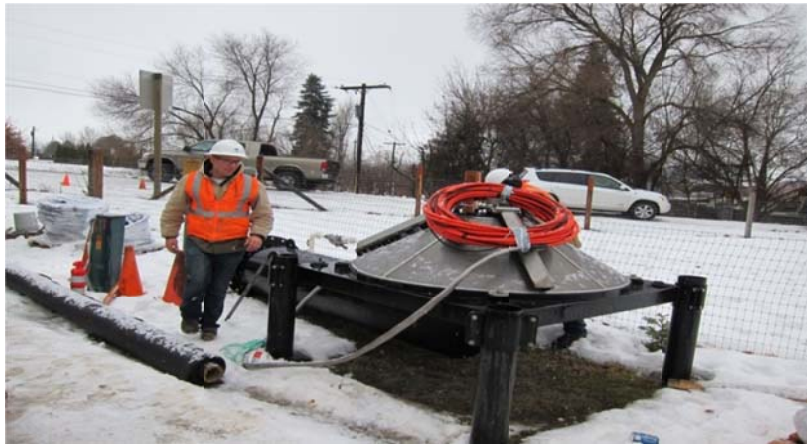
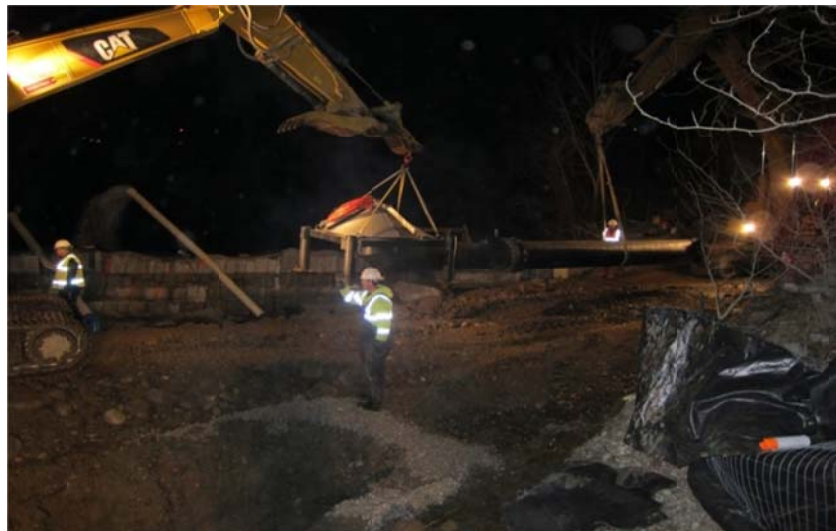
With the fish screen in place, next came the suction line and suction header. PWUA chose to go with 24-inch ductile iron for the suction and the suction header was 24-inch steel. This work was tedious and progress was very slow because precise elevation of the suction line was needed. Generally, it took the crew about eight hours to go 20-feet, during excavation and placement.

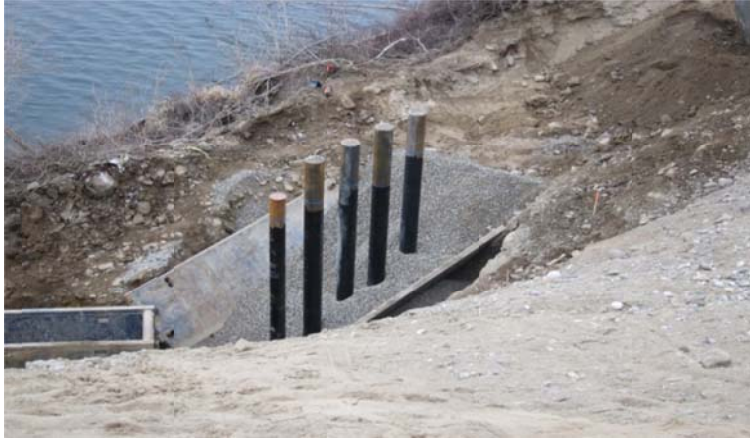
Near the beginning of March, with the fish screen and suction line installed, the pump house was next on the agenda. The construction of this went quickly, in no time POW had the footings and floor poured and the framing done.

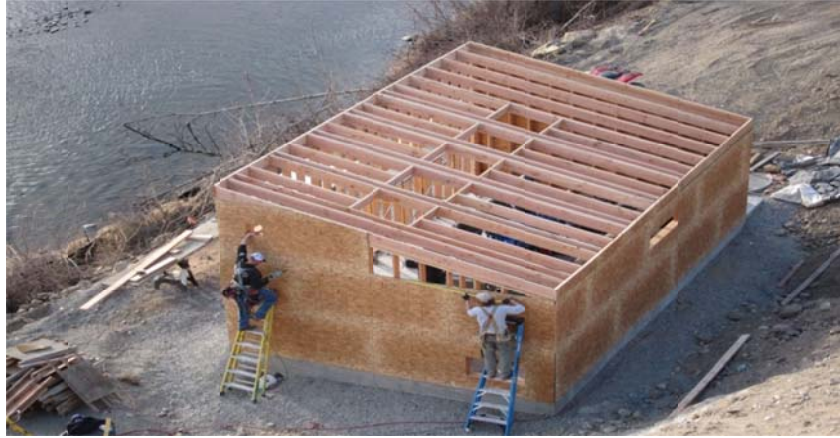
At the same time the construction of the pump house was being done, the heart of the system was also being installed; this consisted of all the electrical, including five VFD aqua drives (one for each motor, four 75 hp and one 25 hp); along with five vertical industrial turbine type Gould pumps. The 25 hp was installed to take care of low water use times when demand is under 250 gpm. Once the demand exceeds 250 gpm, a 75 hp will come on-line and the 25 hp shuts off.

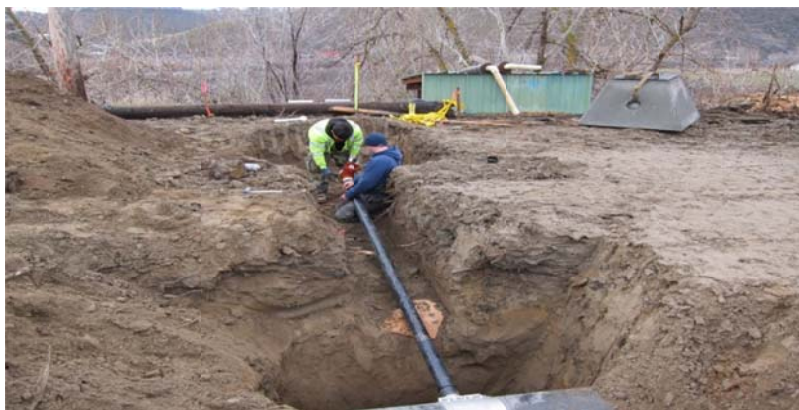
By the middle of March the pump house building was nearing completion, all the HDPE pipe was installed, and the services connections were close to completion.

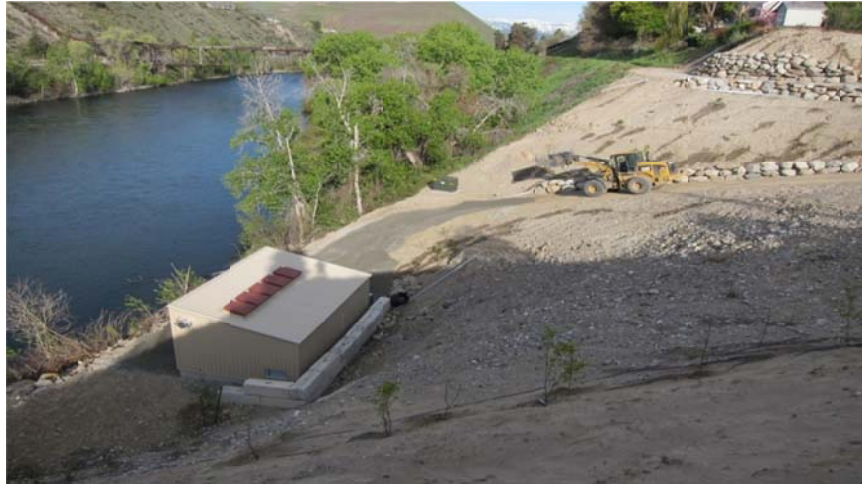
With the April 1st completion date just around the corner, POW had a few more things to accomplish. The road crossings for some service connections were one of the last pieces of the Project to complete and they created some challenges. Locating existing water lines was time consuming along the county road right-of-way but in the end the necessary four main road crossings were completed.

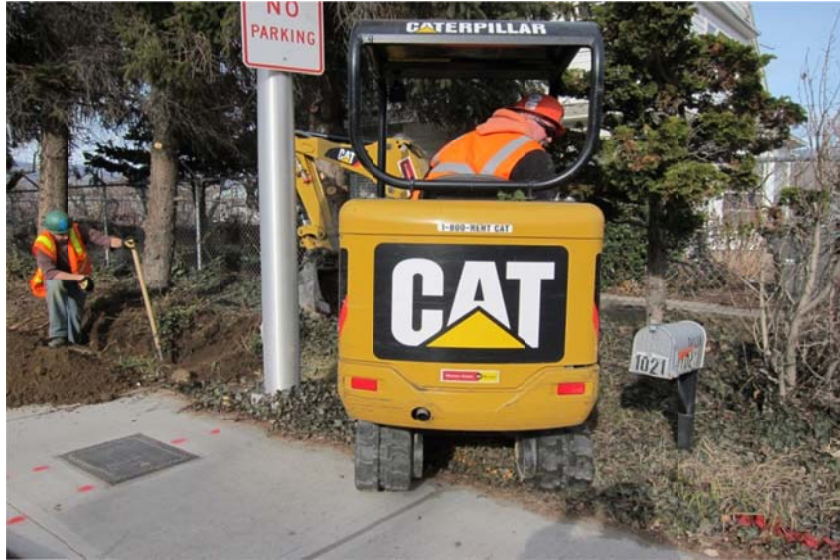
One of the challenging issues the crew faced on the Walla Walla project were the 10 road crossing. They were time consuming, particularly with consideration of the traffic on Walla Walla Avenue. POW would do half of the road at a time and then move the traffic to the opposite side while working. Once one side was completed, they moved over to the other side and changed the traffic lane. This proved to be an effective way to accomplish this part of the project. Every road crossing had a carrier pipe installed, which the mainline was placed through; this will help if PWUA ever needs to replace the pipe under the road.

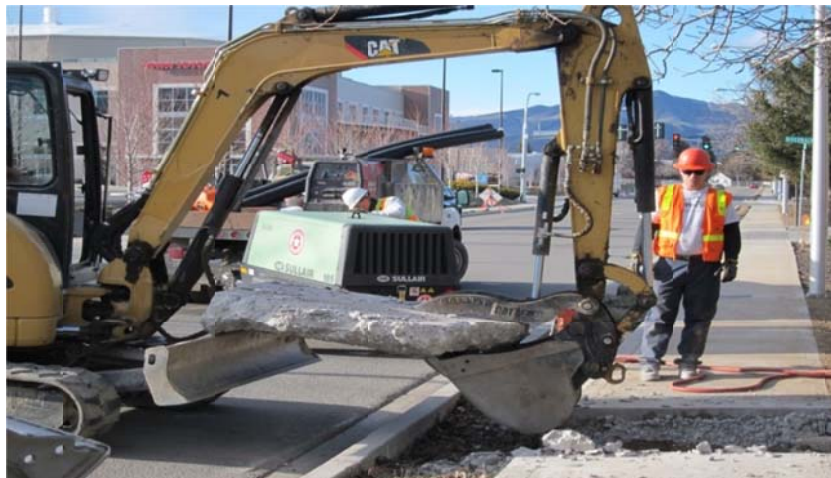
The Walla Walla HDPE was welded the same way as the North River project, except on a smaller scale. Basically, the crew welded the pipe in place, then put it in the trench and back filled. This worked out very well and the crew made good progress.

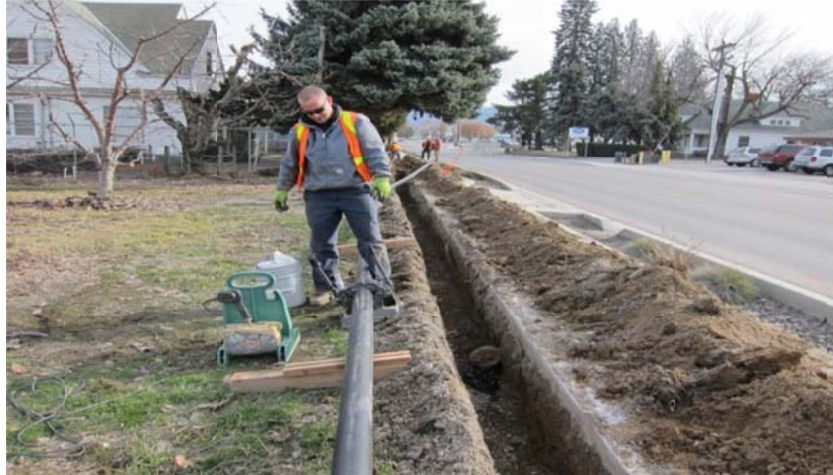
All service connections were installed in an irrigation box with a 2-inch gate valve with a restrictor pipe at each property owners' parcel. Like the North River project, the sizes of the restrictor pipe were based on shares, which correlates to irrigated acres.
